## Incident Summary #II-747636-2018 (#8333) (FINAL)

SUPPORTING INFORMATION	Incident Date	August 23, 2018	
	Location	Cranbrook, BC	
	Regulated industry sector	Boilers, PV & refrigeration - Refrigeration system	
	Impact	Qty injuries	0
		Injury description	None
		Injury rating	None
	Damage	Damage description	Cross-contamination between ammonia and brine side of a chiller vessel (tube leak)
		Damage rating	Major
	Incident rating	Major	
Incident overview	Contamination occurred between the ammonia (shell side) and brine (tube side) of the shell and tube brine chiller, Figure 1. The presence of ammonia was detected in the brine by sensory evaluation (smell) while troubleshooting start-up issues. The plant was shut down and emergency actions were taken to remove ammonia from the system.		
INVESTIGATION CONCLUSIONS	Site, system and components	Shell and tube exchanger section of a skating rink refrigeration system. Under normal operation the ammonia and brine systems are separate. Heat is extracted from brine in the tubes and transferred to liquid ammonia on the shell side via tube surfaces within the chiller. Heat extraction is controlled by the operating pressure on the ammonia/shell side

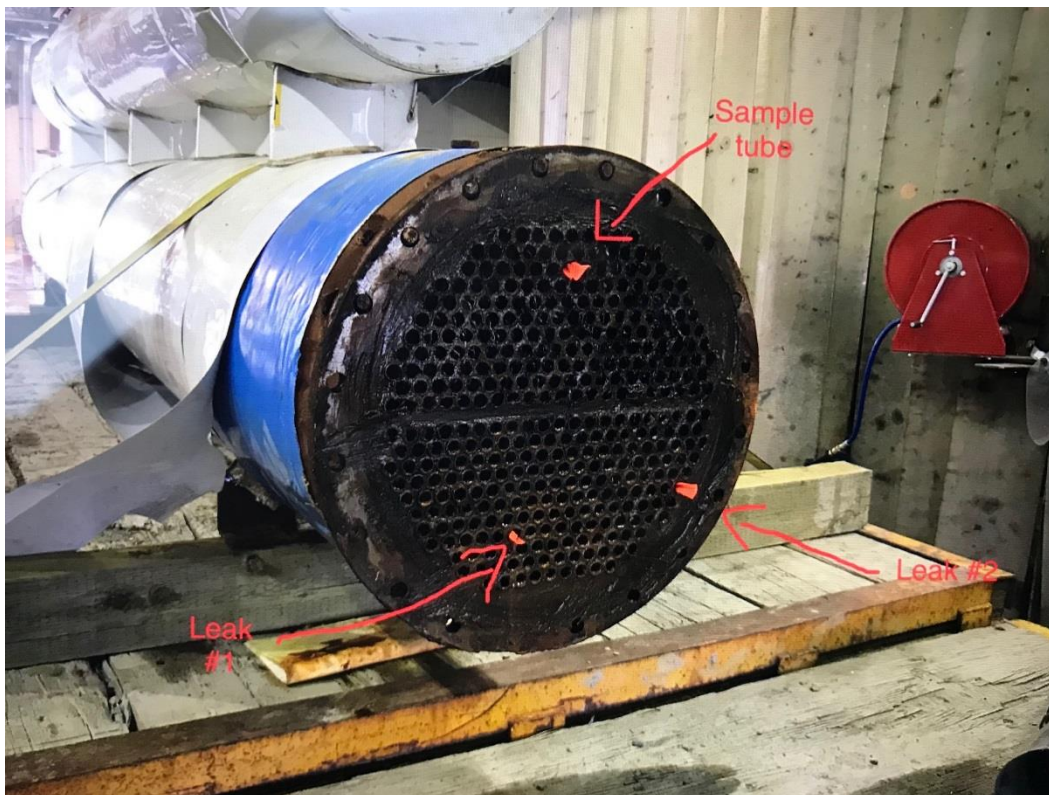
Figure 1: Chiller partially disassembled to examine brine tubes, two tubes found to have leaks.

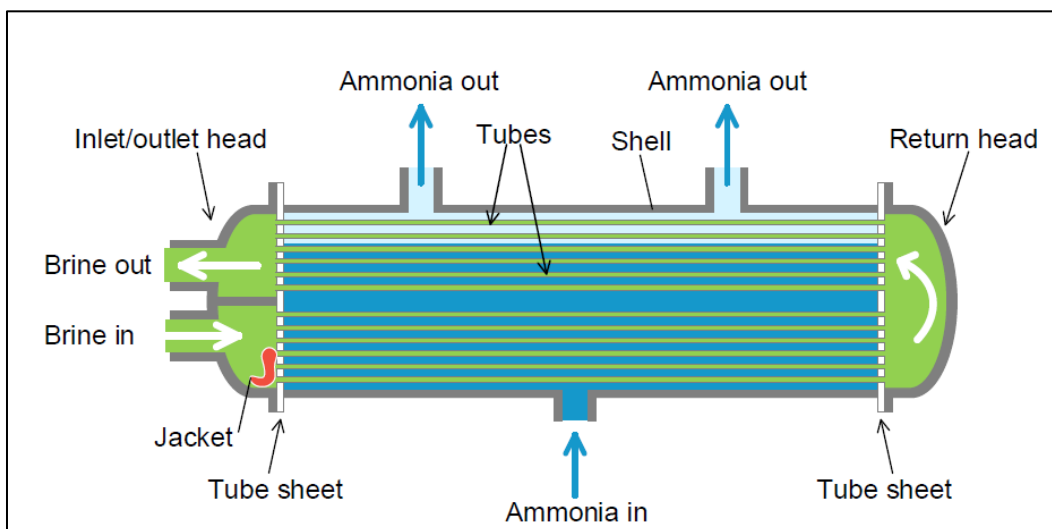
The presence of weld defects and chiller age likely caused the tube leak failure. It is possible that flow disruption due to the jacket blocking some brine tubes may have created conditions that also increased the rate of corrosion within the chiller.

Figure 2: Diagram showing the approximate position of the jacket in the chiller vessel

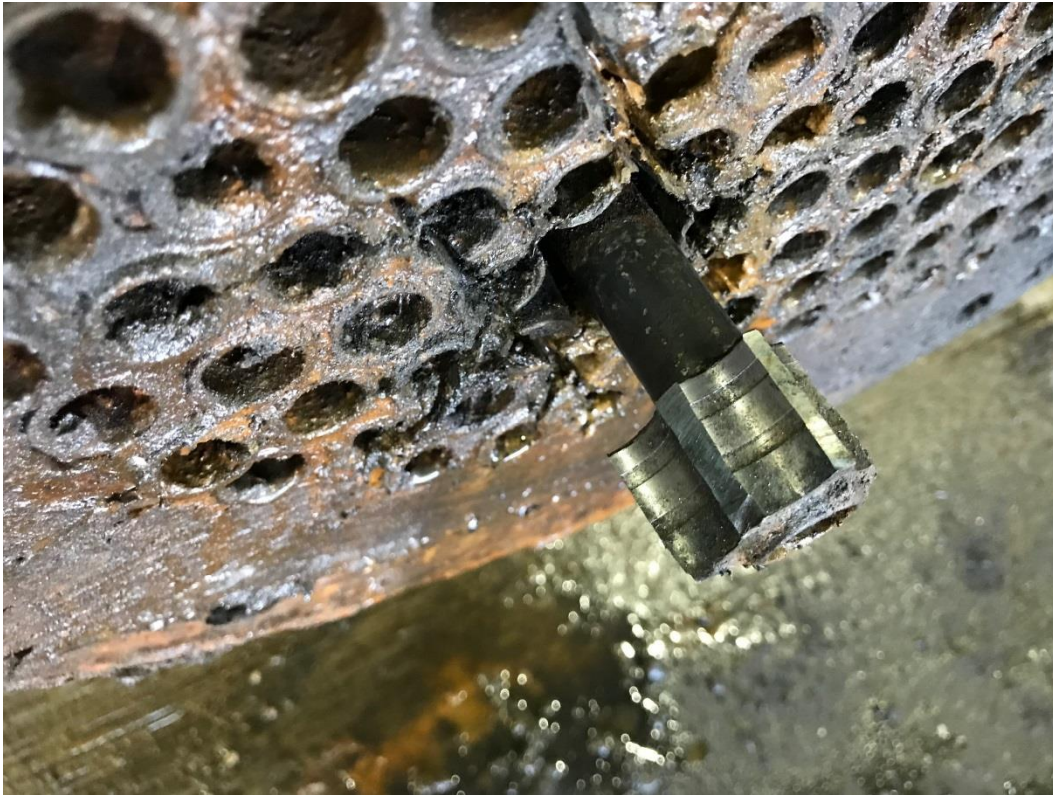
Figure 3: Tube being removed for analysis

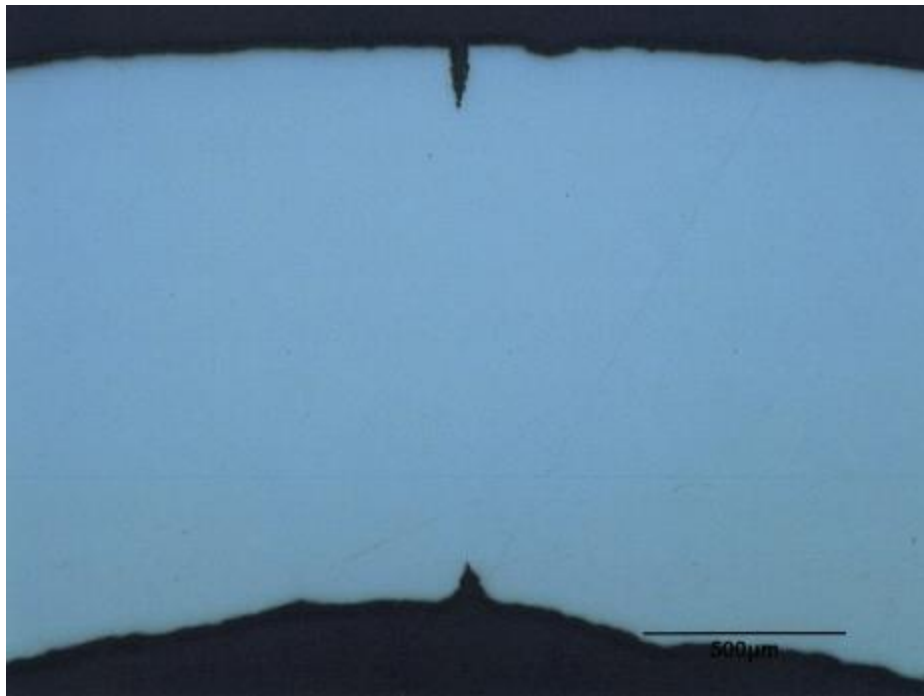
Figure 4: View of tube cross-section showing cracks initiating on the outside and inside wall along weld line.

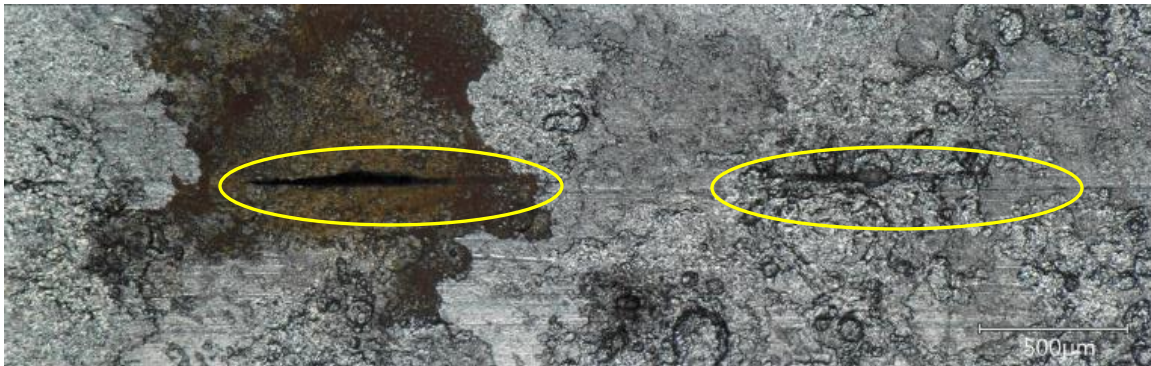
Figure 5: Cracks along the weld line on the outside wall of the tube.

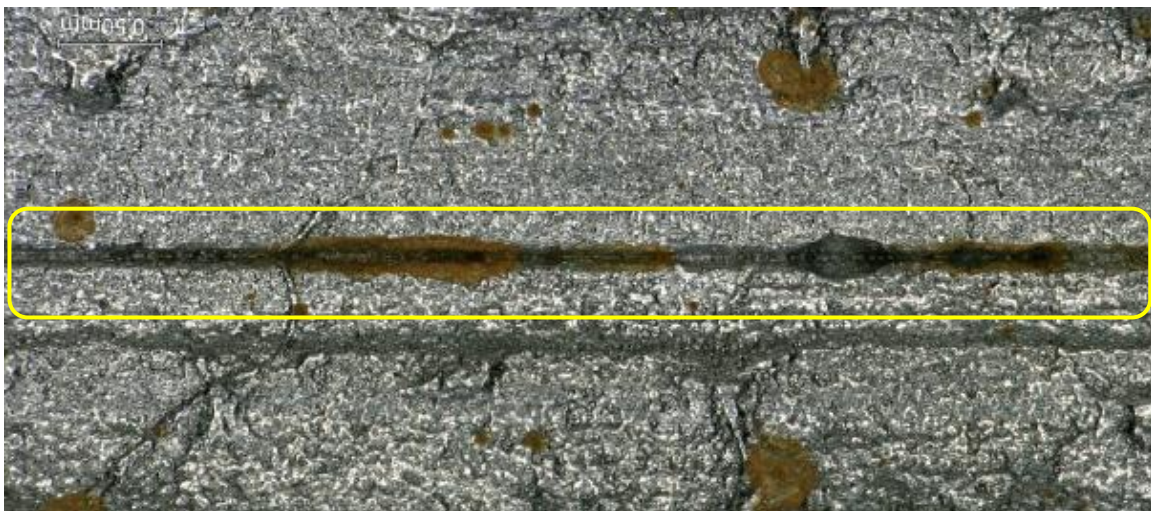
Figure 6: Weld fusion line defect found on the inside wall of the tube.
