Incident Summary #II-890649-2019 (#14784) (FINAL)

SUPPORTING INFORMATION	Incident Date	August 10, 2019	
	Location	Squamish	
	Regulated industry sector	Passenger ropeways - Above surface ropeway	
	Impact	Qty injuries	0
		Injury description	N/A
		Injury rating	N/A
	Damage	Damage description	A haul rope separated and numerous gondola cabins fell to the ground. Some were pulled along the path due to topography or the released energy from the separated haul rope. Numerous cabins were damaged beyond repair. The haul rope came off of the sheave assemblies at numerous towers and was suspended within trees at locations along the length of the gondola path.
		Damage rating	Major
Incident rating	Major		
Incident overview	At approximately [REDACTED] on August 10, 2019, overnight security personnel located in buildings at the top and bottom of the gondola each reported hearing a loud noise and shortly after 5am confirmed that gondola cabins located at the stations were on the ground with damage to the cabins and stations.

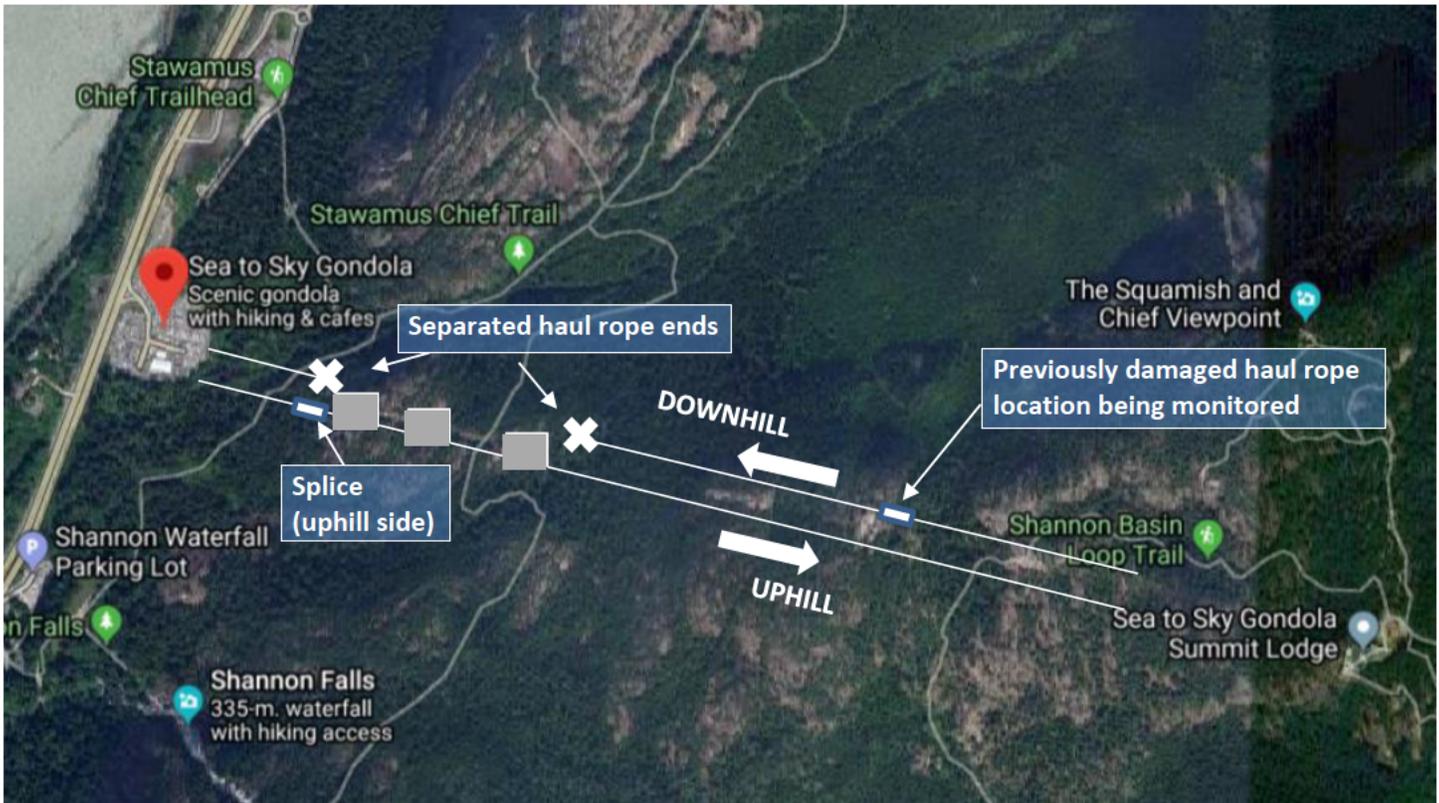
Image 1: Diagram of gondola line showing approximate locations of haul rope [redacted]. White X's illustrate the approximate locations where the separated ends of the downhill side of the haul rope were found. The splice was found downhill of tower [redacted] on the uphill side of the haul rope. A known area of previous haul rope damage that was identified for maintenance monitoring was found on the downhill side near tower [redacted]
