Incident Summary #II-1659120-2024 (#43277) (FINAL)

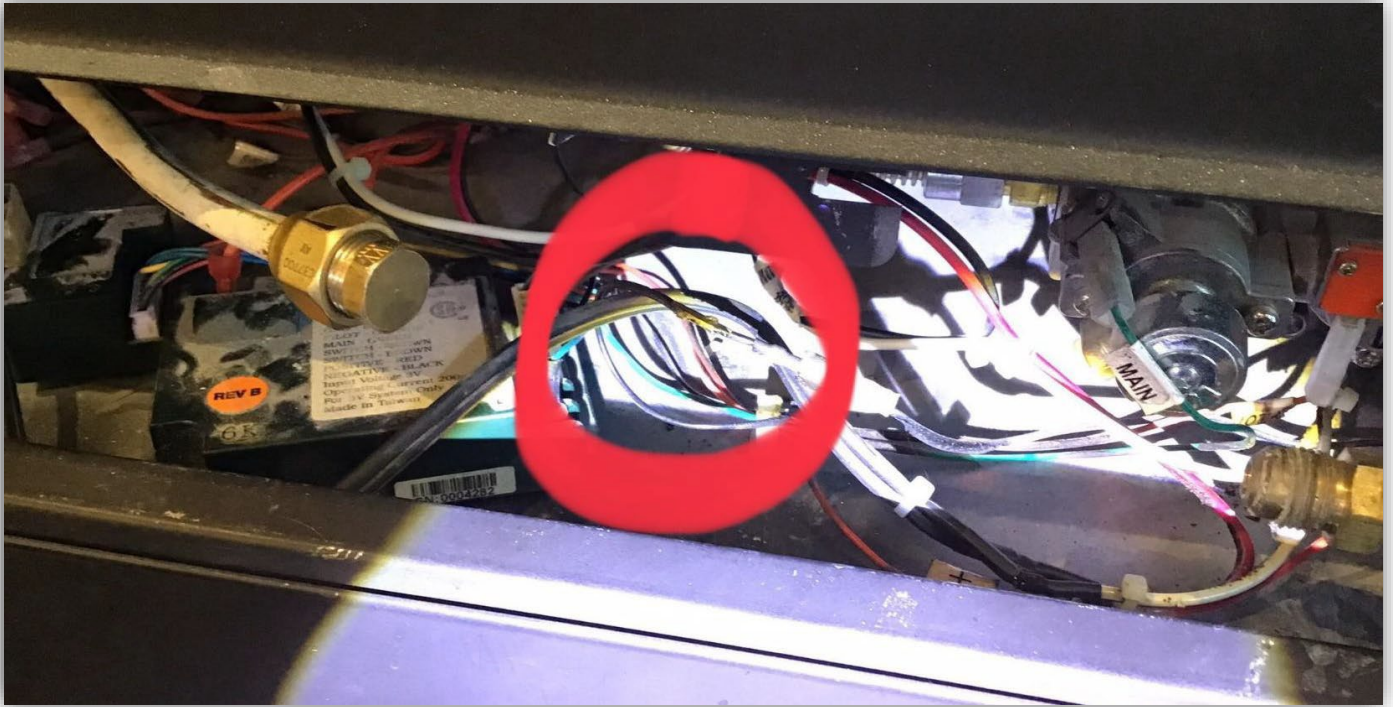
Failure scenario(s)	<p>During the fireplace service, the technician bumped the factory 120V line voltage wiring contacting the gas line resulting in an arc. This arc perforated the gas line resulting in a release of gas and ignition.</p> <p>Further investigation revealed a damaged factory crimp/joint in the wiring with the un-insulated conductor exposed.</p>	
	Facts and evidence	<ul style="list-style-type: none"> Image below shows damaged wiring. The gas line was cut and capped to make safe and was not available for review. 	
	Causes and contributing factors	An open conductor due to a manufacturing defect or possible field damage allowed the energized wire to contact the copper gas line creating an arc, a hole, and igniting the escaping gas.

Image – Damaged conductors below fireplace.
