Incident Summary #II-1021754-2020 (#18134) (FINAL)

SUPPORTING INFORMATION	Incident Date	June 5, 2020	
	Location	Abbotsford	
	Regulated industry sector	Boilers, PV & refrigeration - Refrigeration system	
	Impact	Qty injuries	0
		Injury description	No injury reported
		Injury rating	None
	Damage	Damage description	A piping connection failed and released ammonia that was intended to be contained within the refrigeration system.
		Damage rating	Moderate
	Incident rating	Moderate	
Incident overview	The ammonia piping connection within a refrigeration system of an industrial food processing facility failed and released ammonia in a cold storage room.		
INVESTIGATION CONCLUSIONS	Site, system and components	<p>Ammonia refrigeration systems are typically designed for maximum allowable working pressure of 250 psig on the high pressure side and 150 psig on the low pressure side. The refrigeration cycle contains four major components; compressor, condenser, evaporator and expansion devices. The refrigerant remains piped between these four components and is contained in the refrigerant loop. In cold storage facilities, food products are kept well below freezing for maintaining their texture an

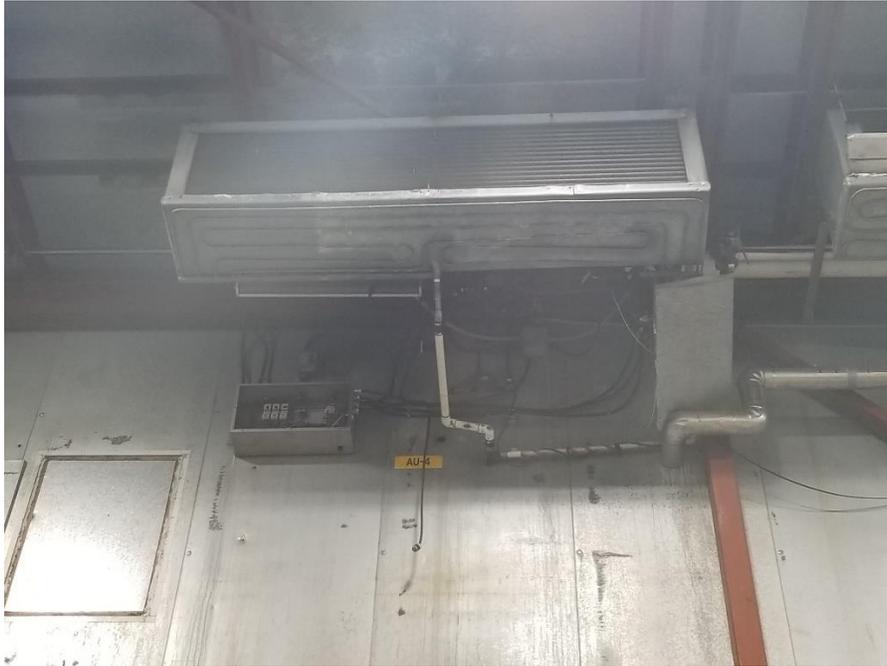
Fig. 1: Evaporator (Image provided by repairing contractor)

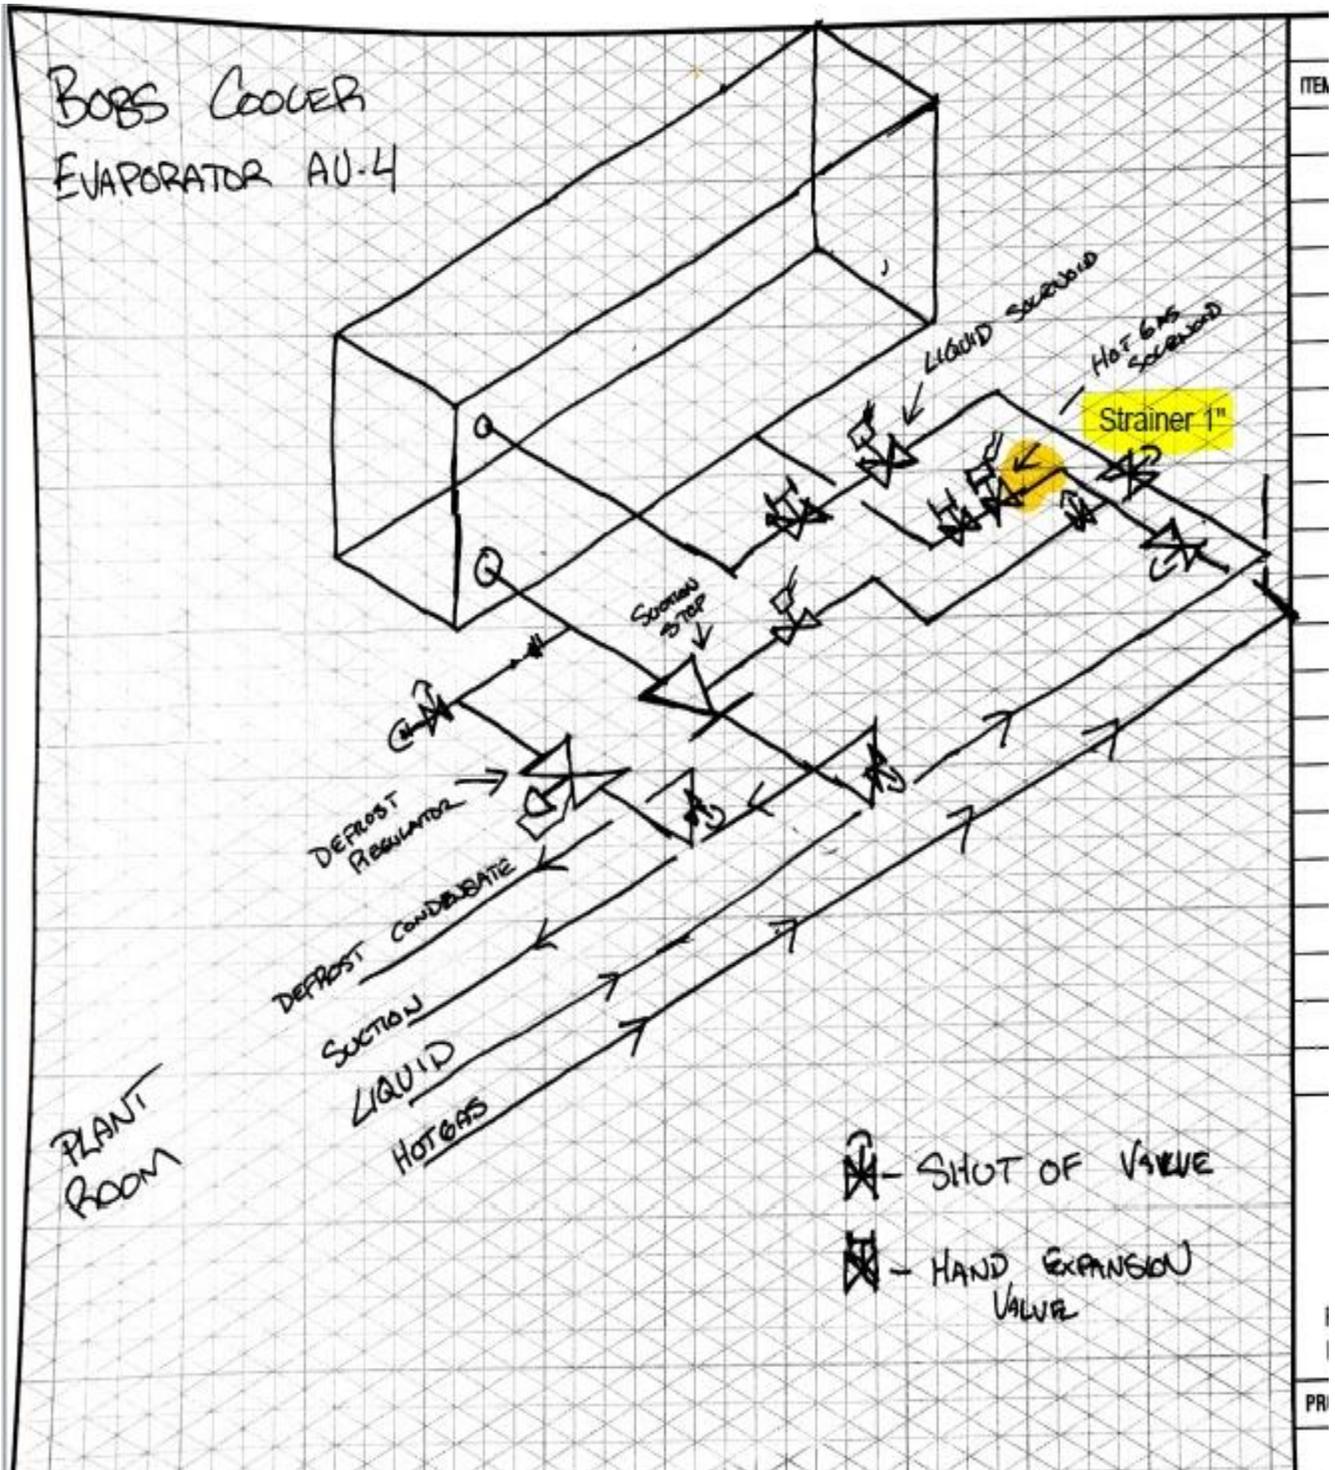
Fig. 2: Location of Leak (Image provided by repairing contractor)

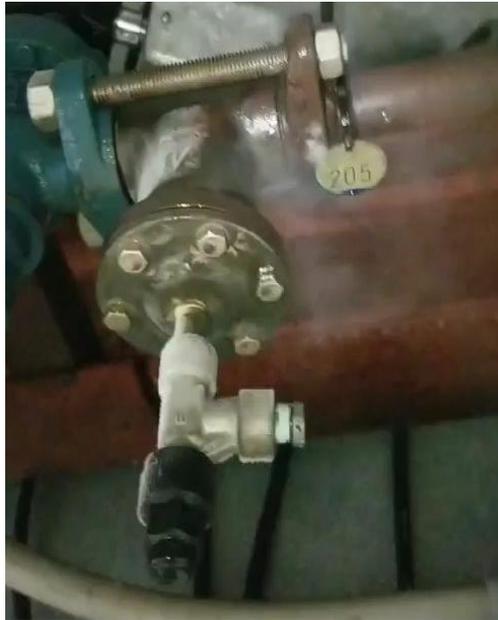
<p>Failure scenario(s)</p>	<ul style="list-style-type: none"> In the cold storage room, ammonia from the flanged valve (strainer – Fig.3) of the hot gas defrost line was released which triggered the audio ammonia alarm. The ammonia monitor located outside the cold storage room showed 400 ppm and then dropped to 0 ppm when the hot gas system was shut off. Doors were opened and Industrial fans were used to move ammonia fumes out of the cold storage room and out of the building.
<p>Facts and evidence</p>	<p>Plant activities</p> <ul style="list-style-type: none"> The evaporator and the associated ammonia system in the cold storage room was in operation. The alarm went off at 2:45am. At 3:00am, the unit that was leaking the ammonia was shut down. Then, the system was operated in suction to prevent any further release. Maximum ammonia reading noted was 400 ppm. The maintenance contractor was contacted. The plant building was evacuated. Maintenance contractor identified the leak and isolated the system The industrial fans were turned on and exterior doors were opened to help exhaust the ammonia. <p>Maintenance contractor's activities</p> <ul style="list-style-type: none"> Maintenance contractor isolated the refrigerant liquid line and hot gas line. The maintenance contractor investigated the leak and performed pressure test by using nitrogen. The leak was found on the Strainer cover plate and flange connection of defrost hot gas line (inlet side of evaporator). Repair was performed by replacing the strainer, flange, gasket and bolts Then, the lines were pressure tested before use. <p>Phone Interview with Chief Engineer and Maintenance supervisor & Manager</p> <ul style="list-style-type: none"> Reported the above mentioned plant and maintenance contractor's activities Informed that the piping was installed in 1980s, the lines were pressure tested two weeks ago but no other inspection was performed on piping (hot gas line) Also informed that only Gasket was found deteriorated upon detailed inspection (Fig. 4 & 5) <p>Information gathered from the manufacture's recommendations:</p> <ul style="list-style-type: none"> Recommendation for maintenance: The owner/user must establish appropriate service and/or replacement intervals for refrigeration system parts (fittings, valves, gaskets etc.), these products do wear and can deteriorate over time. Environmental conditions can significantly accelerate this process. The valves and gaskets need to be serviced or replaced on routine intervals. <i>(Copied from manufacturer's recommendations)</i> Recommendation for Design: Valves/ fittings part of refrigeration piping can and do fail without warning for many reasons. Thus, design all systems and equipment in a fail-safe mode, so that failure of these products and related accessories will not endanger persons or property. <i>(Copied from manufacturer's recommendations)</i>

Fig. 3: Strainer cover plate and flange (picture taken during leak investigation)

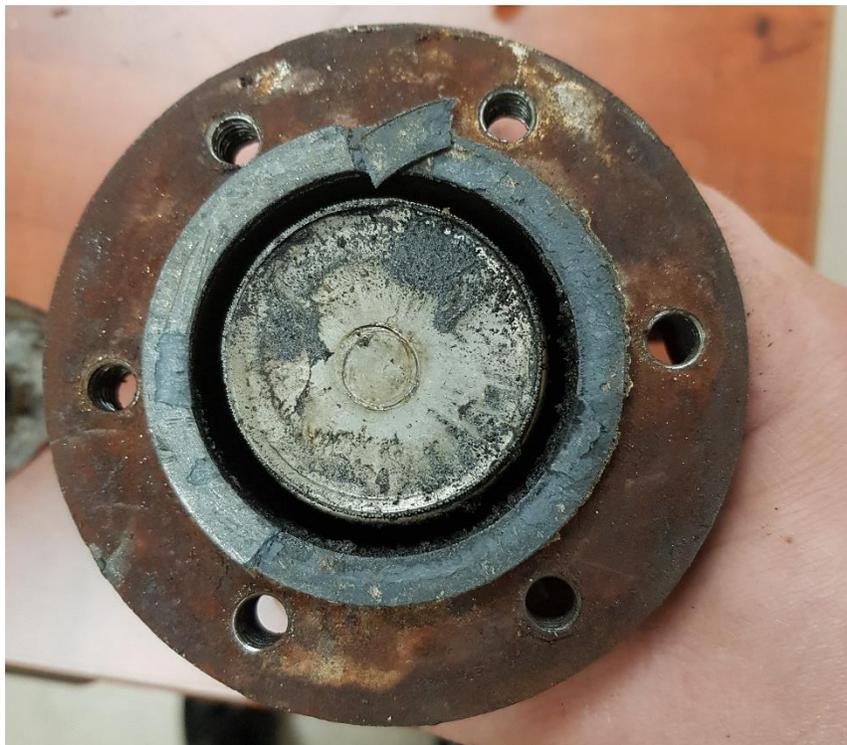
Fig. 4: Gasket

<p>Causes and contributing factors</p>	<p>It is very likely that the gasket associated with the strainer valve failed as it deteriorated over time. The gasket was never replaced since it was installed in the 1980s despite the manufacturer's recommendation for service and/or replacement at appropriate intervals.</p>

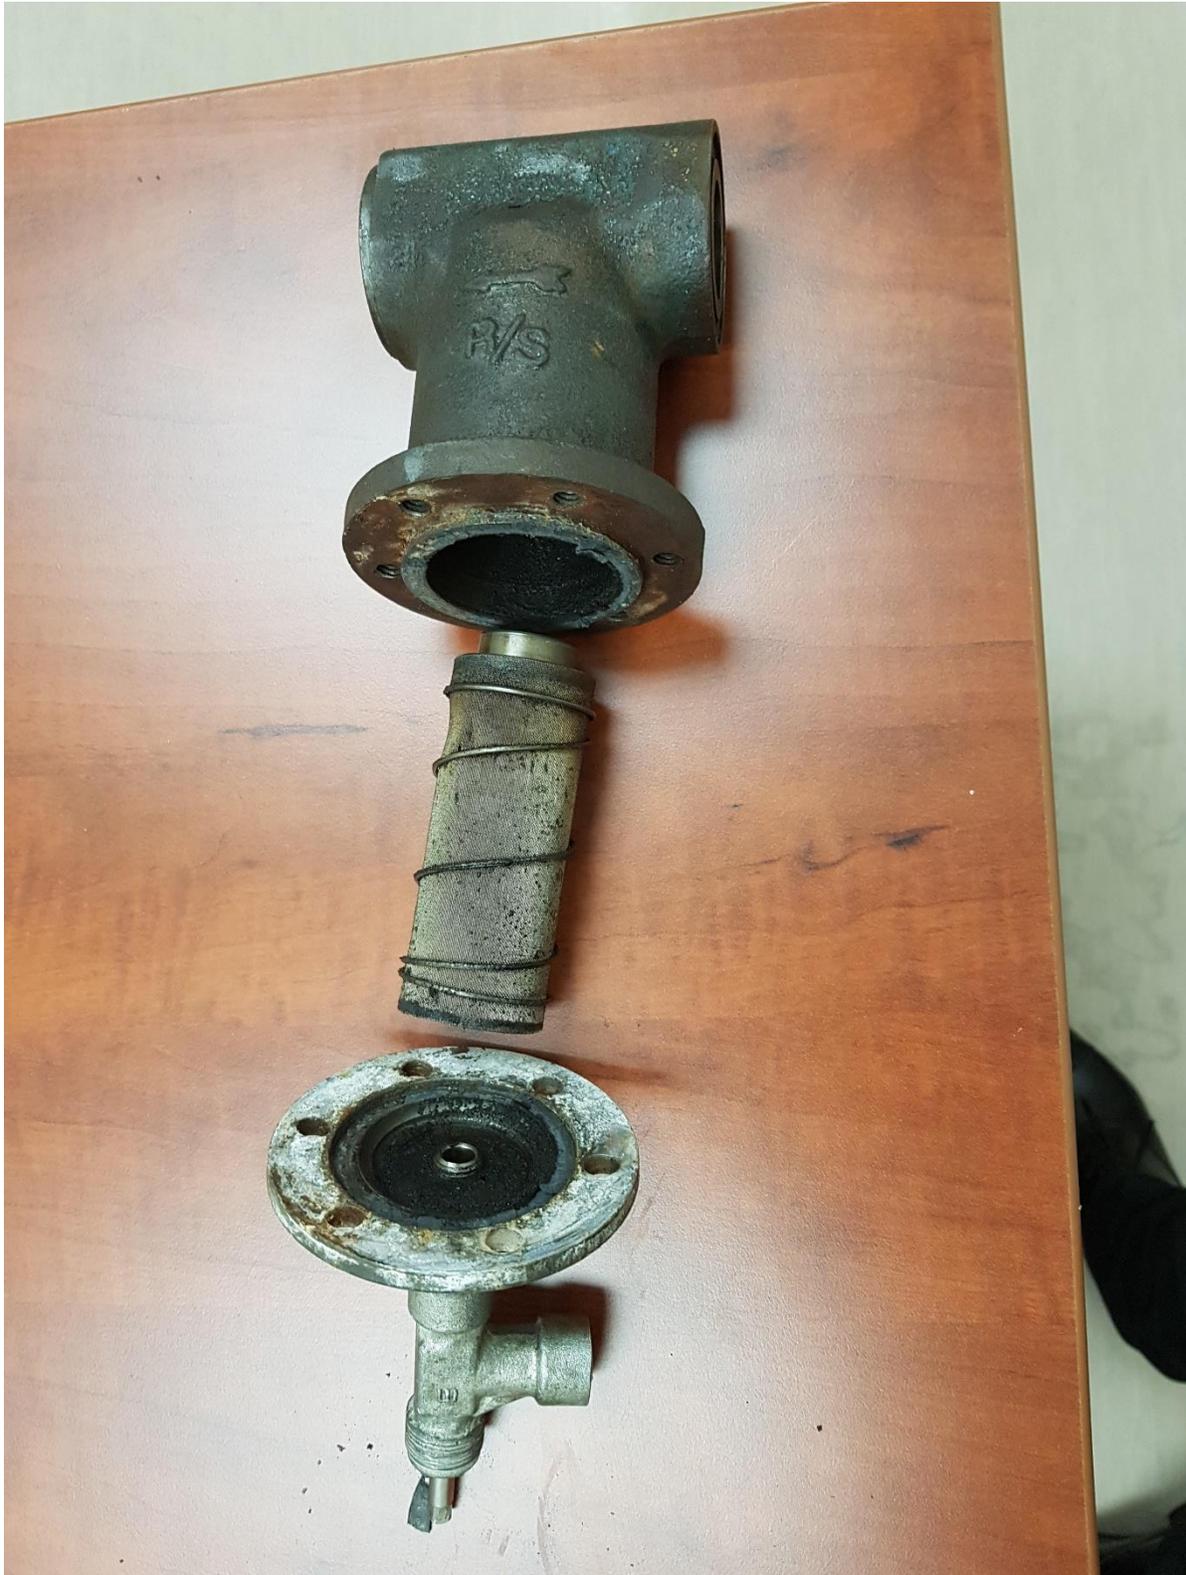
Fig. 5: Strainer parts
