## Incident Summary #II-1069070-2020 (#19265) (FINAL)

SUPPORTING INFORMATION	Incident Date	September 18, 2020	
	Location	Nanaimo	
	Regulated industry sector	Gas - Natural gas system	
	Impact	Qty injuries	0
		Injury description	NA
		Injury rating	None
	Damage	Damage description	An uncontrolled release of natural gas on a newly installed piping system, resulted in a fire which damaged the floor and warped a stainless steel wall.
		Damage rating	Moderate
	Incident rating	Moderate	
Incident overview	Natural gas leaked from a newly installed gas line in the deli section of a warehouse type grocery store. The Deli department was only accessible to employees, and the uncontrolled release of natural gas was ignited by a nearby appliance resulting in a fire.		
INVESTIGATION CONCLUSIONS	Site, system and components	<p>A gas contractor assembled a newly installed gas line which was approximately 65 feet in length and equipped with the following:</p> <ul style="list-style-type: none"> <li>-The piping which contains the natural gas was assembled with black iron piping.</li> <li>-The fittings used to connect the black iron piping in this installation are known as MegaPressG fittings. These fitti

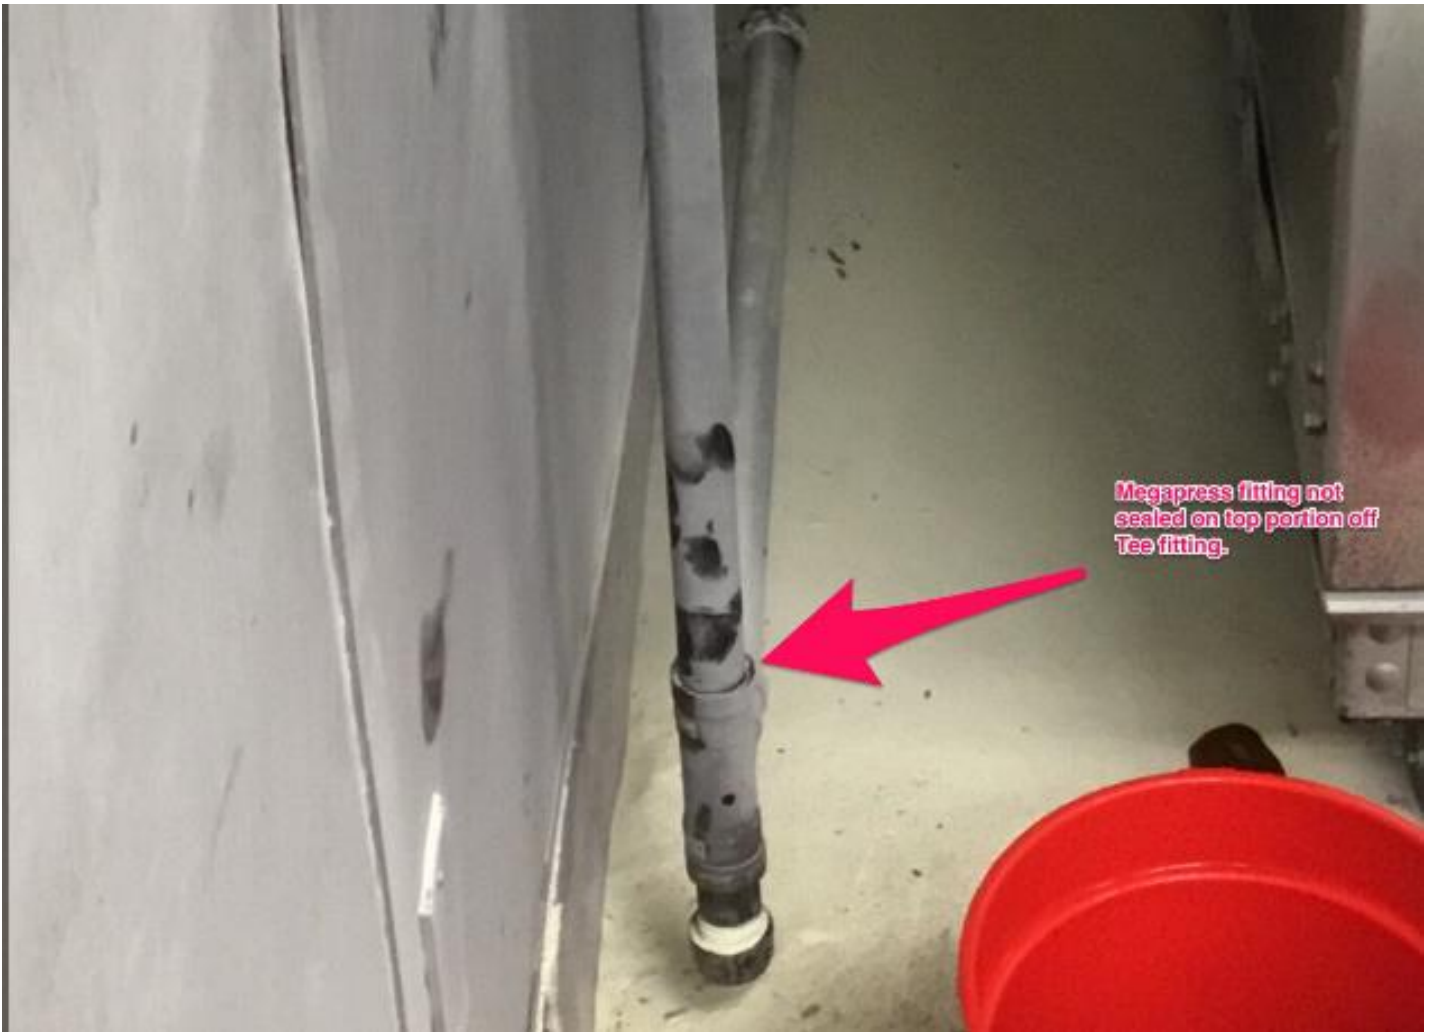
<p><b>Failure scenario(s)</b></p>	<p>Natural gas was isolated with a shut off valve while the contractor was assembling the new piping system.</p> <p>The contractor had failed to pressure test the newly installed piping system upon completion of work and opened the shut off valve which then energized the piping system with natural gas.</p> <p>Natural gas leaked from the unsealed fitting on the top portion of a Tee fitting.</p> <p>The fuel was released from the un sealed MegapressG fitting and was ignited by a nearby gas fired rotisserie oven.</p>
<p><b>Facts and evidence</b></p>	<p>Upon visual inspection of the Tee, it was apparent the MegaPressG fitting was not mechanically crimped on to the piping system.</p> <p>The location of the unsealed MegaPressG fitting is where staff had indicated the flames were coming from.</p> <p>Upon interviewing the gas contractor who had assembled the piping system, the contractor indicated that the newly installed piping system was not pressure tested and that natural gas was introduced into the piping system without the required pressure test.</p> <p>When the natural gas leaked out of the unsealed fitting, the natural gas was ignited by a nearby oven resulting in a fire.</p> <p>The Assistant Warehouse Manager had indicated in an interview that the fire occurred at approximately 10:15 am.</p> <p>Staff extinguished the flames with 2 portable fire extinguishers and the fire suppression system was energized by employees. The fire department had attended the scene.</p> <p>As a result of the fire, the floor was damaged and the stainless steel wall was warped.</p>

<p><b>Causes and contributing factors</b></p>	<p>If a pressure test was conducted prior to the introduction of fuel into the newly installed piping system, the leak would have been more than likely found at the non-mechanically sealed fitting.</p>
