Incident Summary #II-983150-2020 (#16673) (FINAL)

SUPPORTING INFORMATION	Incident Date	February 20, 2020	
	Location	Abbotsford	
	Regulated industry sector	Electrical - Low voltage electrical system (30V to 750V)	
	Injury	Qty injuries	1
		Injury description	During electrical testing after the initial incident the electrician received a minor electric shock to their hand.
		Injury rating	Minor
	Impact Damage	Damage description	The flexible metal dryer ducting melted and burned the backside of a clothes dryer and surrounding walls.
			The bonding path in electrical circuits became energized in multiple condo units. The bonding path continued to be energized until the power was turned off.
		Damage rating	Moderate
	Incident rating	Moderate	
Incident overview	A fire occurred behind a stackable washer/dryer in a new unit of a multi-unit condo building that was in the final stage of construction. An electrician that was investigating the cause of the fire received a minor shock when he contacted between the dryer ducting and the electrical outlet .

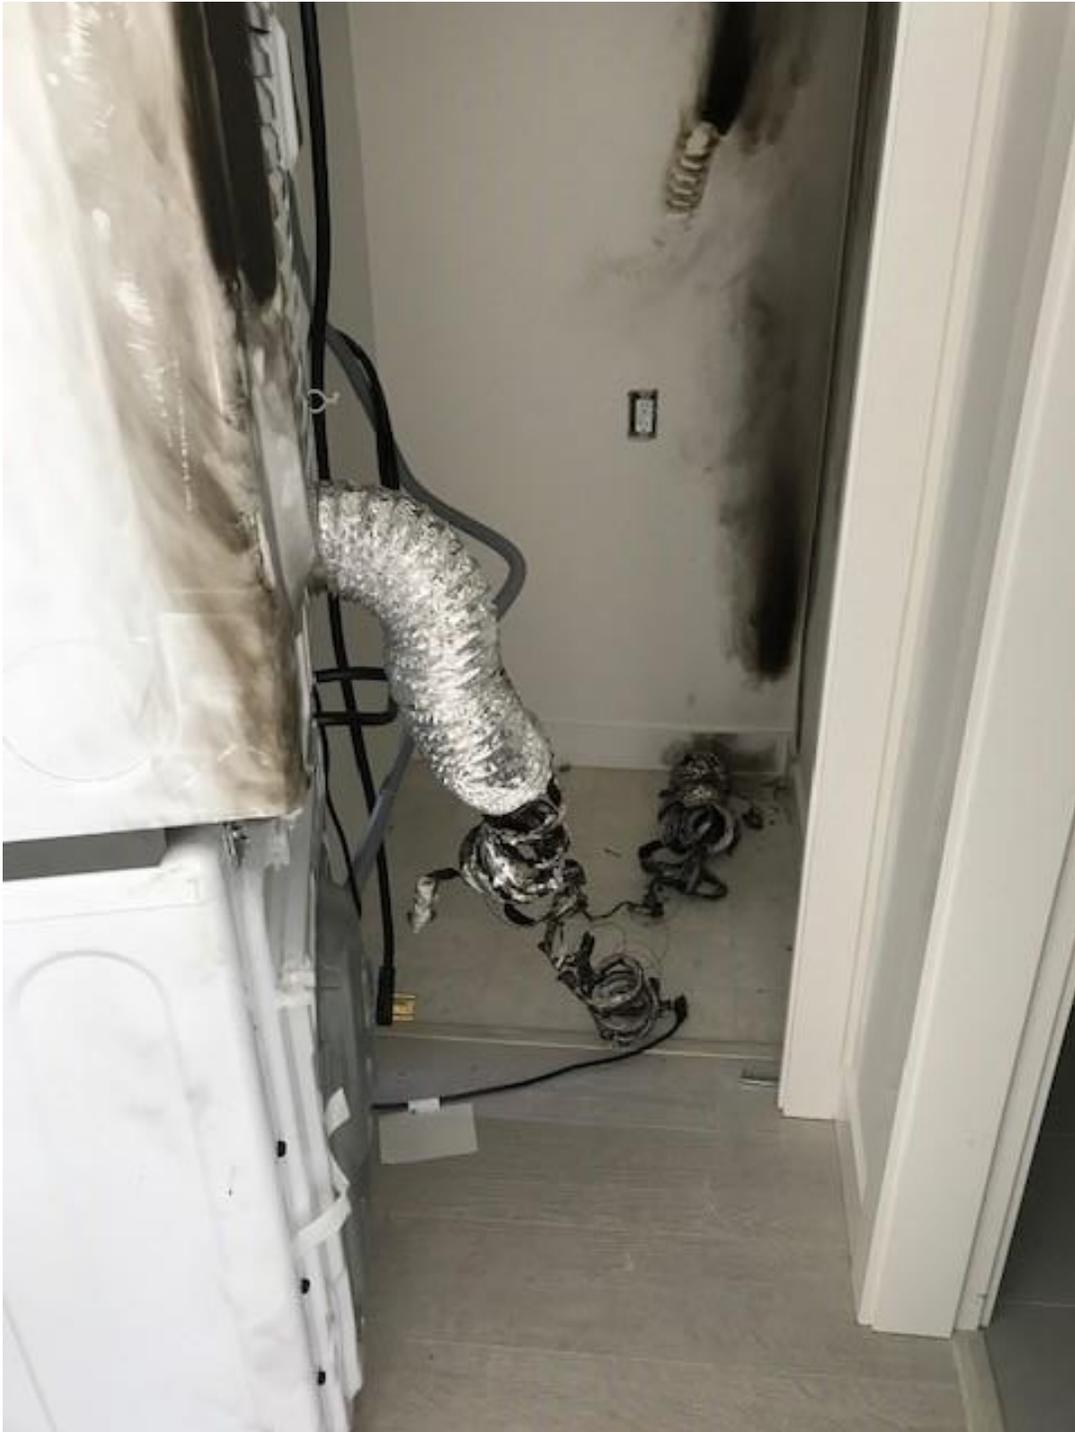
Photo 1: Overall damage to stackable washer, dryer, venting and surrounding area in unit 115.

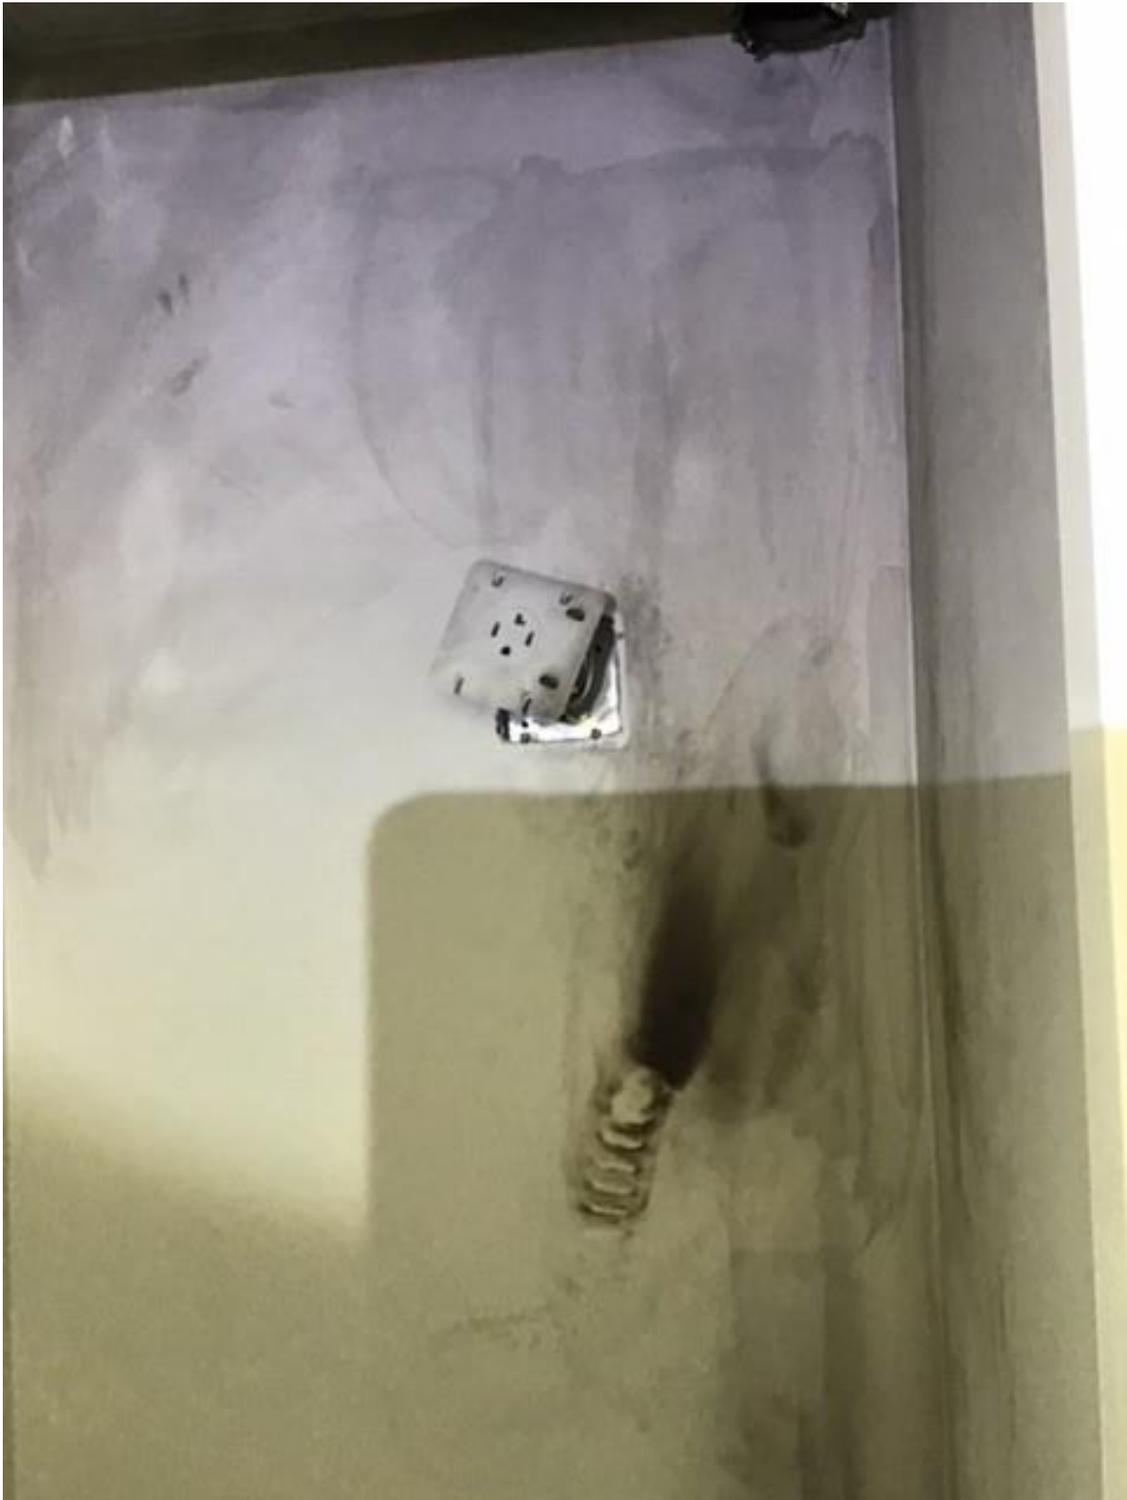
Photo 2: Fire damage located behind stackable washer and dryer unit 115.

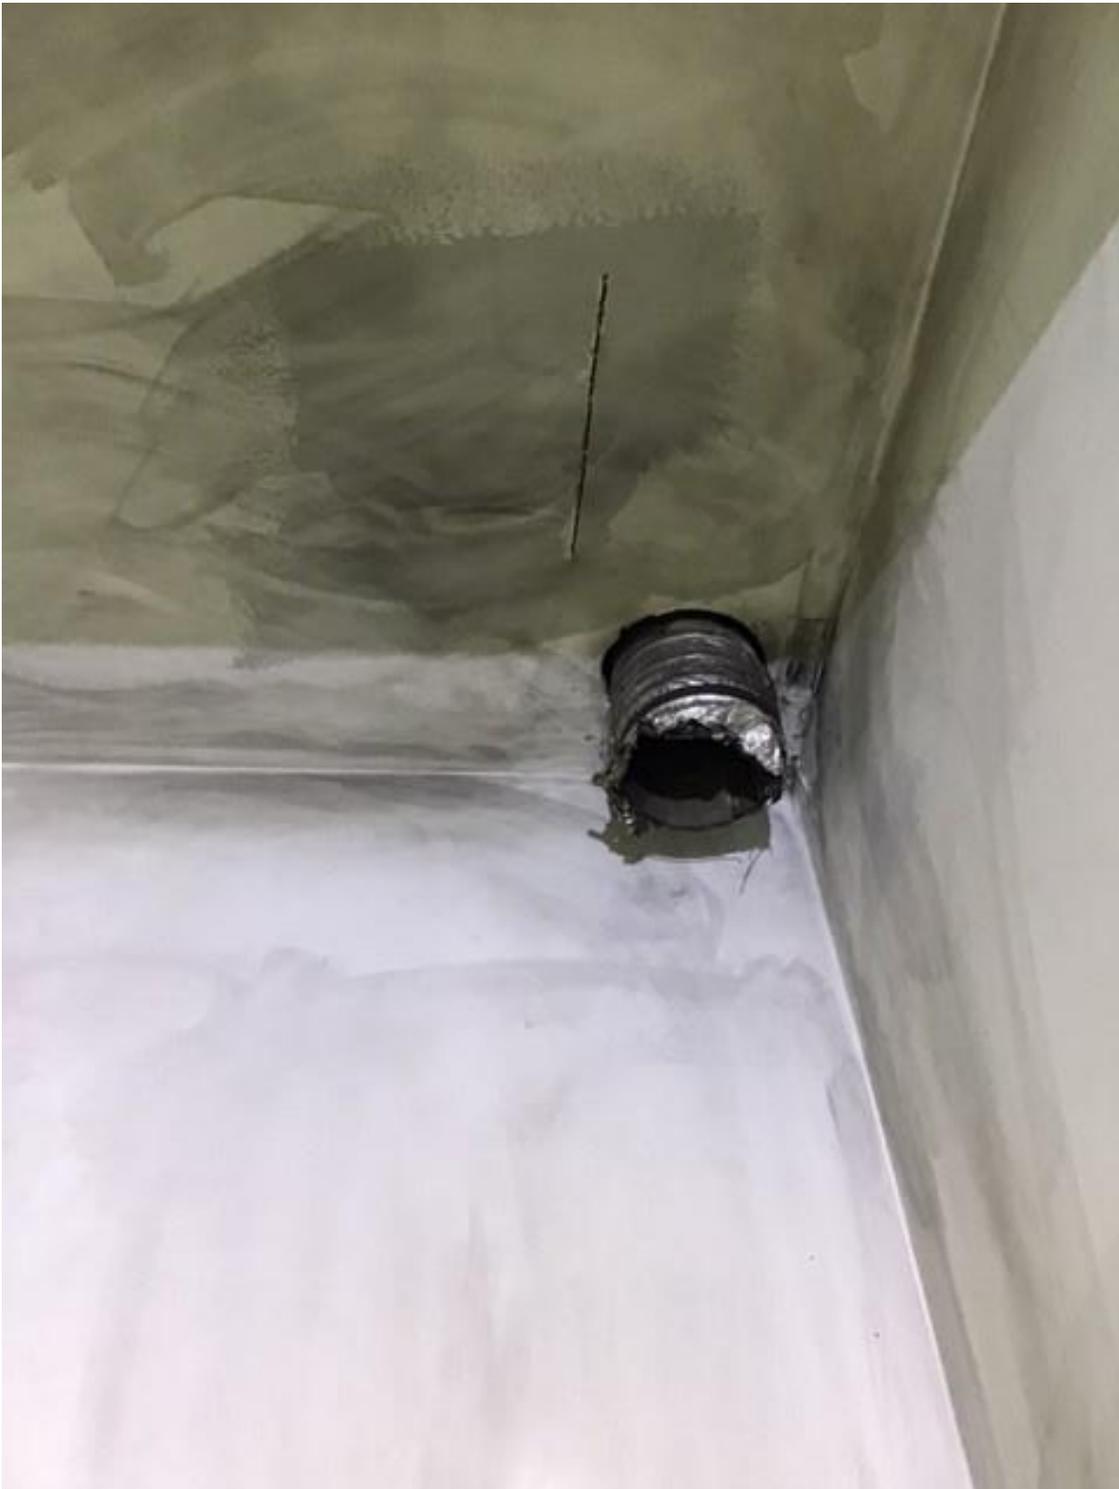
Photo 3: Fire damage behind stackable washer and dryer looking up towards the venting unit 115

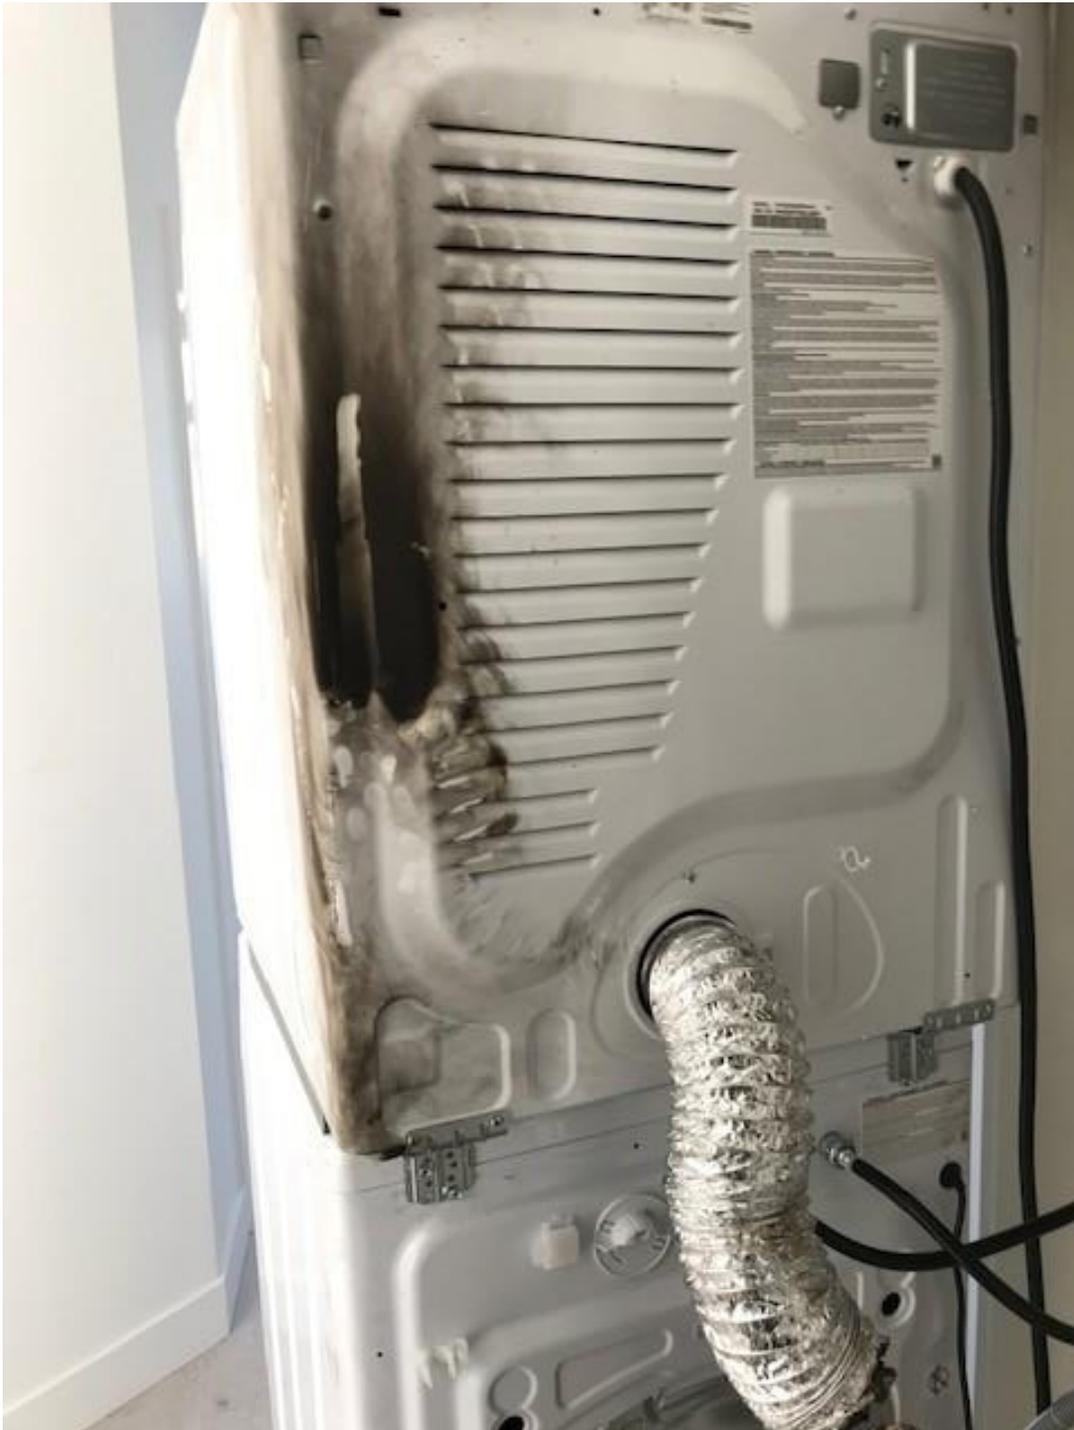
Photo 4: Overall photo of damaged stackable washer and dryer in unit 115.

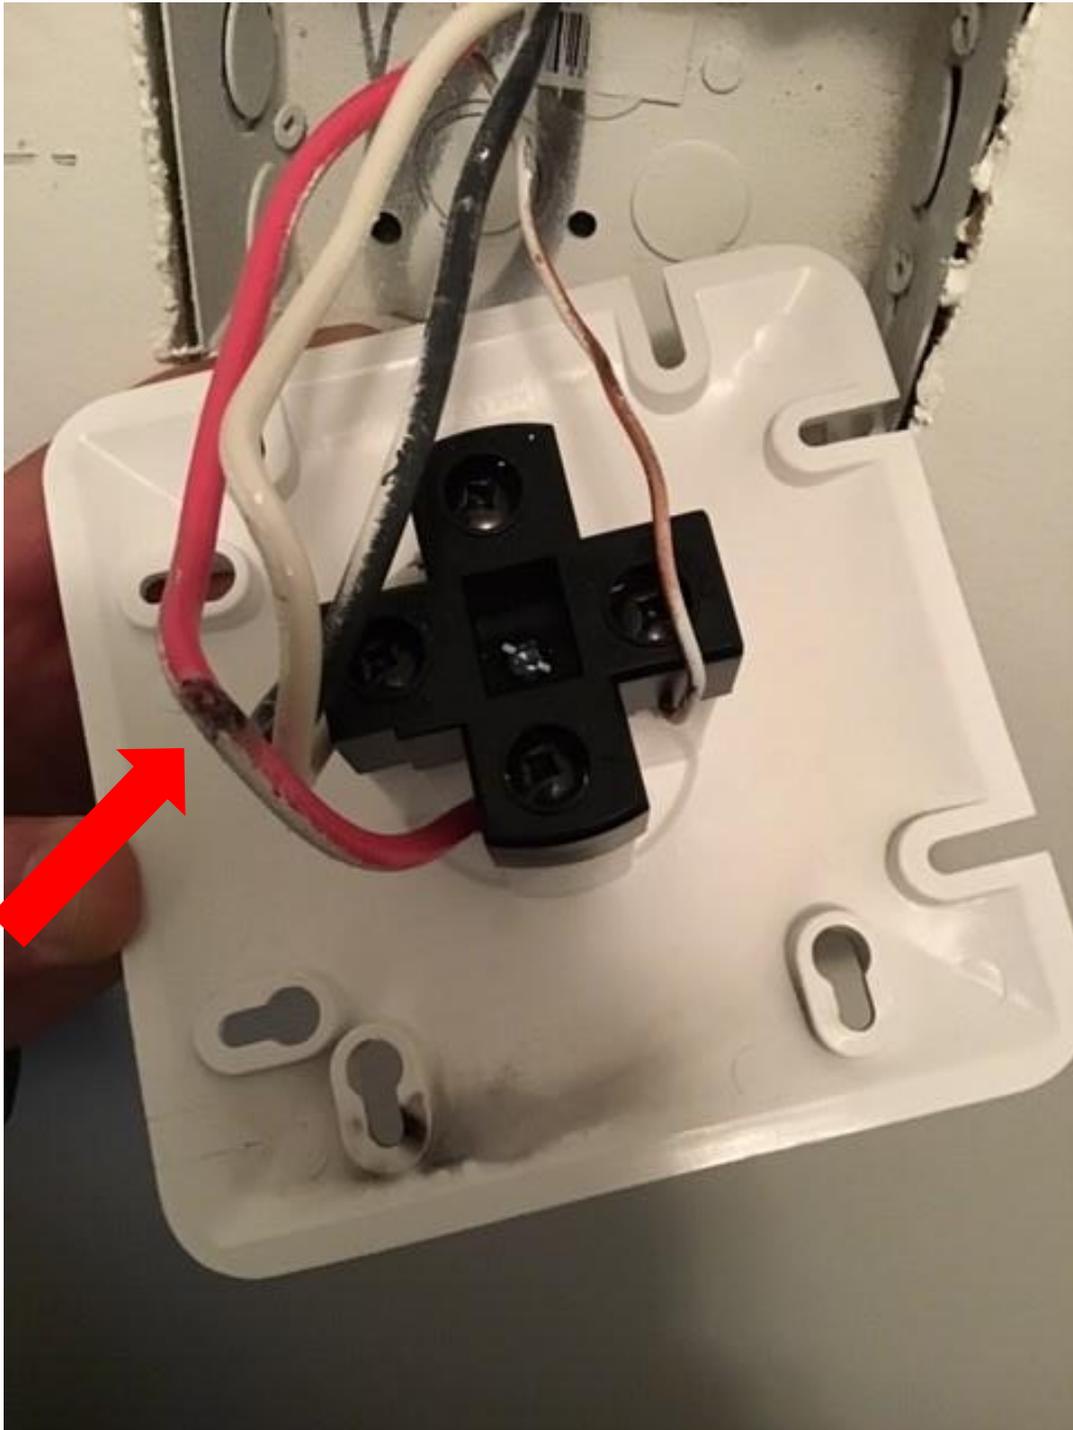
<p>company did not ensure that the regulated work complied with all requirements before the meter stack was energized.</p> <p>The dryer receptacle in unit 114 was mounted to the metal dryer box with 4 mounting screws. One of the mounting screws holding the dryer receptacle to the metal box pierced the insulation of a ungrounded (hot) conductor connected to the receptacle. When the damaged dryer circuit was turned on, the breaker did not trip and the bonding path became energized.</p> <p>When the receptacle was energized, current flowed on the bonding path conductor from the dryer receptacle in Unit 114 to the panel in Unit 114. The current continued to flow on the bonding conductor back to the meter stack. The meter stack was isolated from the low impedance bonding path in the tap box which went back to the electrical room. The meter stack section also feed units 115,116,117,118 and 119. All of these units bonding conductors are connected in the meter stack, therefore, the bonding paths in unit 115-119 became energized as well.</p> <p>The rigid dryer ducting in unit 115 was installed in such a way that it was making contact with other metallic construction material that provided a path to ground. Current began to flow through the bonded metal frame of the dryer, through the flexible metallic foil duct, to the grounded rigid metal ducting.</p> <p>The dryer ducting from the appliance to the building ducting is made up of flexible metallic foil with a structural metal coil wire inside which has a high electrical resistance. When current flows through a point of high resistance, heat is generated. This heat caused the flexible metallic foil ducting to melt and burn the surrounding area.</p> <p>When an electrician went to investigate the cause of the fire, the electrician turned off power to unit 115. The electrician removed the receptacle from the box and was in contact with the receptacle bond screw. When the electrician made contact with the grounded dryer duct with the other hand, the electrician received a minor shock.</p>

Photo 5: Close up of pierced dryer receptacle wire in unit 114.

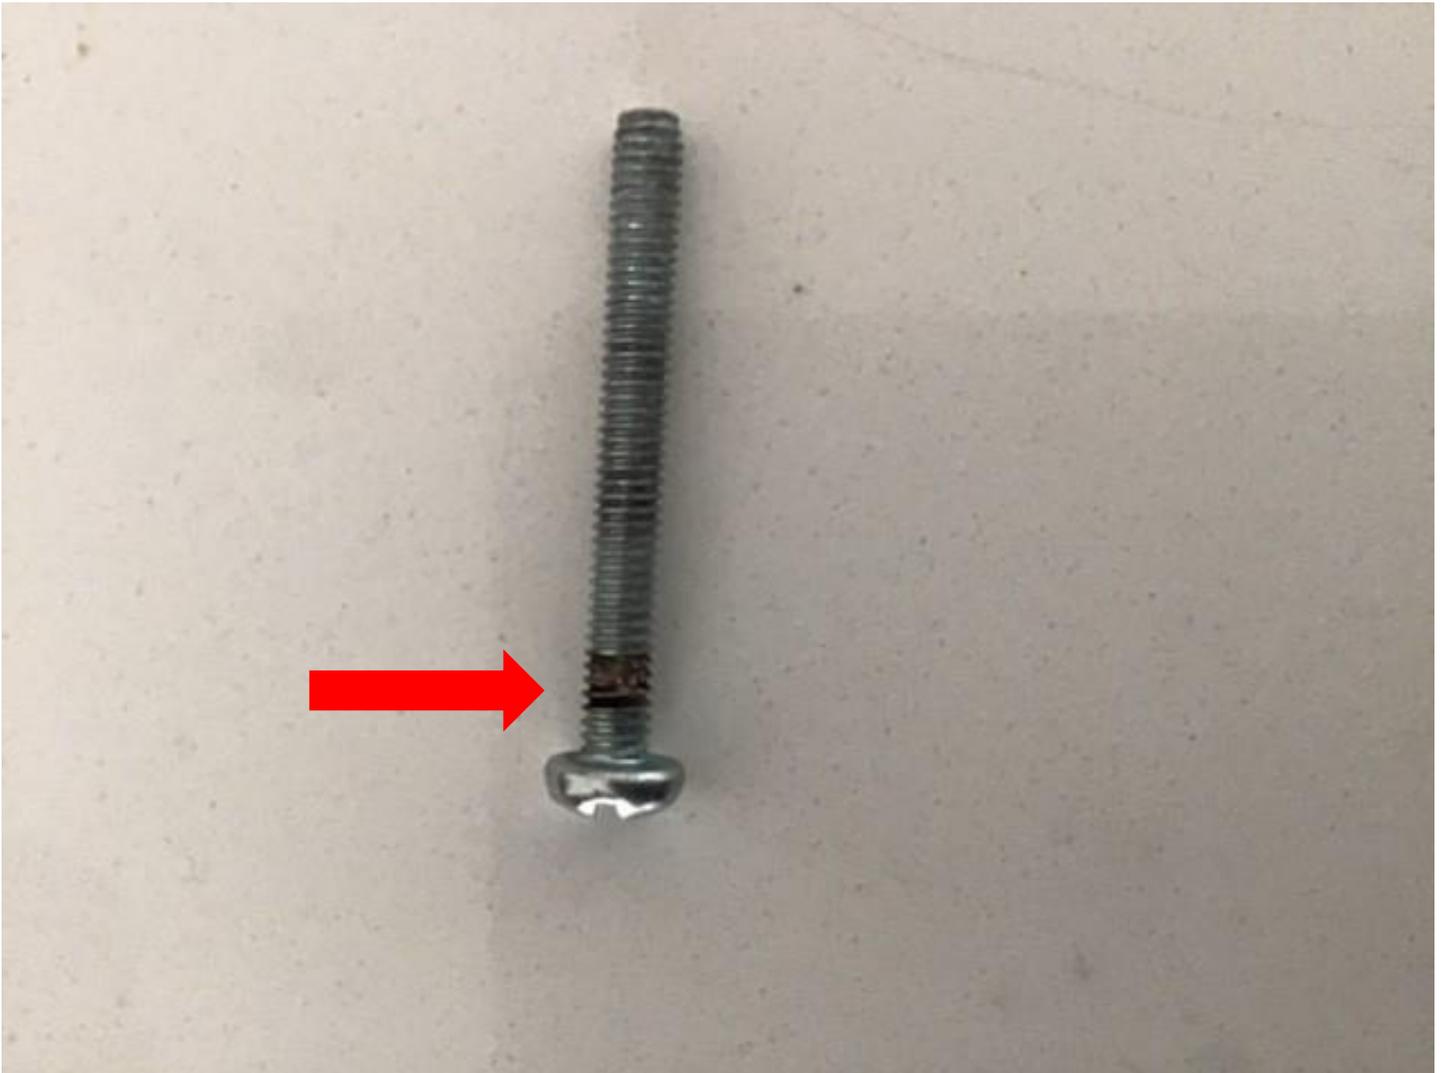
Photo 6: Close up of electrical arcing on the mounting screw that was holding the dryer receptacle in unit 114 to the box in the wall.

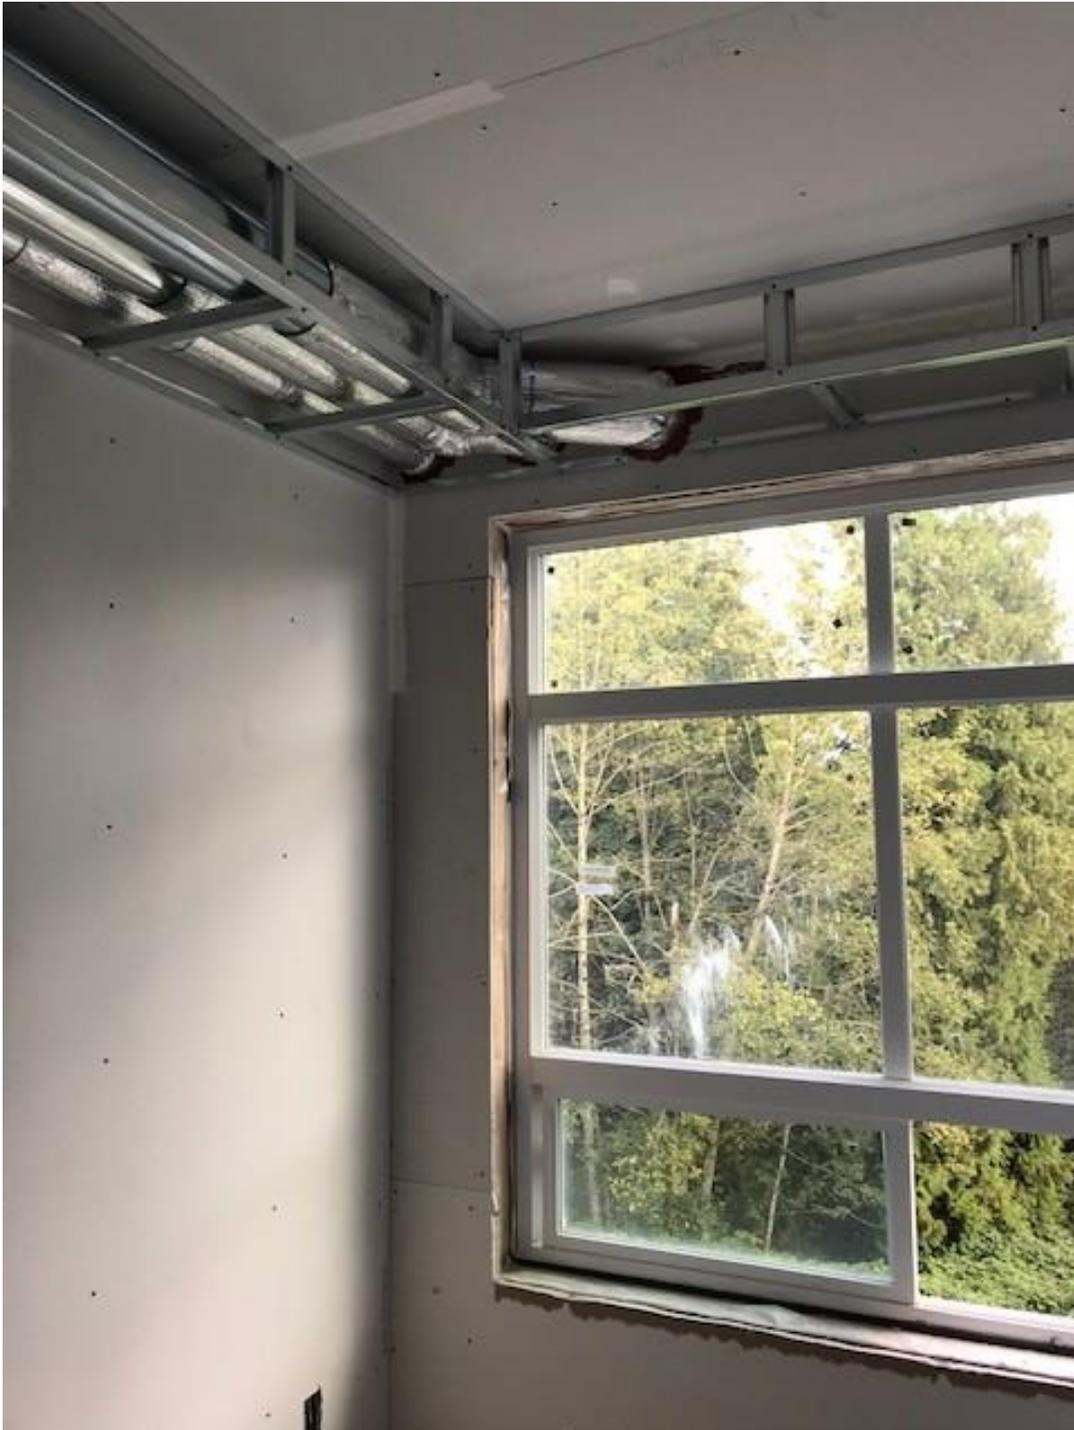
Photo 7: Example of multiple ducts touching each other and touching steel studs drops.

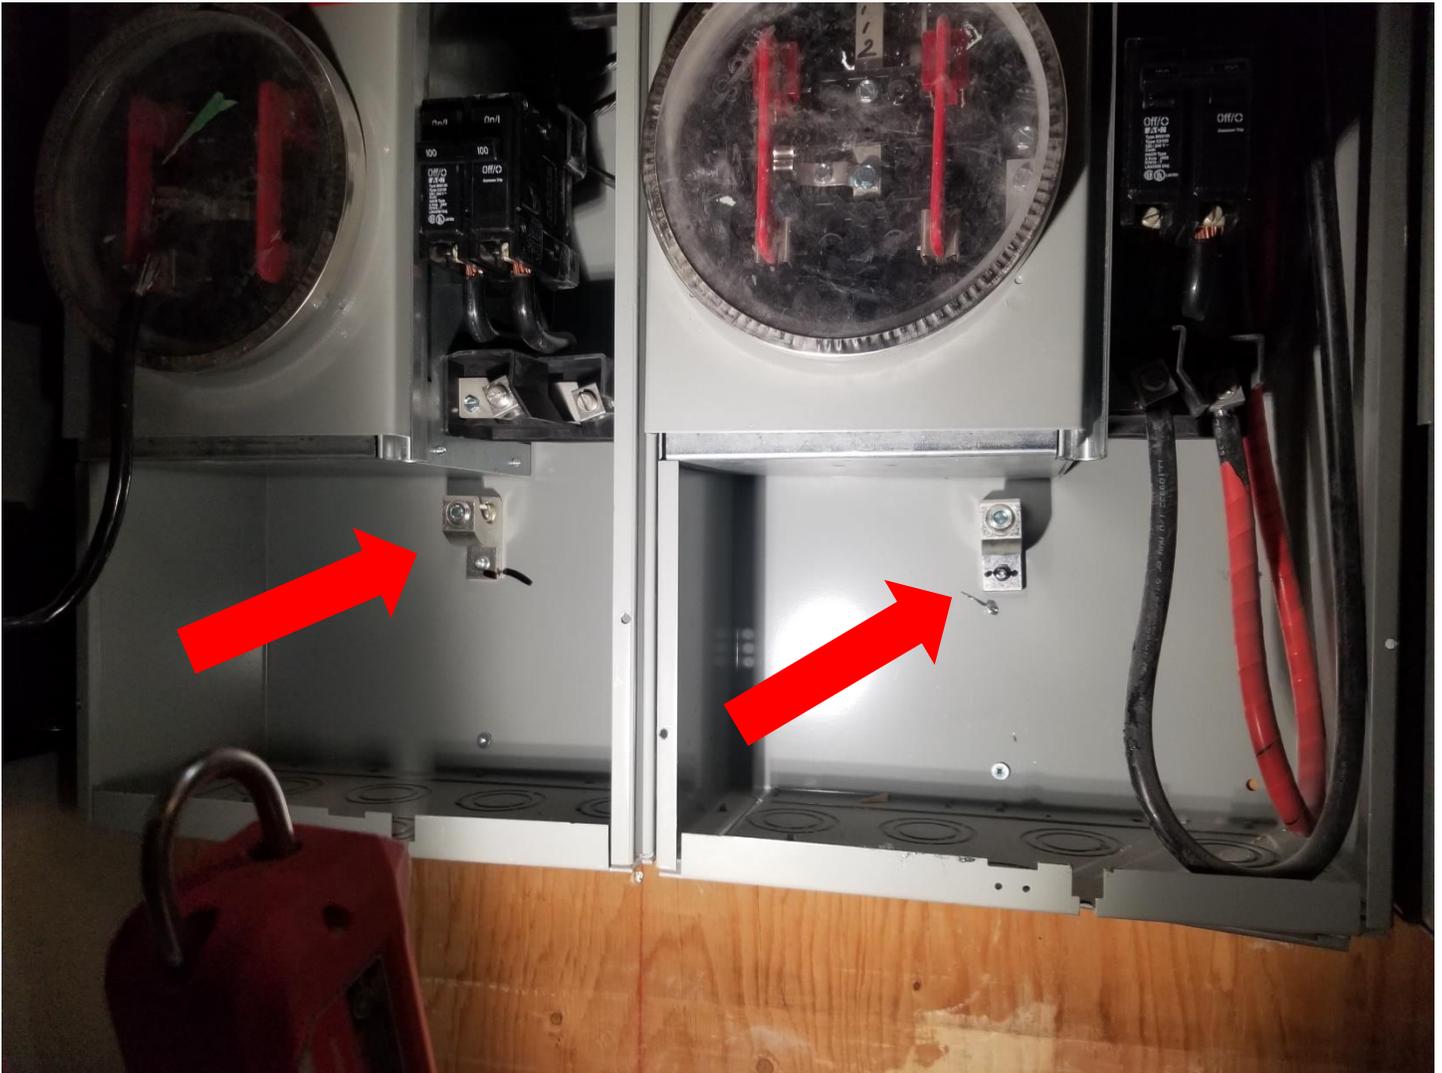
Failure scenario(s)	A three section 120/208V, 800A meter stack was installed on the first floor by an electrical worker without a bonding conductor between each meter stack section and the tap box as required by the manufacturer. The Field Safety Representative for the

<p>Testing post incident by the electrical contractor:</p> <ul style="list-style-type: none">- missing bonding conductor found between 1st floor tap box and 1st floor meter stacks. (See photo 8)- manufacturers installation instructions for meter stack requires ground conductor.- FSR stated that he missed not seeing the bonding cable conductor during his inspection of the meter stack installed by other worker.- once power was returned and the bonding conductor installed, the dryer breaker in unit 114 tripped, notifying the electrical contractor of the location of the fault.(See photo 9 and 10)- pierced conductor was found in unit 114 dryer receptacle. (See photo 5 and 6.)
<p>Causes and contributing factors</p>	<p>The cause of this incident is very likely the electrical contractor piercing the dryer receptacle conductor and not installing the bonding conductor between the meter stack sections as per the manufactures installation instructions. Both of these actions contributed to the flexile dryer ducting becoming energized and hot enough to melt and scorch the surrounding areas. This subsequently caused the electrician to receive a shock when contacting isolated energized equipment.</p> <p>Electrical contractors are required to have a Field Safety Representative (FSR) inspect all work prior to energizing electrical equipment. In this case the FSR inspection did not detect the missing bonding conductor or the pierced branch circuit conductor at the dryer receptacle.</p>

Photo 8: Missing bonding conductor in meter stack to tap box.

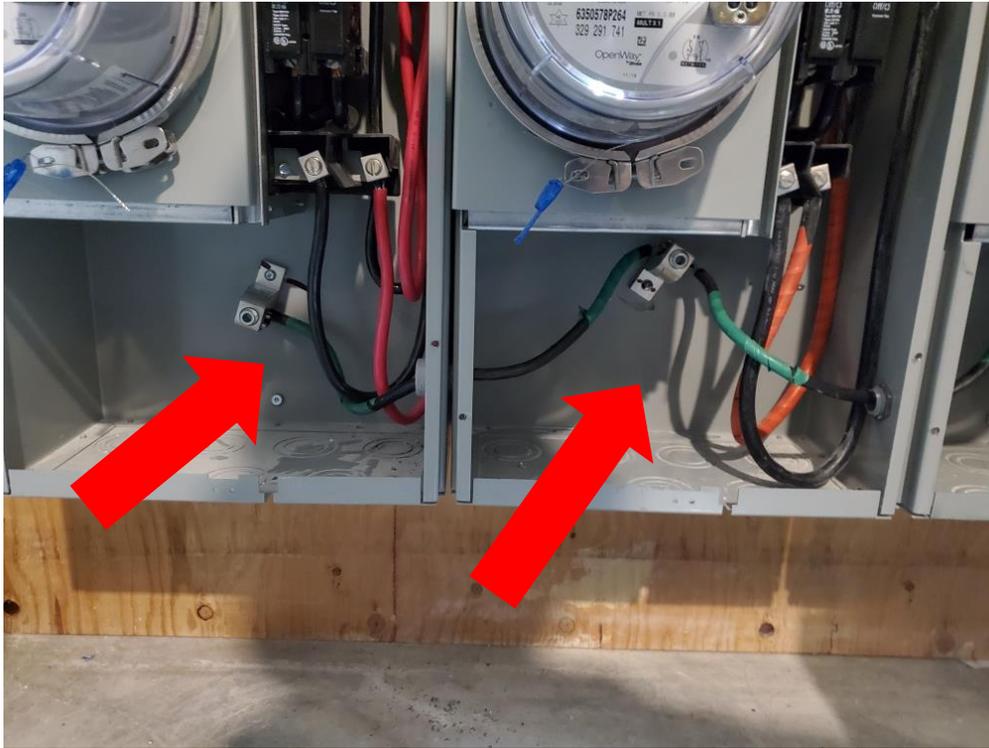
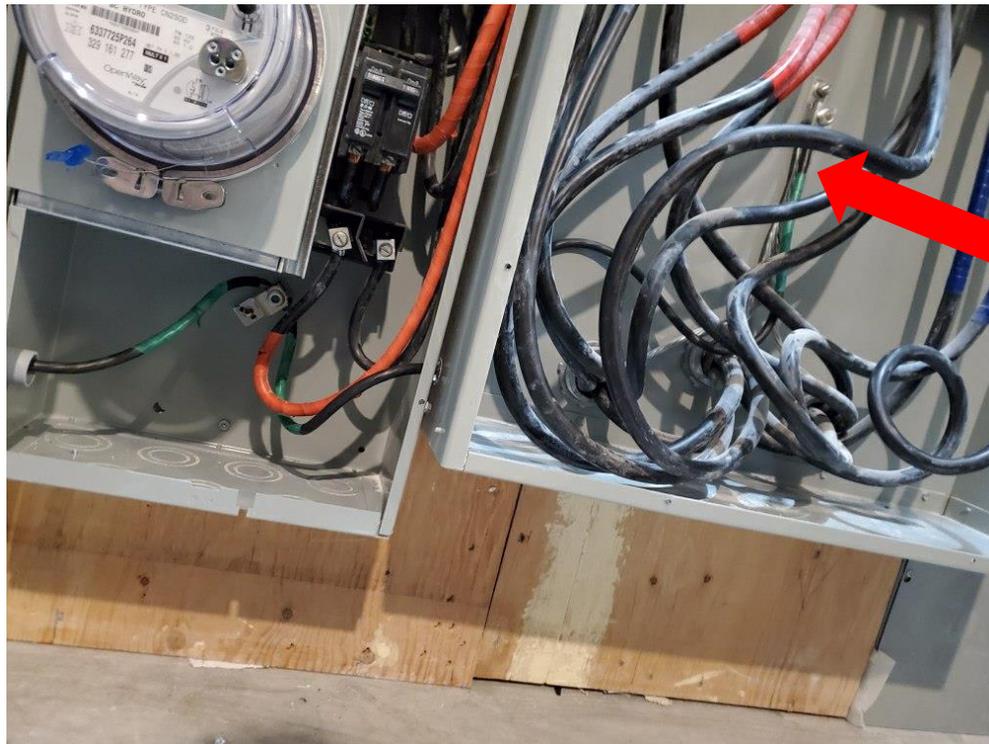
Photo 9 and 10: Bonding conductor that should have been installed in meter stacks to tap box.

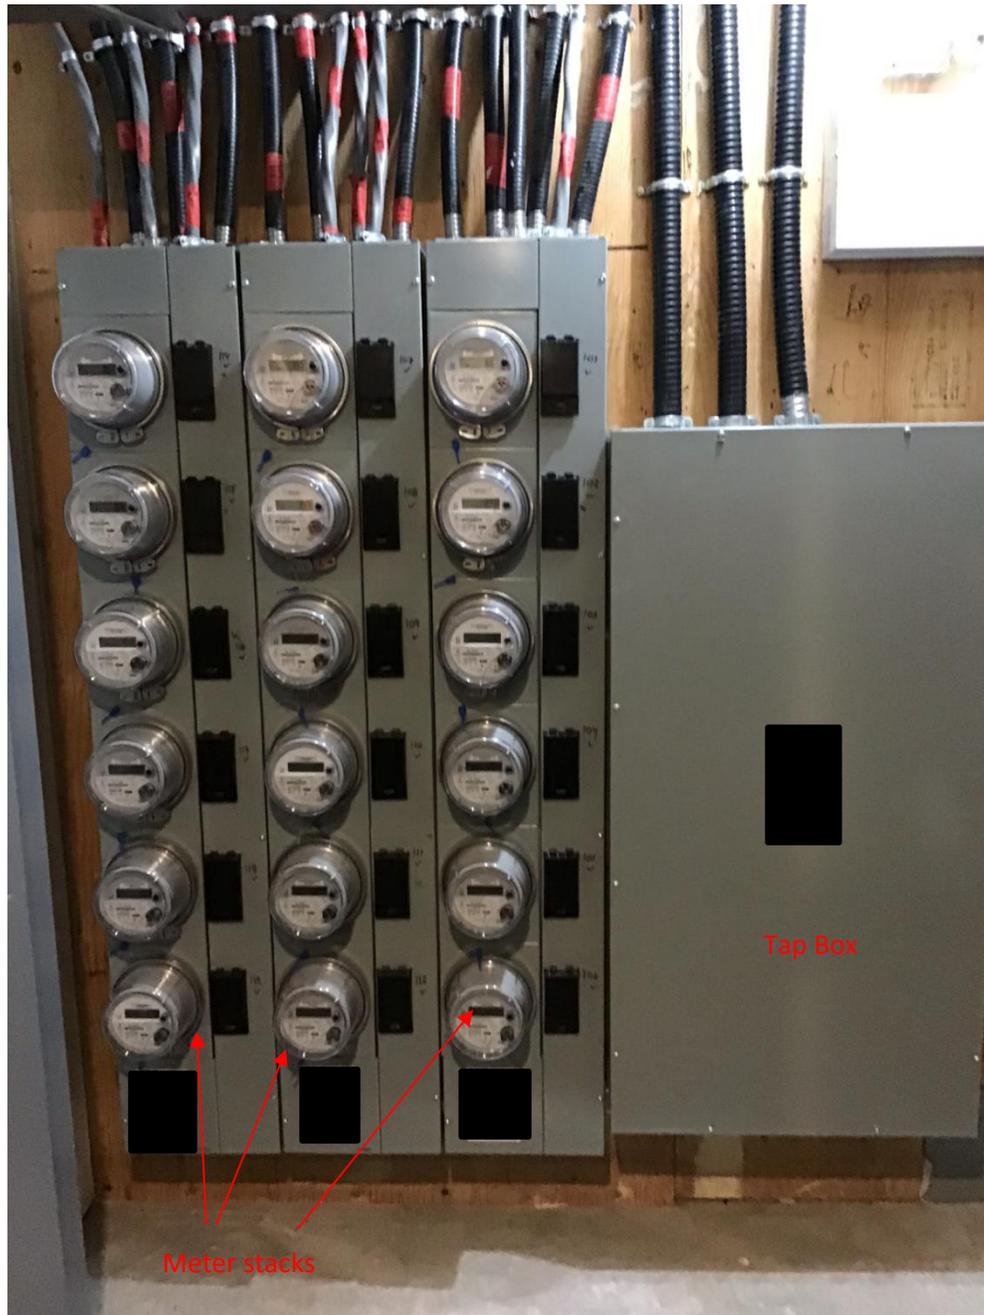
Photo 11: Overall view of meter stacks and tap box on level 1.

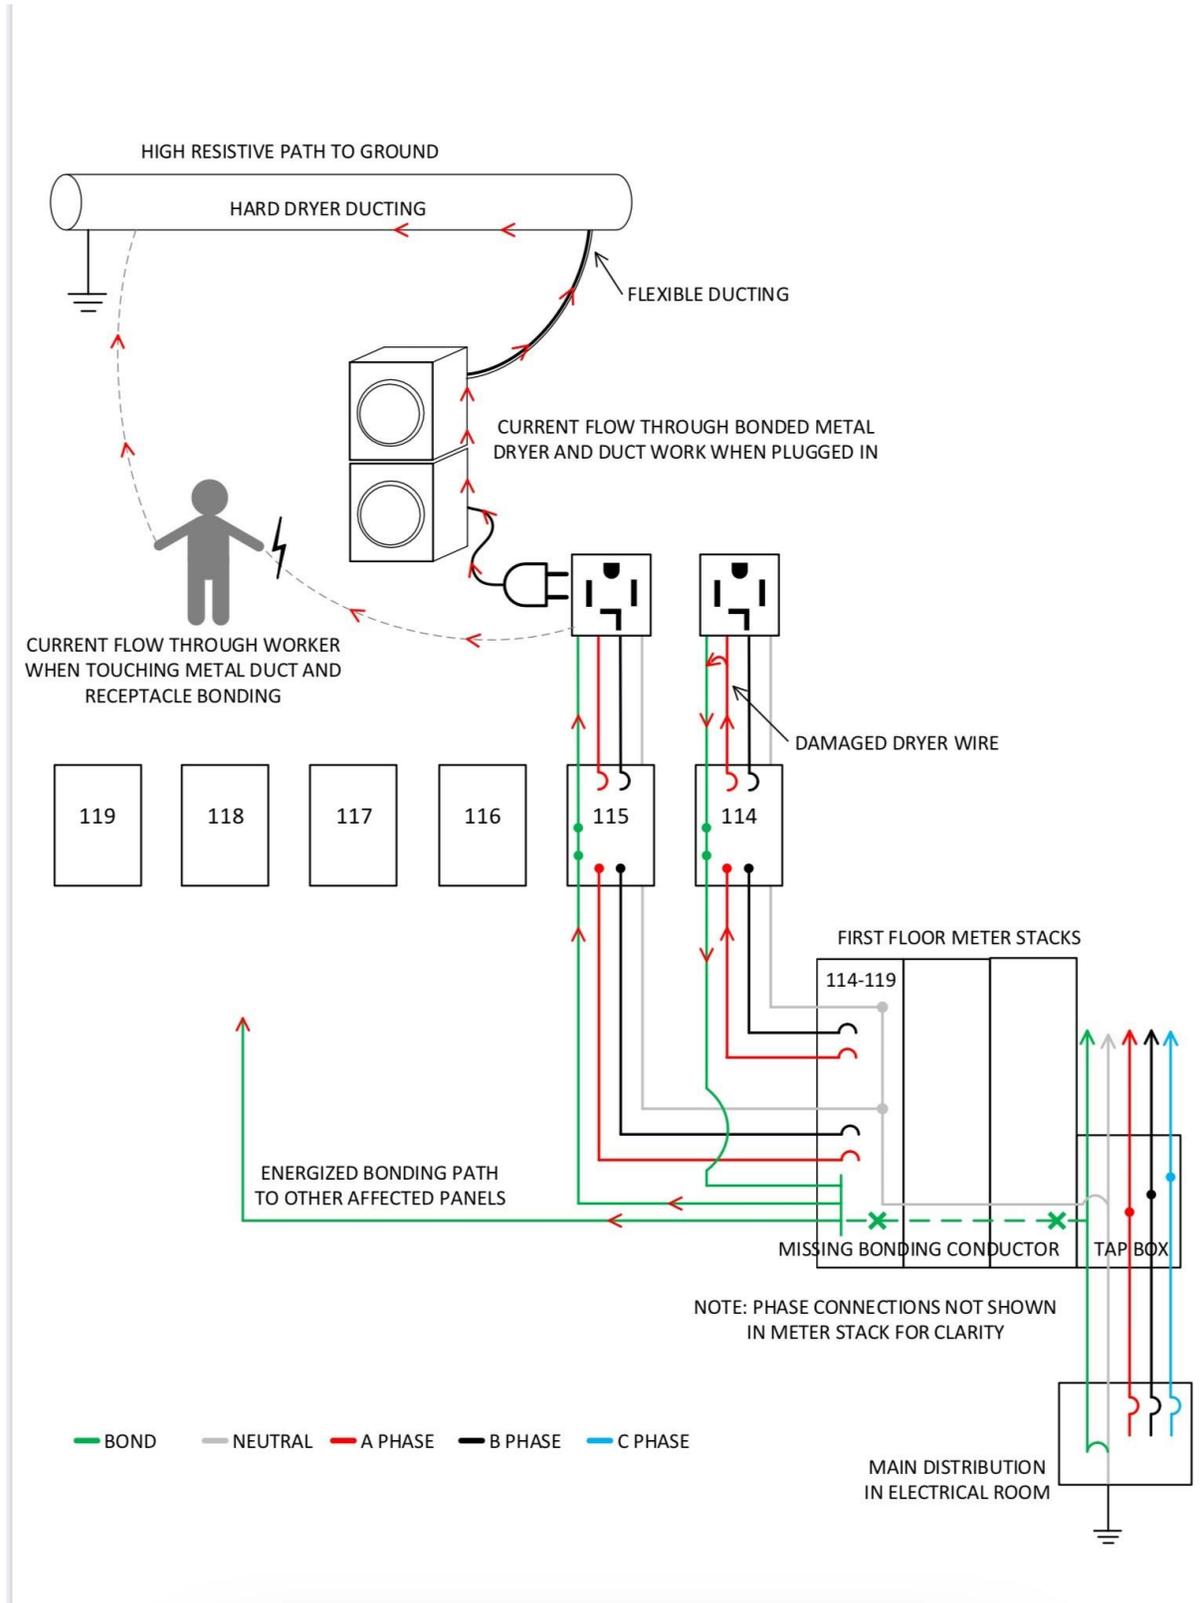
Photo 12: Diagram of incident.
