Incident Summary #II-1000866-2020 (#16972) (FINAL)

SUPPORTING INFORMATION	Incident Date	April 6, 2020	
	Location	Campbell river	
	Regulated industry sector	Gas - Natural gas system	
	Impact	Qty injuries	0
		Injury description	N/A
		Injury rating	None
	Damage	Damage description	Products of combustion including carbon monoxide (CO) were exhausted into the mechanical room of a middle school. 6 of the 8 boilers had blown pressure vessel gaskets and 3 of the 8 boilers had disengaged venting systems.
		Damage rating	Moderate
	Incident rating	Moderate	
	Incident overview	Multiple natural gas fired boilers in a school building experienced delayed ignition detonations and emitted products of combustion including CO from dislodged vents into the boiler room.	
INVESTIGATION CONCLUSIONS	Site, system and components	<p>Site and system</p> <ul style="list-style-type: none"> The school building utilizes natural gas boilers with electronic spark ignition for water heating. The hydronic boiler uses the combustion of natural gas to heat water which is circulated to heaters in the school. <p>Boiler components</p> <ul style="list-style-type: none"> The boiler's ignitor applies an electrical arc to nat

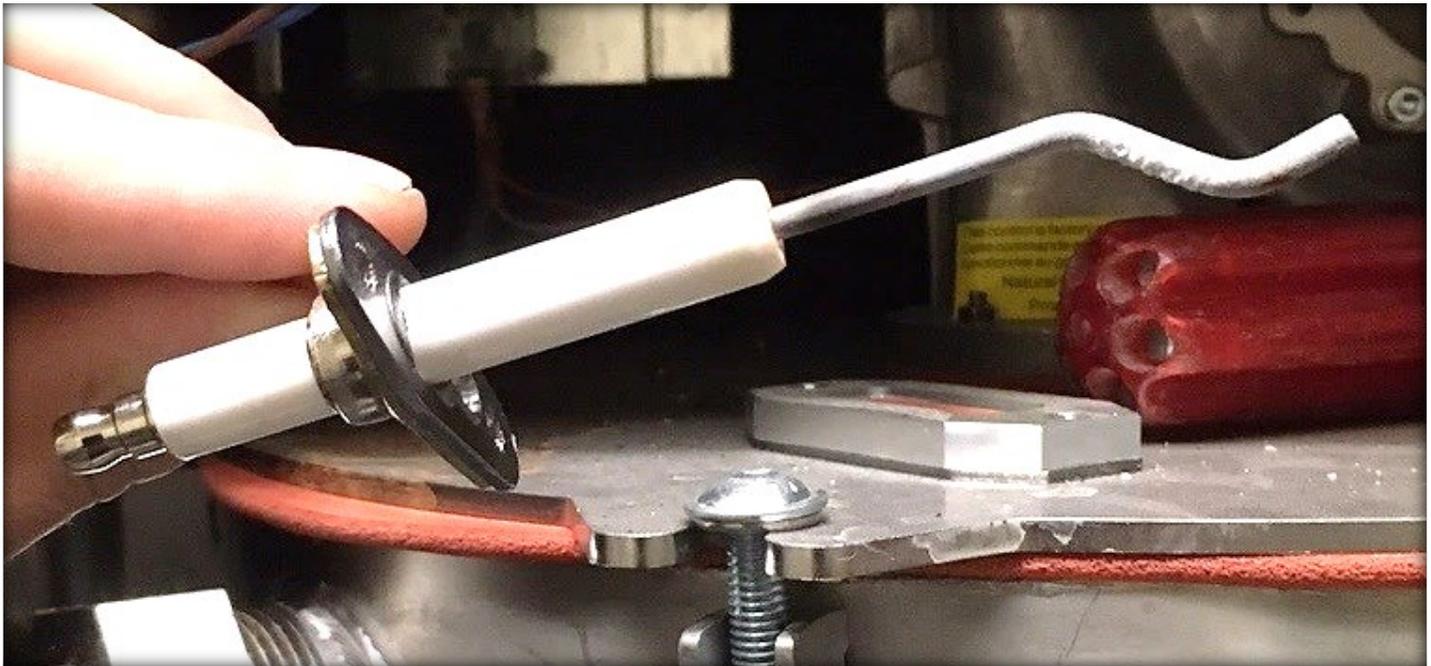
<ul style="list-style-type: none">The boiler manufacturer identified issues with the original ignitors and issued a discontinuation of P-340 single prong ignitors that applies to the SL G3 boiler at this site as well as other models on their website on January 22, 2021, including the following wording: <i>"Effective immediately, the P-111B double-prong ignitor (Figure 1) replaces the P-340 single-prong ignitor. The P-111B is the new standard for the SL-series boilers as it combines an improved metallurgic formula for longevity with the convenience of a factory-set spark gap."</i> Link: P-111B change
Causes and contributing factors	The gap between the single prong ignitor and the burner very likely exceeded the maximum recommended gap leading to the delayed ignition detonations causing the boilers venting to become dislodged.

Image 1 – Single prong ignitor in use at time of the incident.

- B1-B8 <boiler 1 through 8> were fitted with a new dual prong igniter part number P-111 <after the incident>.
- Suggest that the CPVC exhaust pipes be clamped to the first support cross piece on each exhaust run as added protection against the exhaust being able to lift up if a delayed ignition event were to occur in the future.

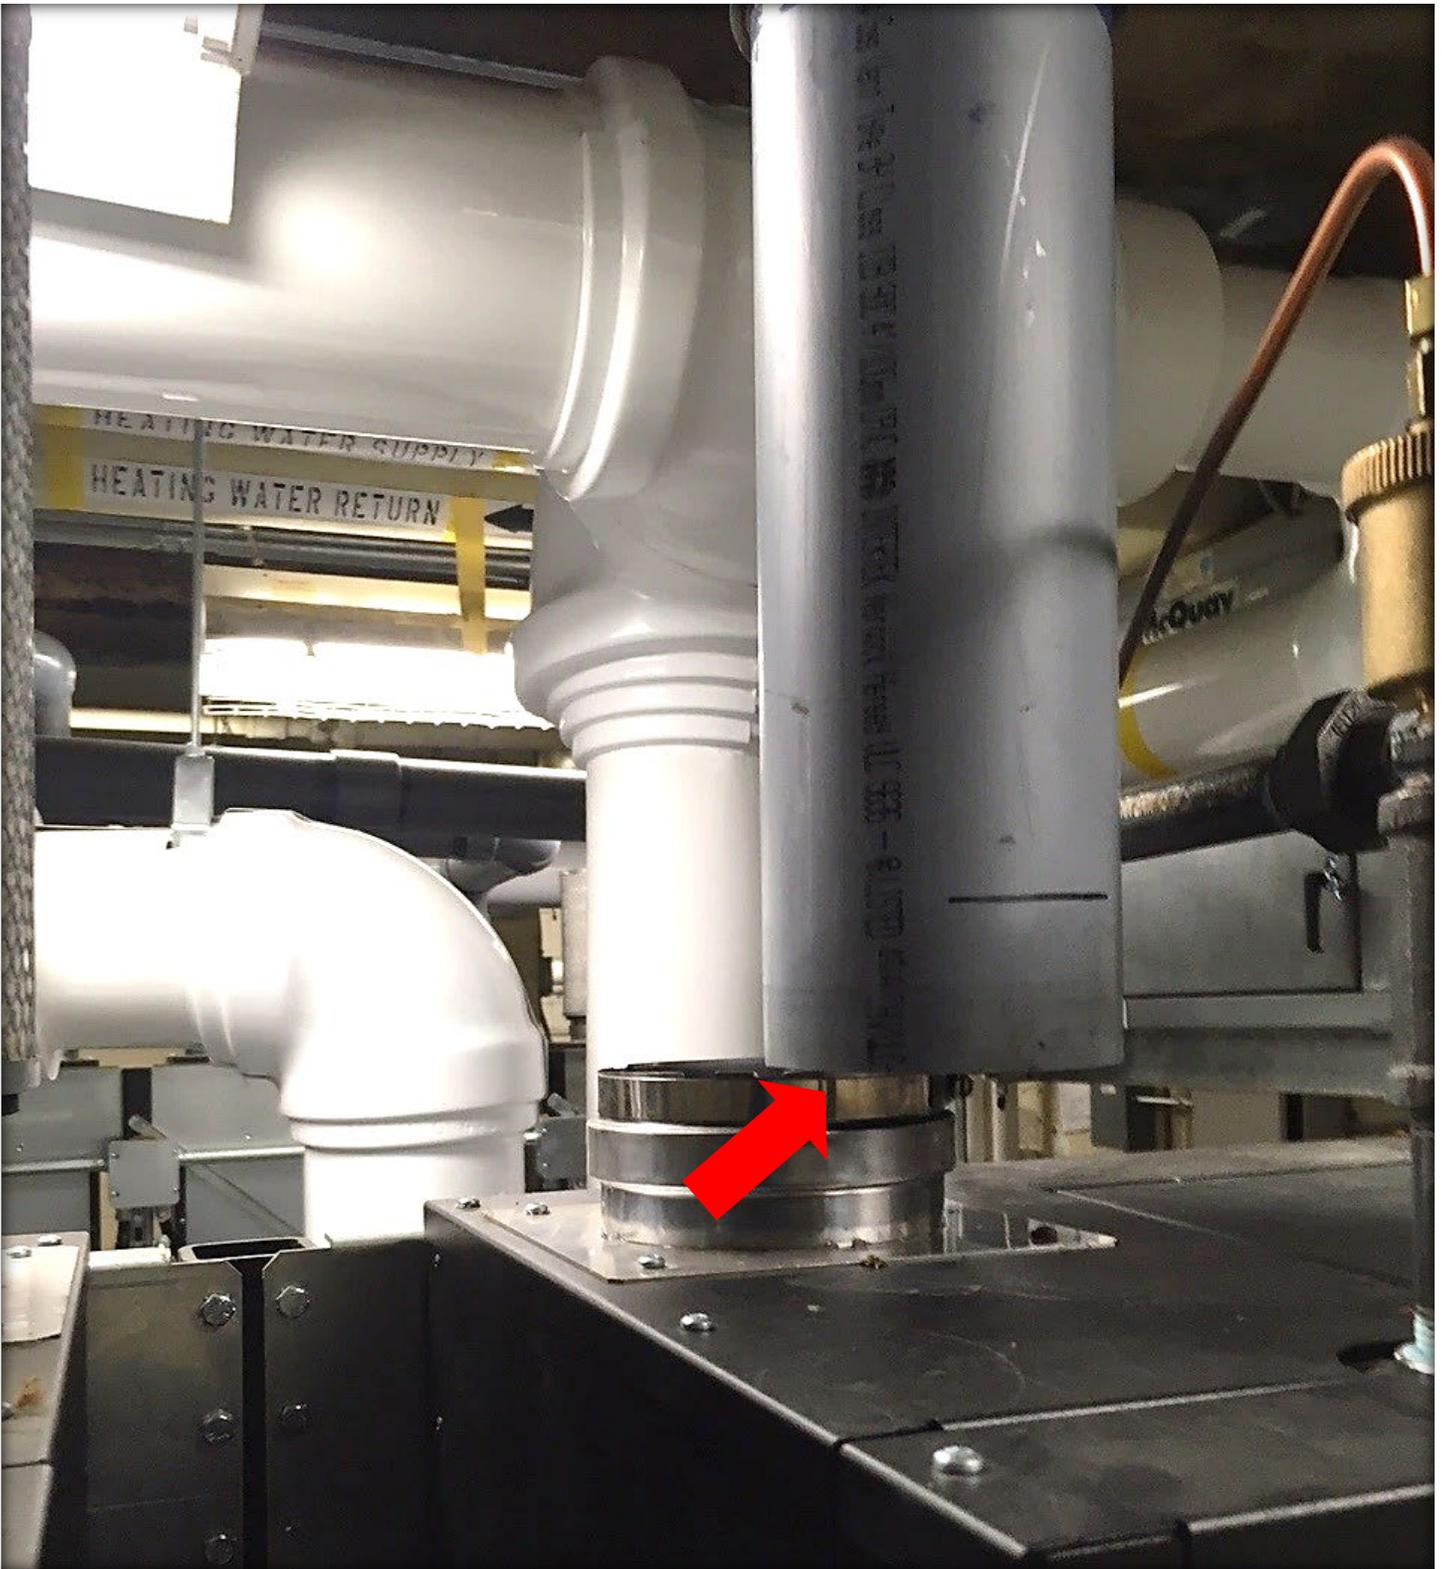
<p>Facts and evidence</p>	<p>School gas fitter statements:</p> <ul style="list-style-type: none"> • The school gas fitter and a colleague randomly came across the boilers and noticed a smell of products of combustion and found boiler venting systems disengaged from at least two running boilers. • The 636 <PVC venting> was not clamped in anymore and was popped right off. • When they <the boilers> would go down to low fire, the regulator would hunt. • Ignitors that were in use were single prong but since then all of the ignitors across the school district have been changed to dual prong. • The boiler room is approximately 20 x 28 <feet> and has a supply fan. • There are no CO detectors in the room. <p>Contractor gas fitter statements:</p> <ul style="list-style-type: none"> • Initial install was completed around late September of 2019 including the scope of placement and piping of the product. This included assembling of the racking system, placement of the boilers on to the racking, and hydronic and gas piping up to the units but excluding commissioning. • The boilers were commissioned by the manufacturer in 2019. • Was called to site after the incident by maintenance staff to investigate disconnected venting related to the 8 boilers originally installed by the contractor. • On site, they found three vents were disconnected, and internal to the boilers, the heat exchanger gaskets had blown out of installation position on six boilers. • Upon investigation, concluded that the boilers had a combustion failure. • The top venting was connected with a gear clamp, so there was quite a bit of force holding that in place. To dislodge that, was something significant. • They were advised by the manufacturer representative, that the boilers were experiencing a 'lifting' situation and the fix for this was to go from single prong to dual prong ignitors.

Image 2 – Venting dislodged from boiler due to delayed ignition detonation (example 1 of 3).

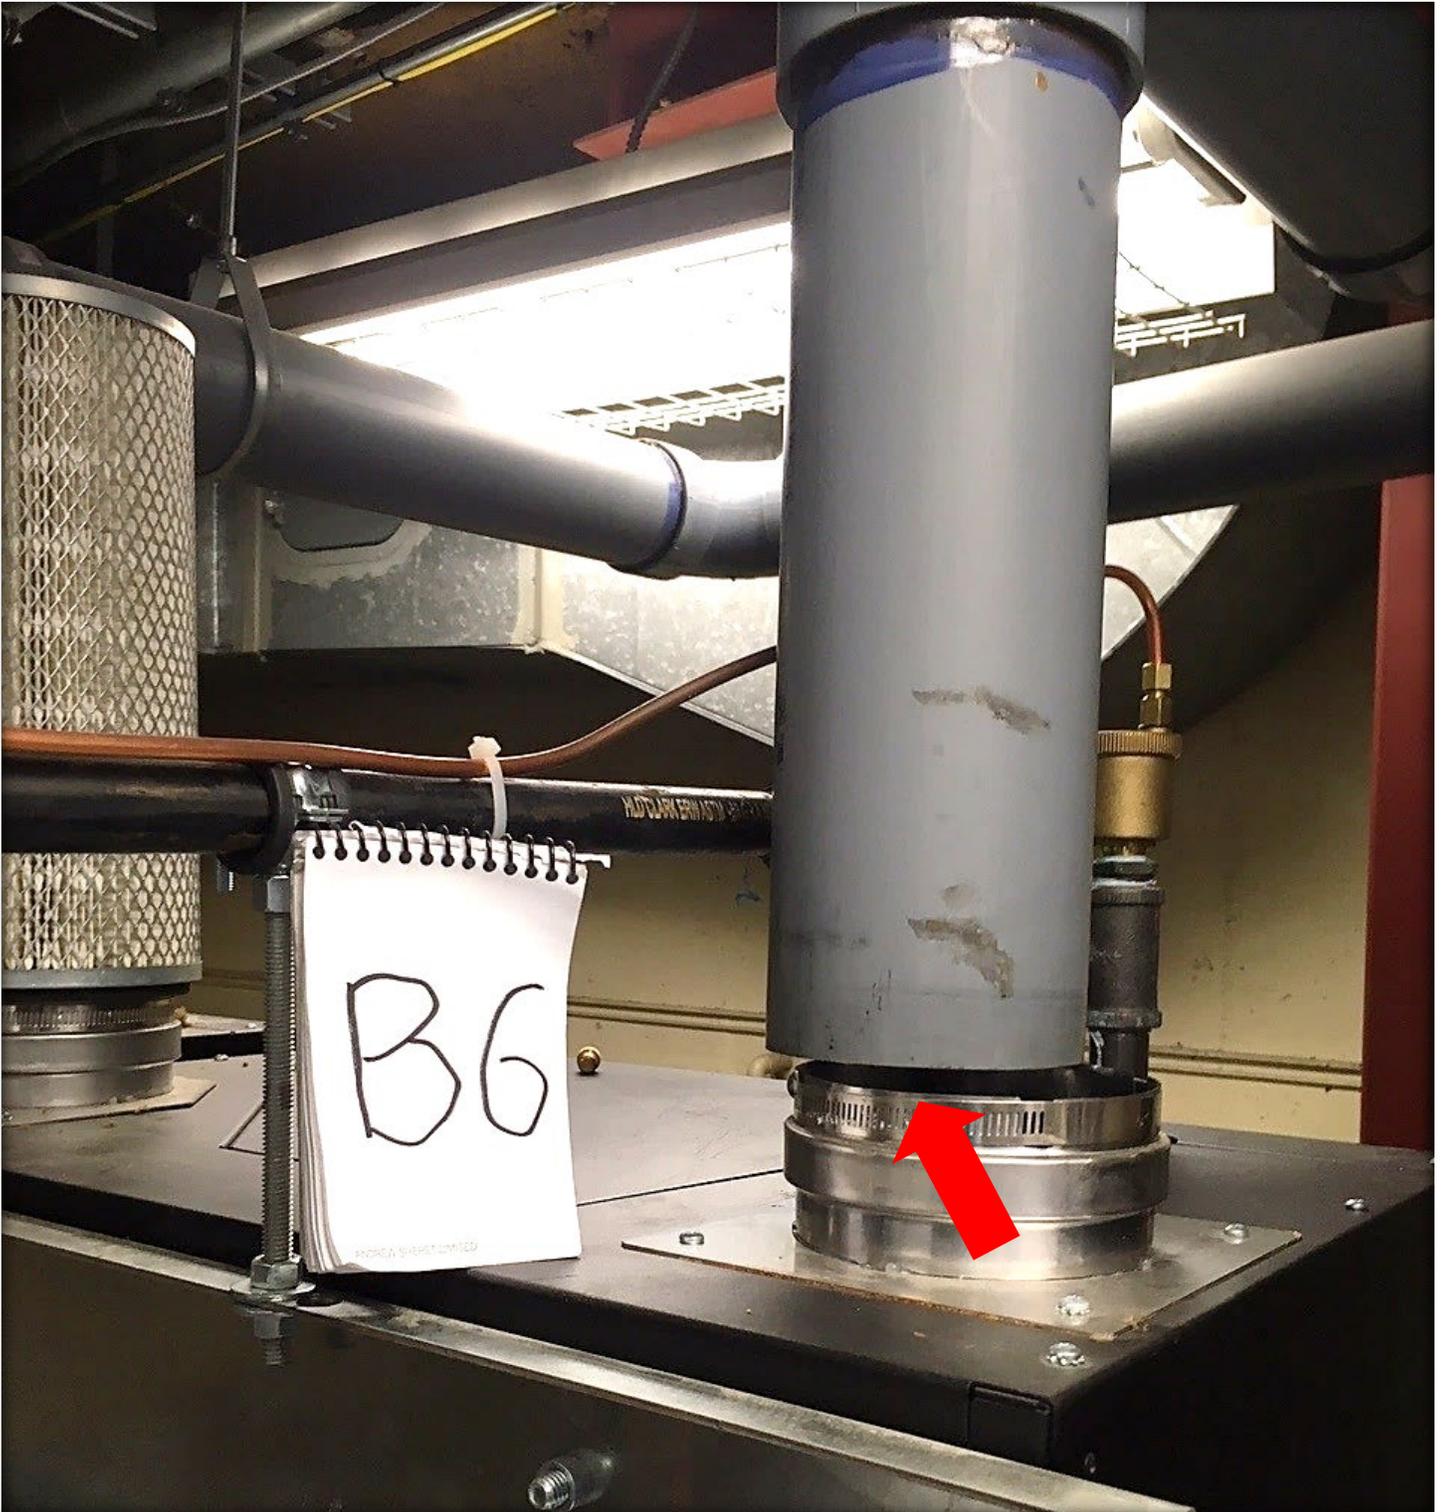
Image 3 – Venting dislodged from boiler due to delayed ignition detonation (example 2 of 3).

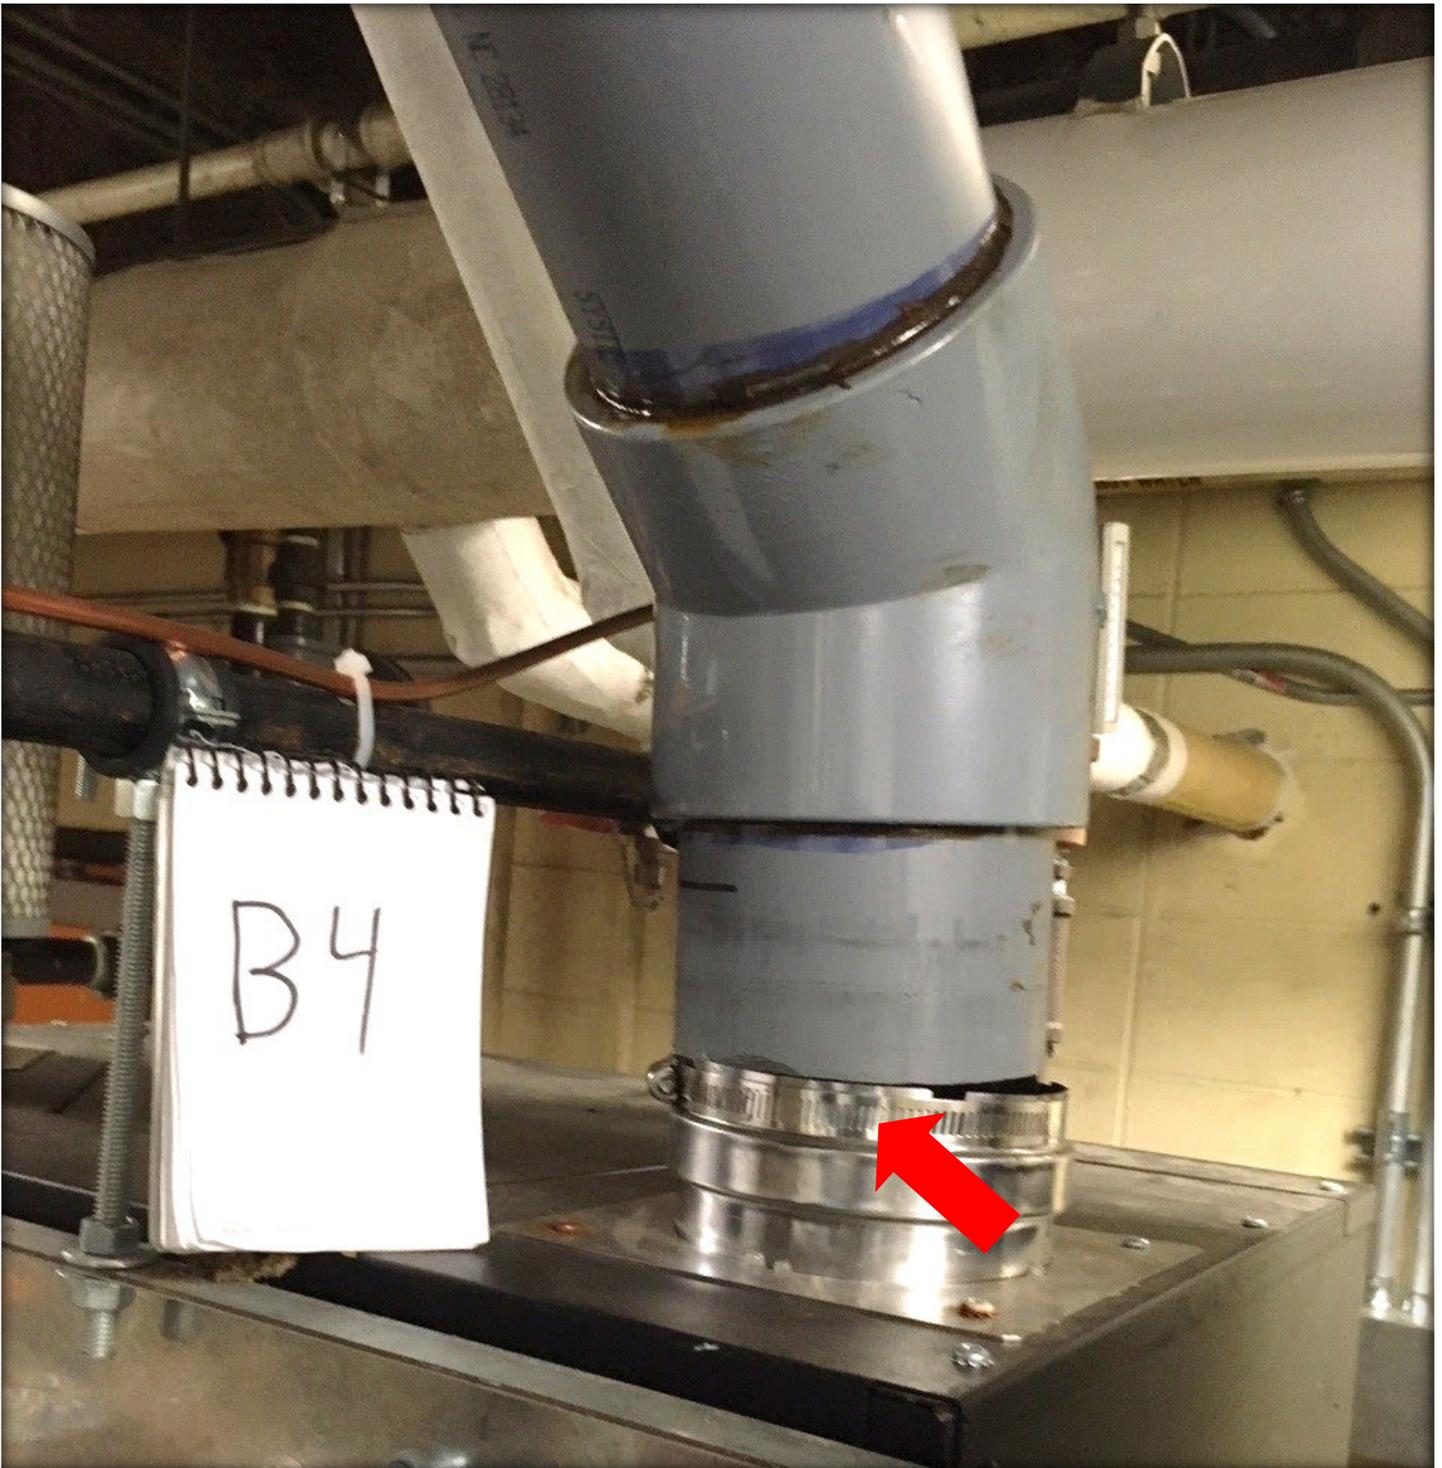
Image 4 – Venting dislodged from boiler due to delayed ignition detonation (example 3 of 3).

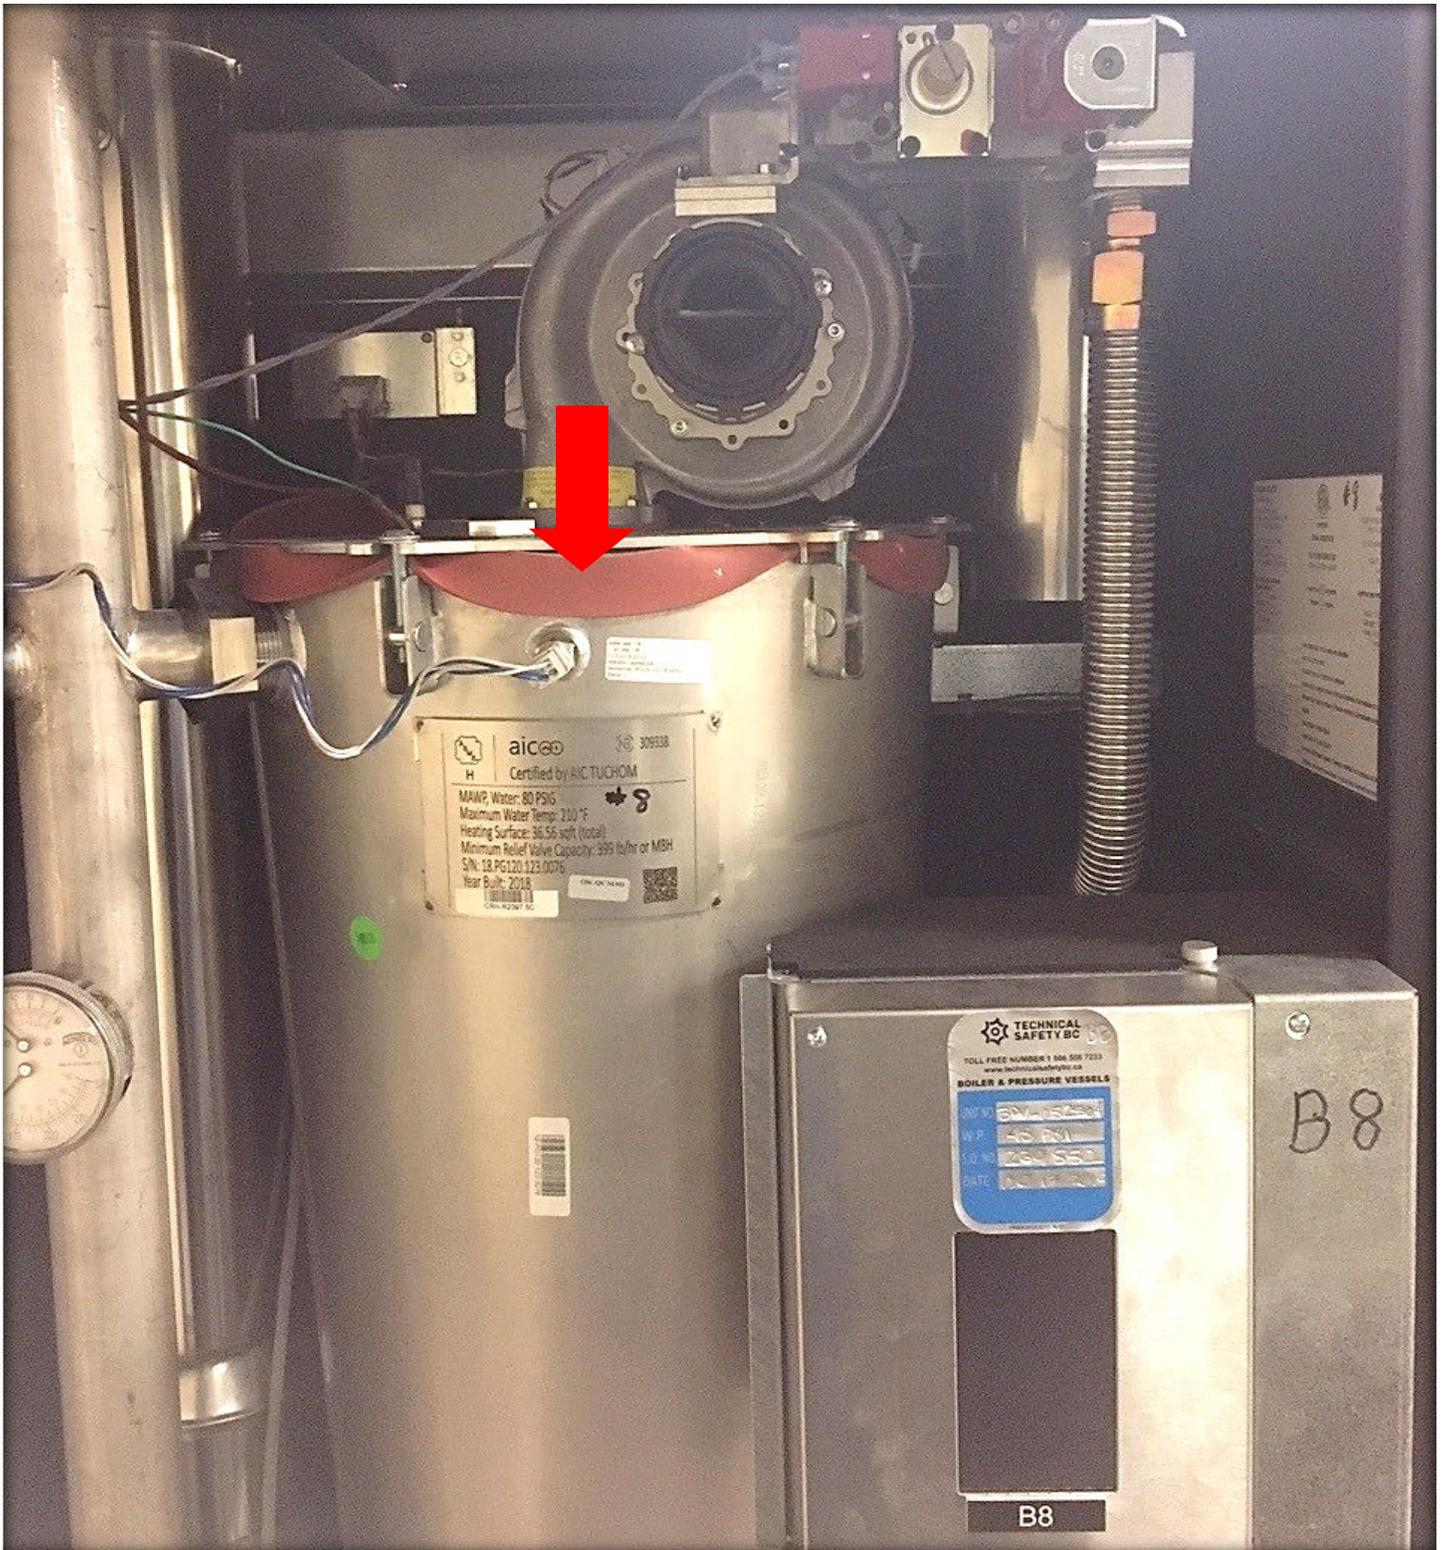
Image 5 – Pressure vessel gasket blown out from delayed ignition on Boiler 8 (example 1 of 4)

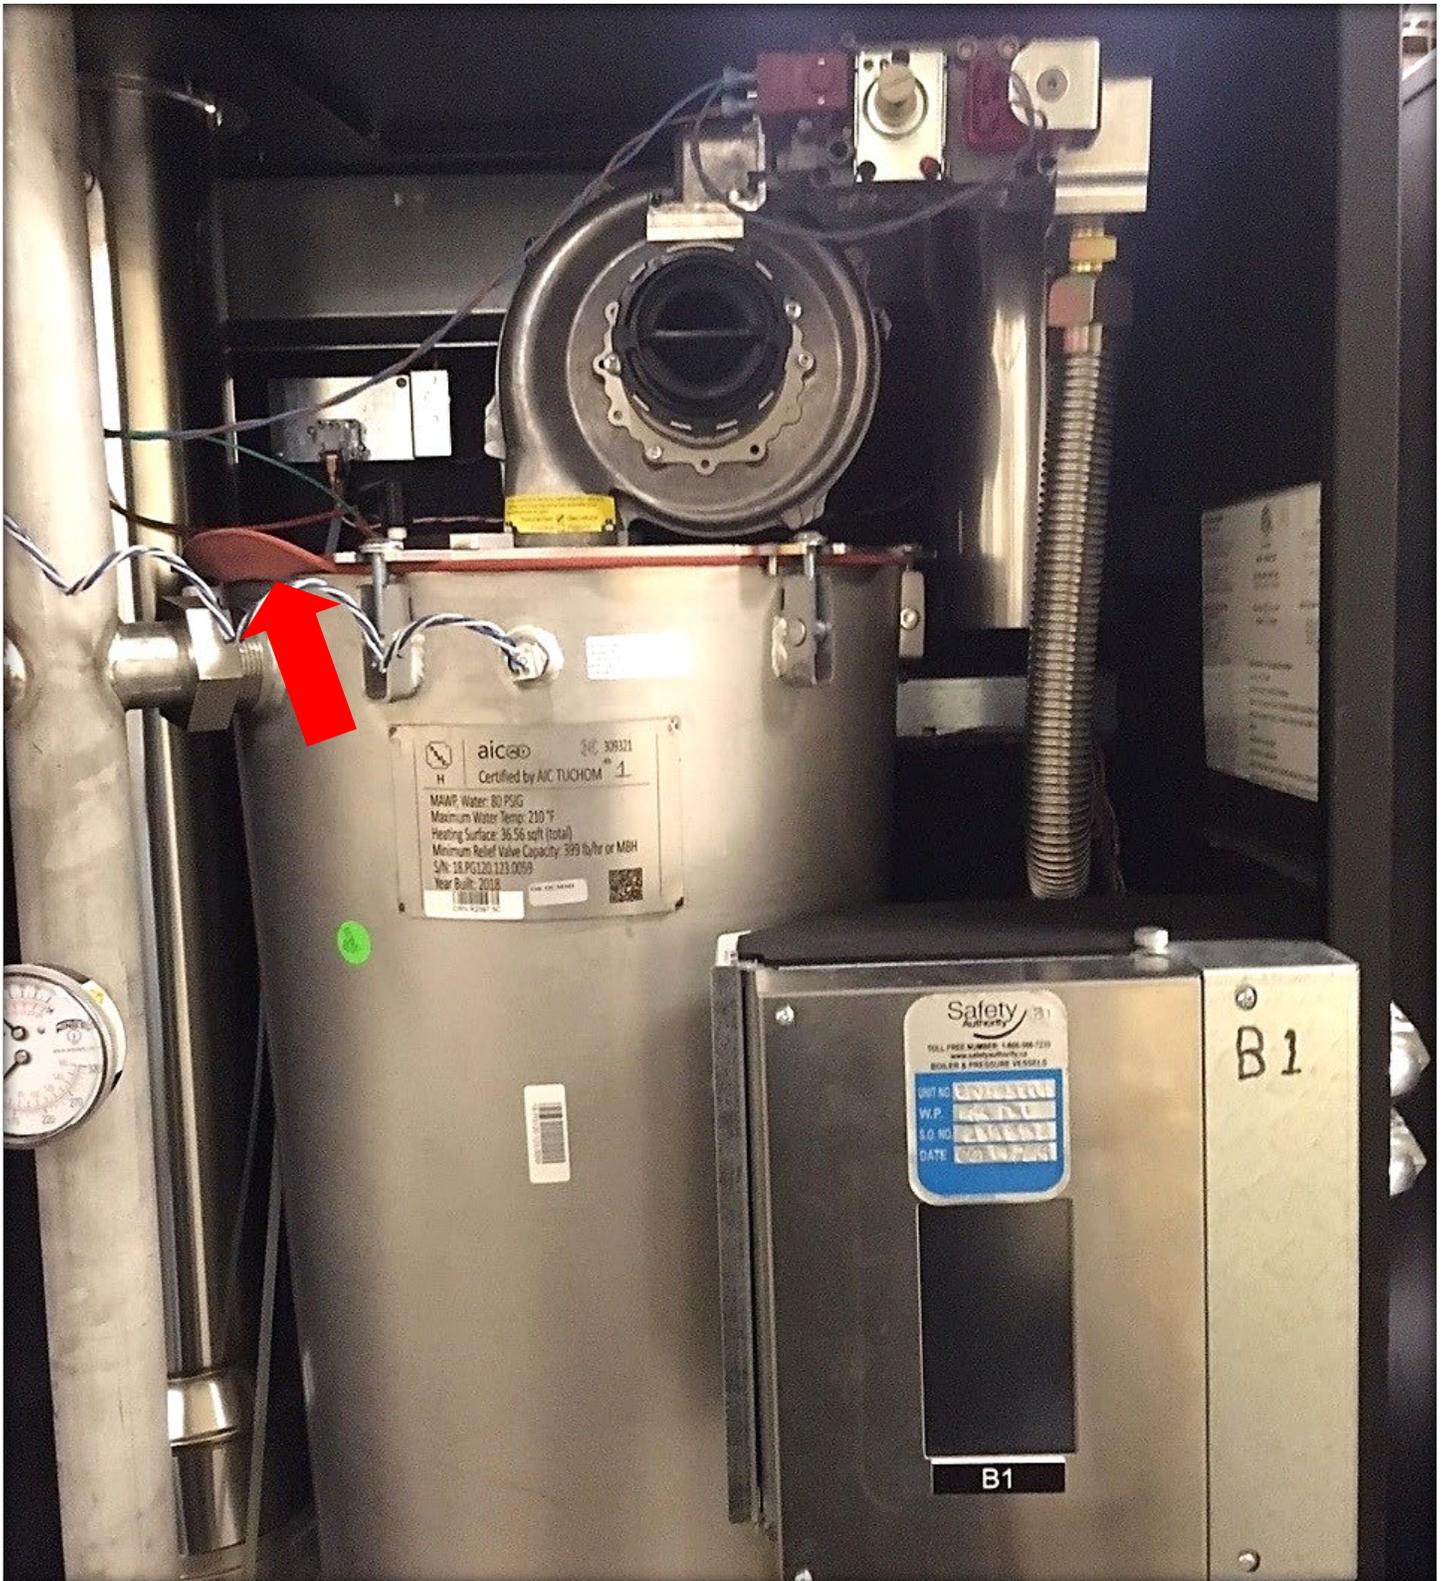
Image 6 – Pressure vessel gasket blown out from delayed ignition on Boiler 1 (example 2 of 4)

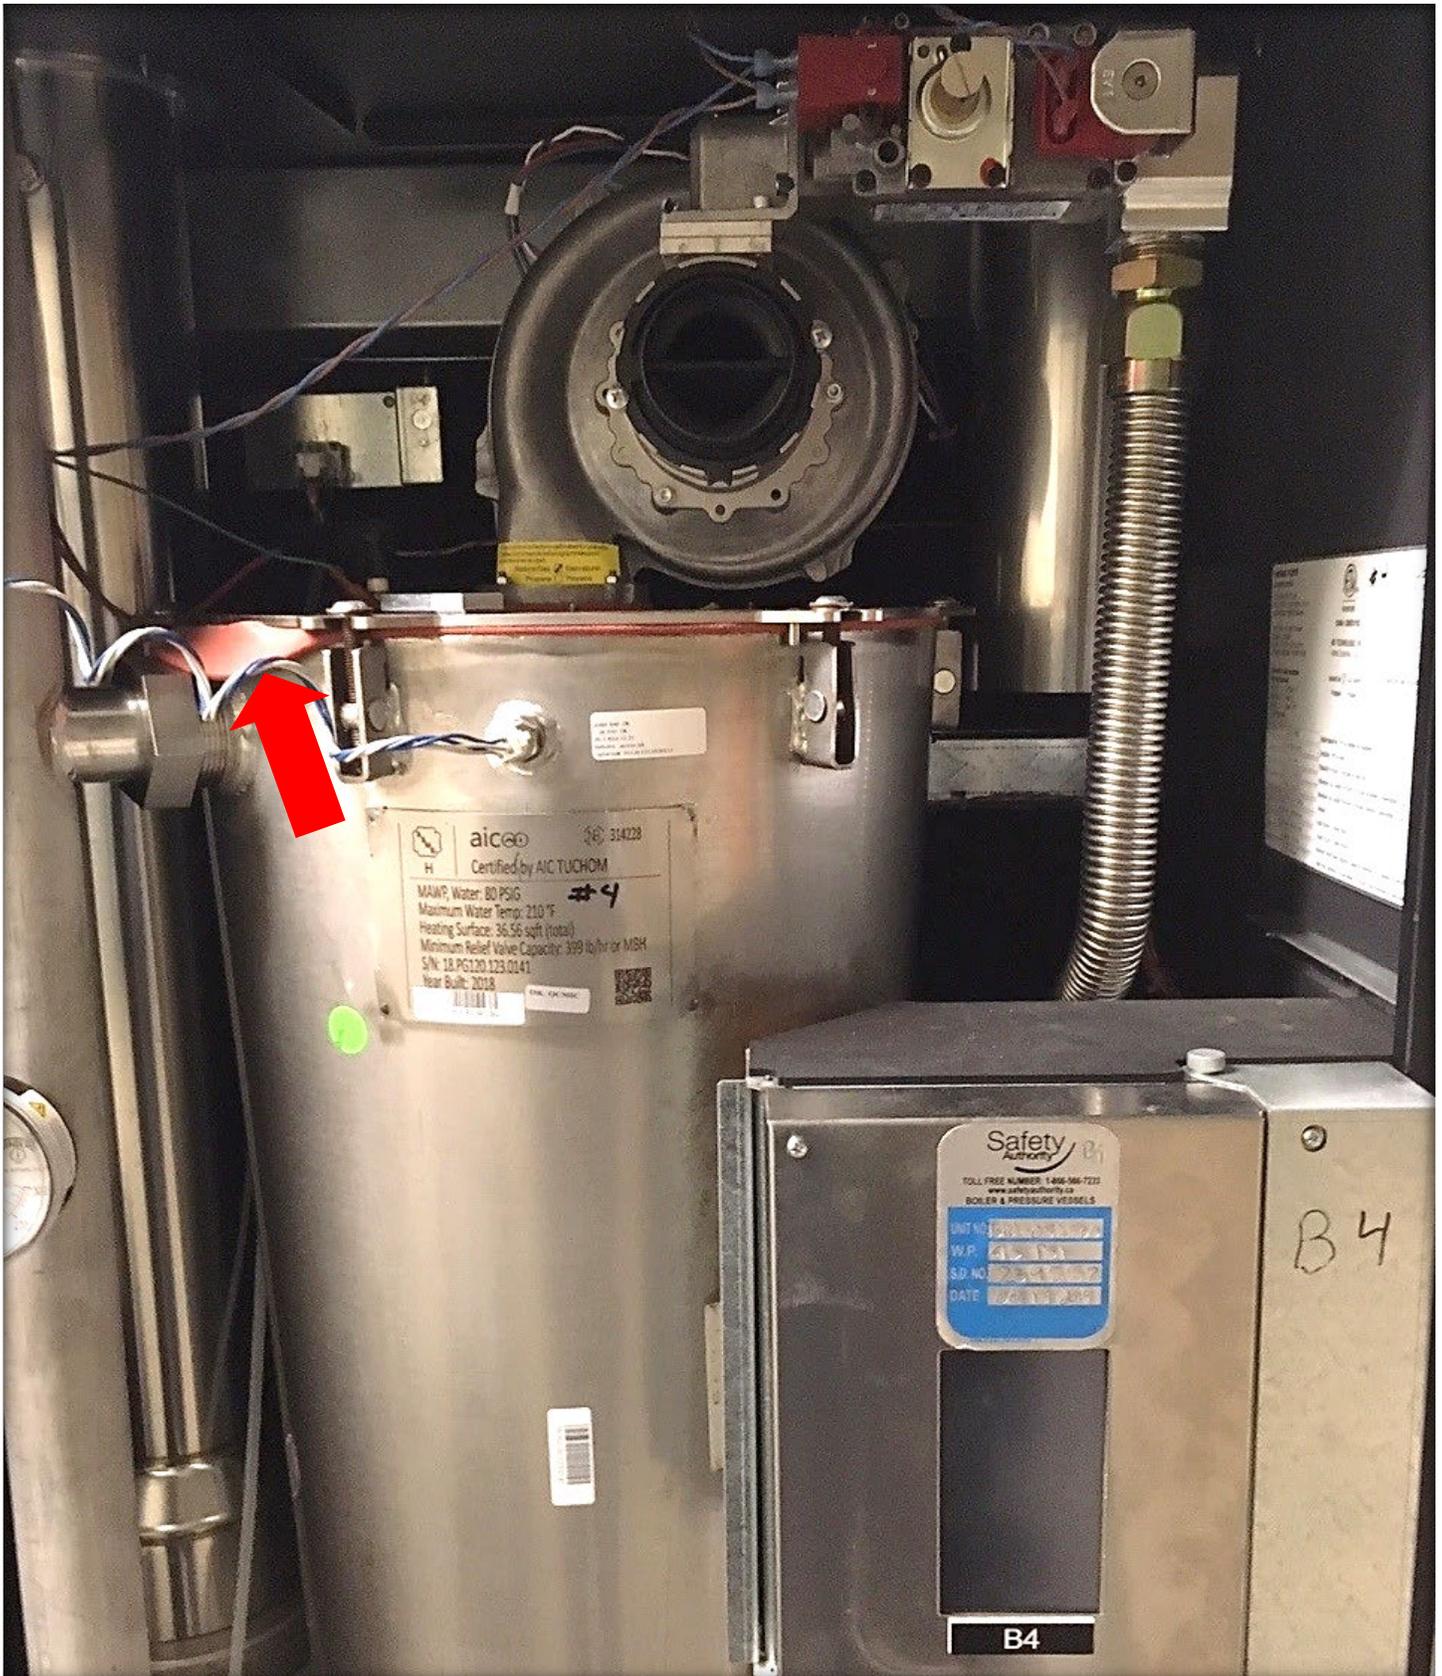
Image 7 – Pressure vessel gasket blown out from delayed ignition on Boiler 4 (example 3 of 4)

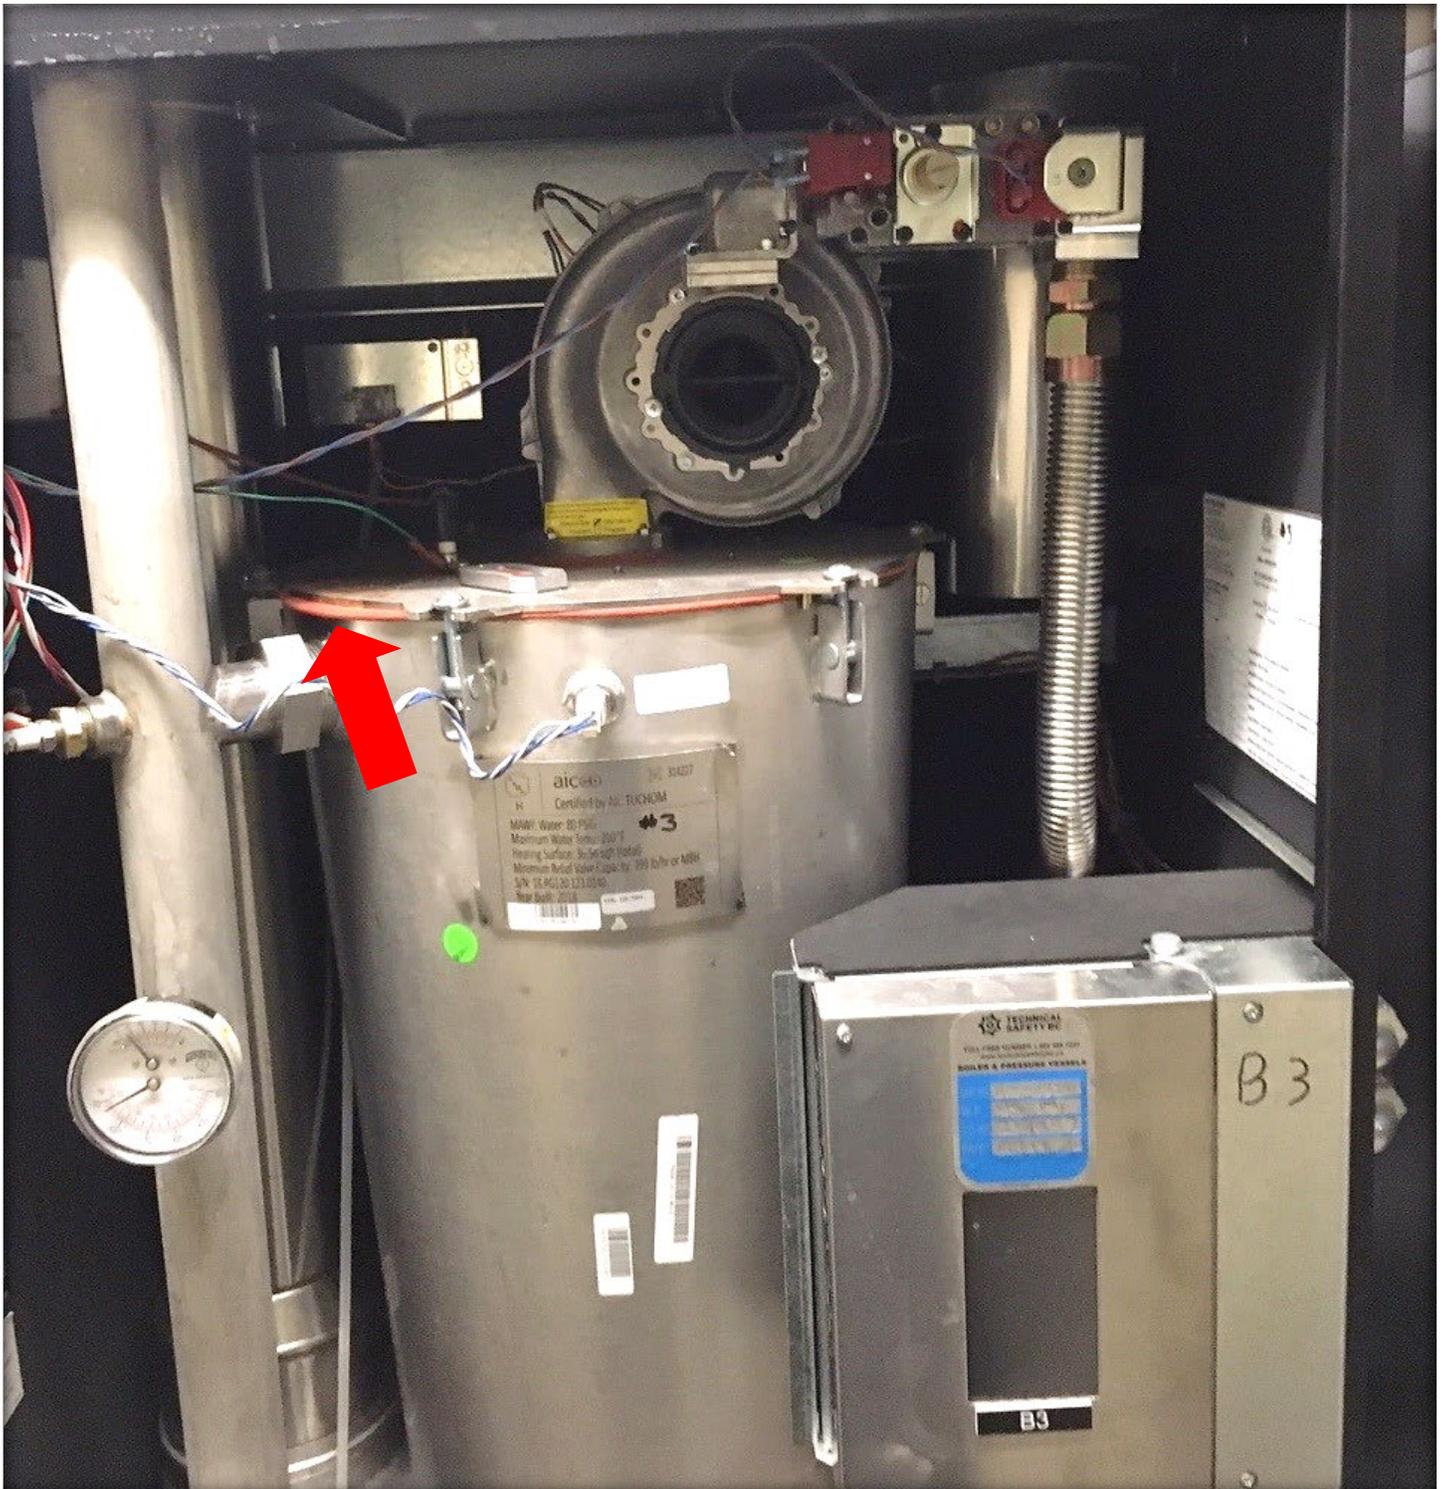
Image 8 – Pressure vessel gasket blown out from delayed ignition on Boiler 3 (example 4 of 4)
