Incident Summary #II-765453-2019 (#9425) (FINAL)

SUPPORTING INFORMATION	Incident Date	October 29, 2018	
	Location	Cloverdale	
	Regulated industry sector	Boilers, PV & refrigeration - Refrigeration system	
	Impact	Qty injuries	0
		Injury description	N/A
	Damage	Injury rating	None
		Damage description	-Ammonia hot gas piping was corroded. -20ft of carbon steel piping had to be replaced due to corrosion. -The amount of ammonia released from system was calculated to be approximately 125lbs.
		Damage rating	Minor
Incident rating	Minor		
Incident overview	An ammonia release occurred in the mezzanine area at an industrial food processing facility, which resulted in the evacuation of the facility and temporary shutdown of the ammonia plant.		
INVESTIGATION CONCLUSIONS	Site, system and components	<p>The industrial food processing facility has designated refrigerated rooms to keep food from spoiling.</p> <p>During a refrigeration cooling cycle, liquid ammonia travels through piping to an evaporator. The evaporator is part of the refrigeration system designed to produce the refrigeration by vaporization. Frost build up occurs as a result of vaporization effect on the evaporator coils which o

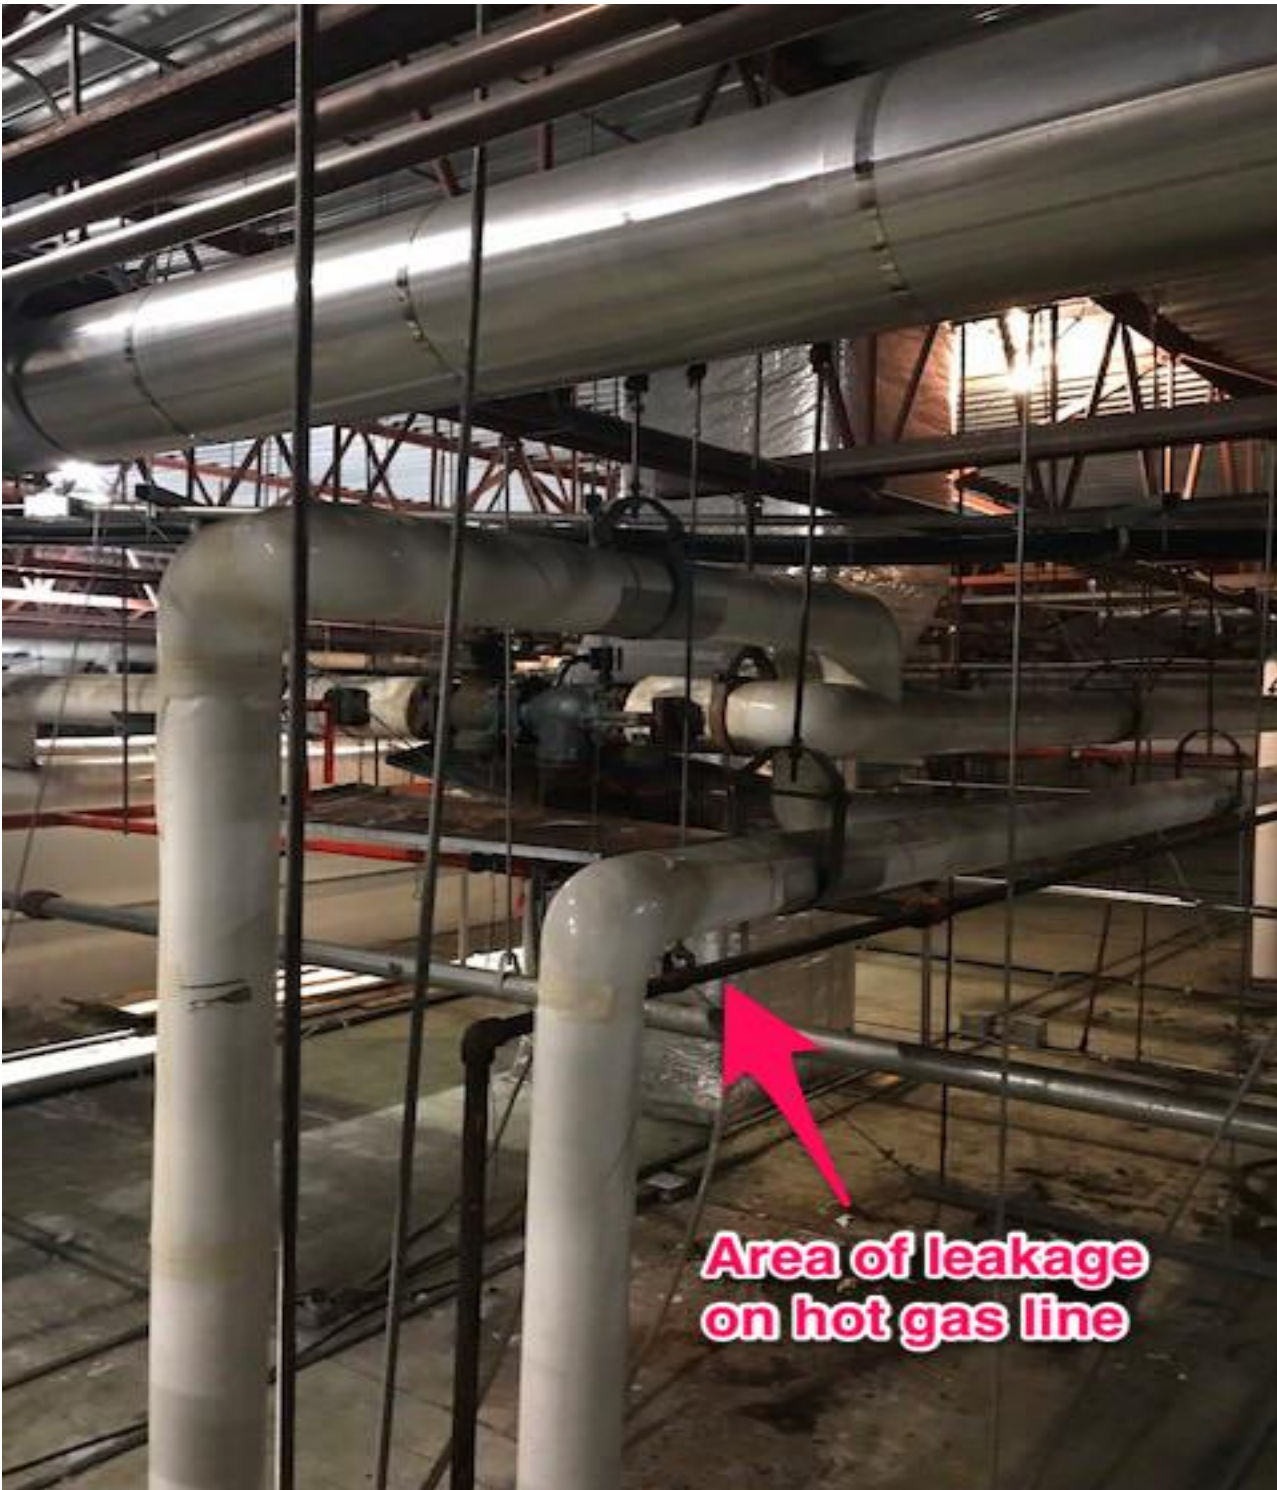
Picture 1 Mezzanine area above grinding room

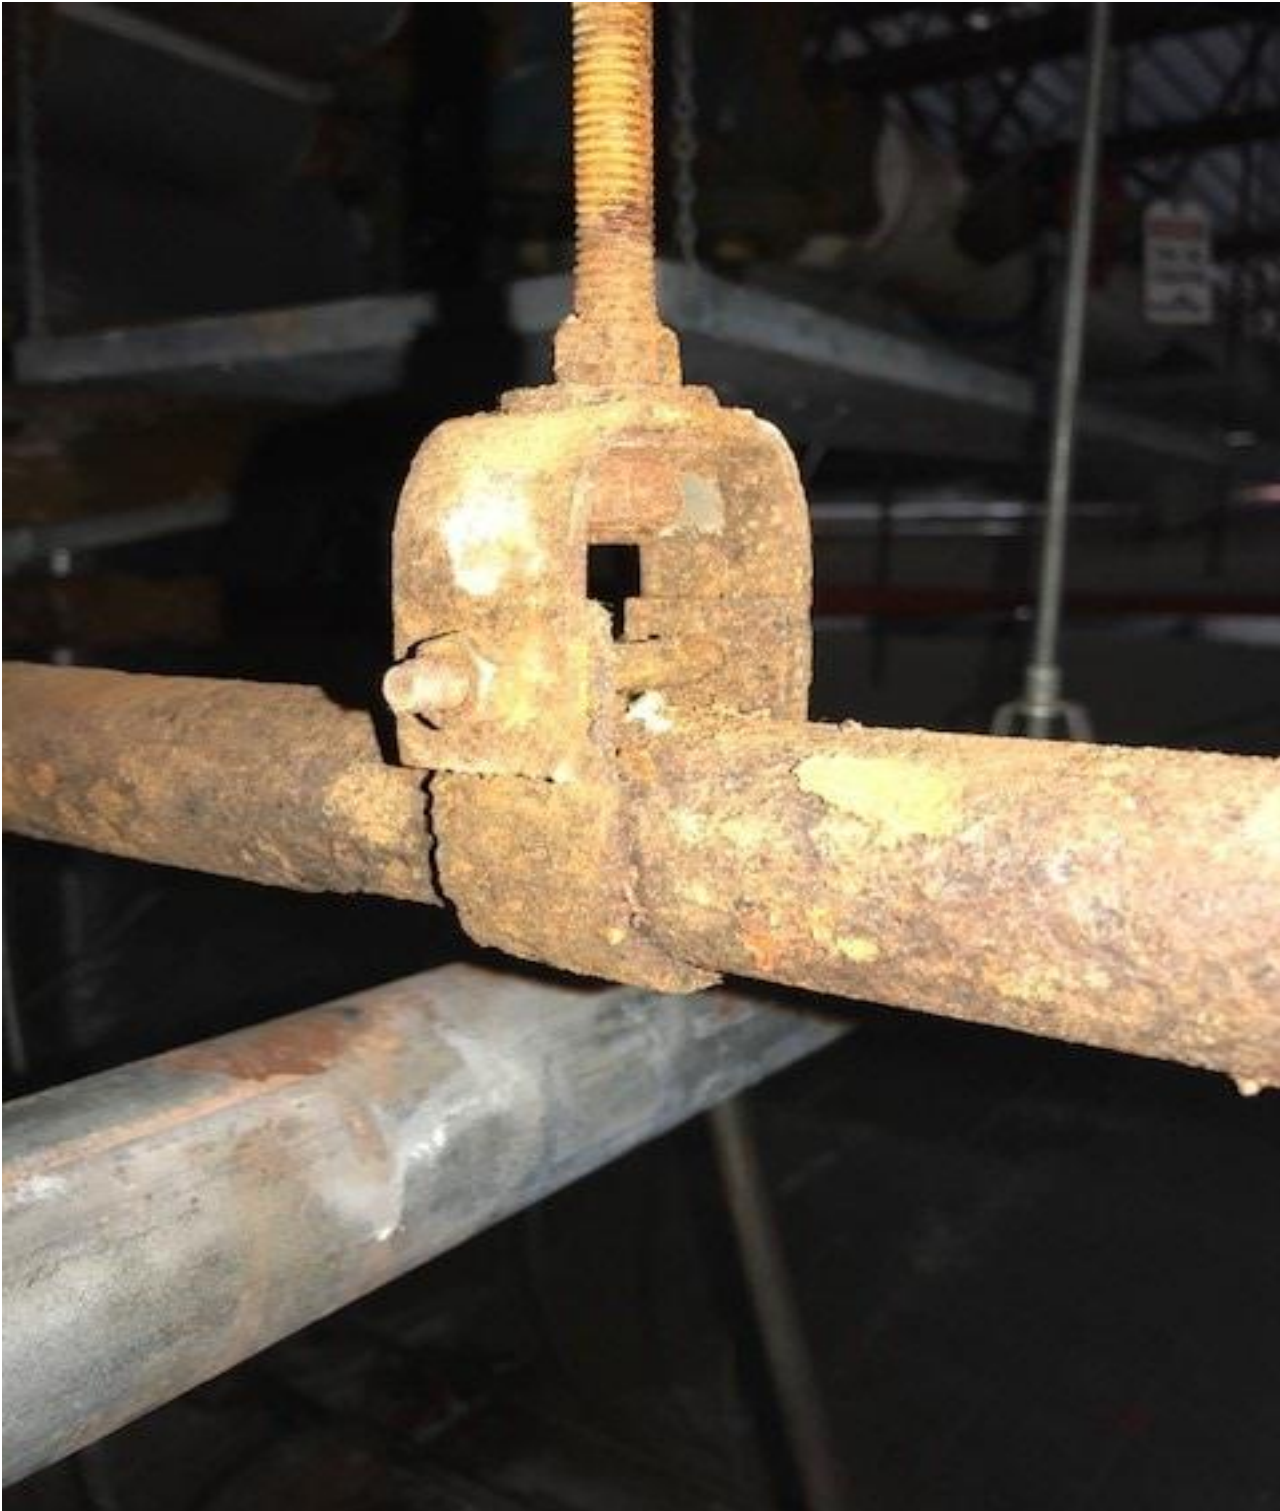
<p>Causes and contributing factors</p>	<p>It is very likely that the type of insulation that was used on the section of pipe, created the atmosphere for corrosive conditions to exist, which then led to ammonia escaping from a pinhole leak in the pipe.</p>

Picture 2 Corroded pipe, pipe hanger and metal thinning

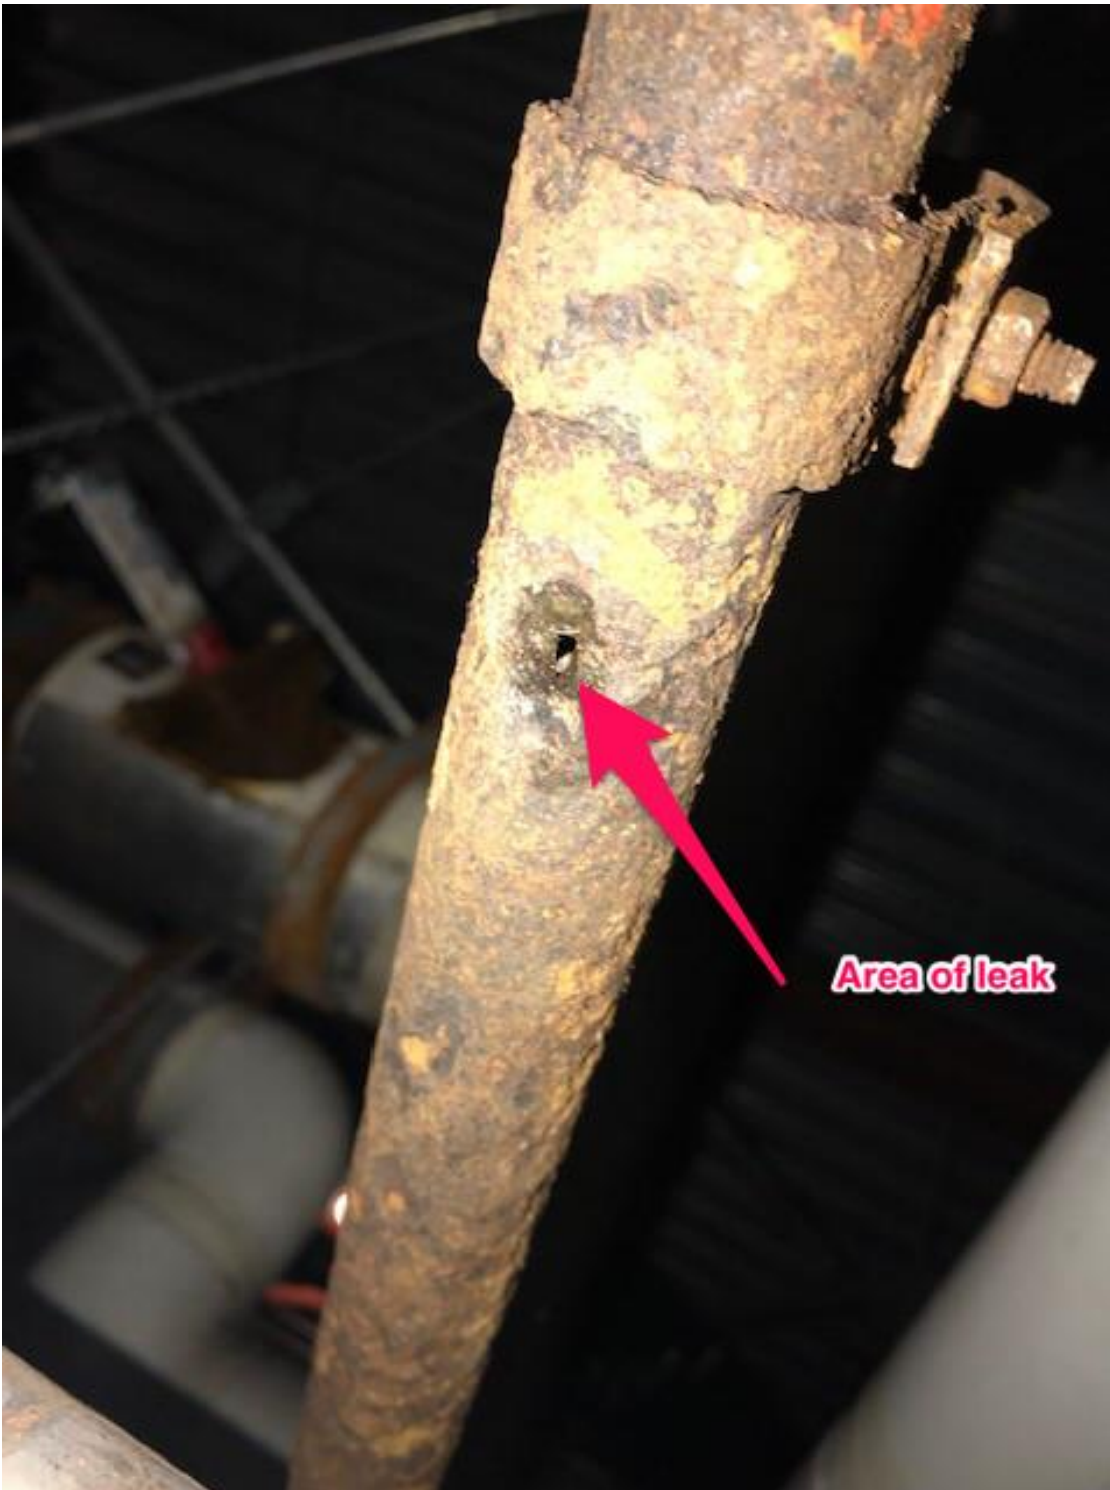
Failure scenario(s)	<p>During an evaporator defrost cycle, condensation formed on the hot gas line pipe.</p> <p>A section of hot gas pipe was insulated with a fiberglass material that did not have a vapor barrier and retained the moisture from condensation that was occurring during the defrost cycle.</p> <p>The fiberglass insulation material maintained a wet saturated condition that created an environment of corrosion attack from the contact of moisture to the carbon steel pipe.</p> <p>The slow process of the insulation absorbing the condensate created by the hot gas line during the defrost cycle caused thinning and degradation of the metal from the effects of corrosion. Over time, this caused an opening in the wall of the pipe where ammonia was able to escape to the space. (see picture 3&4 below)</p>

Picture 3 Hot gas line and pin hole leak

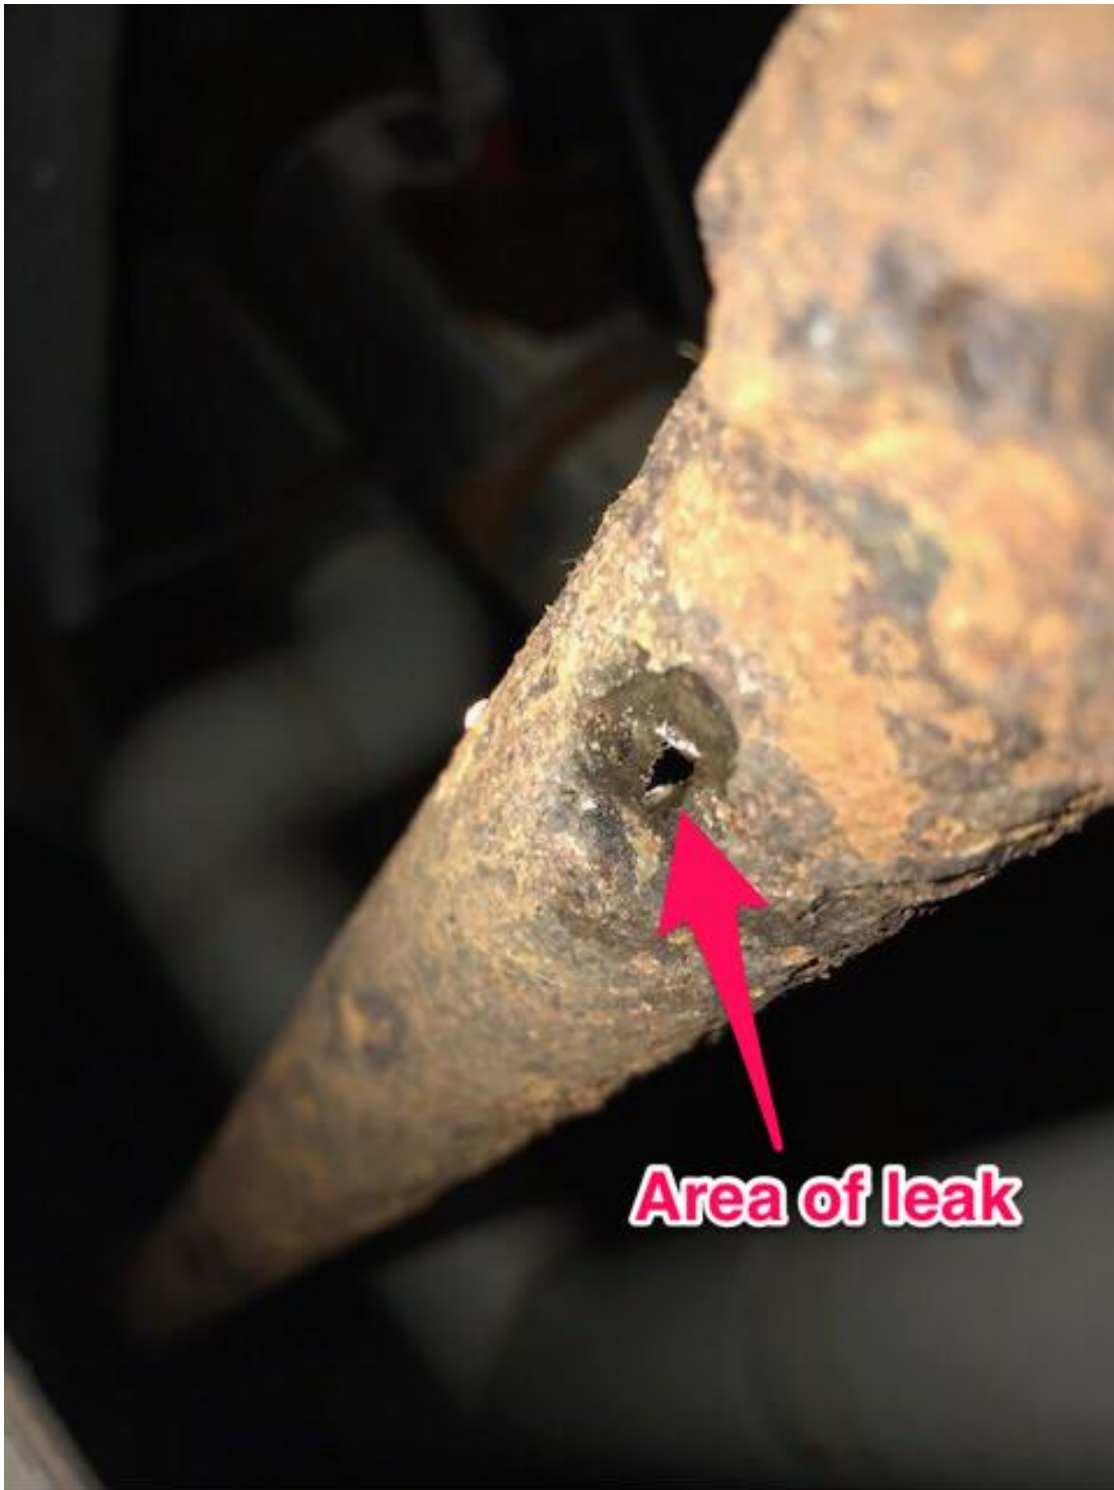
Picture 4 Close up of pin hole

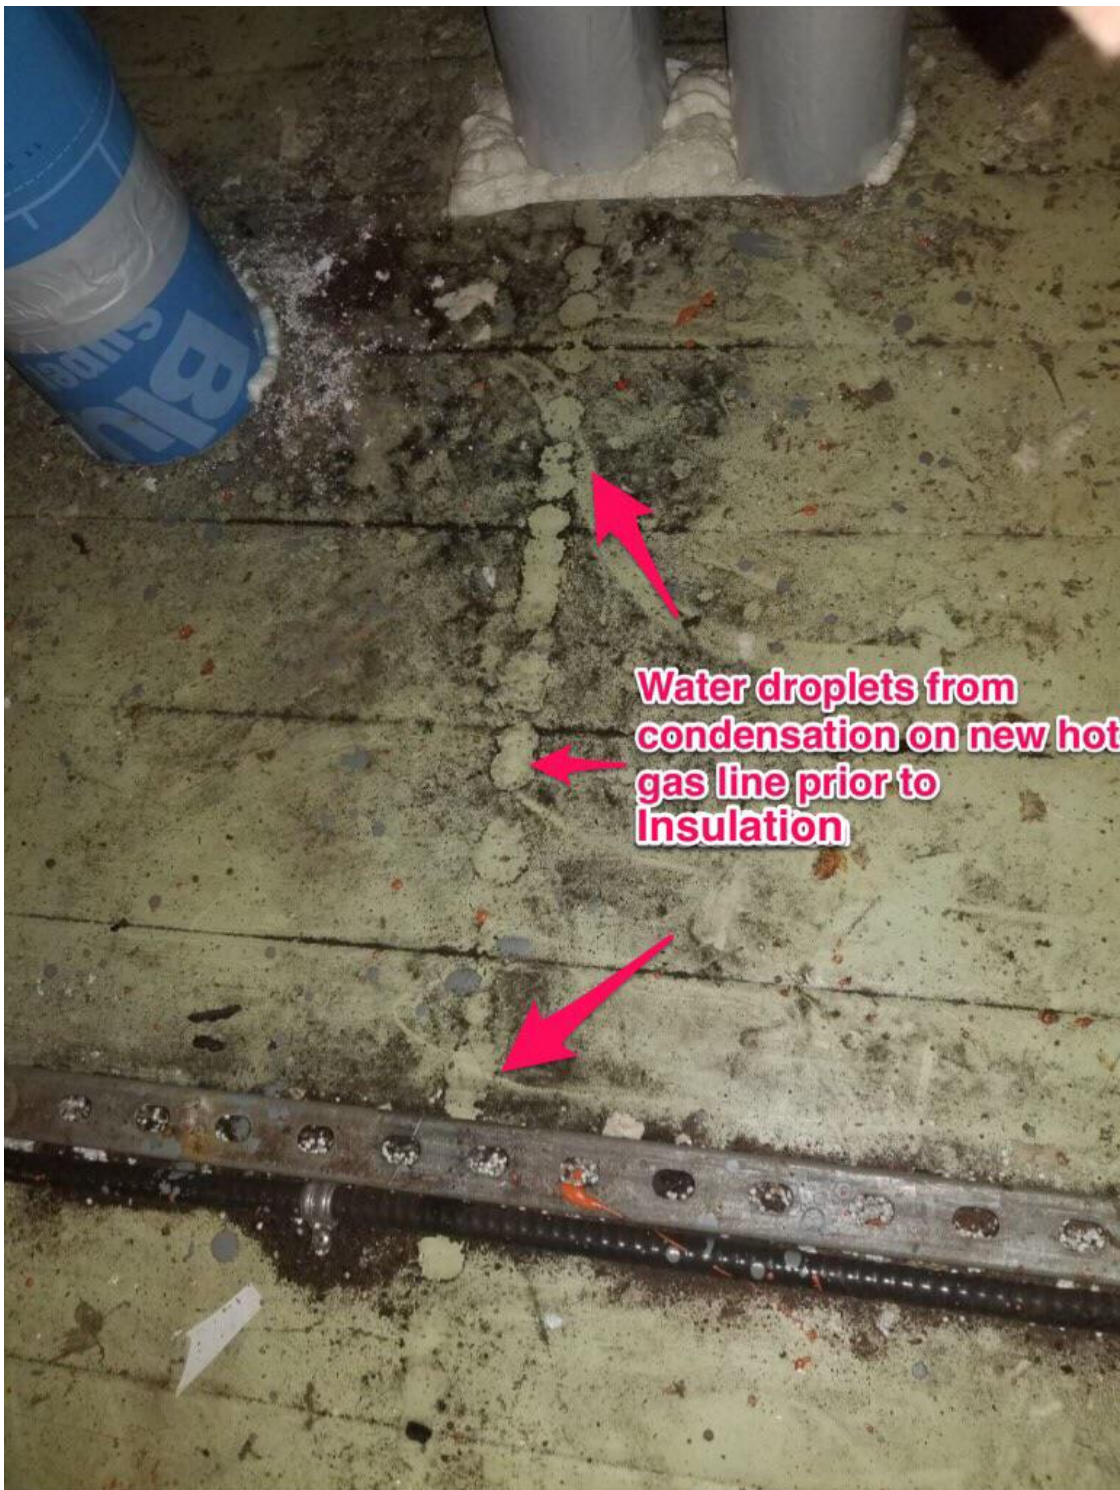
<p>Facts and evidence</p>	<p>Contractor Witness statement</p> <ul style="list-style-type: none"> • Contractor stated that original pipe was painted red to color code the hot gas line. • Contractor removed insulation and stated the insulation was heavy in weight from absorption of moisture. • Fiberglass insulation not usually applied to ammonia system's in cold environments. • Other hot gas lines that serve other evaporators in building have a Styrofoam vapor barrier type of insulation which protects against condensation and moisture absorption. • Calculated amount of ammonia released from system was 125lbs. • Contractor stated that when system was started up for testing after repairs and new hot gas pipe installed that condensate formed on the line before new insulation with vapor barrier was applied. Water droplets formed on the pipe which dripped on the ground, confirming that the line, if not insulated, formed condensation. <p>Contractor safety bulletin hazard alert</p> <ul style="list-style-type: none"> • Contractor that maintains the facility issued a company internal safety bulletin that indicated similar issues observed at other facilities they service. • There is a chance that ammonia refrigeration piping systems that have fiberglass insulation pose potential risks from corrosion in cold environments. <p>Company incident report</p> <ul style="list-style-type: none"> • Piping installed in 1996. • Non-insulated lines are inspected monthly/annually. • Insulated lines likely have not been inspected since installation. • Moisture underneath the insulation is unable to be identified by visual inspection. <p>Pictures</p> <ul style="list-style-type: none"> • Location of leak in mezzanine area : <i>see picture 1</i> • Corroded pipe: <i>see pictures 3&4</i> • Pipe hangers are of similar material to the pipe. :<i>see picture 2</i> • Pipe hangers were also corroded and were enclosed within the insulation. :<i>see picture 1</i> • Area of leak showed signs of metal thinning compared to rest of line. :<i>see picture 2</i> • Pinhole leak size of approximately 4mm diameter at bottom end of pipe. See <i>picture 4</i> • Hot gas line in question was insulated using a fiberglass insulation. • Removed insulation had signs of rust and metal flakes from pipe on the inside of insulation. See <i>picture 5</i>

Picture 5 Mezzanine floor under newly installed hot gas pipe prior to new vapor type insulation being applied.
