Incident Summary, Final, (Reference #5619558)

SUPPORTING INFORMATION	Incident Date		August 12, 2017	
	Location		District of North Vancouver	
	Regulated industry sector		Passenger Ropeways, Above-surface Ropeway	
	Impact	Injury	Qty injuries	None reported
			Injury description	None
			Injury rating	NA
	Damage	Damage description	<ul style="list-style-type: none"> • <i>Damage to the carriers carriage assemblies:</i> <ul style="list-style-type: none"> ○ <i>Significant impact damage and deformation to multiple sheave beams.</i> ○ <i>Significant side plates damage of multiple sheaves (sheave side plates required replacement).</i> • <i>Impact deformation to a structural member of the hanger of one of the carriers.</i> • <i>Impact damage to lower portion of a cabin also, a cabin window popped out of its molding.</i> • <i>Significant deformation to the end of travel terminal buffer assemblies.</i> • <i>Damage to the wood structure of the return terminal building.</i>

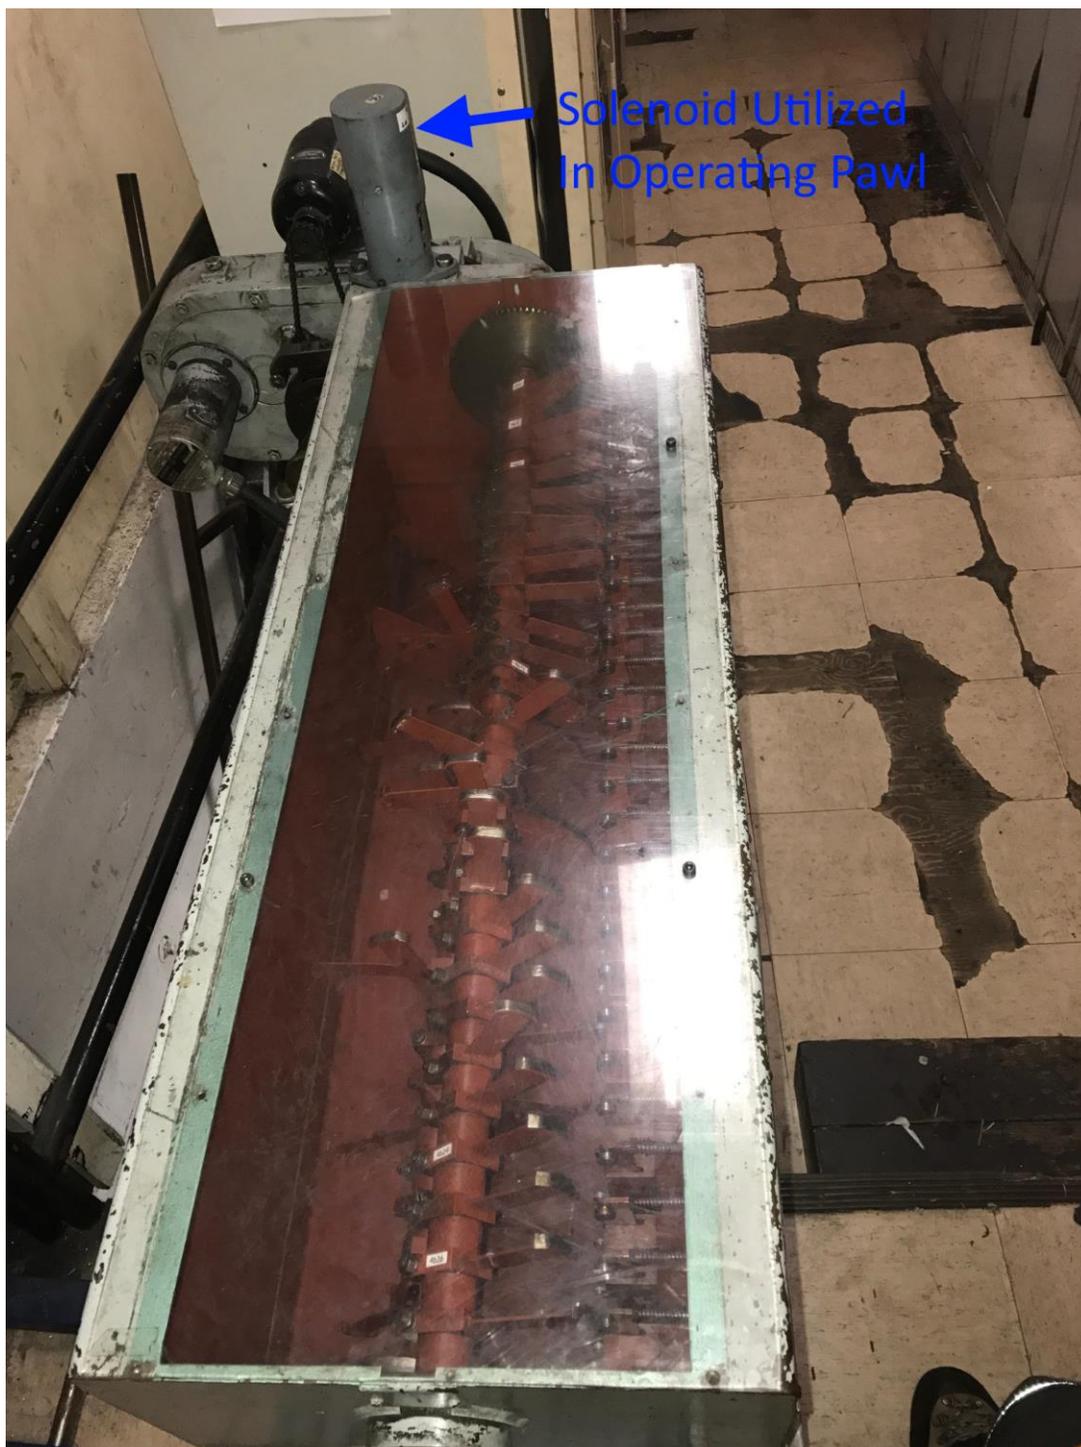
Programmer Coupling/Clutch (1)

- *At the end of each ride cycle a solenoid operated pawl engages with a gear that is coupled to the programmer through a toothed spring loaded clutch. When the pawl engages, rotation of the gear is stopped causing the toothed drive coupling (clutch) to slip and forcing the mating surface of the coupler to separate (clutch opens) and in turn cause the programmer to stop. A limit switch is used to monitor the opening of the clutch and cause the ropeway to stop upon actuation (clutch slipping will actuate switch).*

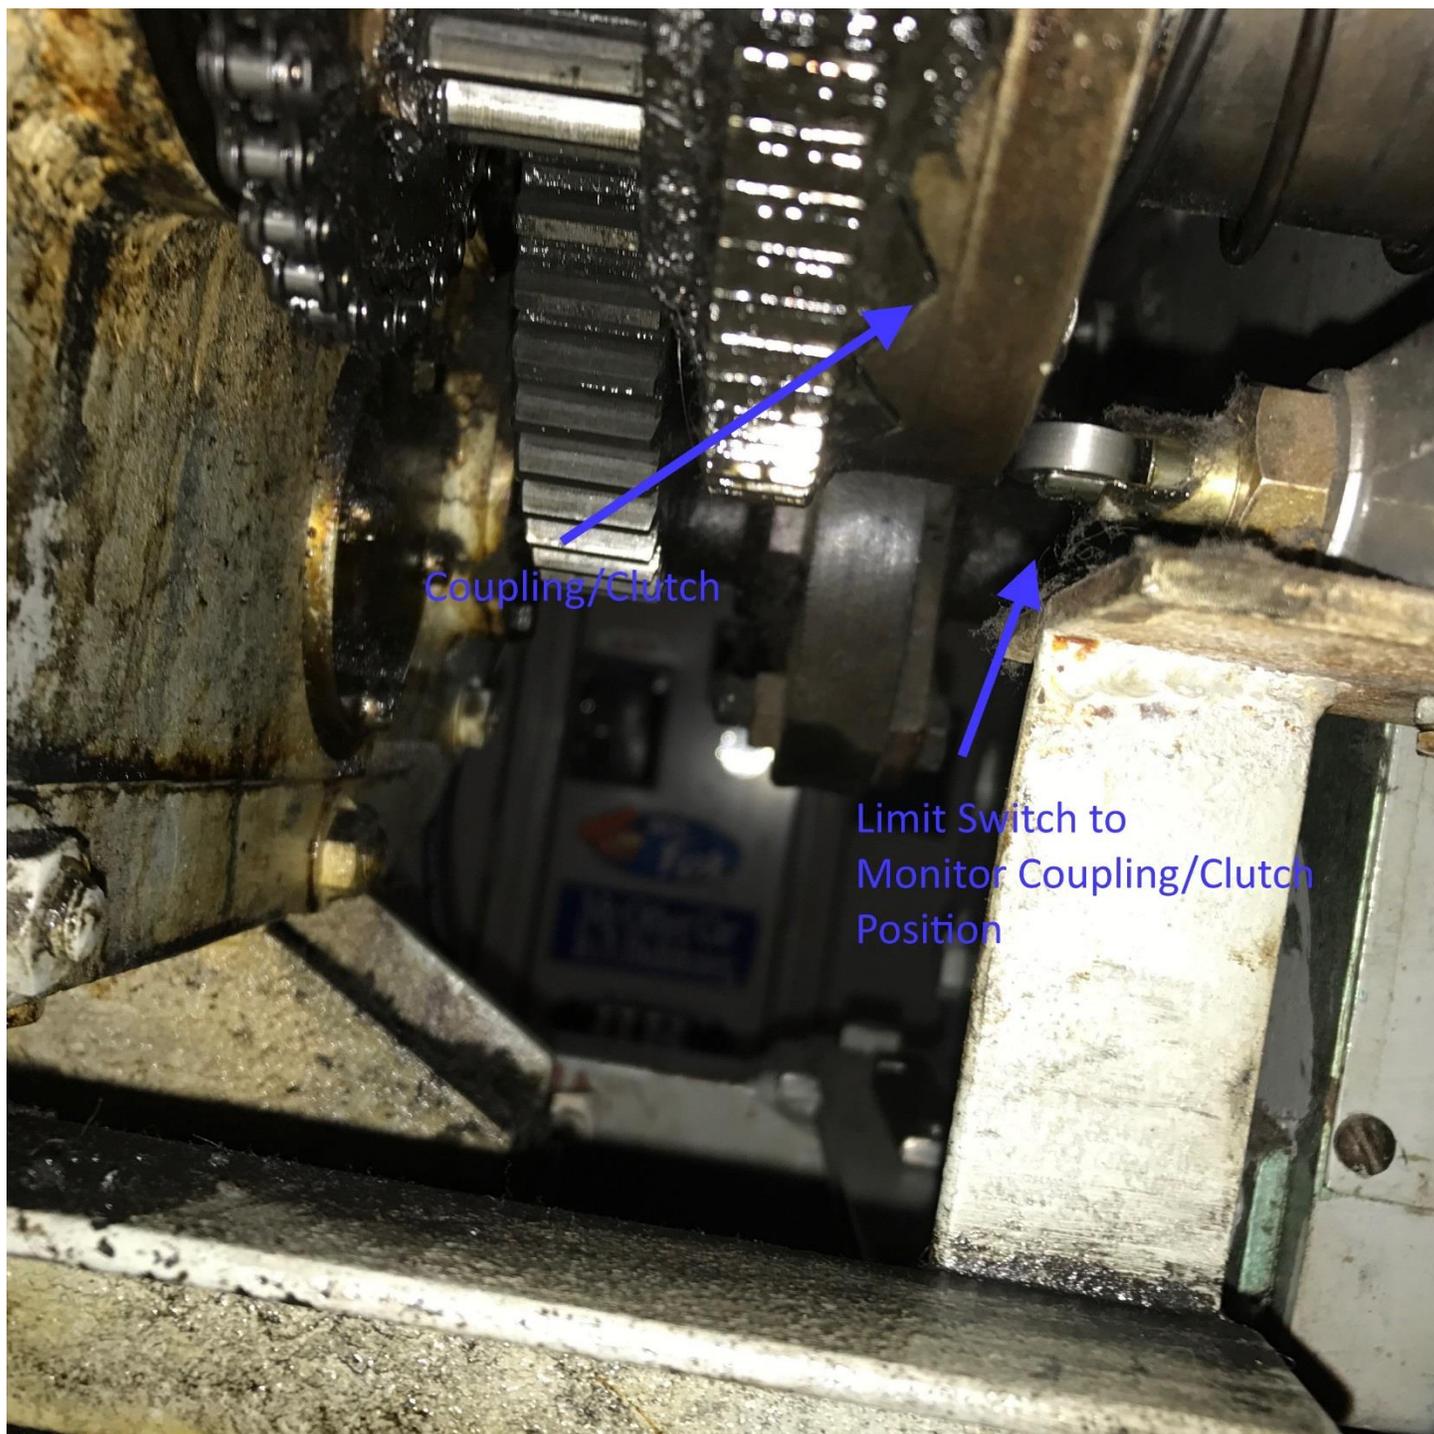
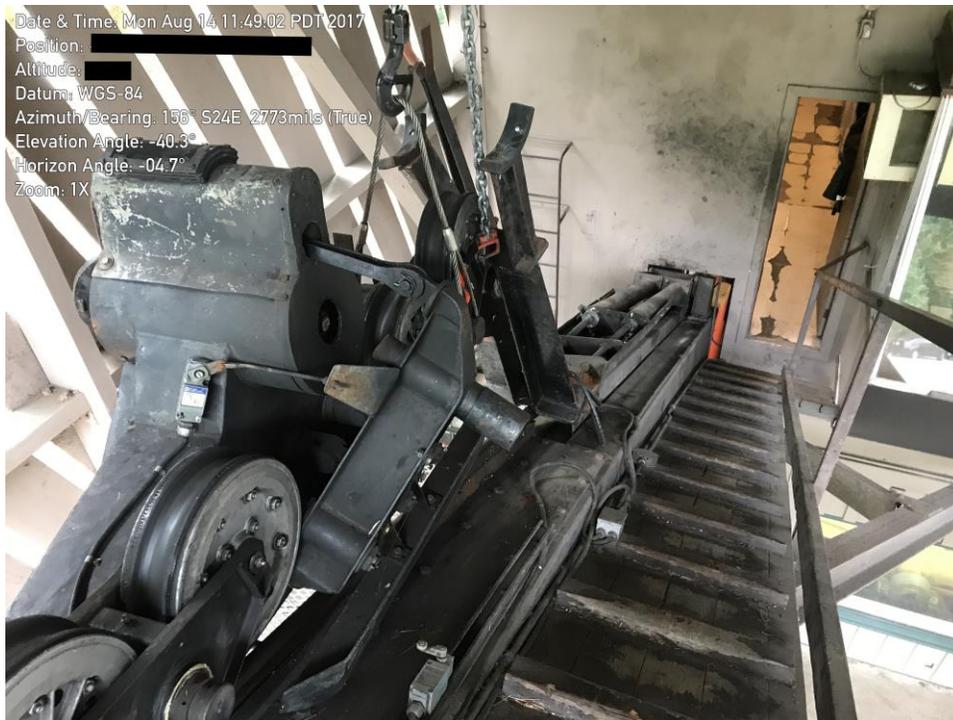
Damage at Bottom Terminal, Carrier Carriage and Buffer

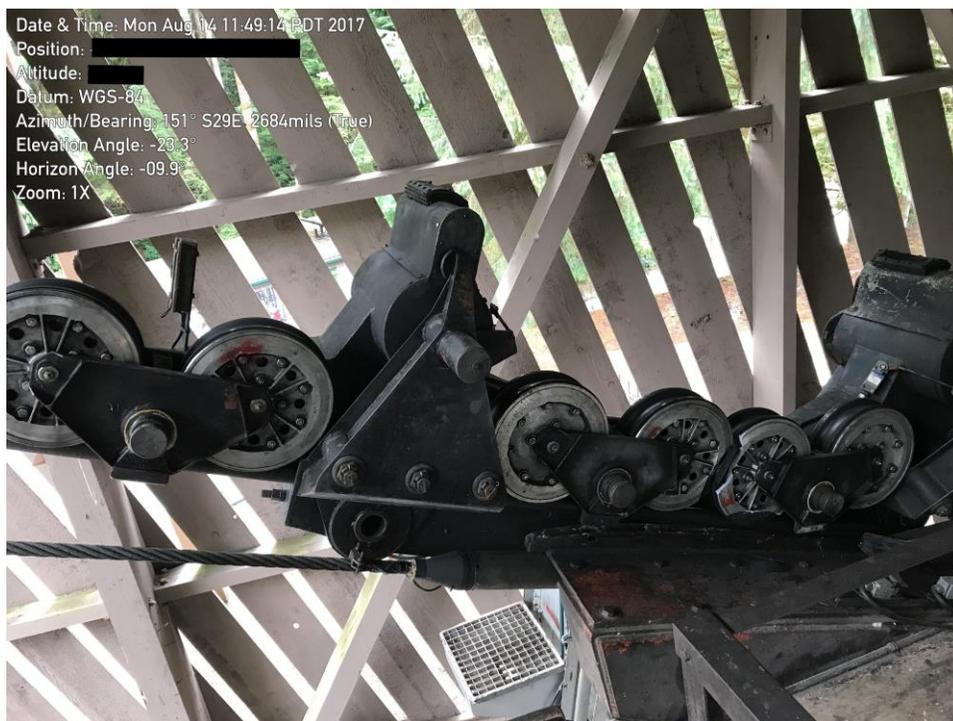
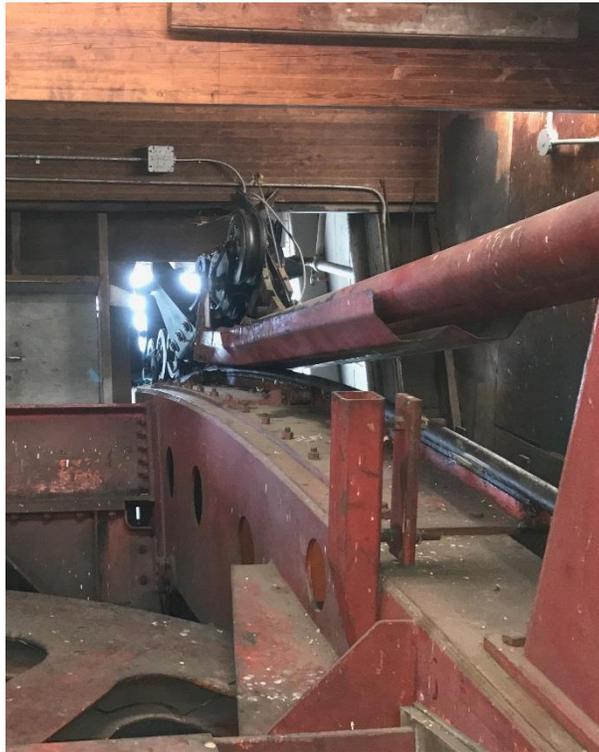
Damage at Top Terminal, Carrier Carriage and Buffer

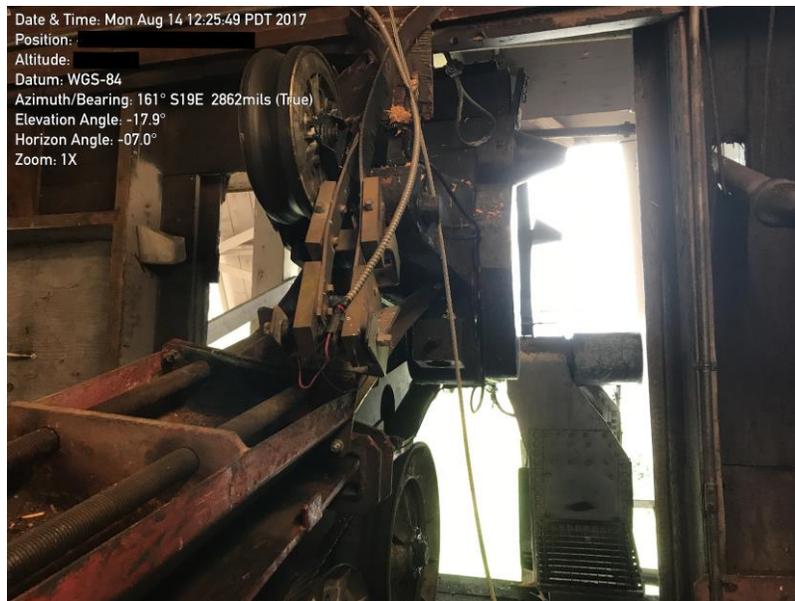
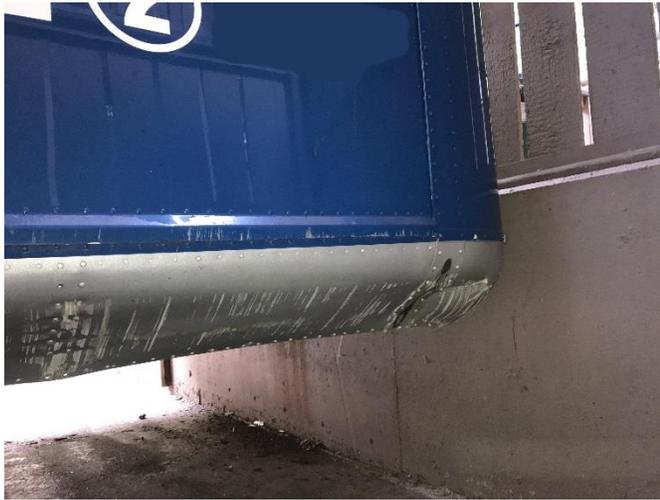
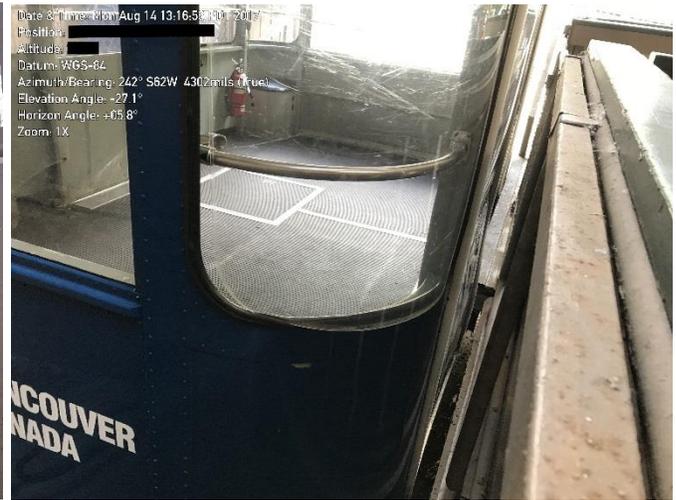
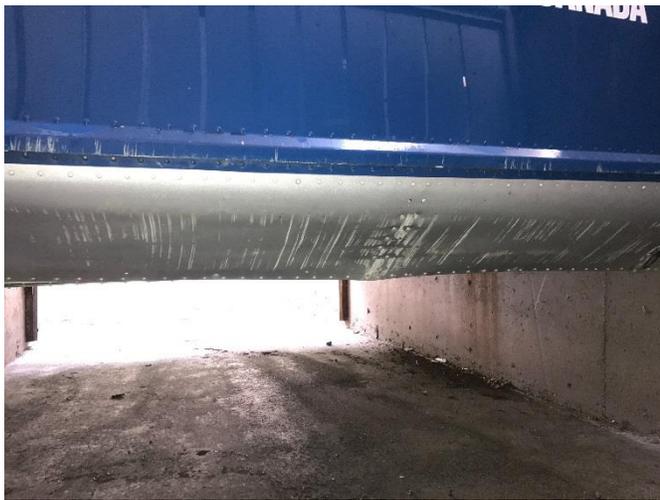
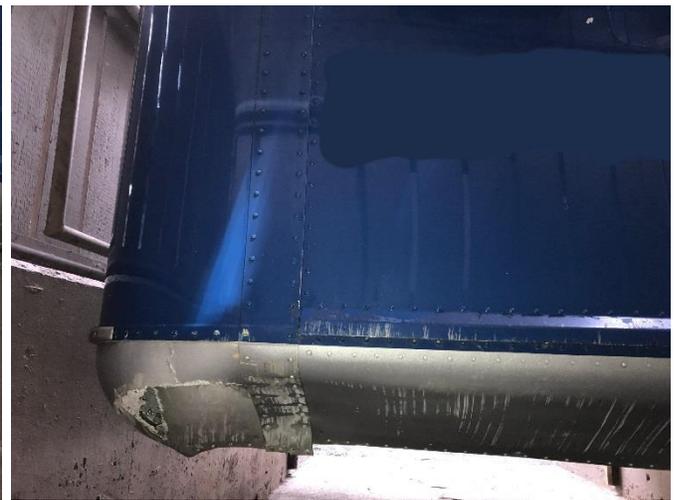
Damage to Cabin, Bottom Edge and Window
