Incident Summary #II-705415-2018 (#7630) (FINAL)

SUPPORTING INFORMATION	Incident Date	June 18, 2018	
	Location	Burnaby	
	Regulated industry sector	Elevating devices – Elevator	
	Impact	Qty injuries	1
		Injury description	Workers right forearm, wrist and hand were crushed between the main sheave and ropes.
		Injury rating	Moderate
	Damage	Damage description	NA
		Damage rating	None
Incident rating	Moderate		
Incident overview	Worker was working alone measuring the brakes air gaps with a feeler gauge while the elevator was in operation. Measuring the brake with a feeler gauge required reaching between the sheave and hoisting ropes. Workers right arm got caught by the ropes and pulled into the sheave as the elevator drove in the up direction.		
INVESTIGATION CONCLUSIONS	Site, system and components	<p>Traction elevators are driven by a steel wire rope that is propelled by a drive sheave (wheel). The wheel is driven by a drive motor and gear box assembly that is directly coupled to the drive sheave. Traction elevators have a machine brake that is located between the motor and drive sheave. When the elevator is in motion, the machine brakes are open (not applied). When the elevator comes

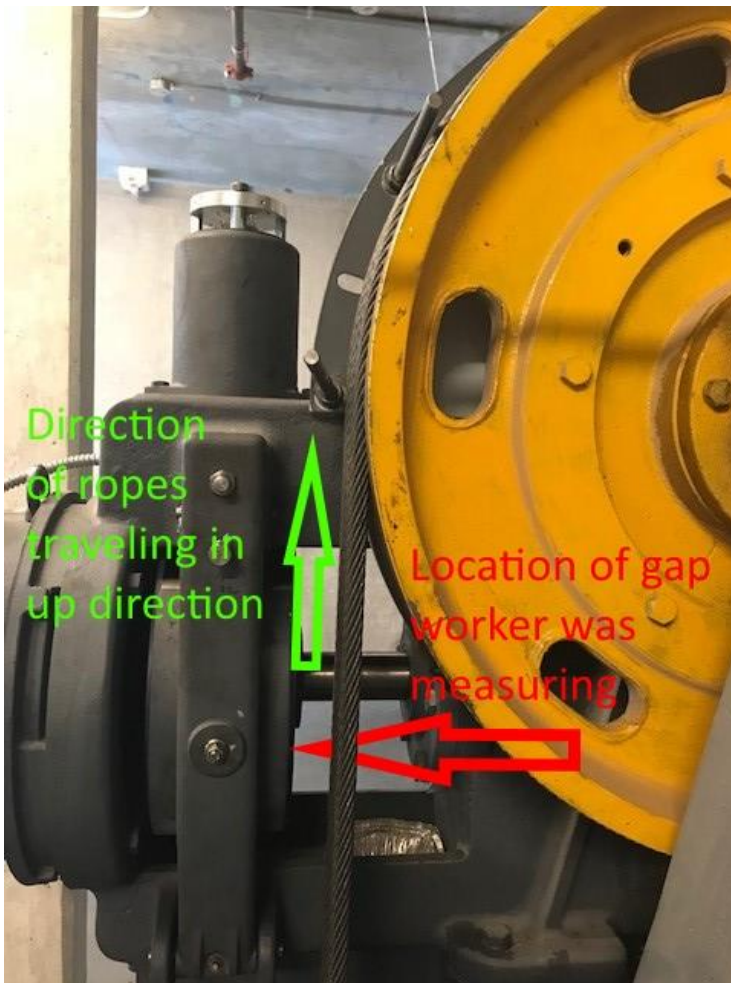
<p>While investigating the scene of the incident, the workers glove was observed stuck to the sheave with dried blood along with a trail of dried blood that followed the workers route out of the machine room as reported in the employers incident summary.</p> <p>Interviewing the workers employer and speaking with the WorkSafe BC Safety Officer assigned to this incident corroborated what was seen in the machine room along with their summary report.</p> <p>Employer informed that the mechanics helper had called in sick that day and the mechanic was working alone.</p> <p>When speaking to the employer they stated that the job had been taking longer than normal.</p>
Causes and contributing factors	It is highly likely that the worker was not following the safe work procedures they had been provided by their employer. It is possible the worker was rushing to complete the job.

Picture of the machine where the incident occurred.

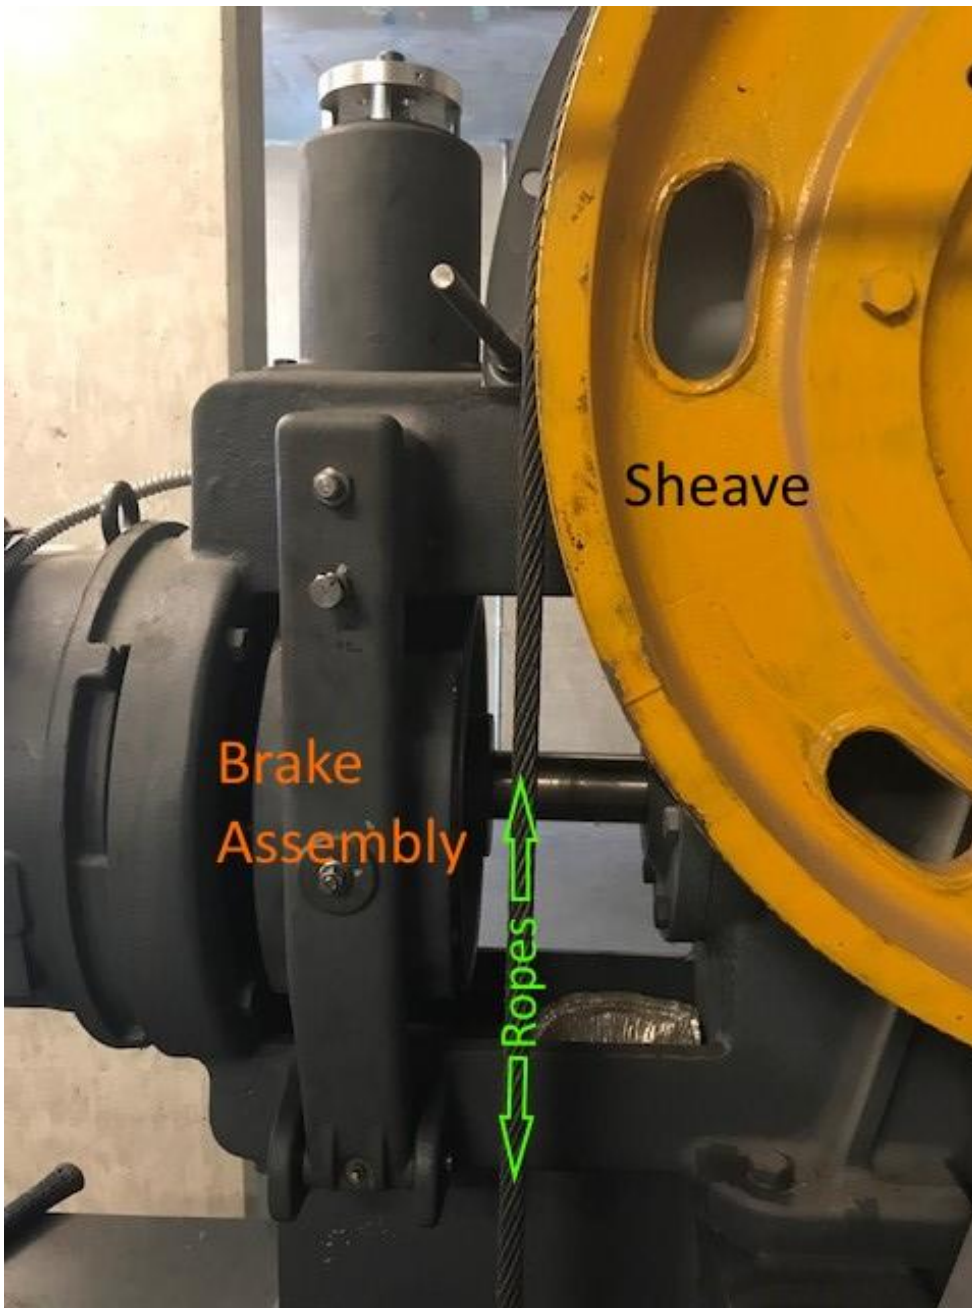
Failure scenario(s)	The worker was working alone. The worker put the elevator into automatic operation to measure brakes. The worker placed two commands, one for the elevator to go up a floor and another to come down a floor. The workers hand and wrist got caught on the ropes and pulled into the Sheave while the elevator was driving in the up direction. When the elevator drove in the down direction the workers hand and wrist were released.	
	Facts and evidence	The employer provided their documented procedures for measuring brakes along with their incident summary report that outlines the order of events. As-per the elevator contractors training material; If working alone, the air gaps should be verified visually without using measuring tool (feeler gauge). If working with a helper, the helper should be at the controller with the elevator put into maintenance mode. The helper would send the elevator in the up direction, until the counterweight is resting on its buffers, the helper would then set the elevators speed to Zero so the brakes could be lifted and the elevator would not move. While the elevator brakes are lifted, with the elevator stationary, the mechanic would measure the brake air gaps safely.

Components involved in the incident.
