Incident Summary #II-812735-2019 (#10824) (FINAL)

SUPPORTING INFORMATION	Incident Date	February 4, 2019	
	Location	Kelowna, BC	
	Regulated industry sector	Electrical - Low voltage electrical system (30V to 750V)	
	Impact	Qty injuries	0
		Injury description	N/A
		Injury rating	None
	Damage	Damage description	Electrical arc and heat damage to a 120 volts 15 amp general use receptacle, heat damage to circuit conductors inside outlet box
		Damage rating	Minor
Incident rating	Minor		
Incident overview	A 120 volts 15 amp general use receptacle overheated which damaged the receptacle supply conductors. The supply conductors arced causing a small flash and some smoke to exit the receptacle and cover. Damage was contained within the outlet box except for minor smoke stain on the wall beside the receptacle cover. The owner was present and disconnected the circuit prior to calling the Kelowna Fire Department.		
INVESTIGATION CONCLUSIONS	Site, system and components	Residential device wiring and components are required to be installed within an outlet box. The box provides a means for mounting the device and equipment to the wall, provides an enclosed space to make branch circuit splices and c

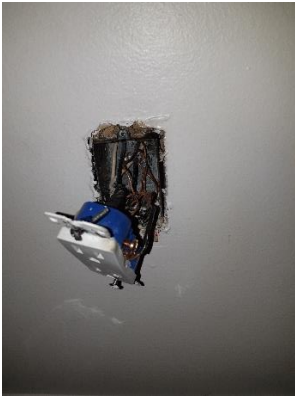
Failure scenario(s)	An individual replaced the original receptacle device with a newer one. The circuit connections from the conductors to the device were poorly made using the screws provided on the side of the device. The poor connection, made by wrapping just a portion of the copper wire around the screw head, overheated when the device supplied the lamp and other loads. The heat travelled back through the copper conductor a few centimeters to the point where the circuit splicing was made. The splice had been covered in electrical tape in a manner consistent with trade practise. The tape heated and melted until the energized conductor under the tape touched the side of the metal box creating a short circuit and the resulting sparks and hot metal flyings.	
	Facts and evidence	A new receptacle had been installed on the existing outlet box The branch circuit conductors could be seen connected to the receptacle screws provided in a manner which contravenes good trade practise. The line conductor could be seen burnt back to the circuit splice cap. Arc marks could be seen on the side of the outlet box Smoke stains could be seen on the wall paint beside the outlet box cover.

Causes and contributing factors	A poor circuit connection made to a general use receptacle overheated causing the circuit conductor insulation supplying the receptacle to fail and short circuit

Receptacle and outlet box at scene of incident

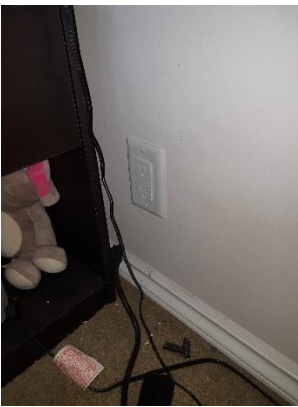
Completed repair
