Incident Summary #II-1617609-2023 (#41638) (FINAL)

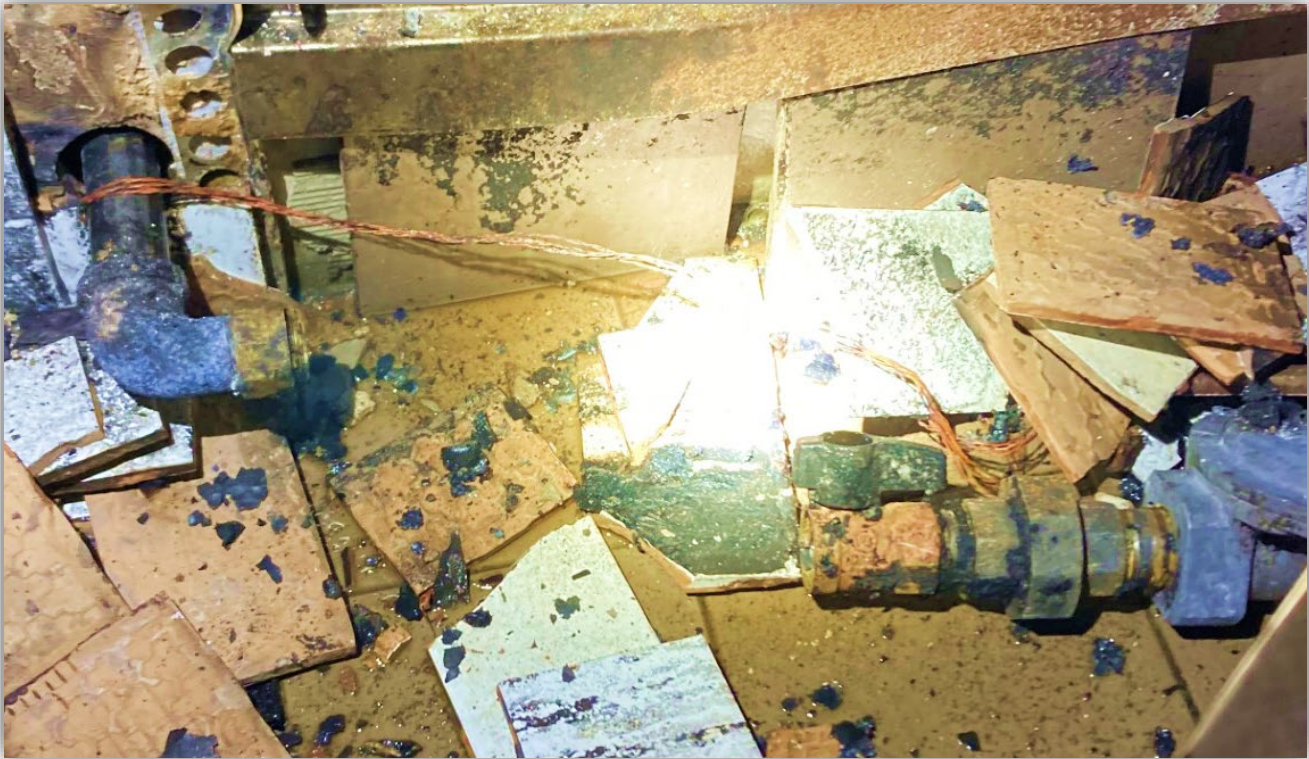
Facts and evidence	<p>The gas ball valve manufactures literature show that it is manufactured in two pieces. The main body which contains the handle and the ball and an end cap to contain the internal components and allow the insertion of piping. Post fire photo clearly shows the full separation of the shut off valve.</p> <p>Post fire examination found the cable restraints attached to the appliance only, with the tie off point located on the back wall unused.</p>	
	Causes and contributing factors	The incident was caused by the ineffective use of the appliance restraining device which allowed the appliance to move a distance that strained and broke the gas shutoff valve.

Image 1 - Separation of two-piece ball valve.

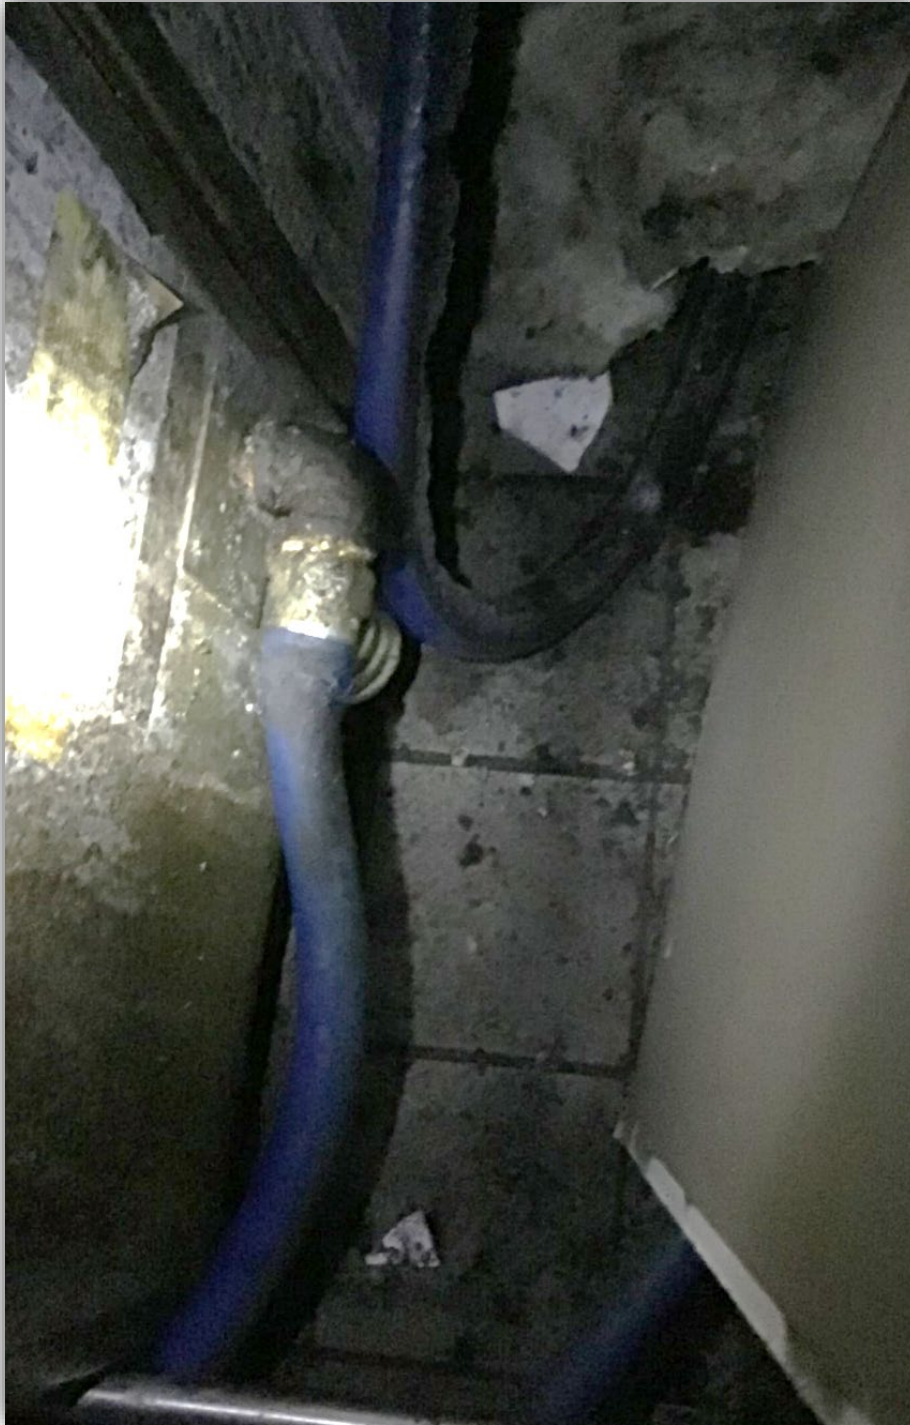
Image 2 - Cable restraint located on rear of fryer bank.
