Incident Summary #II-1173964-2021 (#21532) (FINAL)

| | Regulated industry sector | Elevating devices - Escalator or moving walkway | |
| Incident overview | The escalator steps piled up into the upper landing. This is a malfunction that occurs when the moving components come into contact with the stationary components. | | |

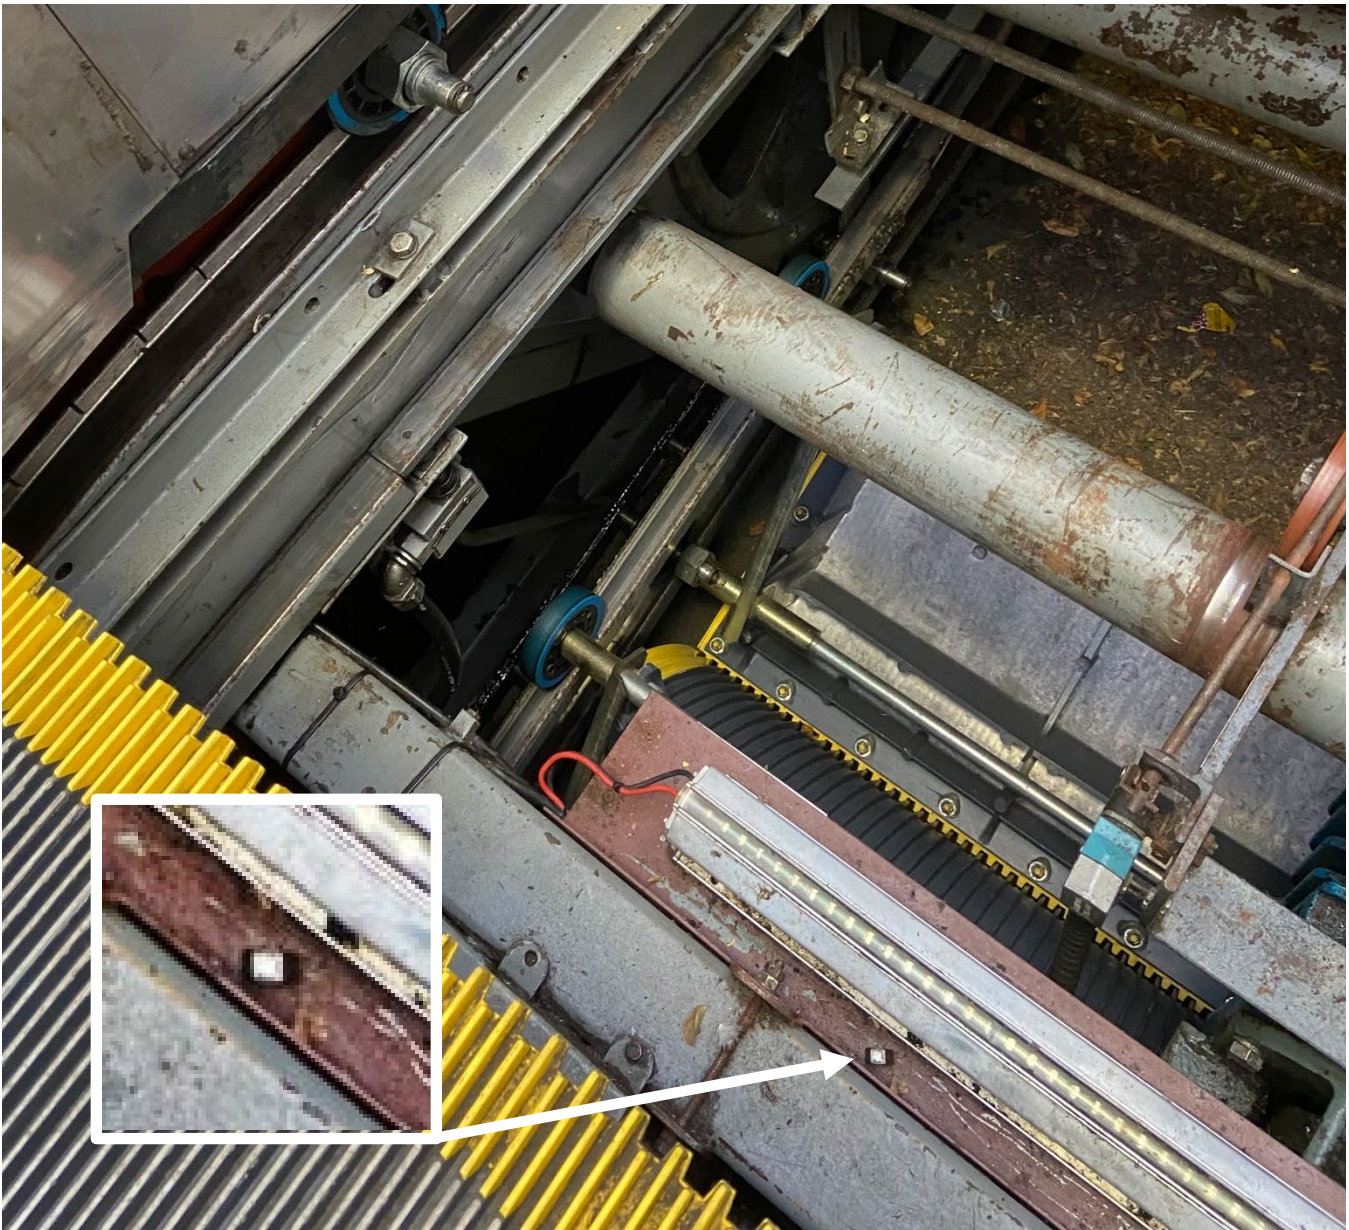
- Upon arrival on site, the escalator was partially disassembled by removing the damaged steps and opening the access floor plates
- Damaged escalator step observed ([Image 1](#))
- During observation of the damage, a nut was discovered ([Image 1 & 2](#))
- During observation, damage on the leading step roller was found ([Image 3](#))
- The point of contact between nut and roller coincided with the location of the step being lifted, and the resulting pileup
- Upon opening the unit, it was found that all other components of the escalator were within manufacturer's specifications, and that the only abnormality was the nut
- All safety devices functioned within manufacturer's specifications

It is probable that a loose nut caused the escalator step to be lifted. It is probable that the raised step was lifted high enough to cause the step to come in contact with the comb plate, causing a pileup.

Image 1 - Location of nut

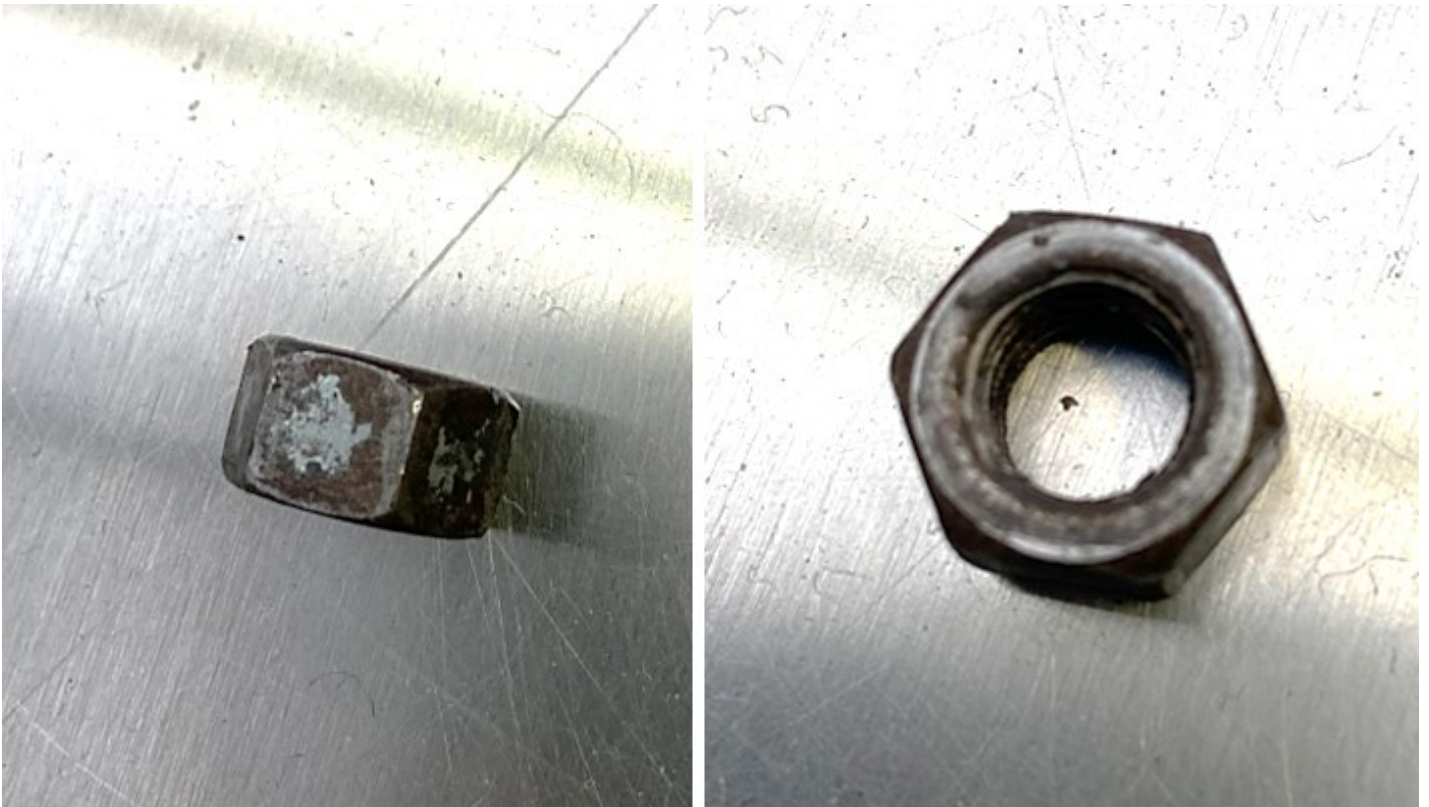
Image 2 - The nut

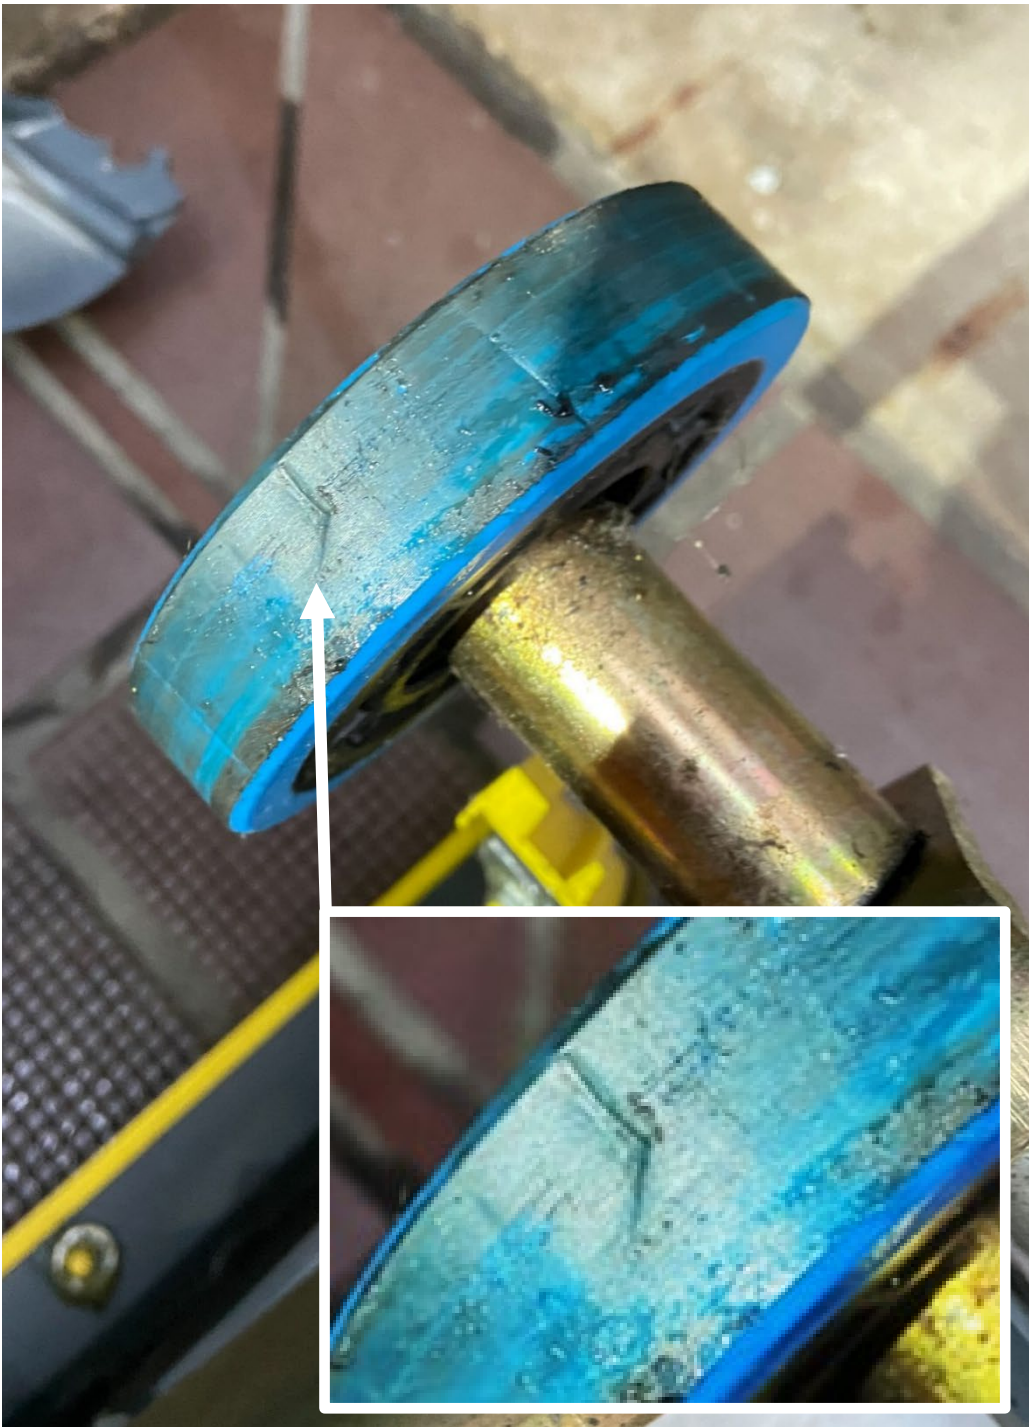
Image 3 - Damage observed on step roller
