Incident Summary #II-1563089-2023 (#36114) (FINAL)

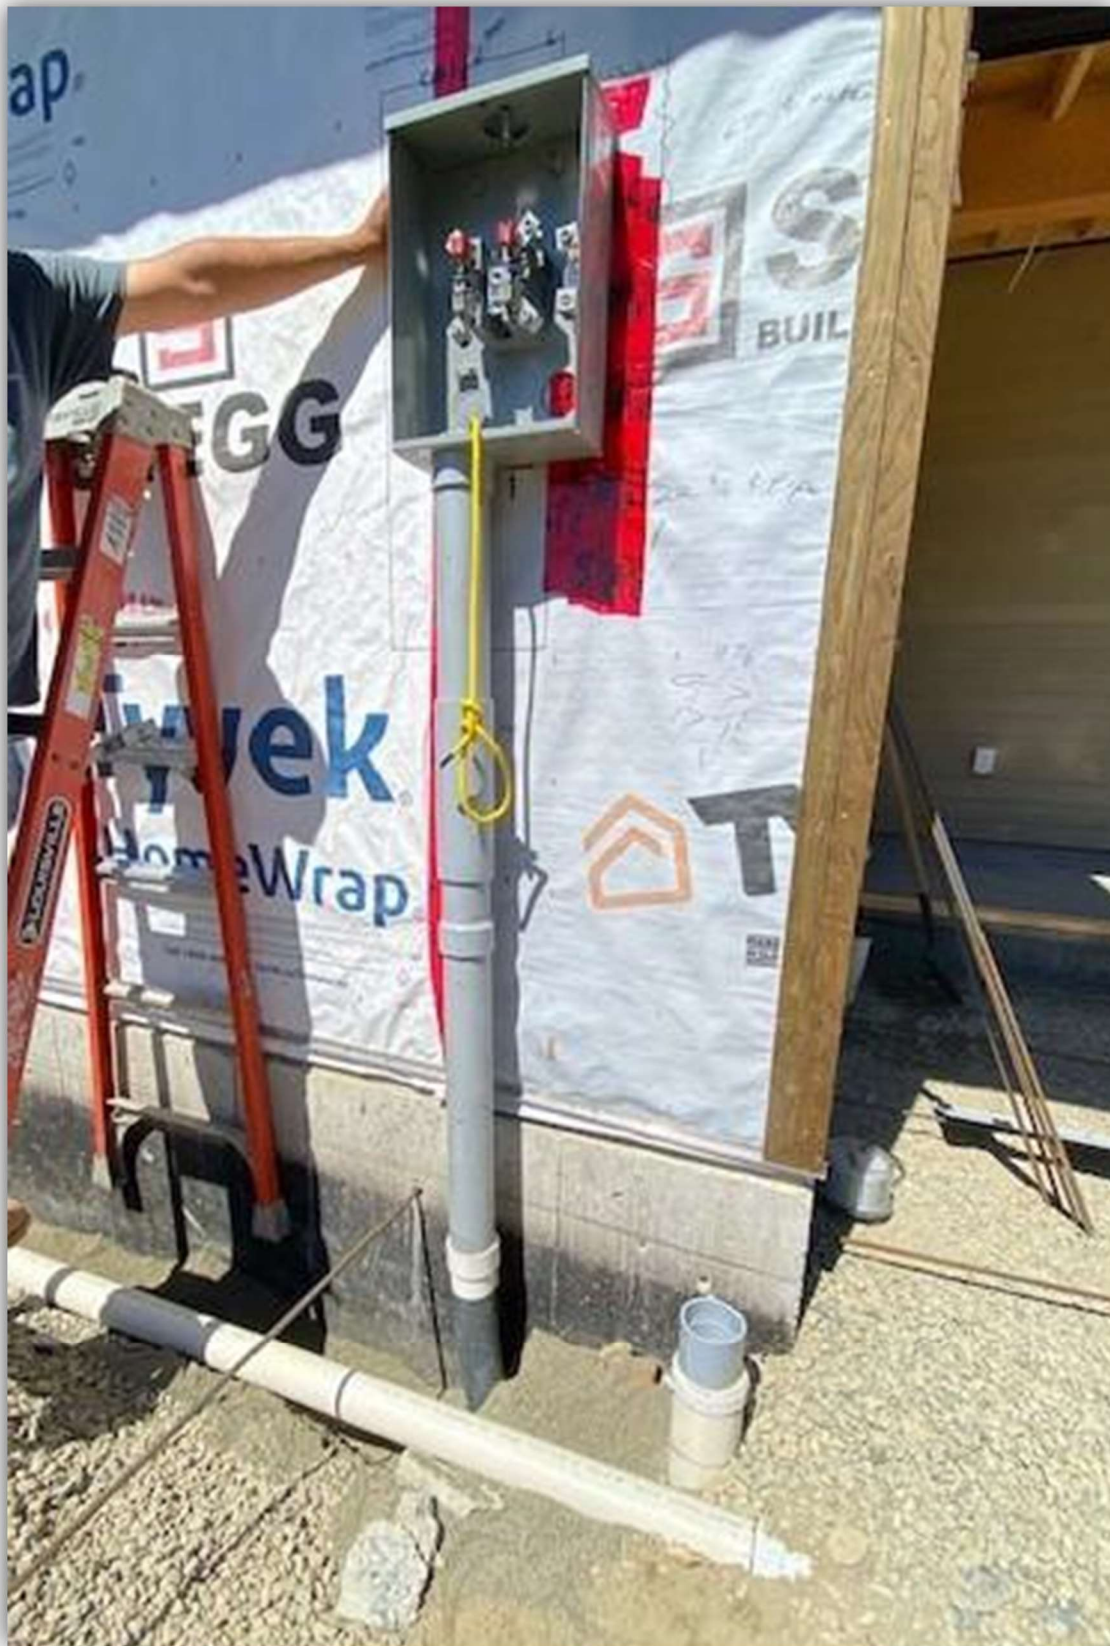
Facts and evidence	The above failure scenario was based on statements made by the general and electrical contractors (Image).	
	Causes and contributing factors	Based on the statements and the evidence examined on site the incident was caused by drilling into the foundation where there was a concealed cable. The installation was code compliant.

[Image](#) - Location where the hammer drill contacted the consumer service cable in the foundation wall. (Rebar was inserted into the hole left of the 3" PVC for ease of viewing).
