## Incident Summary #II-976334-2020 (#16544) (FINAL)

| SUPPORTING INFORMATION | Incident Date | February 5, 2020 | |
| | Location | Surrey, BC | |
| | Regulated industry sector | Elevating devices - Construction / personnel hoist/ man lift | |

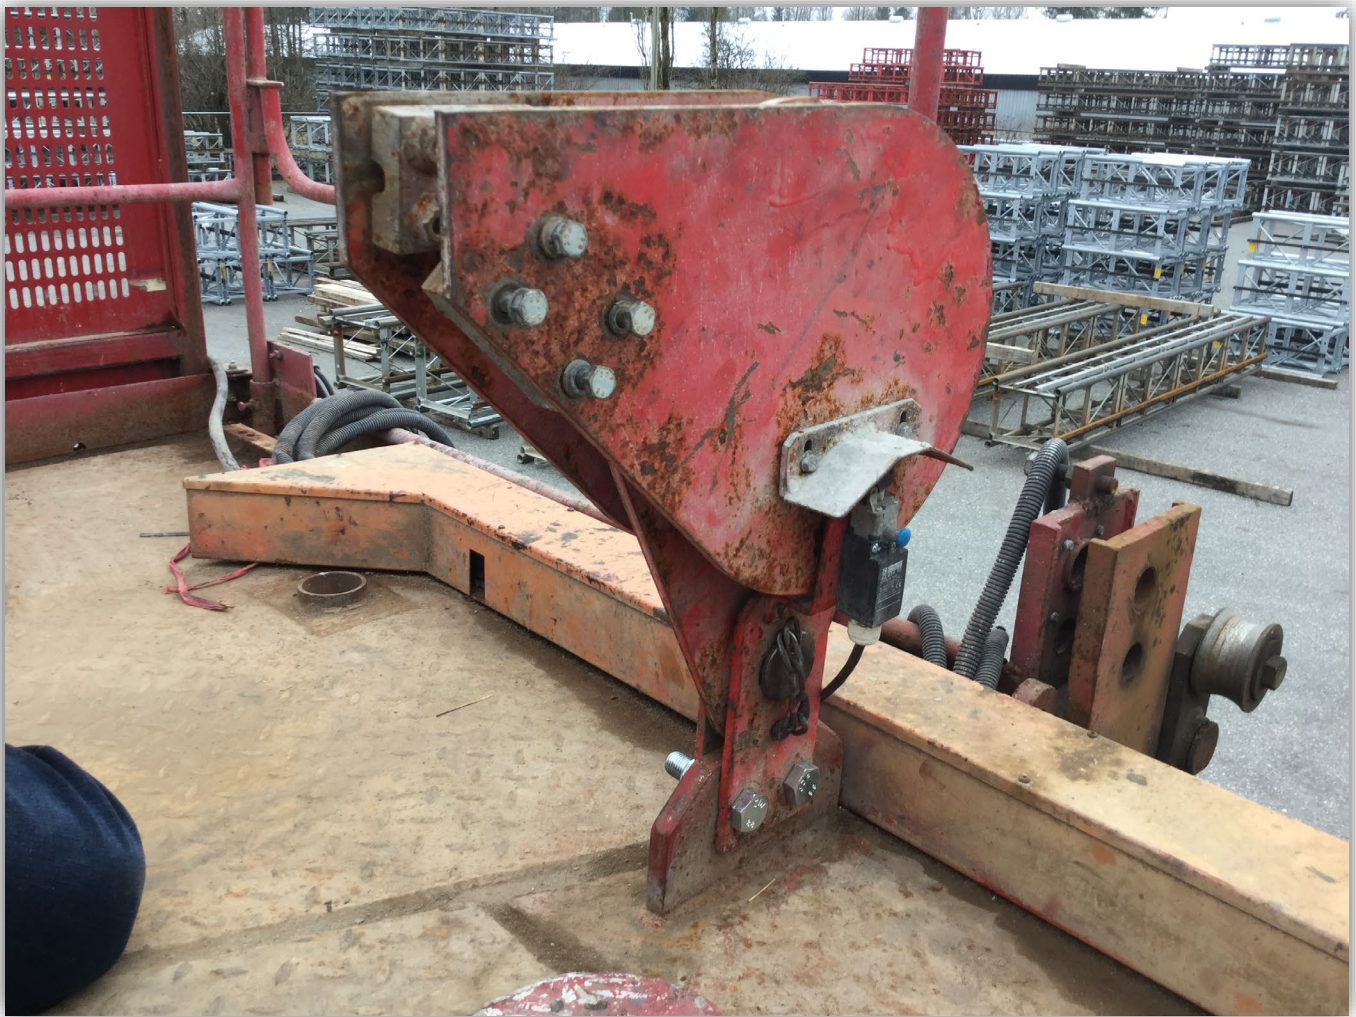
Image 1 - A typical "Leveler" unit that attaches to the top of a construction hoist cab.

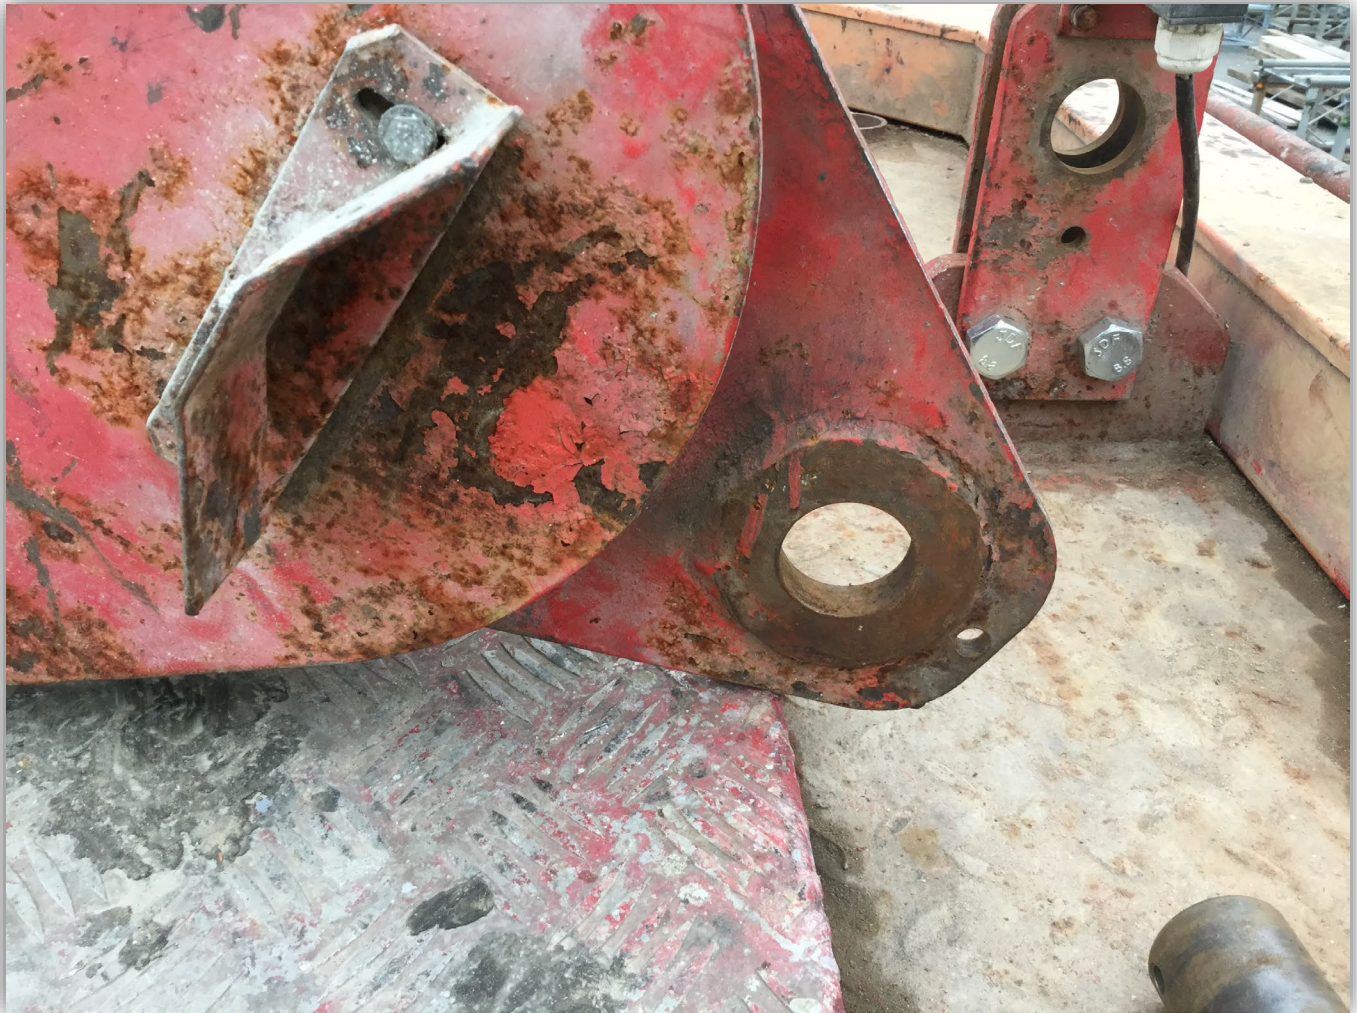
Image 2 - The attach point of a typical “leveler”.

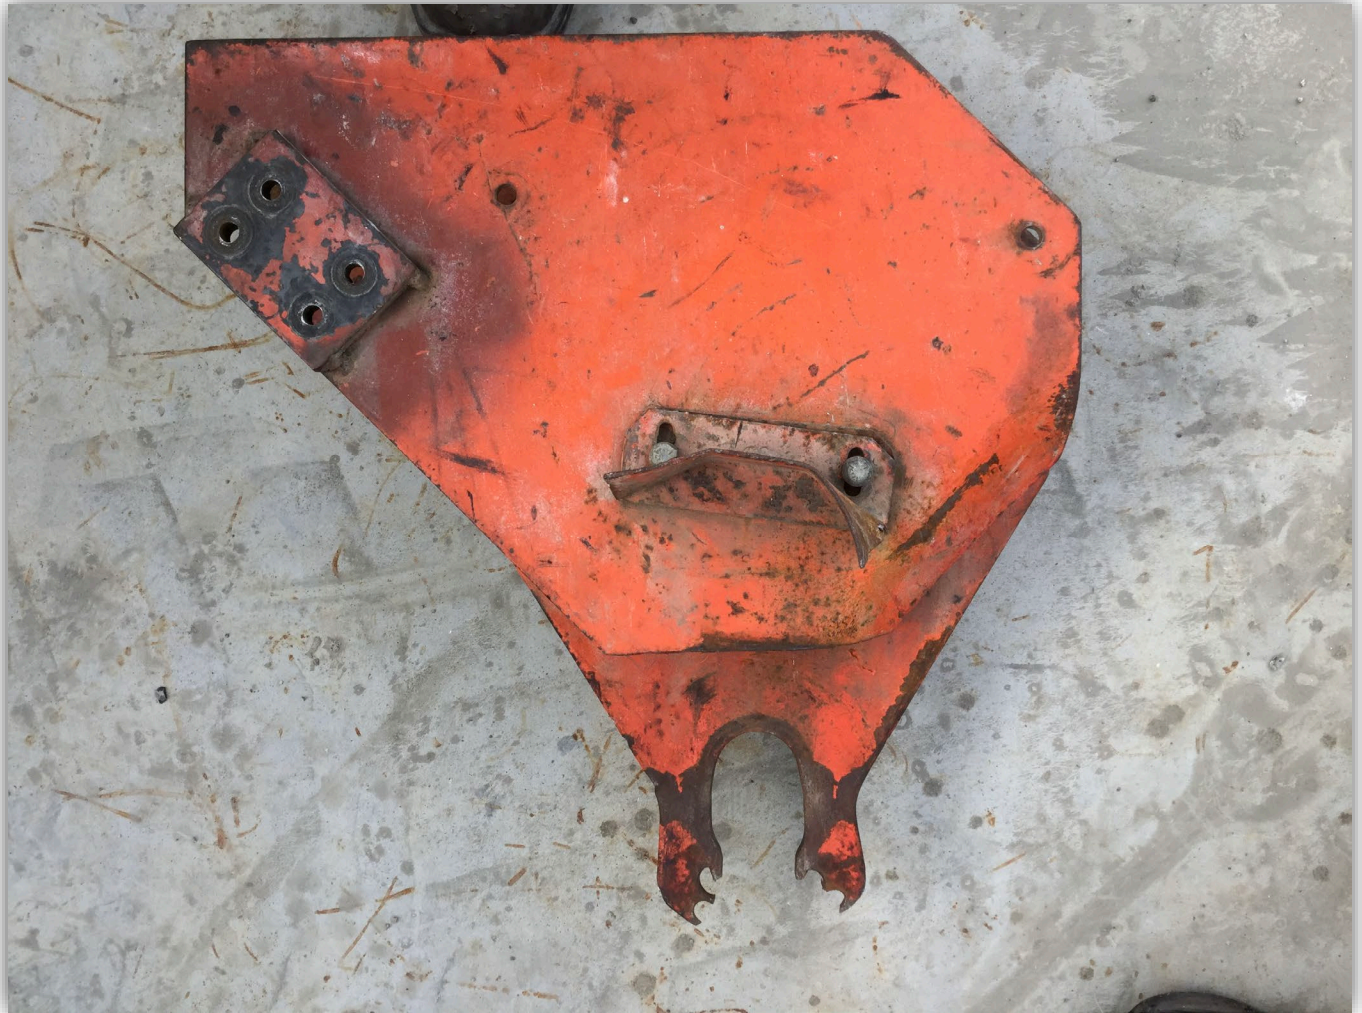
| Incident overview | During a personnel hoist extension, required slacked rope became unknowingly snagged on adjacent equipment. The slacked rope was snagged as the hoist's car began driving down, which resulted in the component that anchors the rope to the top of the car (known as a leveler) to fail. Due to the extreme tension the leveler was under, the leveler was launched upwards and into the arm of a mechanic resulting in an arm injury. | | |

Image 3 - The “leveler” involved in incident.

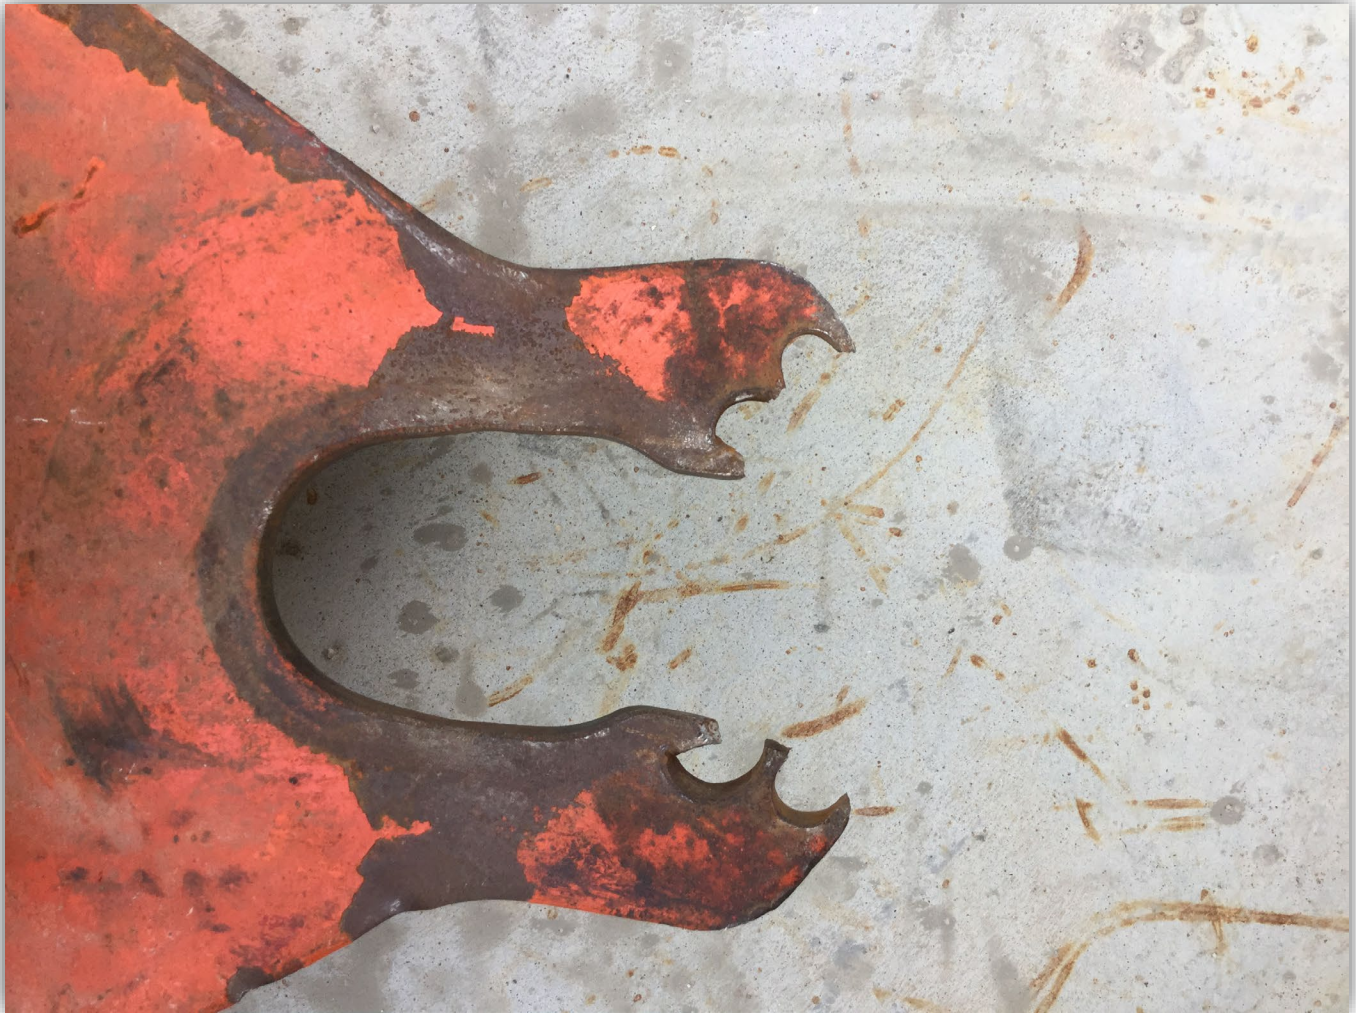
| Facts and evidence | Interviews with the non-injured mechanics involved indicate that they did not have personnel positioned at the bottom landing to visually verify the slack ropes were free of any snags when they began to move the car downwards following the extension. It was unable to be verified if the leveler in this incident was modified, as it was destroyed in the incident. The elevating device contractor has subsequently designed a more robust version of the original leveler which are used in the remaining cars that use counterweights. |

Image 4 - Close-up of "leveler" and failure point.

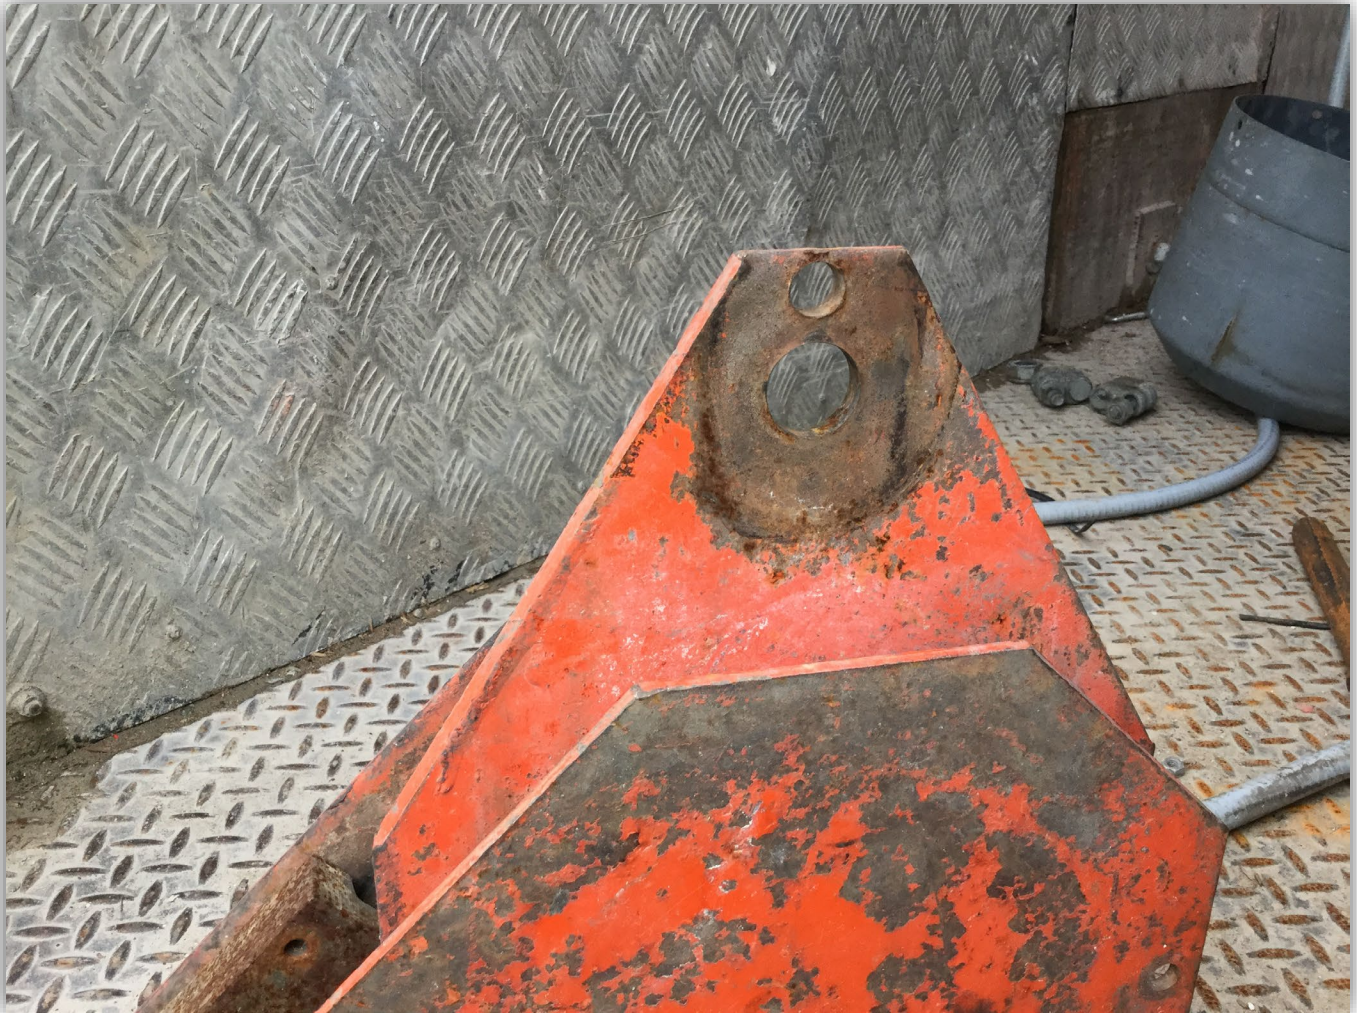
| Causes and contributing factors | It is probable that not having personnel stationed at the bottom landing contributed to the snagged rope not being identified by those at the top of the car. It is possible that the contractor's policy did not include the requirement to have personnel situated at the bottom landing during extensions. It is plausible that the manufactured components were modified, which could have affected the integrity of the equipment. |

Image 5 - Another “leveler” that potentially may have been modified by field personnel.
