## **EXAMINATION OF FAILED COMPONENTS OF A CONSTRUCTION HOIST**

TALL CRANE EQUIPMENT LTD.  
22652 FRASER HWY  
LANGLEY TWP, BC V2Z 2T8

File Number: 60515067  
Date: September 11, 2019

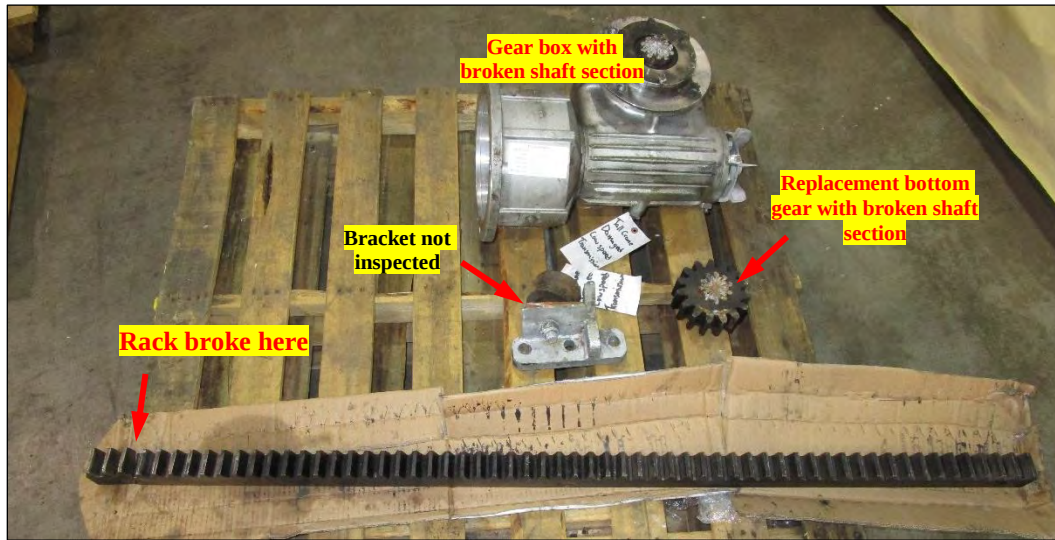
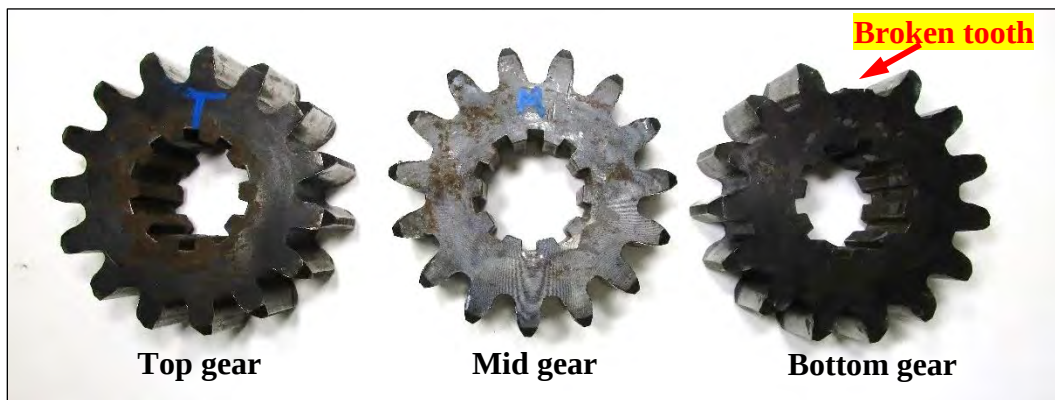
The broken shaft, gear box, replacement gear, and the broken rack section (see **Figure 1a**) were submitted to Acuren for failure analysis. In addition, the three (3) original gears (top, middle and bottom, **Figure 1b**) were also submitted for examination.

**Figure 1** shows the hoist components as received. The broken shaft sections remained inside the gear box on the inboard side and the replacement gear on the outboard side. The rack section broke at one end. The bottom gear of the three (3) original gears suffered a broken tooth.

**Figure 1** Failed components of construction hoist as received.

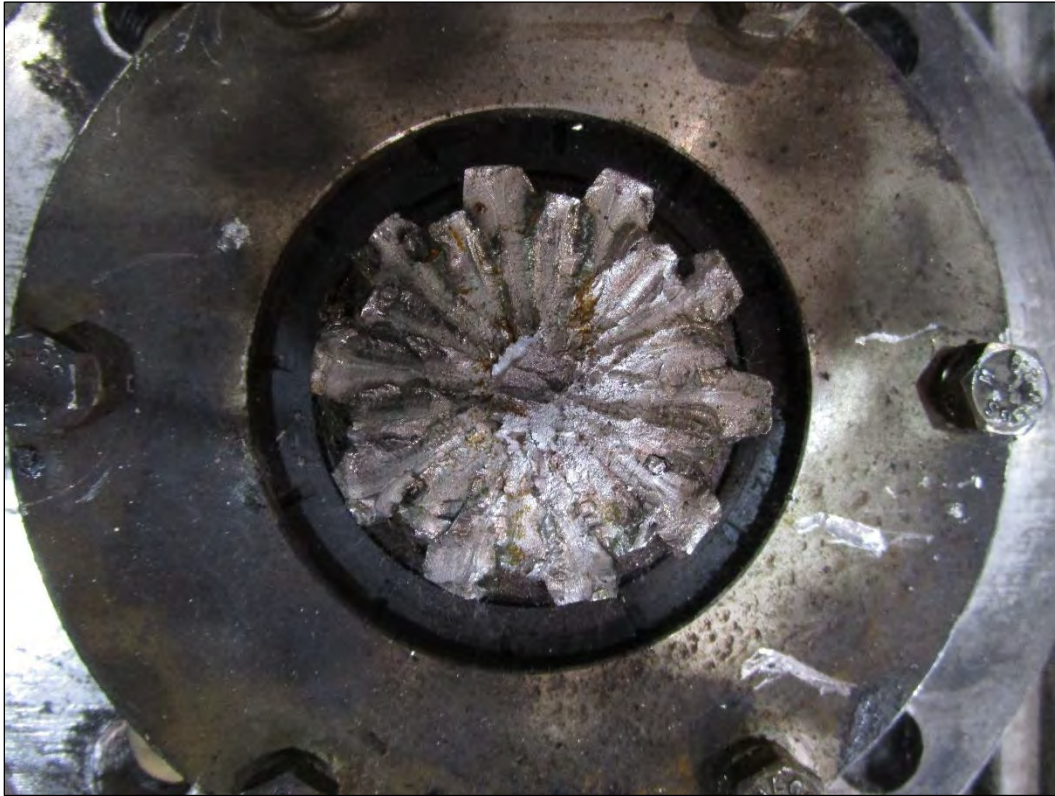
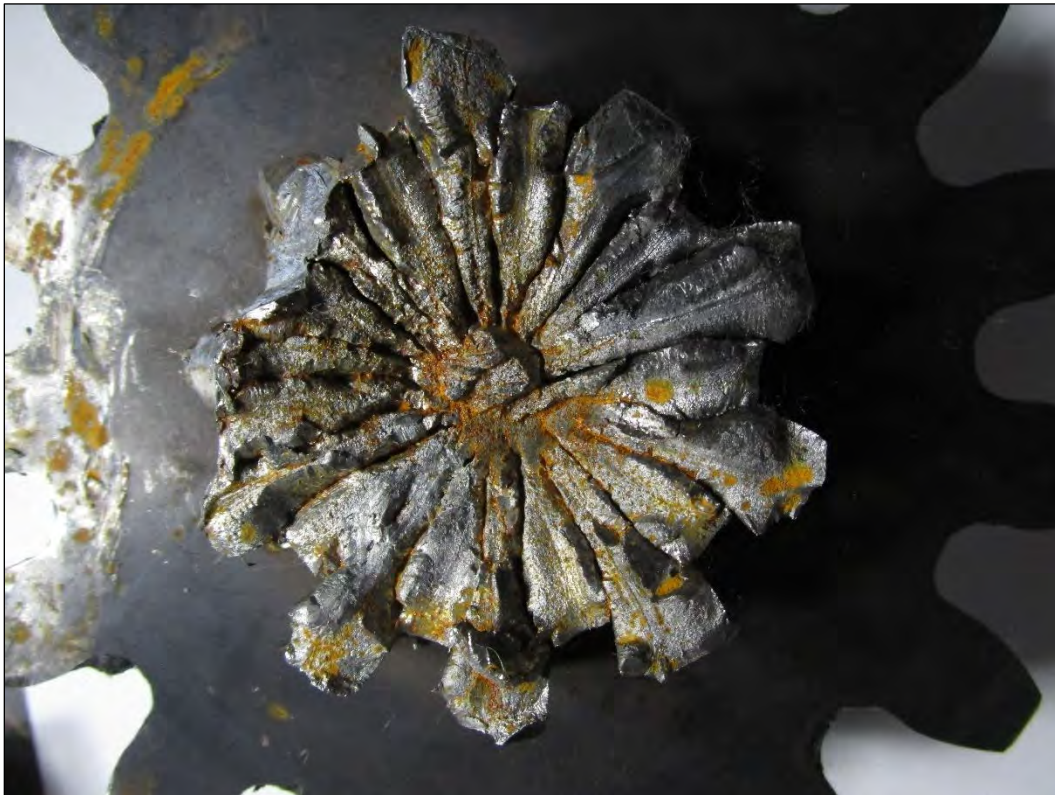
The broken shaft exhibited a star-shaped fracture (also see **Figure 3**). Detailed examination revealed coarse fatigue beach marks on the drive side of each spline (see **Figure 5**). These features are characteristics of a torsional fatigue failure of a splined shaft.

The fracture exhibited a fairly new appearance (see **Figure 3a** for clean fracture on the gear box side and **Figure 3b** for recently formed rust on the gear side). The light rust on the gear side fracture was readily removable by inhibited acid cleaning (see **Figure 6**). These fracture features indicated that the fatigue cracking on the splined shaft was fairly recent, perhaps within a couple of months.

**Figure 3** Fractures of broken bottom gear splined shaft.

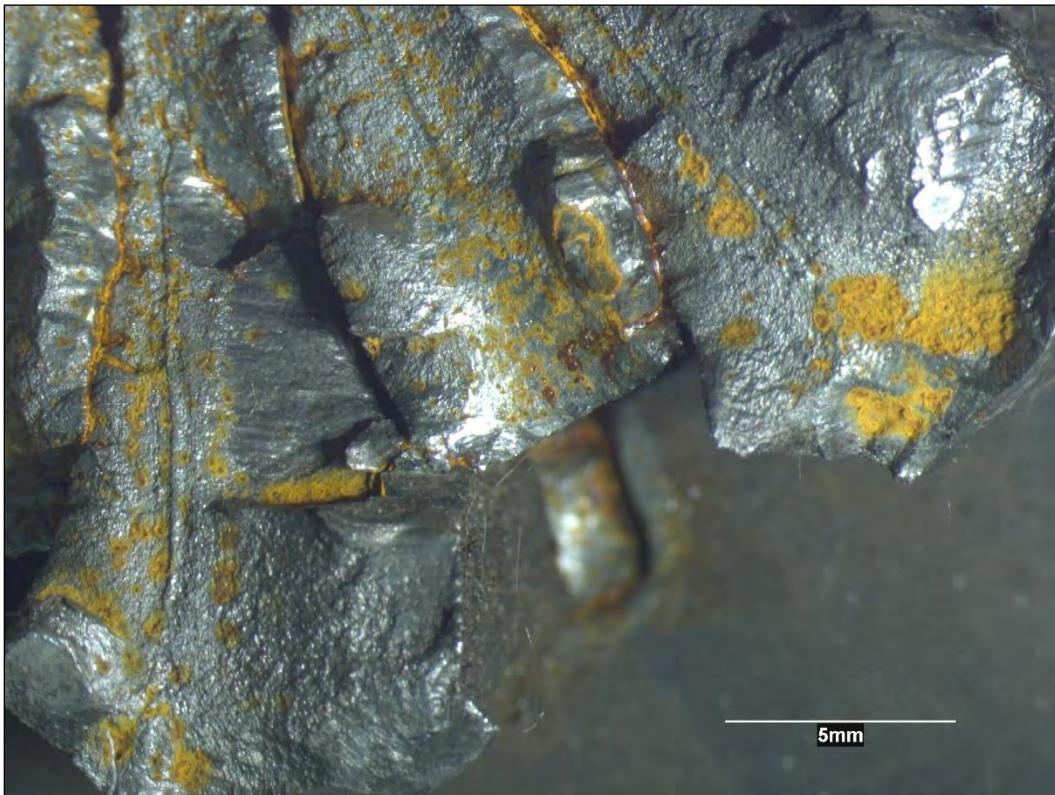
**Figure 5** Close up of shaft fracture showing coarse fatigue beach marks.

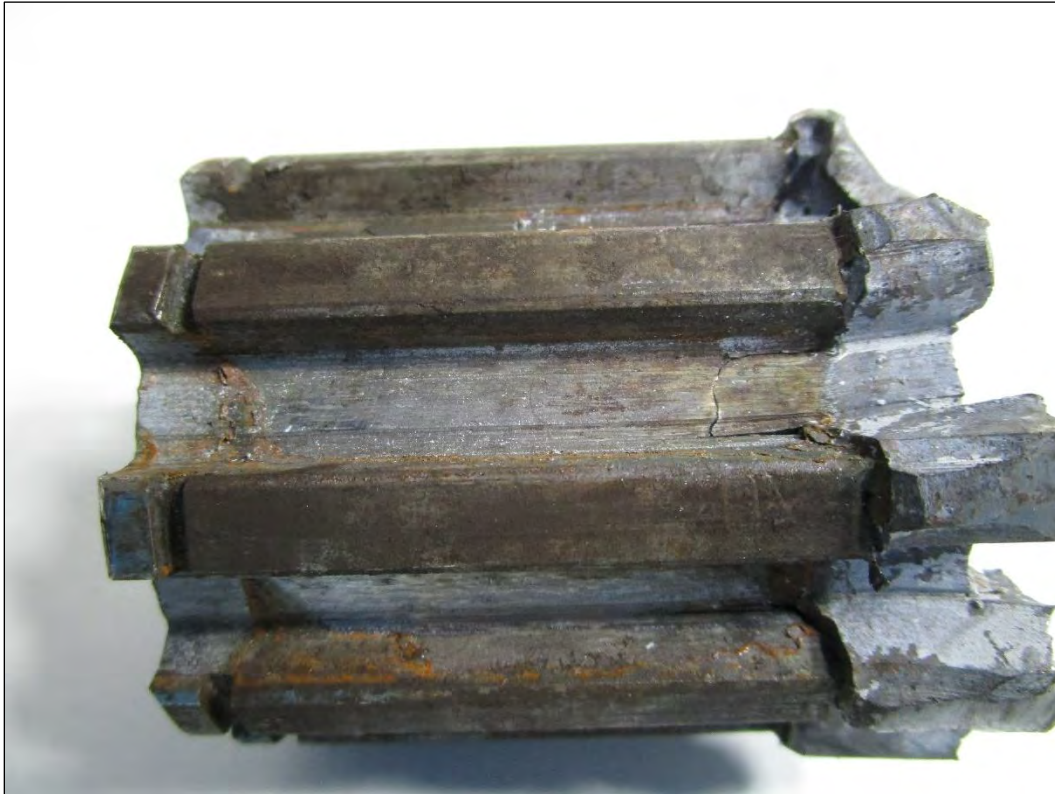
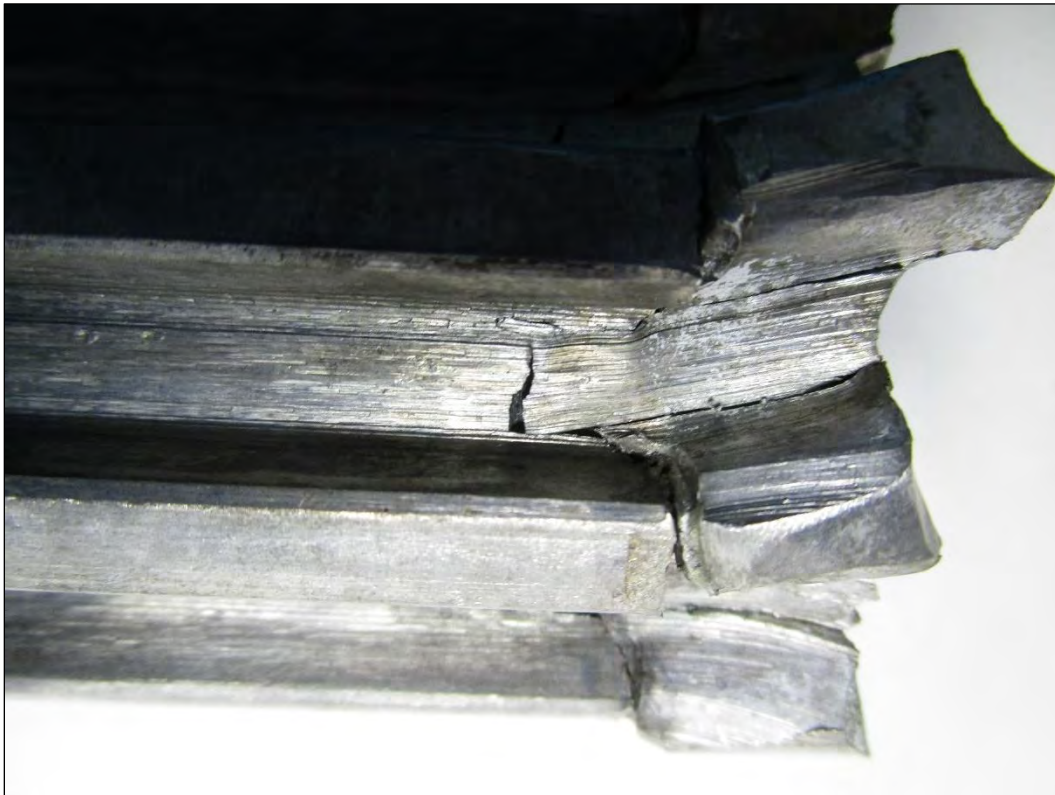
The splined shaft section inside the gear was slightly rusted (see **Figure 7a**). The light rust was readily removable by inhibited acid cleaning (see **Figure 7b**). It is worthwhile noting that the splines exhibited a rough machining surface finish, particularly at the spline roots/fillets. The rough surface finish at the fatigue critical spline roots/fillets would have substantially reduced the fatigue resistance of the shaft.

**Figure 7** General appearance of splined section of broken shaft.

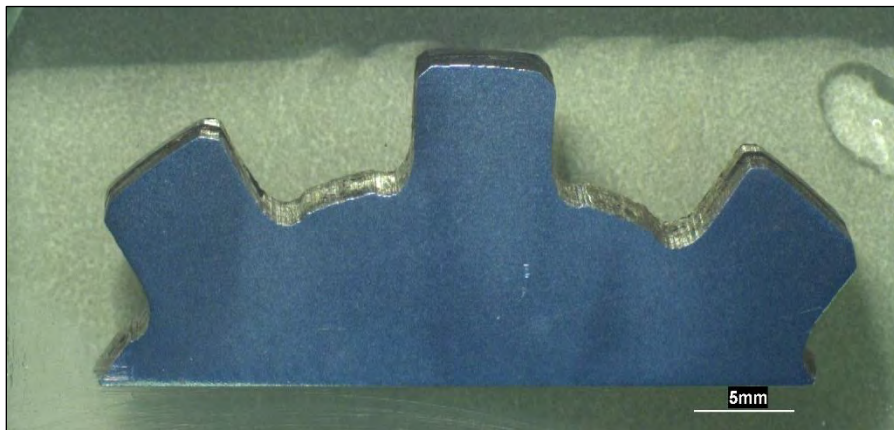
The shaft was found to be through-hardened (see **Figure 8**) with a quenched and tempered martensitic microstructure (see **Figure 9**).

**Figure 8** Metallographic specimen of splined shaft.

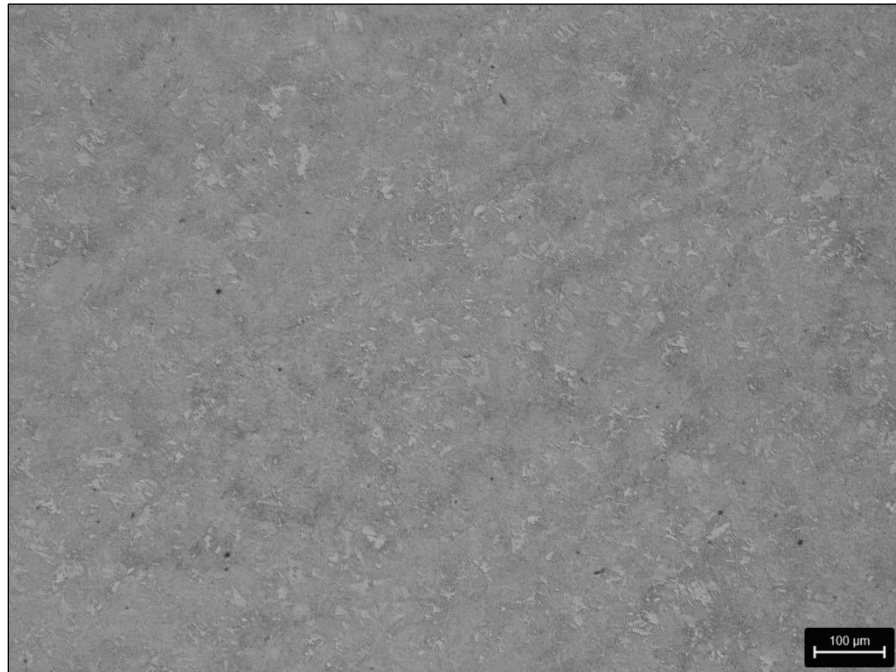
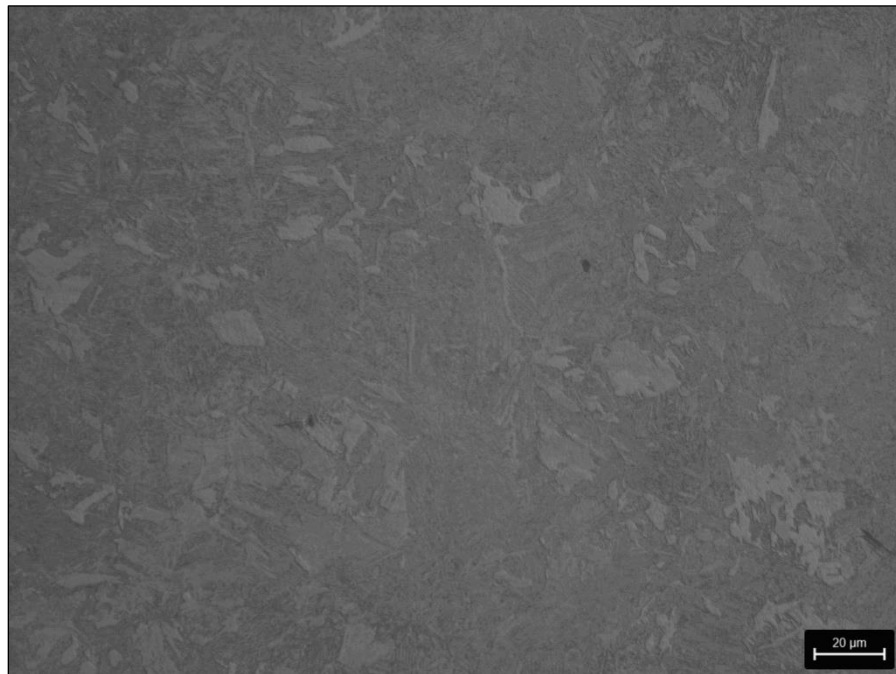
**Figure 9** General microstructure of splined shaft.

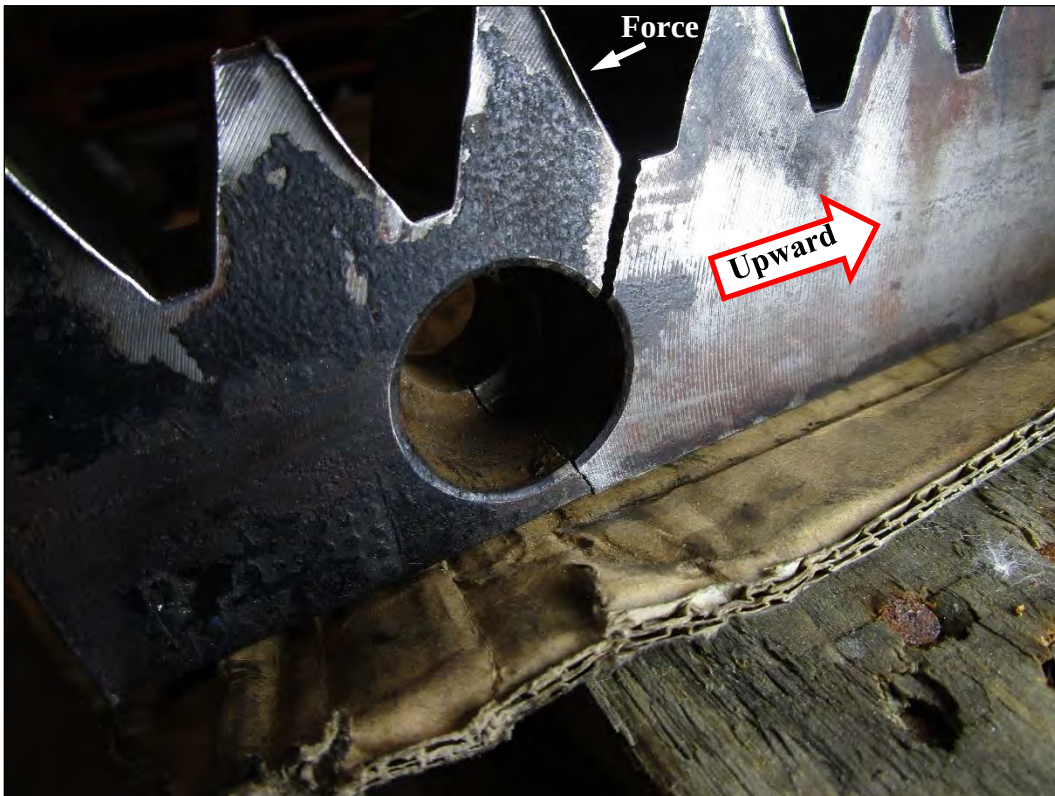
The rack section broke through a bolt hole, as shown in **Figure 11**. Judging by the preferential wear on the driving side of the rack teeth (facing up or hoisting direction), the failure occurred at the lower bolt hole of this particular rack section.

**Figure 11** Rack fractured through one of the bolt holes.

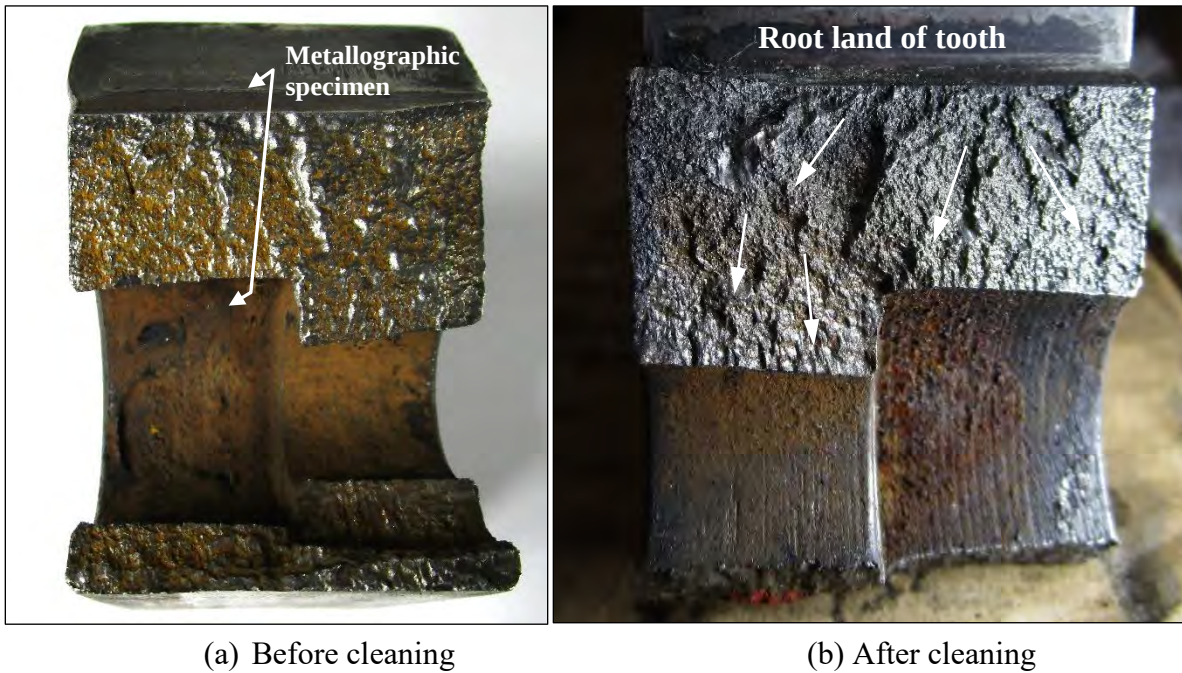
The fracture had been severely damaged by rubbing between the mating fractures after the failure and the damaged fracture was covered with light rust (see **Figure 12a**). The rack had broken for some time before it was

taken out from service. Despite damage, the fracture exhibited a clear brittle fracture pattern on a macro-scale which pointed back to origins along the root of the tooth (see **Figure 12b**).

**Figure 12** Fracture of rack.

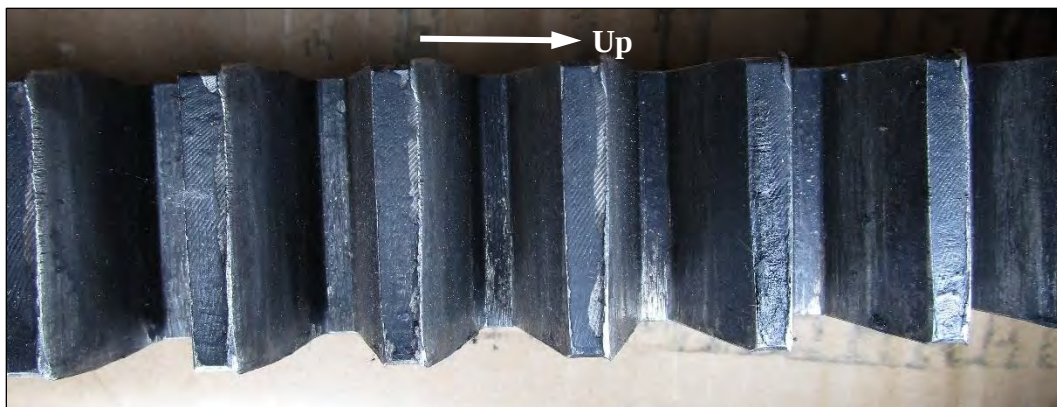
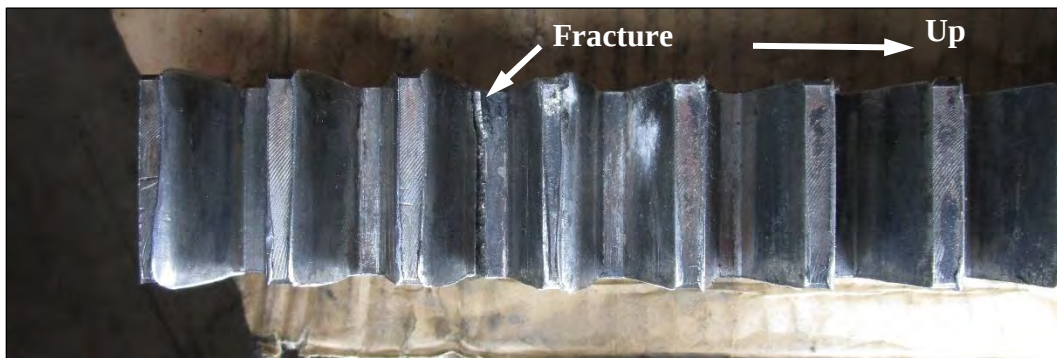
The rack teeth away from the fractured location exhibited moderate material flow on the drive flanks and minor plastic flow on the non-drive flanks (see **Figure 13a**). A few teeth around the fracture sustained severe material flow on both the drive and non-drive flanks (see **Figure 13b**). The plastic flow on the drive flanks of the rack teeth was caused by loading from the gears that exceeded the yield strength of the rack steel. The severe plastic flow on both the drive and non-drive flanks of the teeth close to the rack fracture most likely occurred after the rack failure when the engagement with the gears was out-of-pitch.

**Figure 13** General appearance of rack teeth.

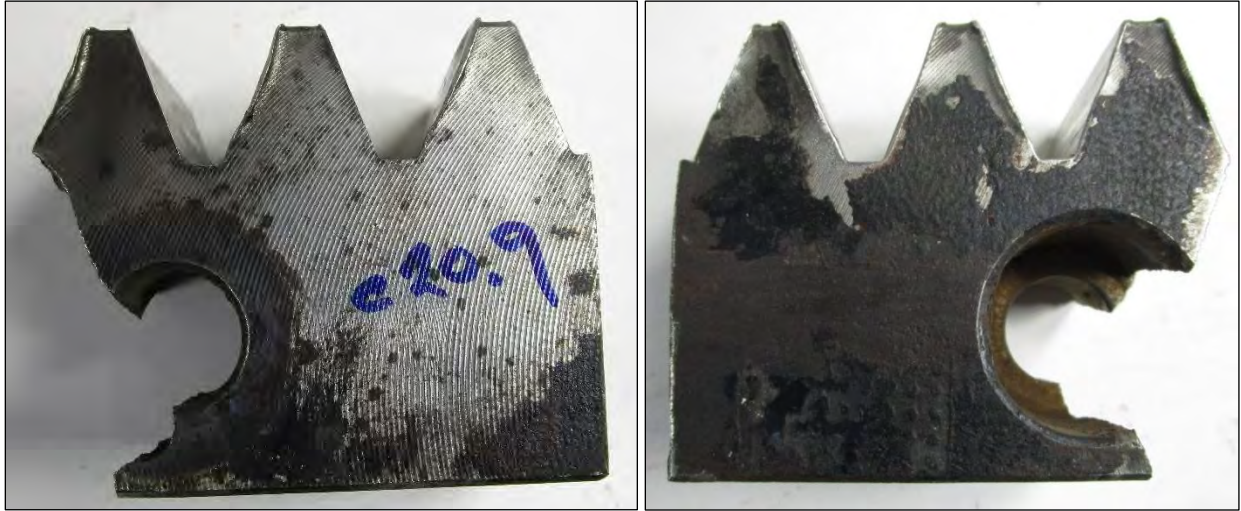
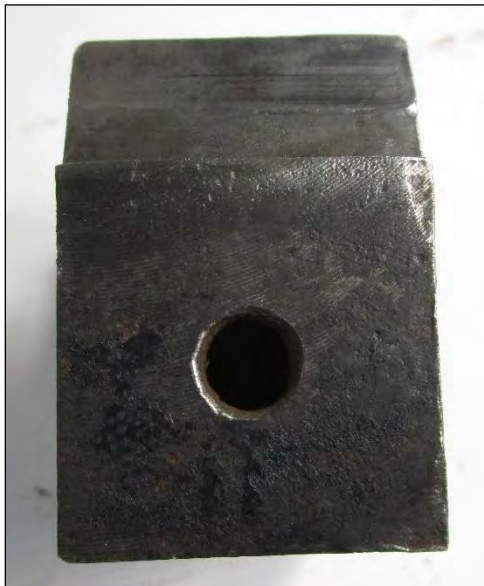
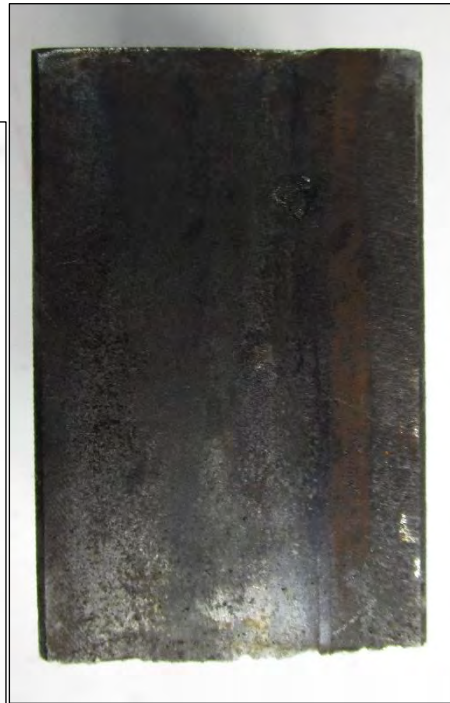
The rack piece that broke away did not exhibit any evidence to suggest that the failure was caused by an impact from a construction object or tooling damage as shown in **Figure 14**.

**Figure 14** General surface appearance of broke away rack piece.

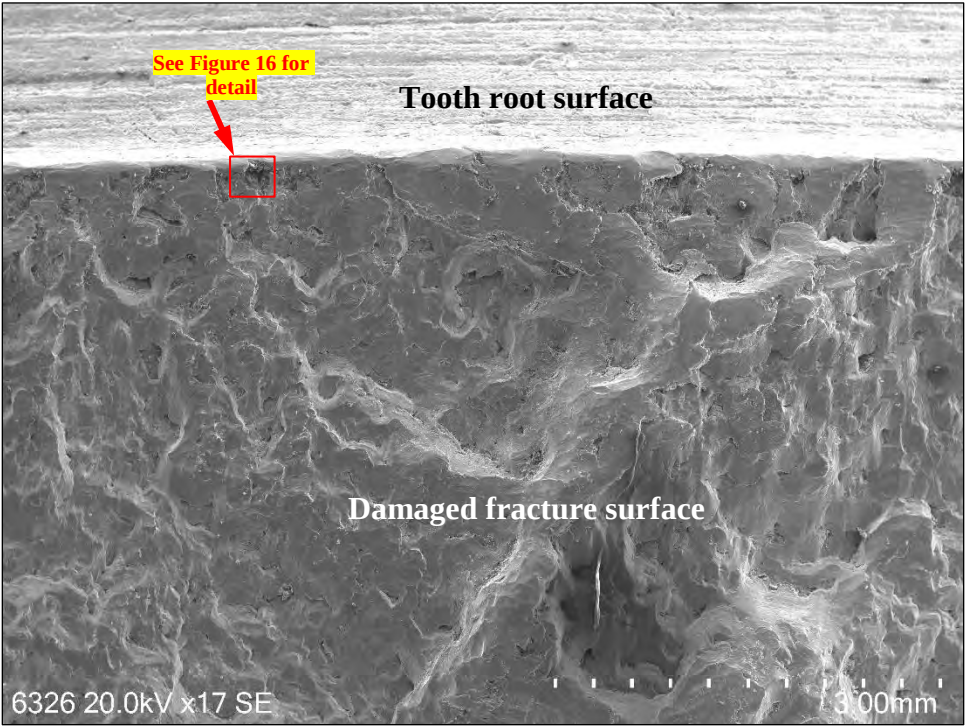
The fracture was substantially damaged by rubbing against its mating fracture after the failure (see **Figure 15**). However, a few microscopic intact areas at the fracture origins were found to exhibit a clear transgranular brittle cleavage fracture pattern (see **Figure 16**). Such a fractographic pattern indicated that the fracture was caused by an impact on the rack tooth.

**Figure 15** SEM image of fracture on rack at origins.

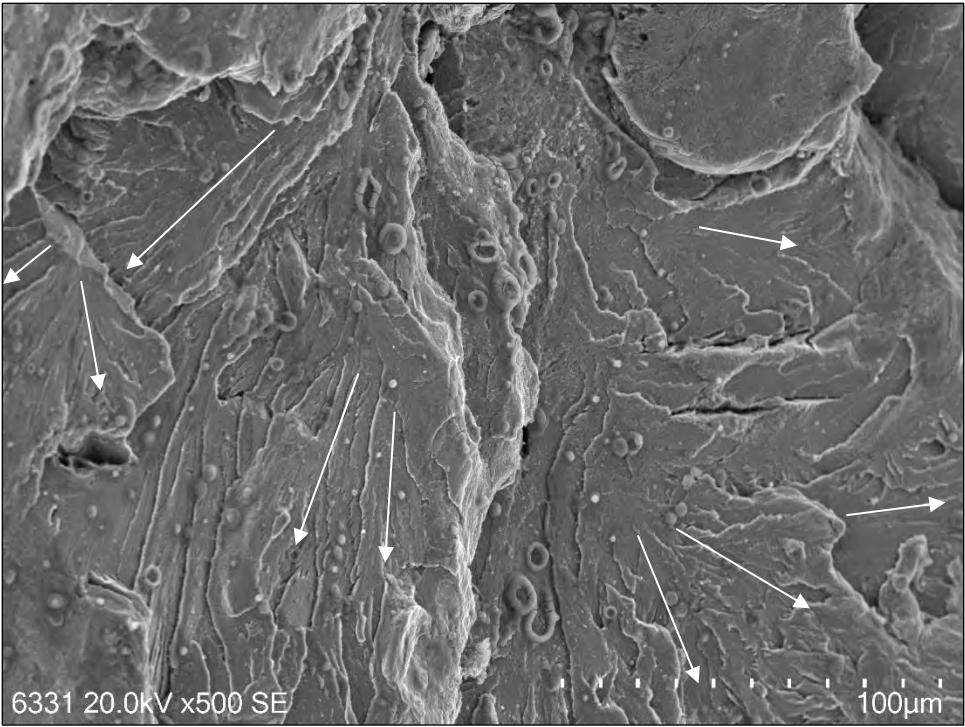
**Figure 16** Fractography of rack fracture showing brittle cleavage pattern.

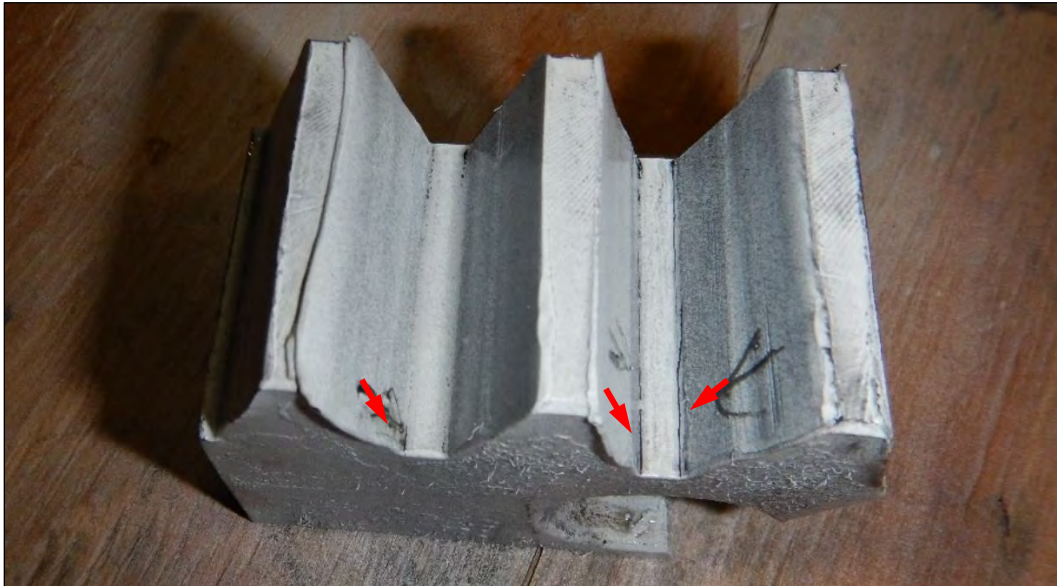
The entire rack section was inspected using a magnetic particle non-destructive inspection method (MPI) for cracks. This revealed linear indications along the roots of two teeth immediately adjacent to the fracture (see **Figure 17**). The nature of these indications was later examined metallographically.

**Figure 17** Linear indications along tooth roots adjacent to fracture revealed by MPI

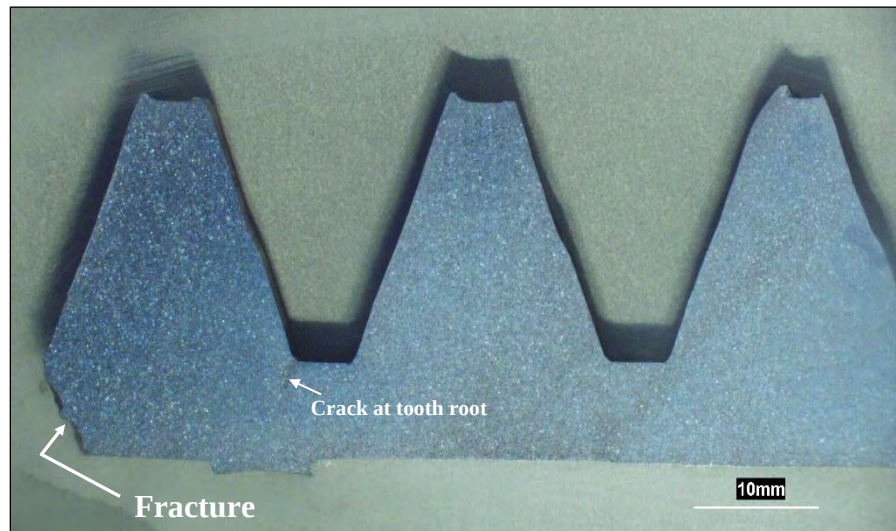
Metallographic examination revealed that the rack exhibited a uniform microstructure throughout its teeth and body (see **Figure 18**). The microstructure of the rack consisted of a mixture of coarse-grained pearlite colonies and grain boundary ferrite (see **Figure 19**). These metallographic features indicated that the rack was machined out of a hot-rolled bar stock of GB/T 699 Grade 60 carbon steel.

**Figure 18** Metallographic specimen of rack across fracture.

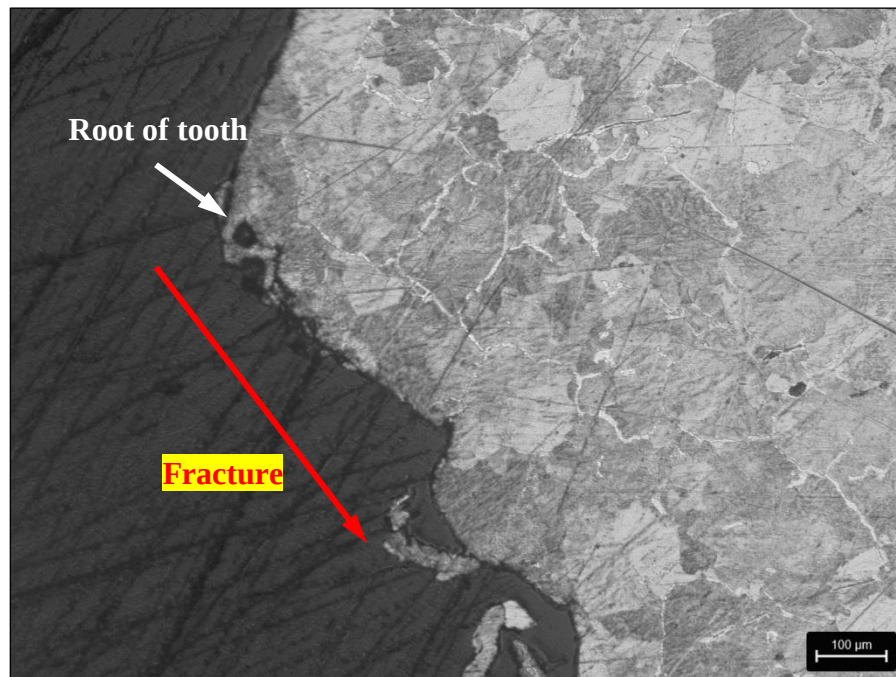
The fracture was transgranular through the coarse grains with a zigzag path (see **Figure 20**). A large tooth crack also exhibited a similar profile (see

**Figure 20** Profile of fracture and surrounding microstructure.

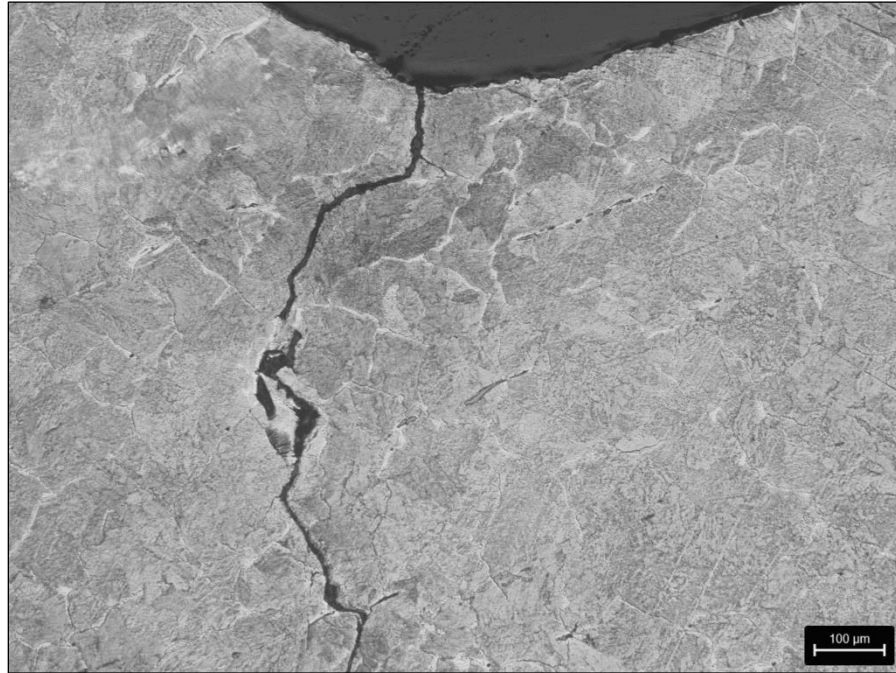
**Figure 21).** Given the brittle cleavage fracture pattern observed on the fracture, the large tooth root crack was also a brittle fracture by impact loads. The brittle cracking might have been generated by multiple impact loads, and the cracking advanced and then arrested during each impact event.

**Figure 21** Profile of large tooth root crack and surrounding microstructure.

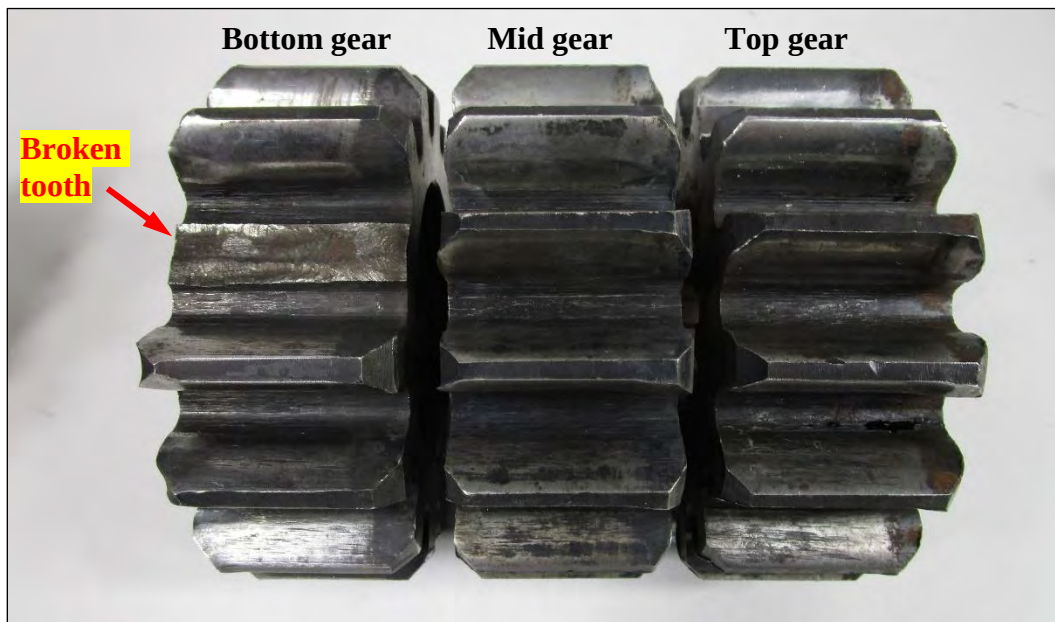
The three (3) original gears are shown in **Figure 22** as received. The bottom gear suffered one broken tooth and the other two (2) gears were intact.

**Figure 22** Three original gears as received.

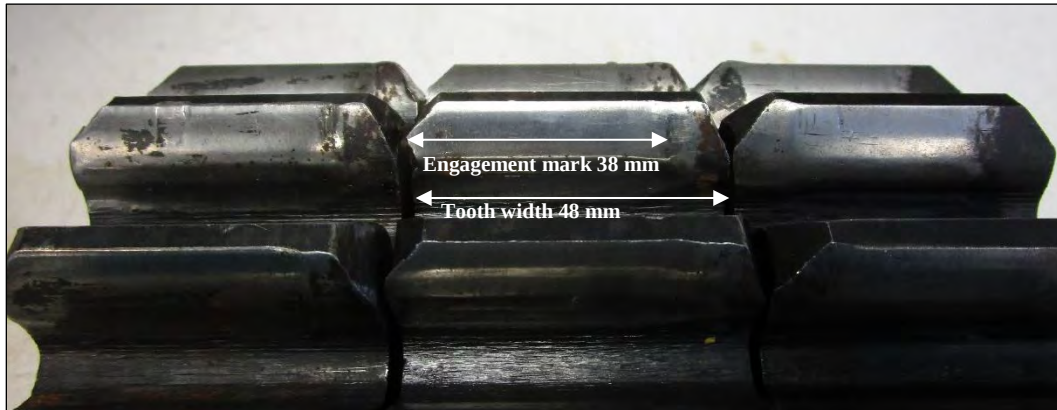
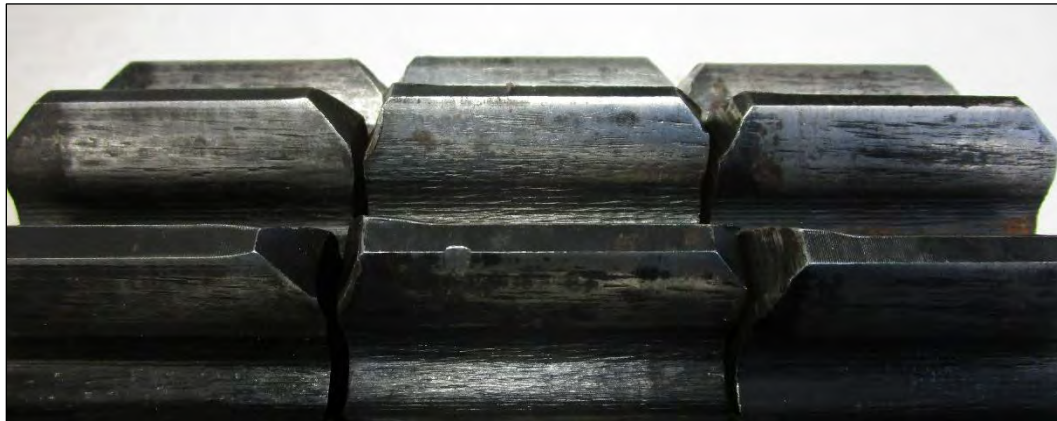
Other than the broken tooth on the bottom gear, these gears exhibited a similar wear pattern as shown in **Figure 23**. The teeth on all three gears showed engagement marks of 38 mm wide over the 48 mm tooth width starting from the inboard edge. The 48 mm wide gears would have been aligned with the 38 mm wide rack on the inboard edge. **Figure 24** illustrates the mismatching outboard side of the gear-rack engagement.

**Figure 23** Close up of meshing pattern on original set of gears.

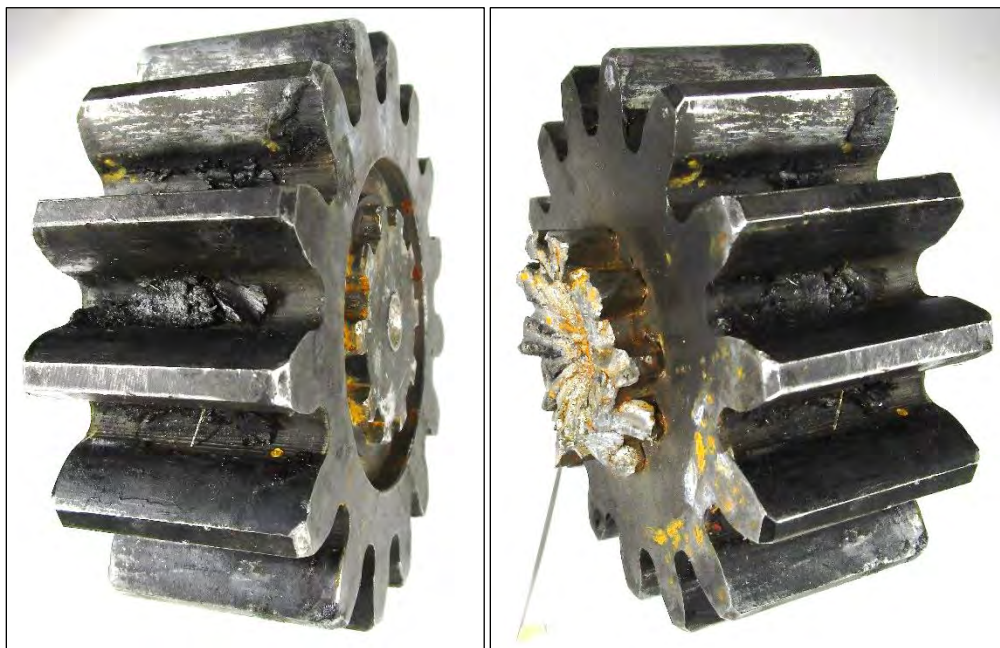
The replacement gear also exhibited a similar engagement pattern (see **Figure 25**). It exhibited a reasonable amount of grease on it, which indicates that it was lubricated.

**Figure 25** Replacement gear with broken shaft inside.

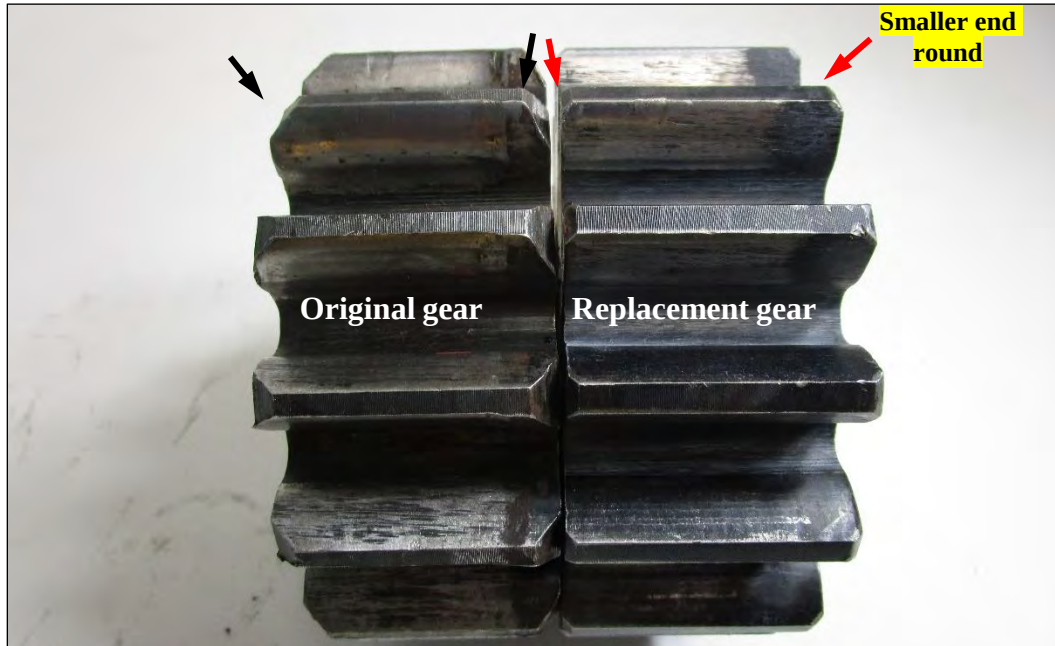
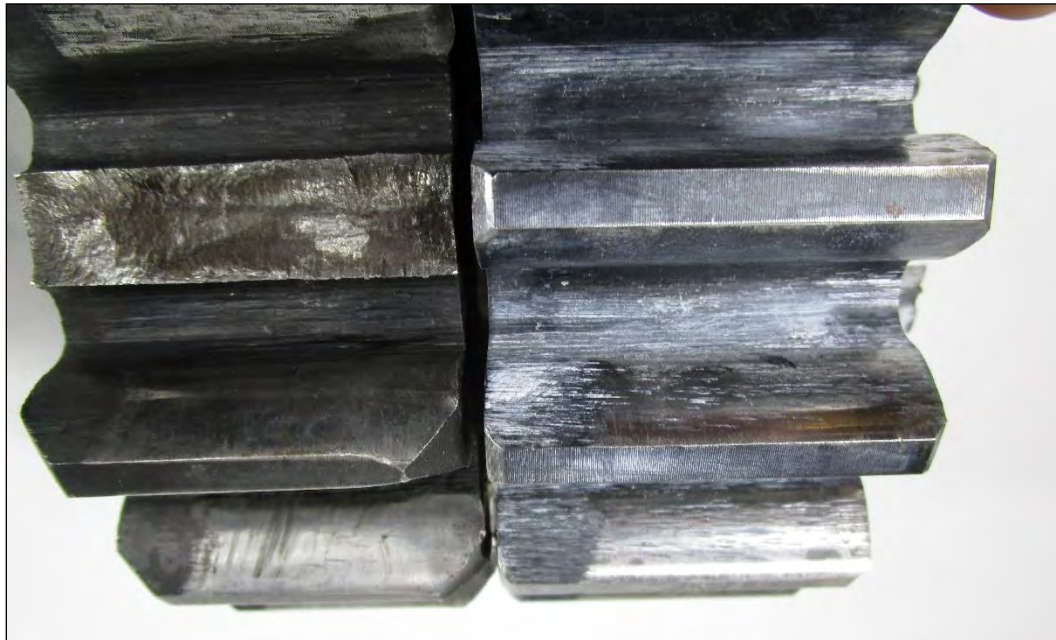
All of the gears exhibited an involute tooth profile. Different from the original gears, the replacement gear exhibited a much smaller end round (see **Figure 26**). This indicated that the original gears and replacement gears were of different batches.

**Figure 26** Comparison of tooth profile of replacement gear and original gear.

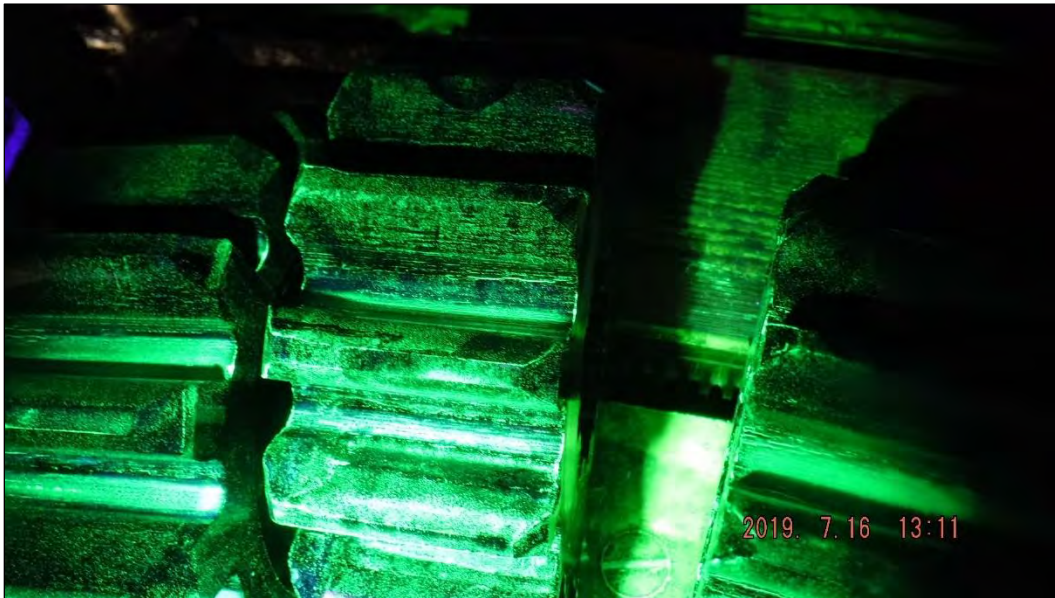
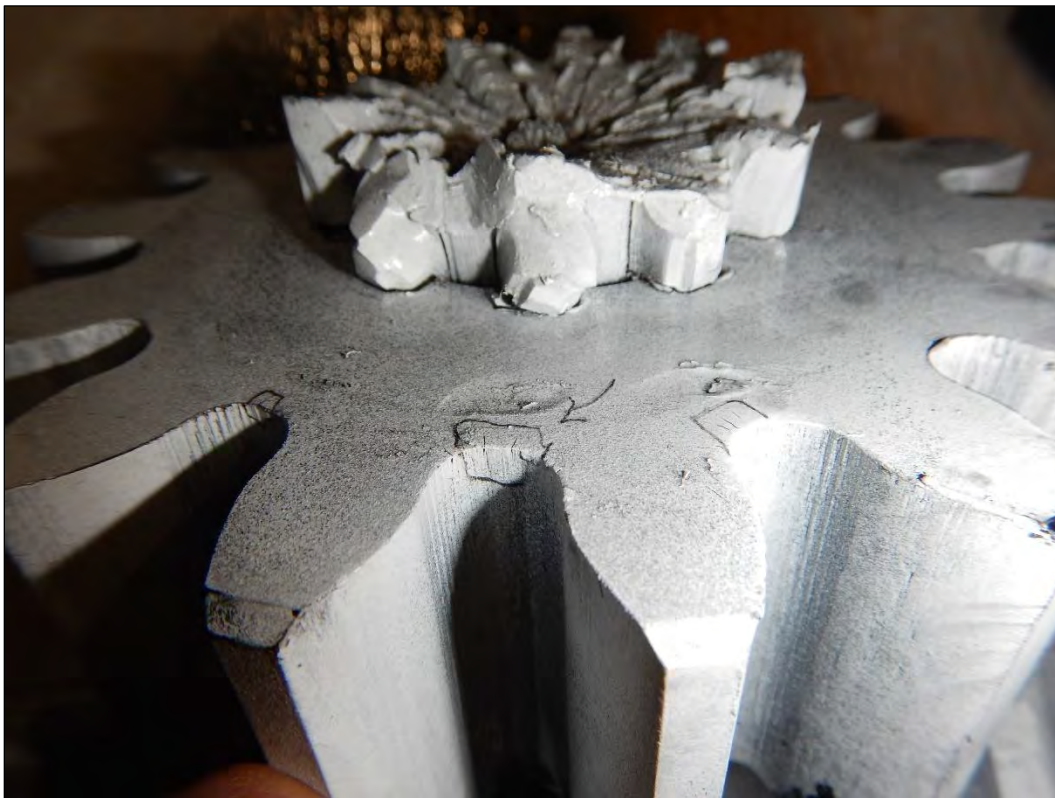
All of the gears were subjected to magnetic particle inspection (MPI) for cracks along the tooth roots. They were all found to have linear indications along the tooth roots (see **Figure 27**).

**Figure 27** Liner indications revealed by MPI inspection.

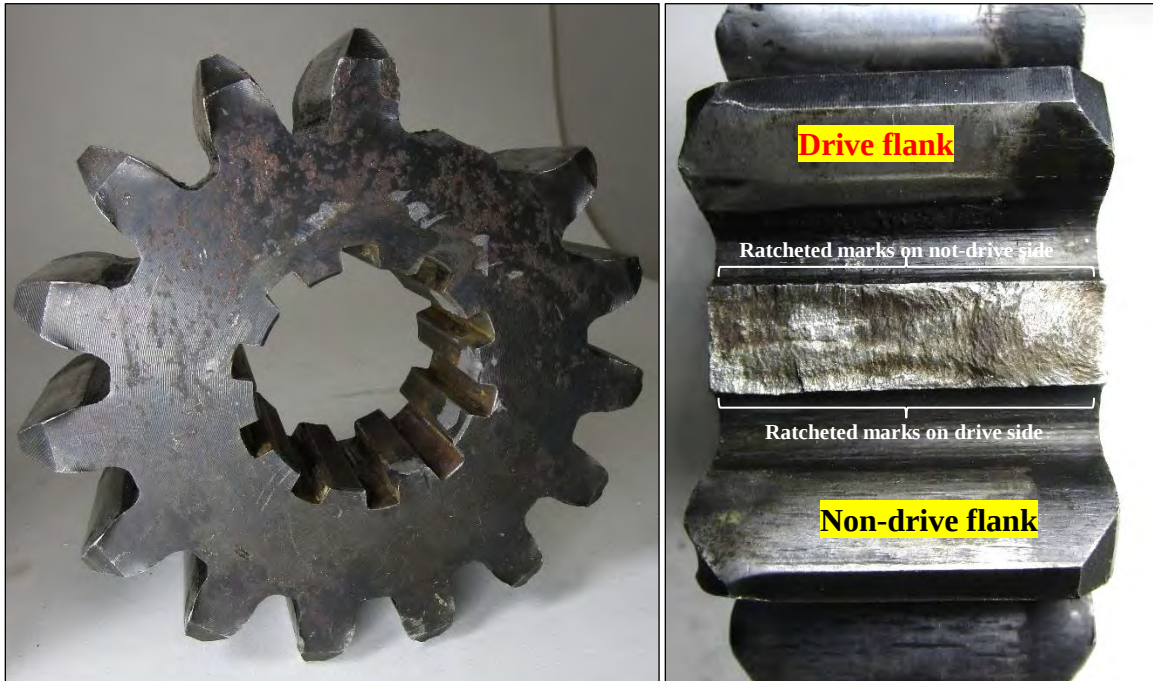
The fracture of the broken tooth was along the tooth fillet (see **Figure 28**). The fracture was generally flat without apparent plastic deformation. It exhibited ratcheted marks along the edges on both the drive and non-drive sides of the tooth. These features are consistent with a reverse bending fatigue fracture that originated from multiple origins on both sides of the tooth.

**Figure 28** Broken tooth and its fracture.

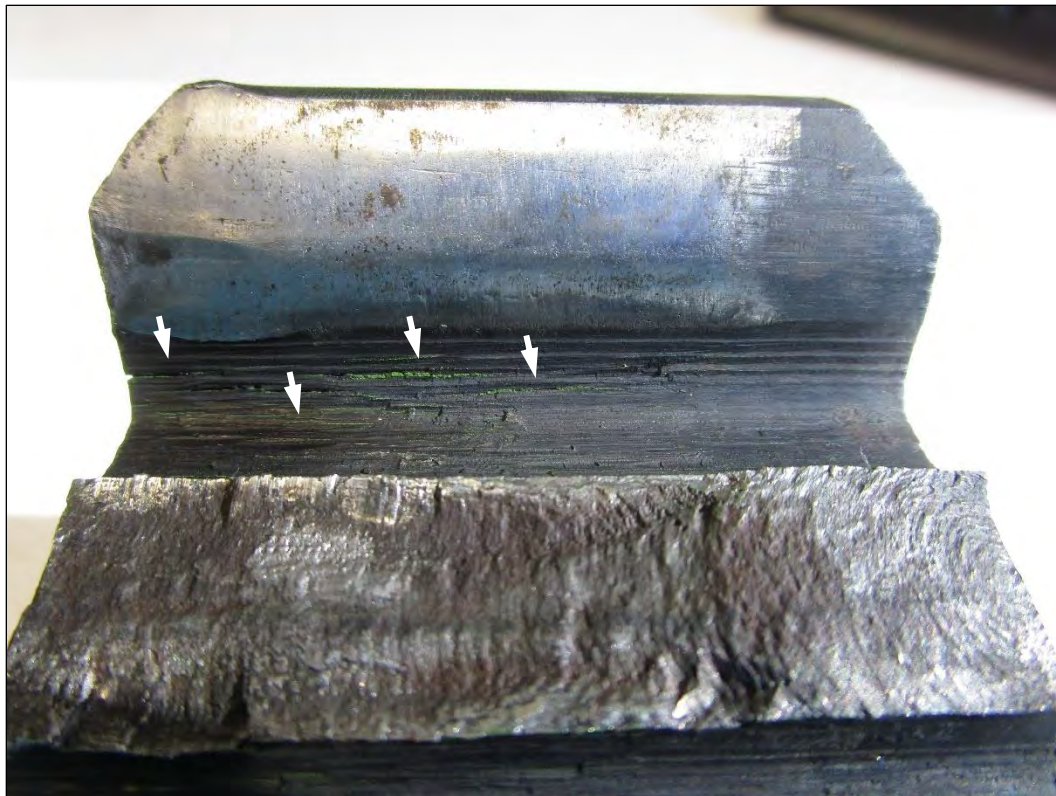
The neighbouring tooth exhibited multiple cracks on the tooth fillet surface along the coarse machining lines (see **Figure 29**). The ratcheted pattern on the fracture of the broken tooth would have resulted from coalescence of multiple cracks similar to the secondary cracks on the neighbouring tooth.

**Figure 29** Secondary cracks on rough machined fillet of neighbouring tooth.
