## **EXAMINATION OF FAILED COMPONENTS OF A CONSTRUCTION HOIST**

TALL CRANE EQUIPMENT LTD.  
22652 FRASER HWY  
LANGLEY TWP, BC V2Z 2T8

File Number: 60515067  
Date: September 11, 2019

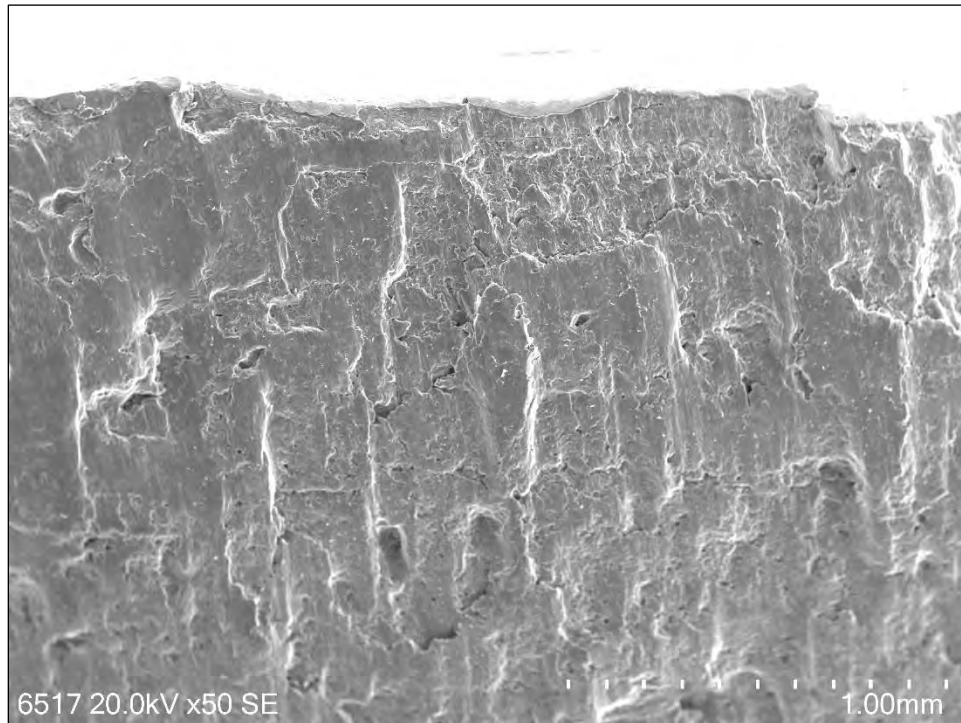
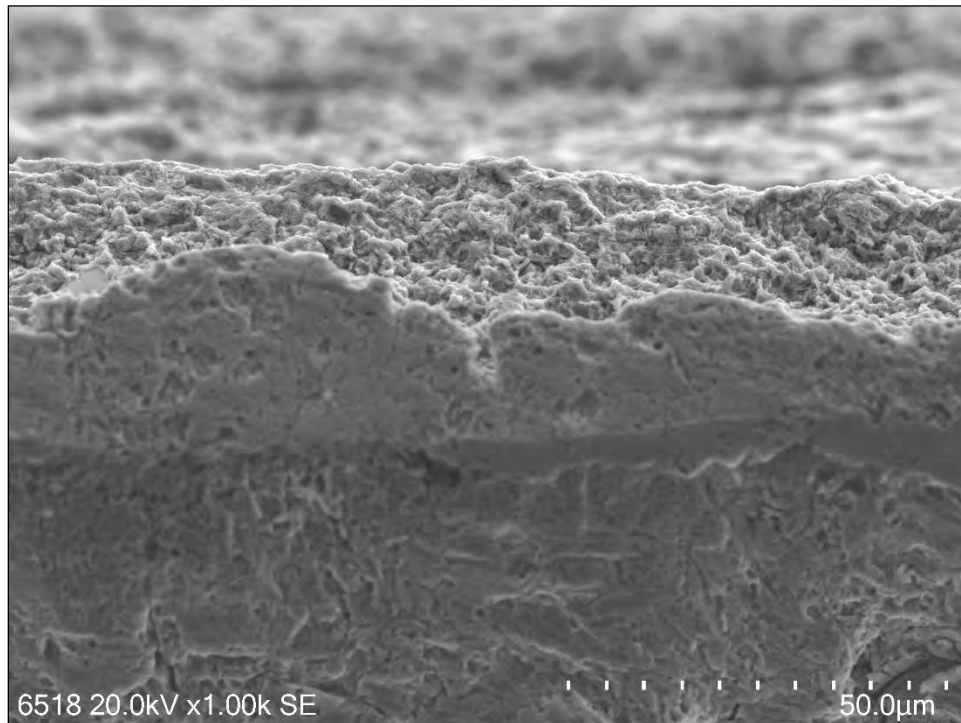
The fracture on the drive side was severely damaged by rubbing against the opposing fracture surface (see **Figure 30a**). A small undamaged area along the edge of the fracture was found to have been severely corroded (see **Figure 30b**). The fracture on the non-drive side also exhibited similar mechanical and corrosion damage, except for less extent of corrosion (see **Figure 31**). The extent of corrosion on the gear fracture indicated that the cracking had occurred long ago.

**Figure 30** SEM images of fracture along edge of drive side.

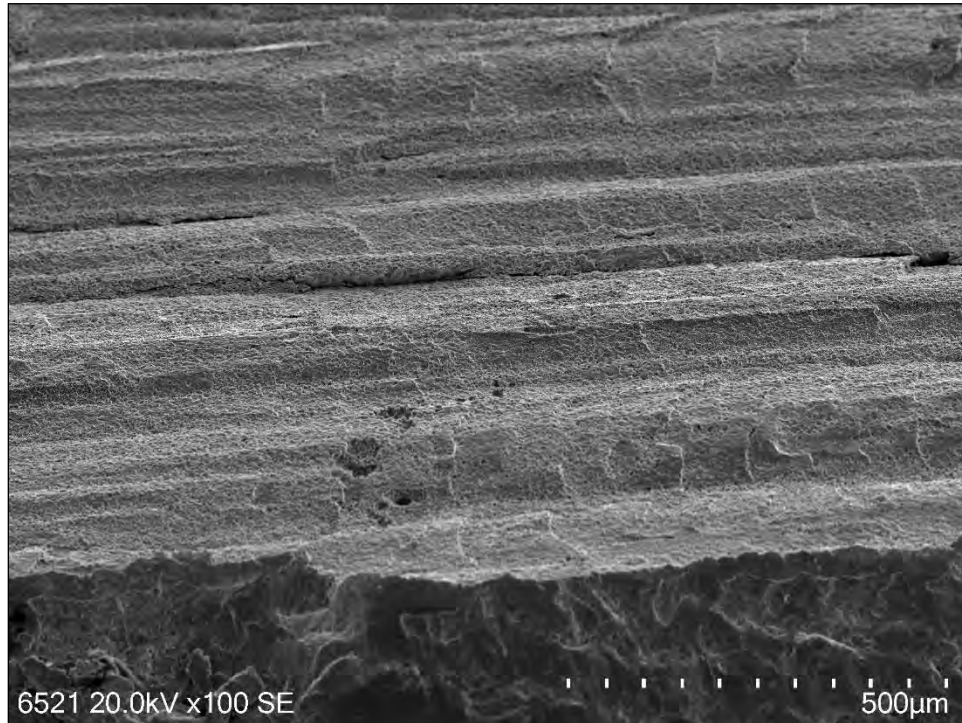
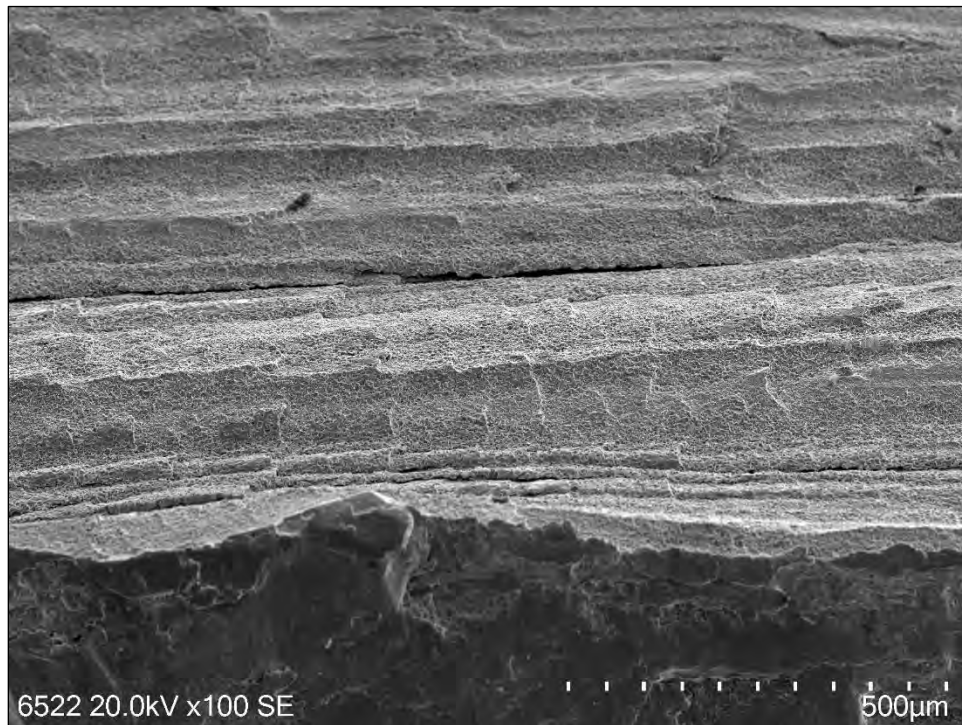
**Figure 32** shows SEM images of fillet cracks on the rough machined surface.

**Figure 32** SEM images of secondary cracks along tooth root on dive side.

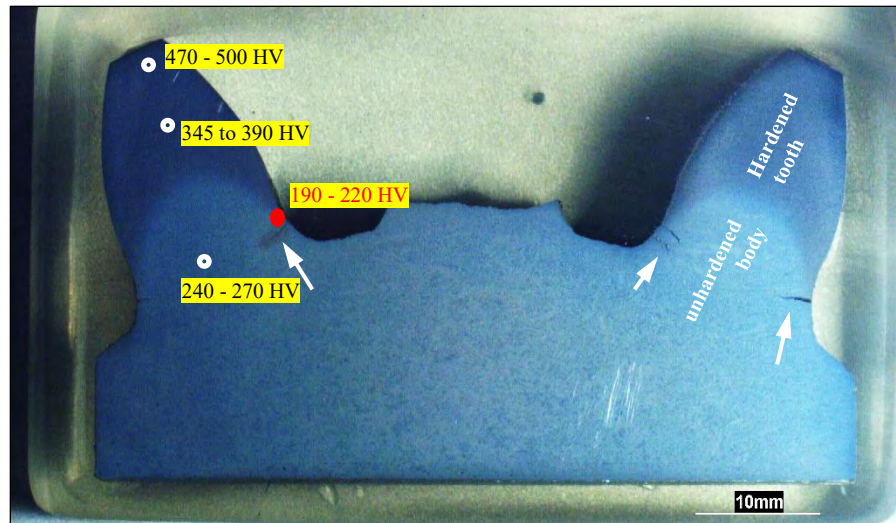
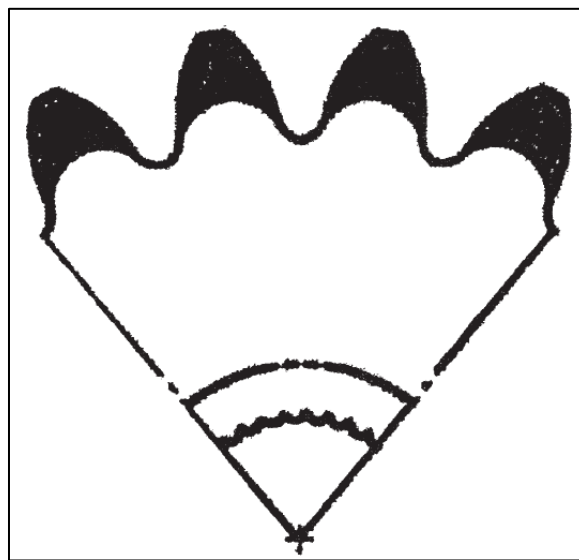
7. The cracks at the tooth fillet were found to be straight and transgranular at the tooth roots through the softest transition zone (see **Figure 33** and **Figure 36**). The profile of the cracks is consistent with fatigue cracks.

The broken bottom gear was flank-and-tooth hardened. In this hardening pattern, the root is not hardened and the transition zone of the tooth hardening is at the fatigue critical fillet/root areas (previously shown in **Figure 33b**). This tooth hardening pattern is used for wear resistance applications where fatigue resistance is not a concern. However, fatigue resistance is a key concern in addition to wear in the hoist gear application. With a hardness less than 20 HRC at the fatigue critical fillet/root areas, this gear is the most vulnerable to fatigue cracking among all the gears. This inadequate tooth hardening was the primary cause of its fatigue failure.

**Figure 33** Metallographic specimen of broken gear across fracture showing flank-and-tooth hardening pattern.

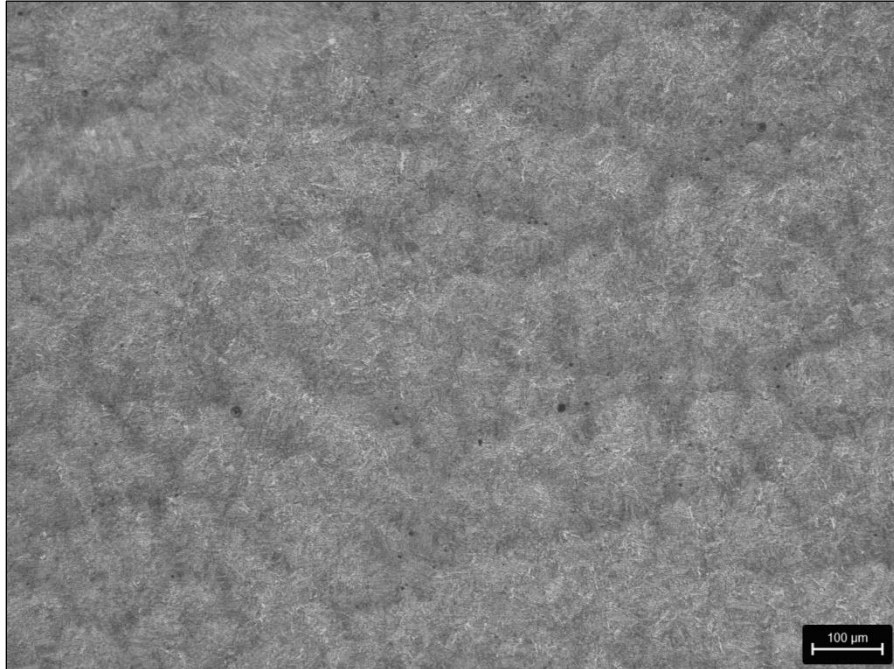
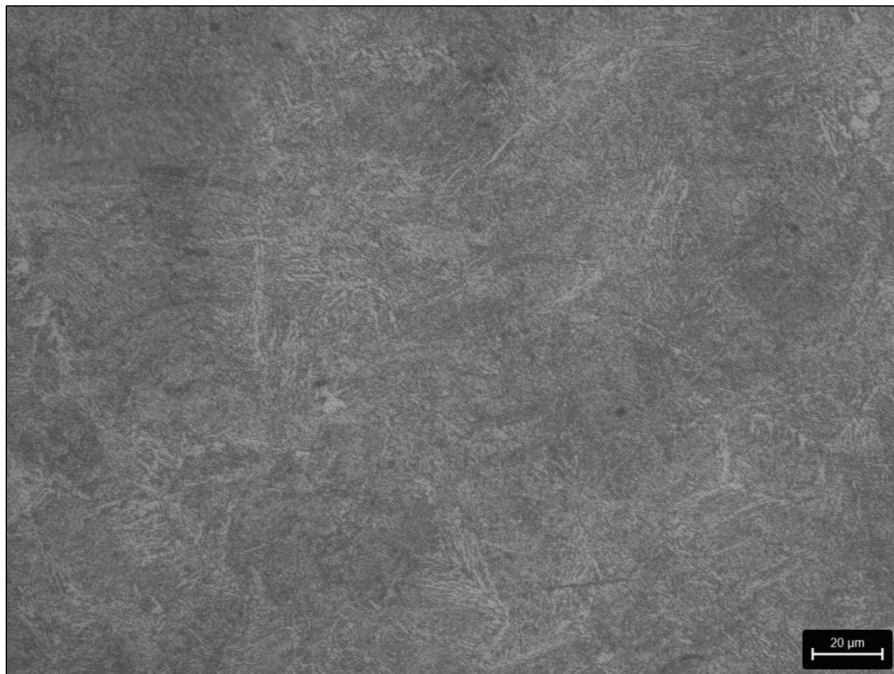
2. The gear body exhibited a quenched and tempered microstructure (a mixture of tempered martensite and bainite) with a relatively coarse grain size (see **Figure 34**). It appeared that the gear was machined out of a heat treated bar stock.

**Figure 34** General microstructure of body of broken gear.

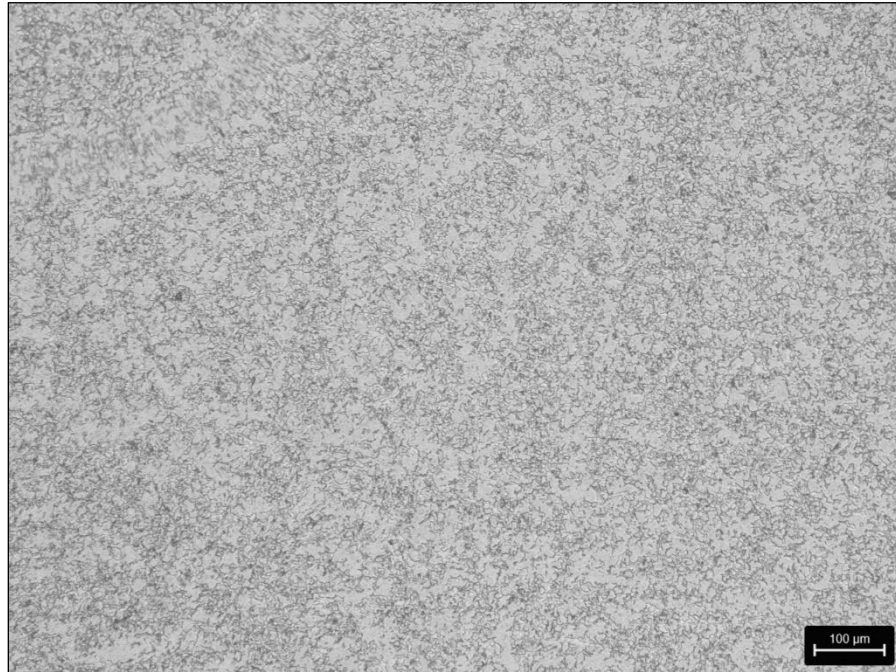
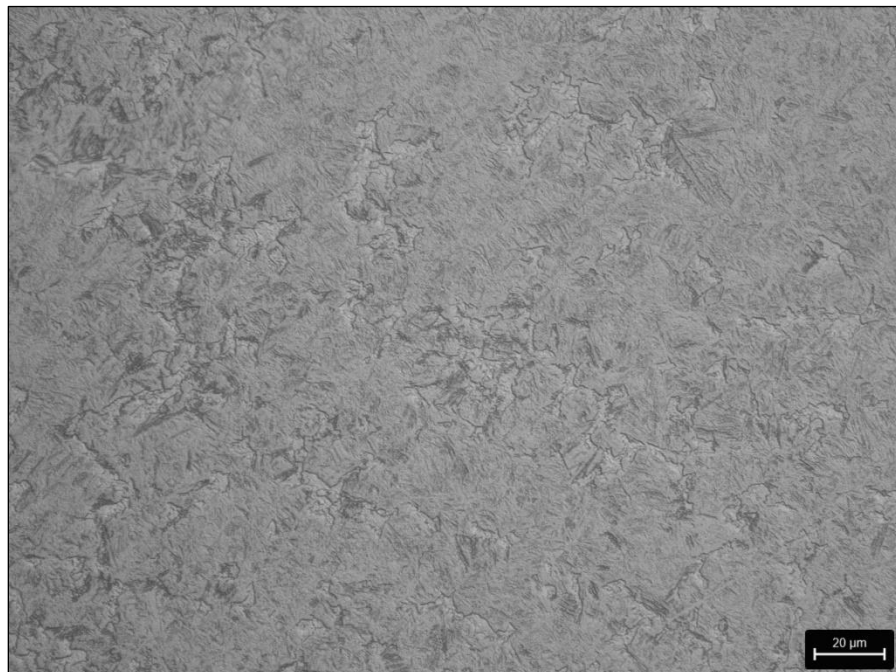
3. The tooth exhibited a mixture of very fine-grained ferrite and tempered martensite microstructure (see **Figure 35**). This indicated that the gear teeth were hardened by an induction hardening method, and that the heating failed to reach the single austenite phase temperature zone. This indicated that the induction tooth-hardening was performed with wrong process parameters.

**Figure 35** General microstructure of tooth in hardened zone, broken gear.

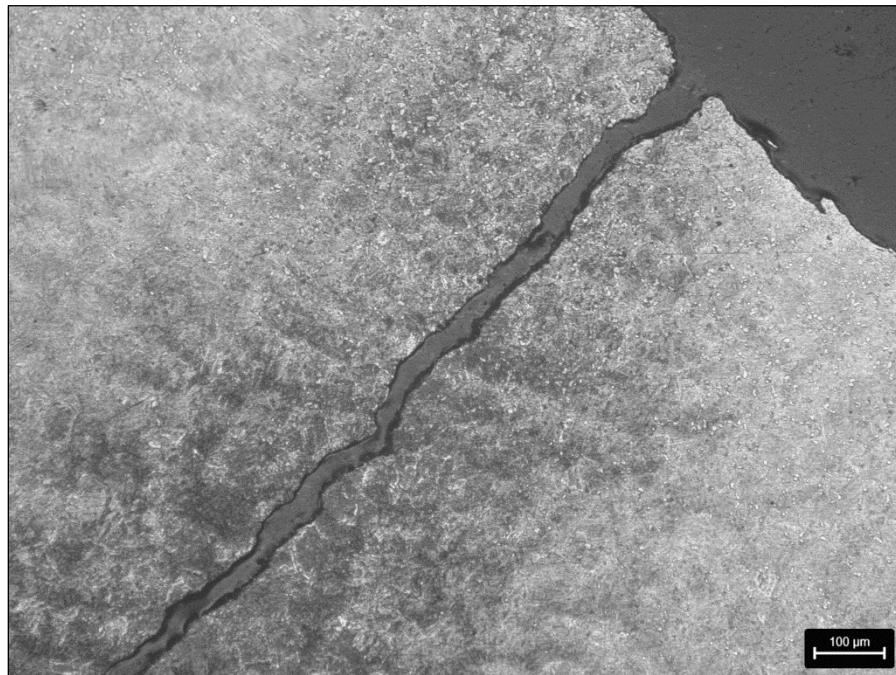
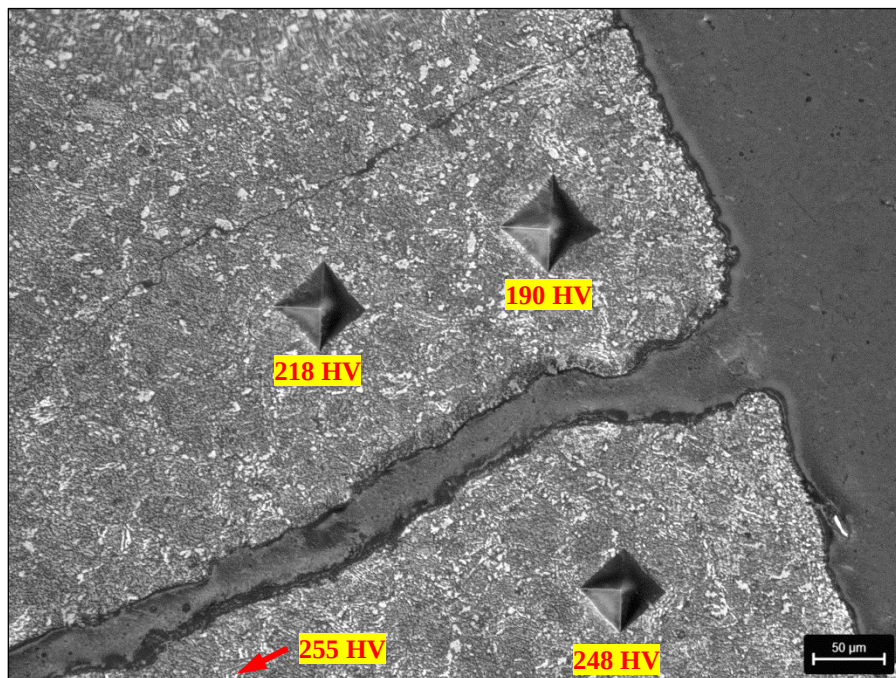
**Figure 36** Profile of crack and surrounding microstructures, broken gear.

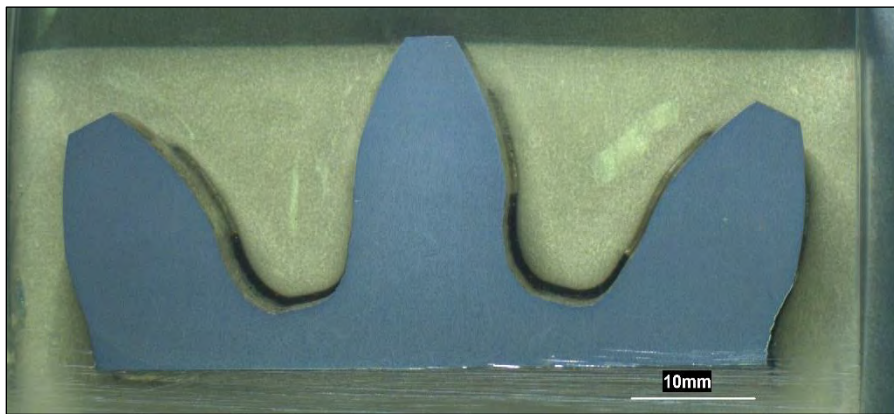
Different from the broken gear, the mid-gear exhibited a uniform microstructure throughout the teeth and body (see **Figure 37**). This meant that the mid-gear was not induction tooth-hardened after machining.

**Figure 37** Metallographic specimen of mid-gear showing through-hardened pattern.

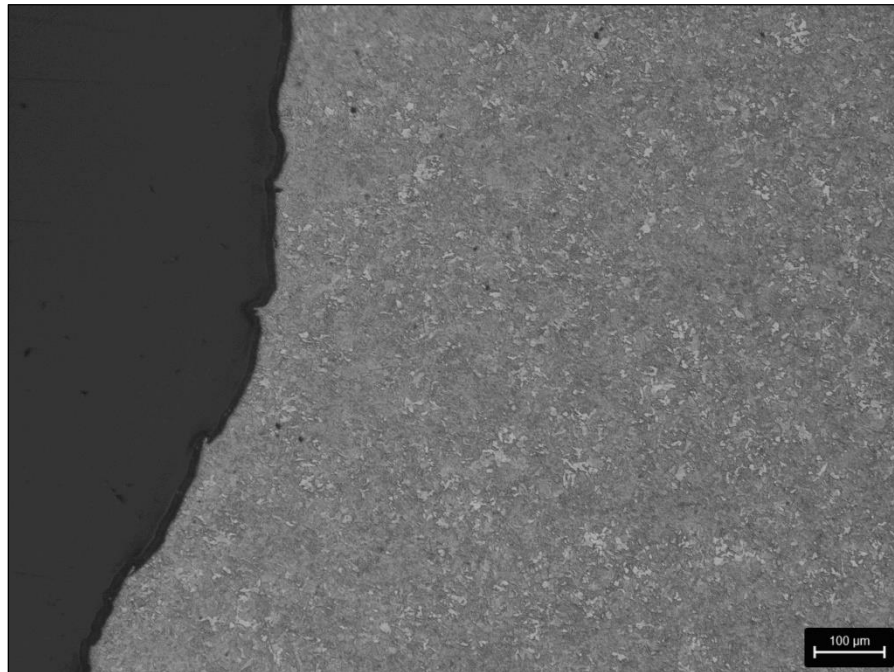
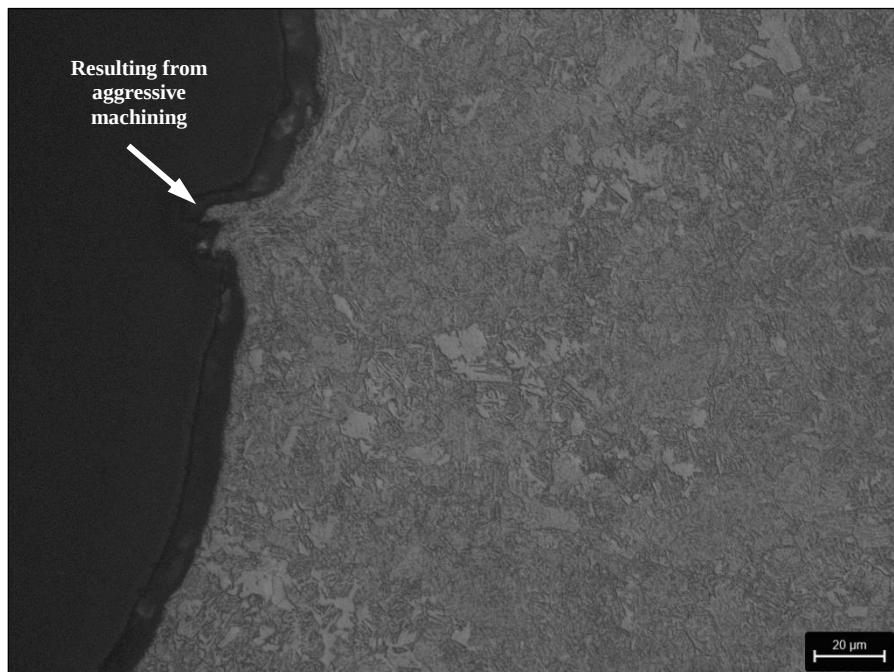
The mid-gear exhibited a quenched and tempered microstructure including the tooth root areas (see **Figure 38**), with a consistent hardness of 350 HV 500g (equivalent to 36 HRC). The hardness on the flanks of the mid-gear is lower than the case-hardened zone of the broken gear, but is higher than the body of the broken gear. More importantly, the harness of the mid-gear at the tooth root is much harder than that of the broken gear.

**Figure 38** Profile of gear root and surrounding microstructure of mid-gear.

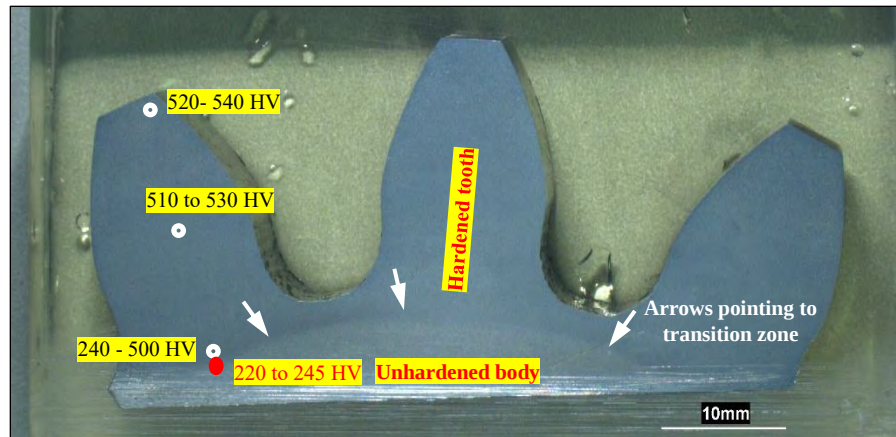
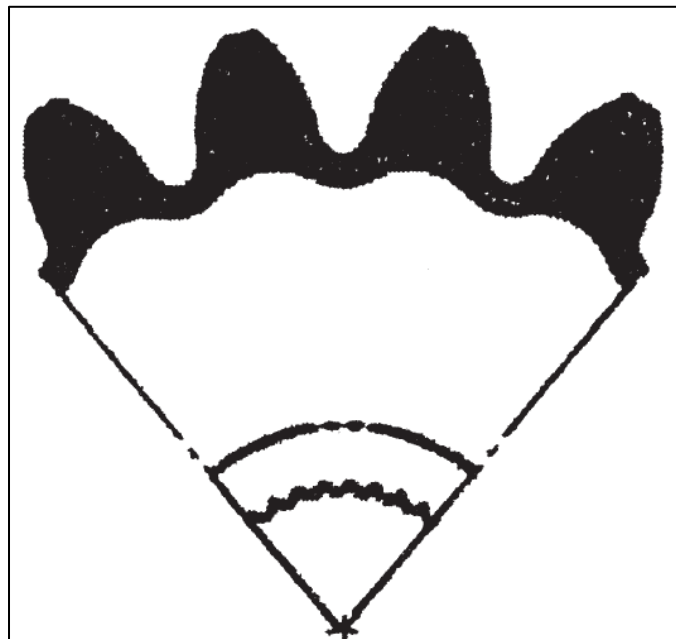
A metallographic specimen was prepared from the replacement gear across three (3) teeth. This revealed that the gear exhibited tooth-and-root hardening pattern (see **Figure 39**). The microstructure of the hardened zone, including the tooth root areas, consisted of a fine-grained tempered martensite microstructure (see **Figure 40**).

**Figure 39** Metallographic specimen of replacement gear showing tooth-and-root hardening pattern.

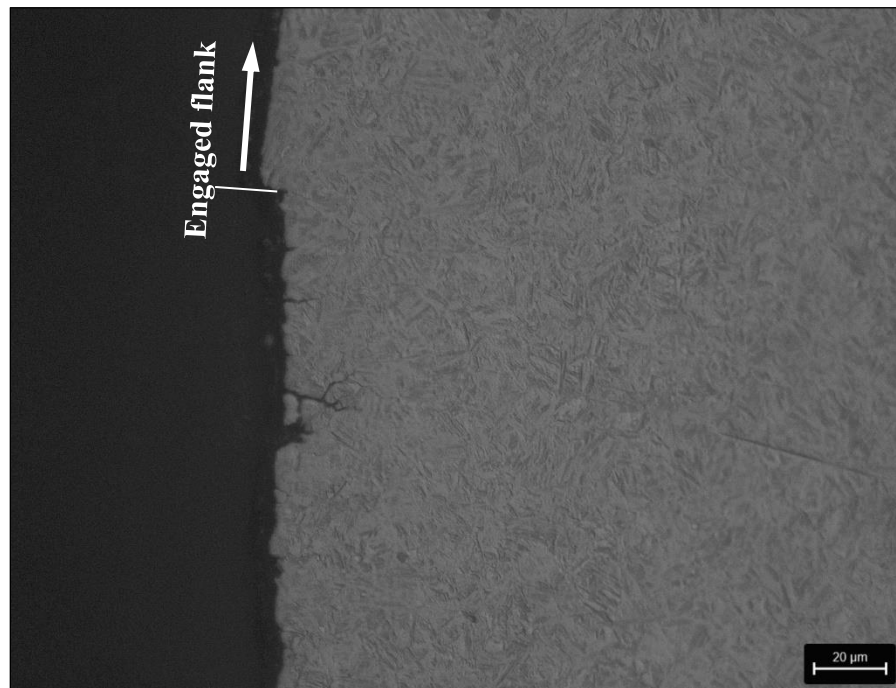
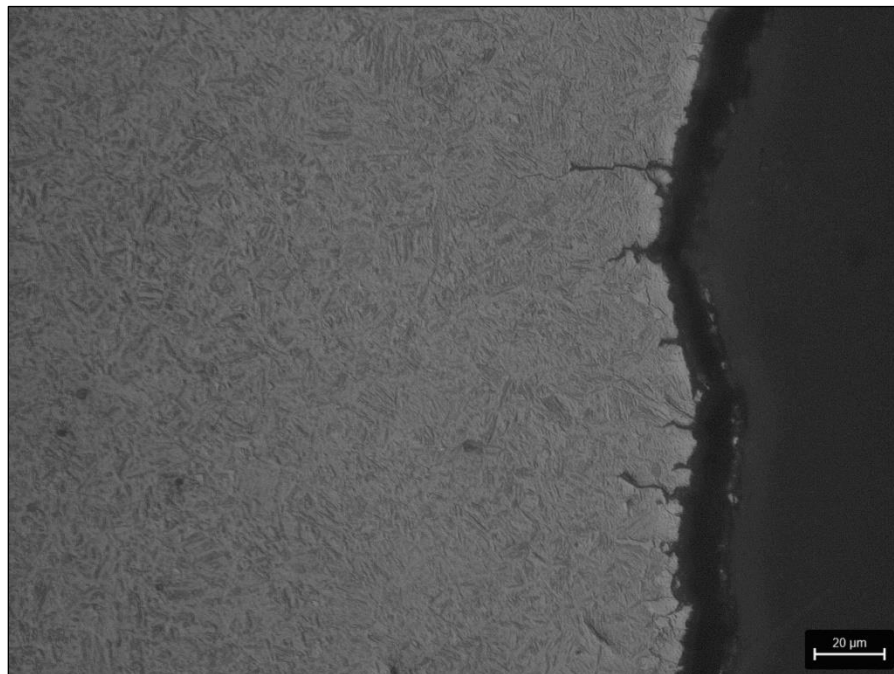
Despite hardening around the tooth roots, the replacement gear had developed multiple fatigue cracks just below the engaged flanks on both the drive and non-drive sides (also see **Figure 40**).

**Figure 40** Cracks at tooth fillet and surrounding microstructure of replacement gear.
