Incident Summary #II-863230-2018 (#13186) (FINAL)

| | Regulated industry sector | Electrical - Low voltage electrical system (30V to 750V) | |
| Incident overview | A component of a door latching mechanism that secures the door of a motor control center motor starter dislodged when the starter control switch lever was closed. The dislodged component contacted energized components inside the motor starter enclosure creating an electrical incident. | | |

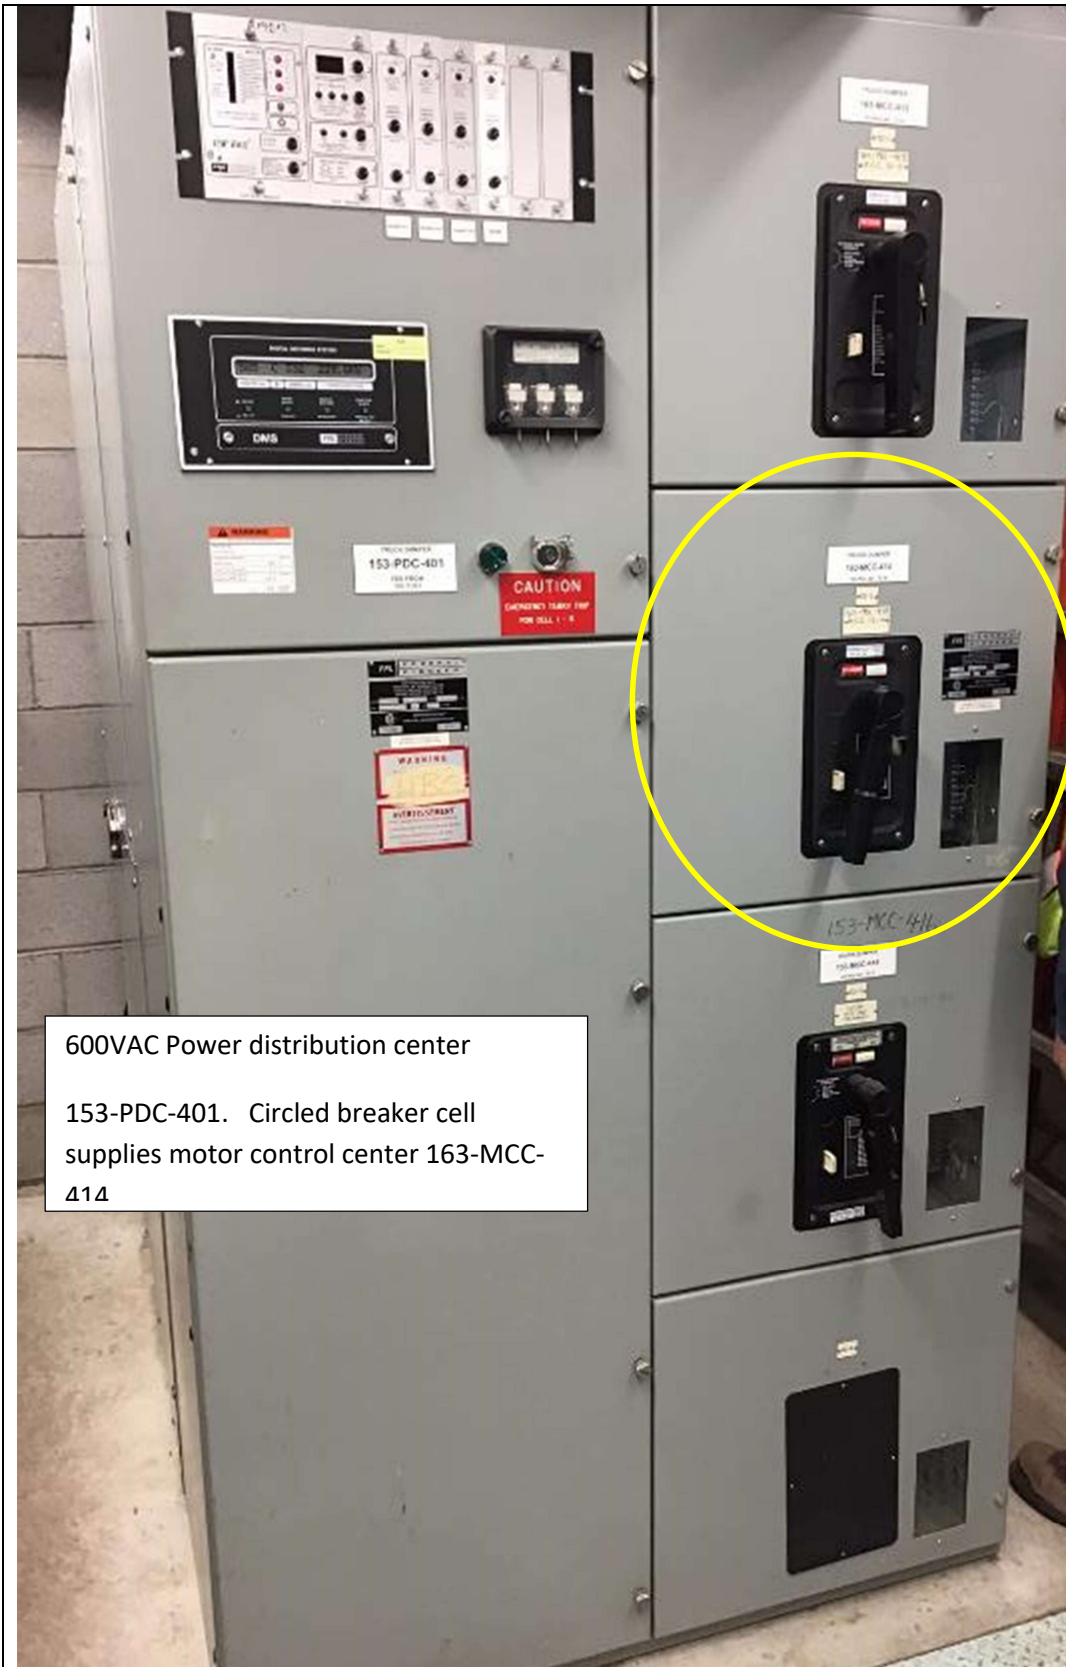
600VAC Power distribution center

153-PDC-401. Circled breaker cell
supplies motor control center 163-MCC-
414

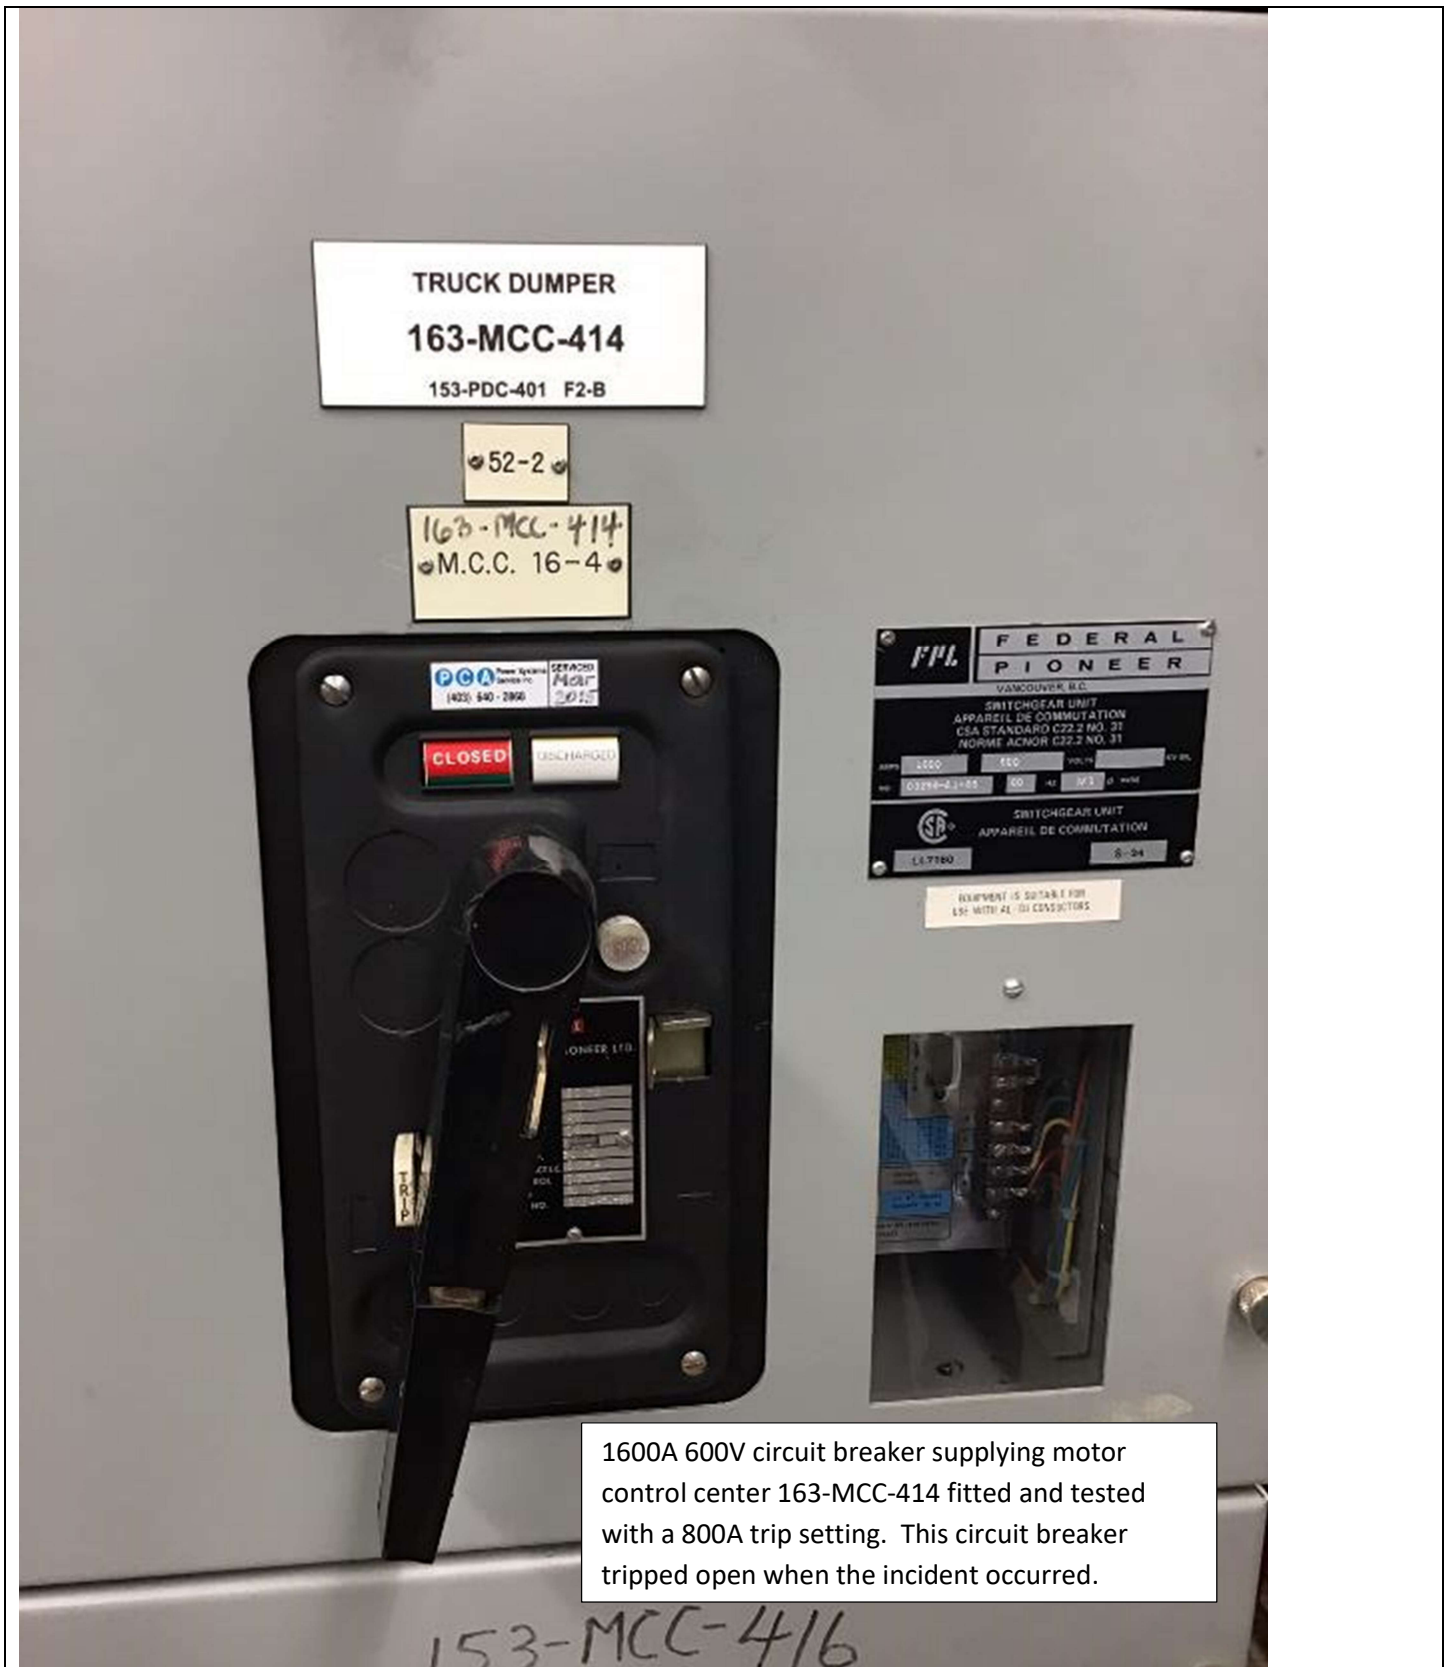
Motor control center 163-MCC-414 supplied and protected from circuit breaker 52.2 installed in power distribution center 153-PDC-401

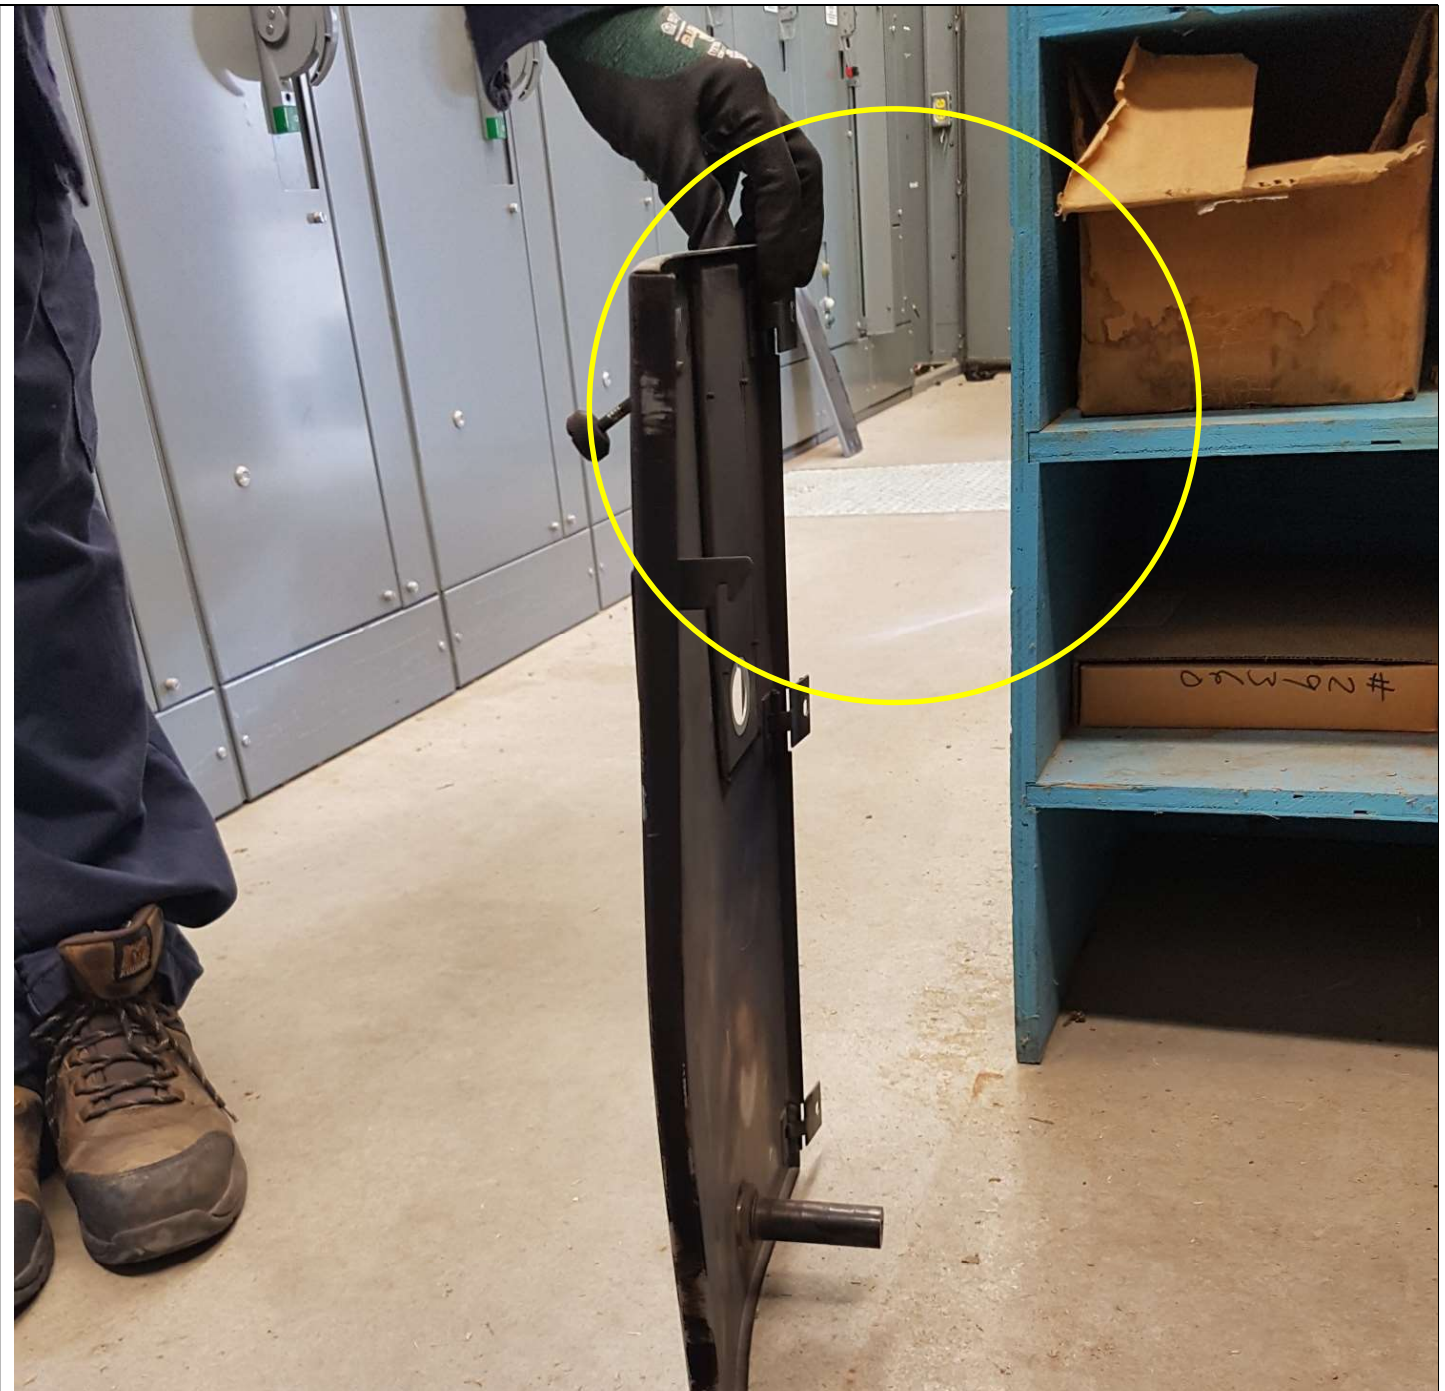
Damaged motor starter 16-1136. Incident occurred in highlighted area. All evidence and indications point toward a failure in the switch mechanism which resulted in an unintentional contact between a component of the switch mechanism and the line side of the fuses. Because the contact occurred on the line side of the fuses, upstream circuit protection initiated at circuit breaker 52.2 in power distribution center 153-PDC-401. The magnitude of damage and fault current levels was limited by the impedance grounding feature of the 600VAC power distribution.

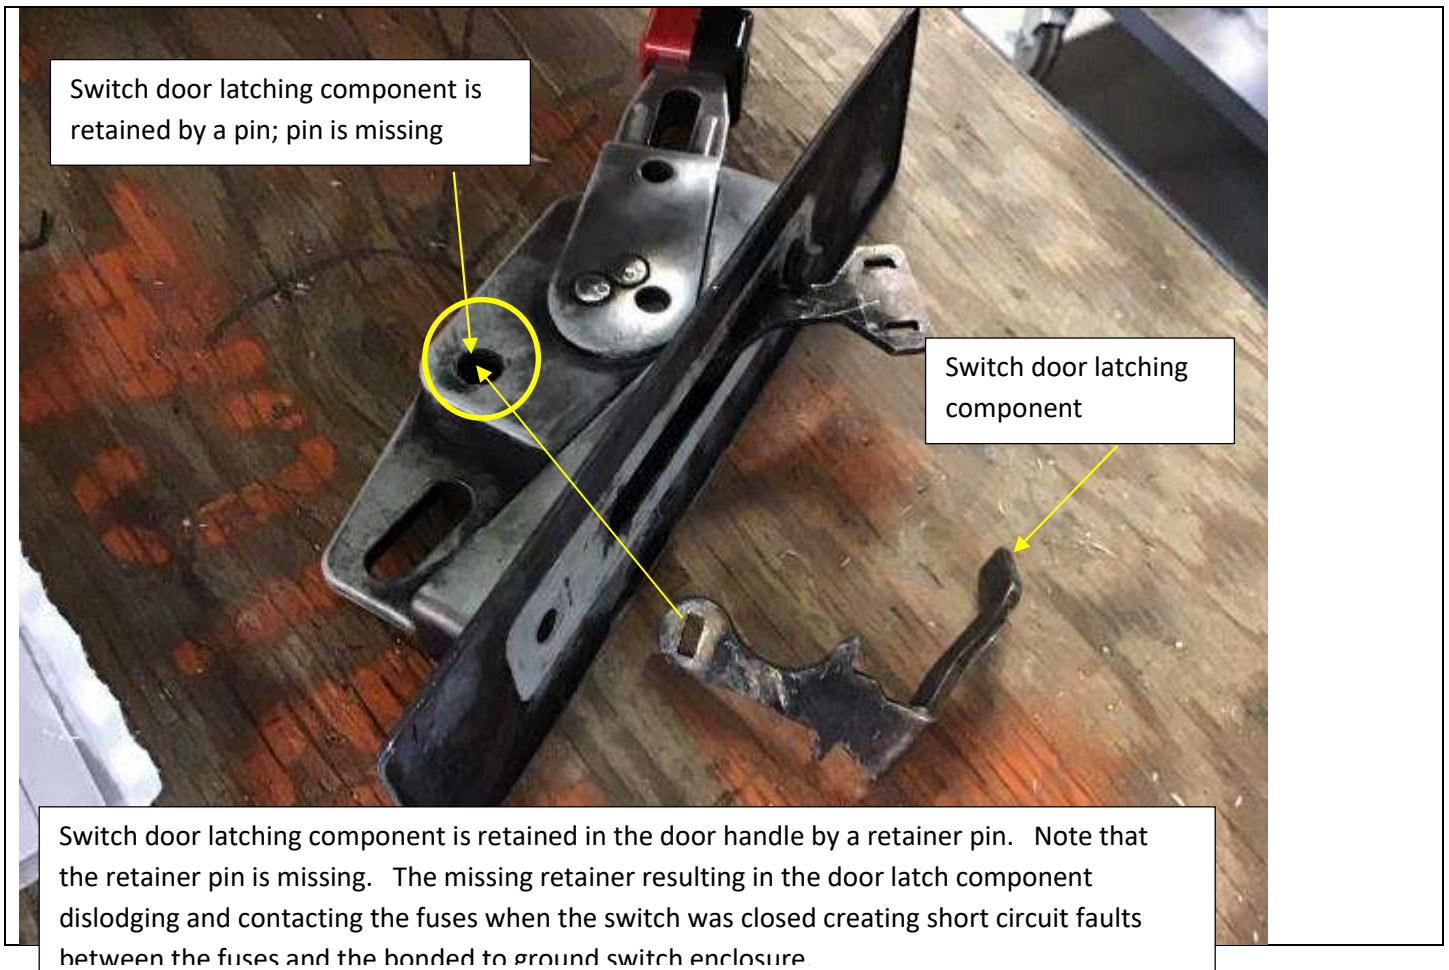
| | Facts and evidence | A retainer pin keeps the door latching interlock secured to the control switch mechanism. Examination of the control switch identified the retainer as missing. The missing retainer permitted the door latch interlock to fall out of the switch mechanism. | |

Dislodged door latching component contacted line side of fuses when switch was closed. The latching arm contacted two fuses creating both phase to phase and phase to ground faults
