Incident Summary (5620434)

| | Regulated industry sector | | Low voltage electrical system (30V to 750V) | |
| | Incident overview | | The bathroom fan overheated and caught fire. | |

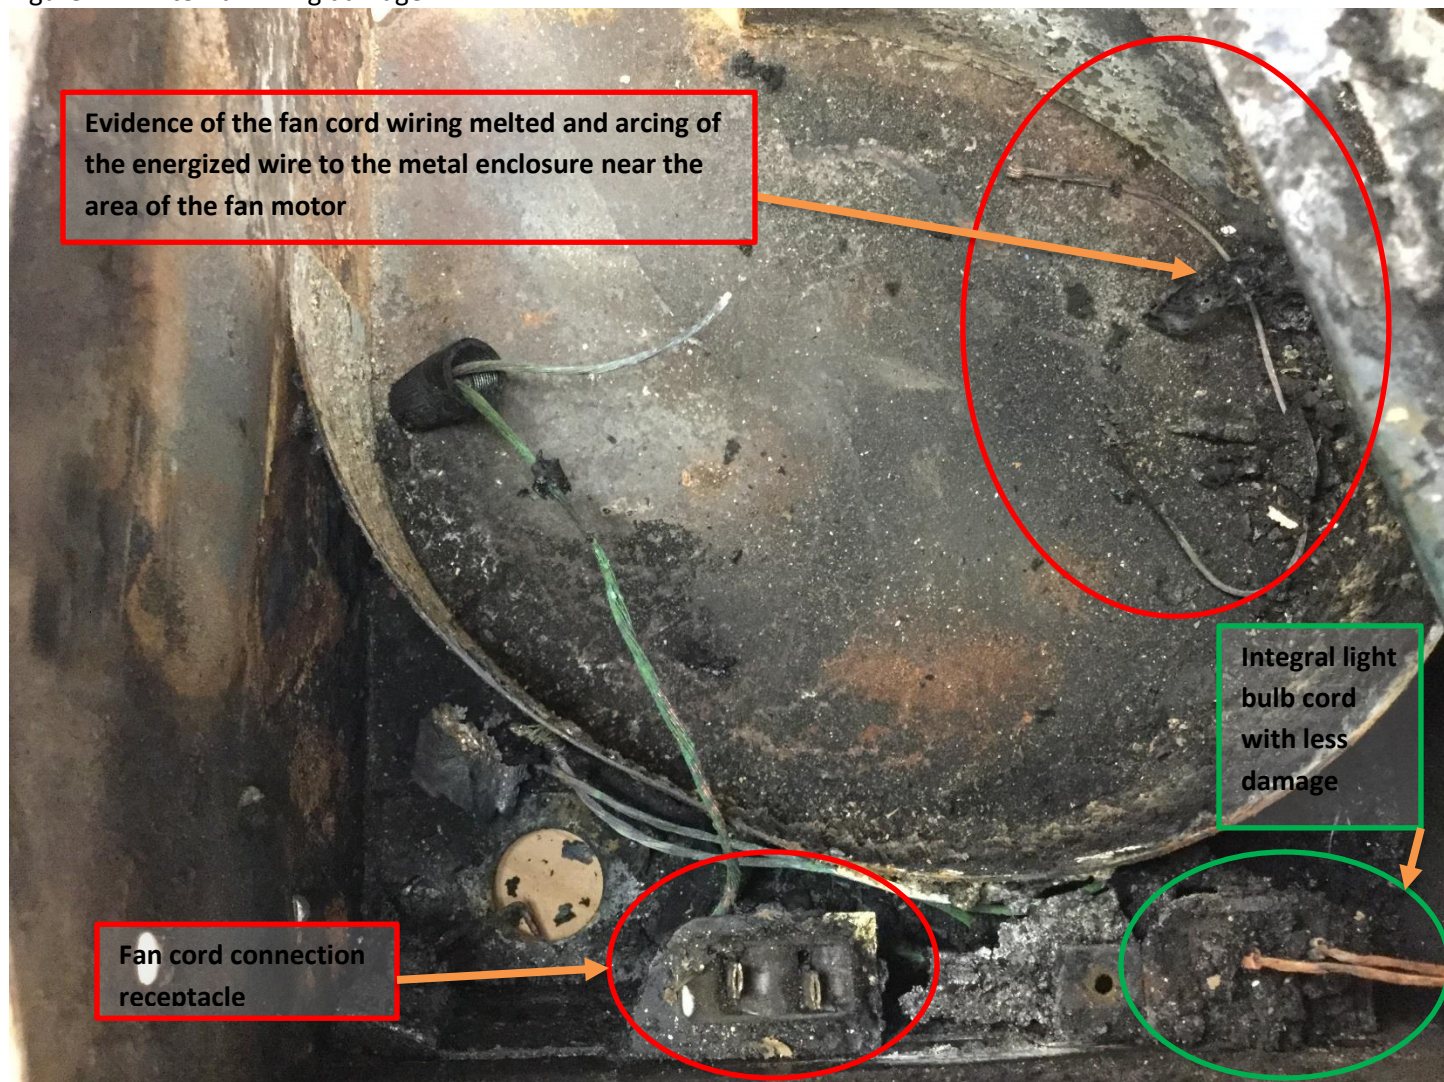
| | Failure scenario(s) | | The bathroom exhaust fan motor experienced a failure due to age and lack of maintenance and cleaning and there was a high current heat condition to the exhaust motor and the fan internal cord. This resulted in the insulation of the fan cord melting and the energized wire arcing to the metal fan enclosure igniting the inside of the fan on fire which spread to the wooden joists and drywall. | |

Figure #1 – Internal wiring damage

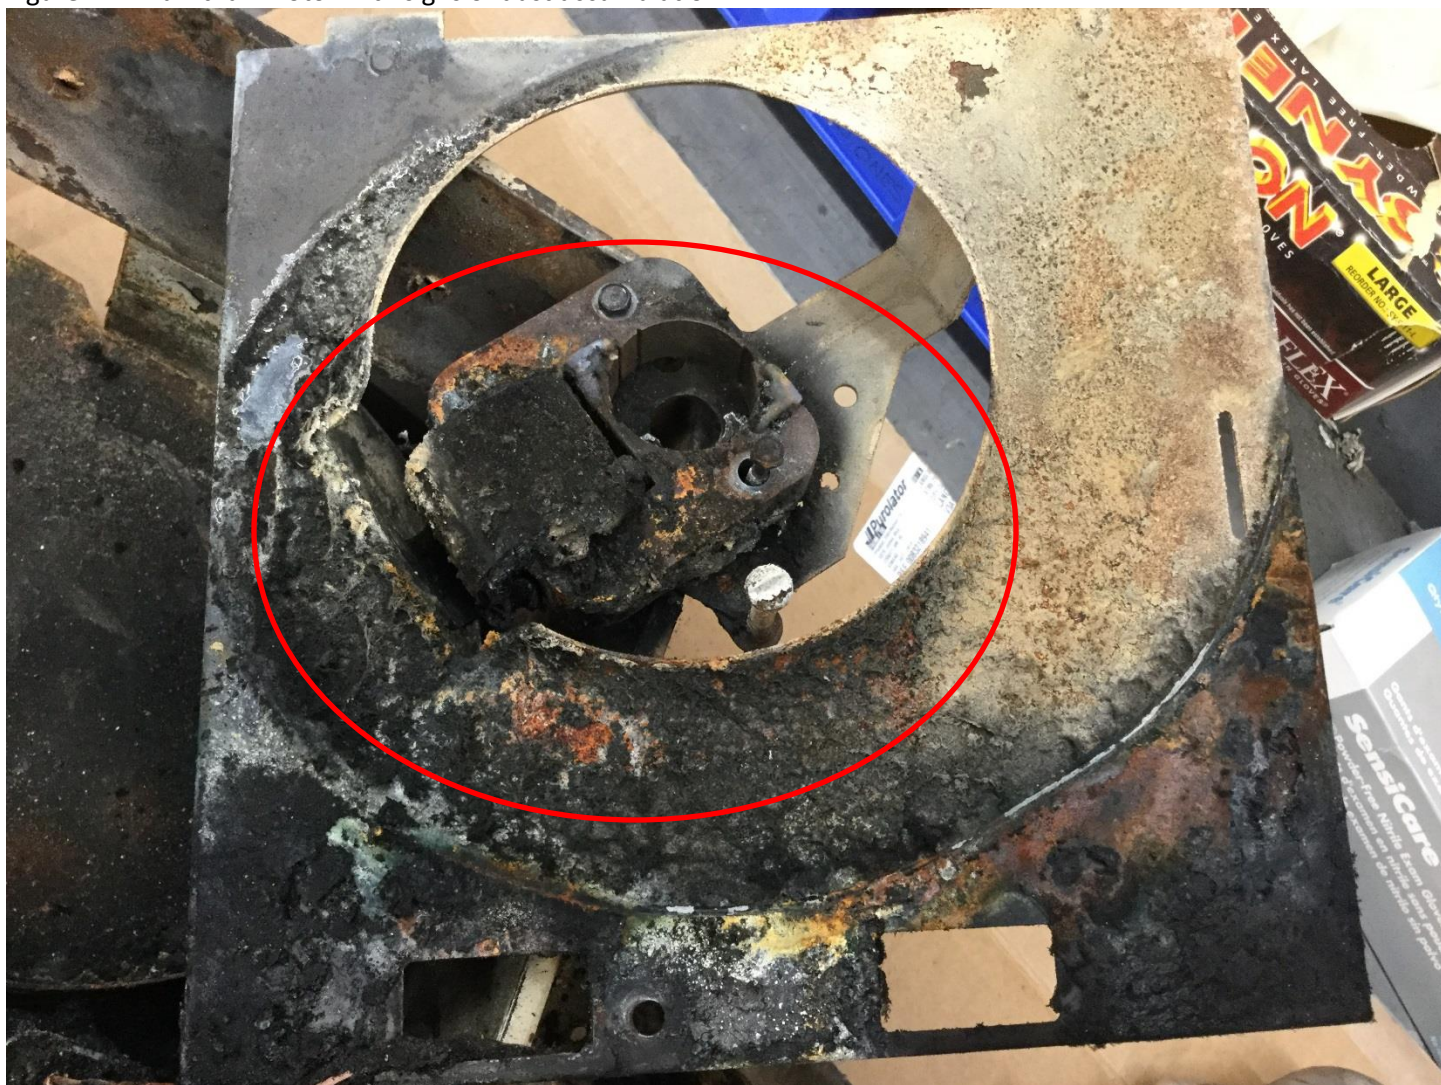
| | Causes and contributing factors | | <p>It is very likely that the cause of this incident was that the bathroom fan exhaust motor was failing due to age and lack of maintenance and cleaning.</p> <p>The resultant high electrical current and high temperatures of the fan motor and the fan internal cord caused the insulation of the fan cord to melt and the energized wire to arc to the metal fan enclosure.</p> <p>The dust accumulations and plastic fan blade within the fan enclosure likely fueled the fire. While the circuit breaker reportedly tripped during the incident, the fire spread beyond the metal fan enclosure to the wooden ceiling joist.</p> | |

Figure #2 – Burnt fan motor with signs of dust accumulation

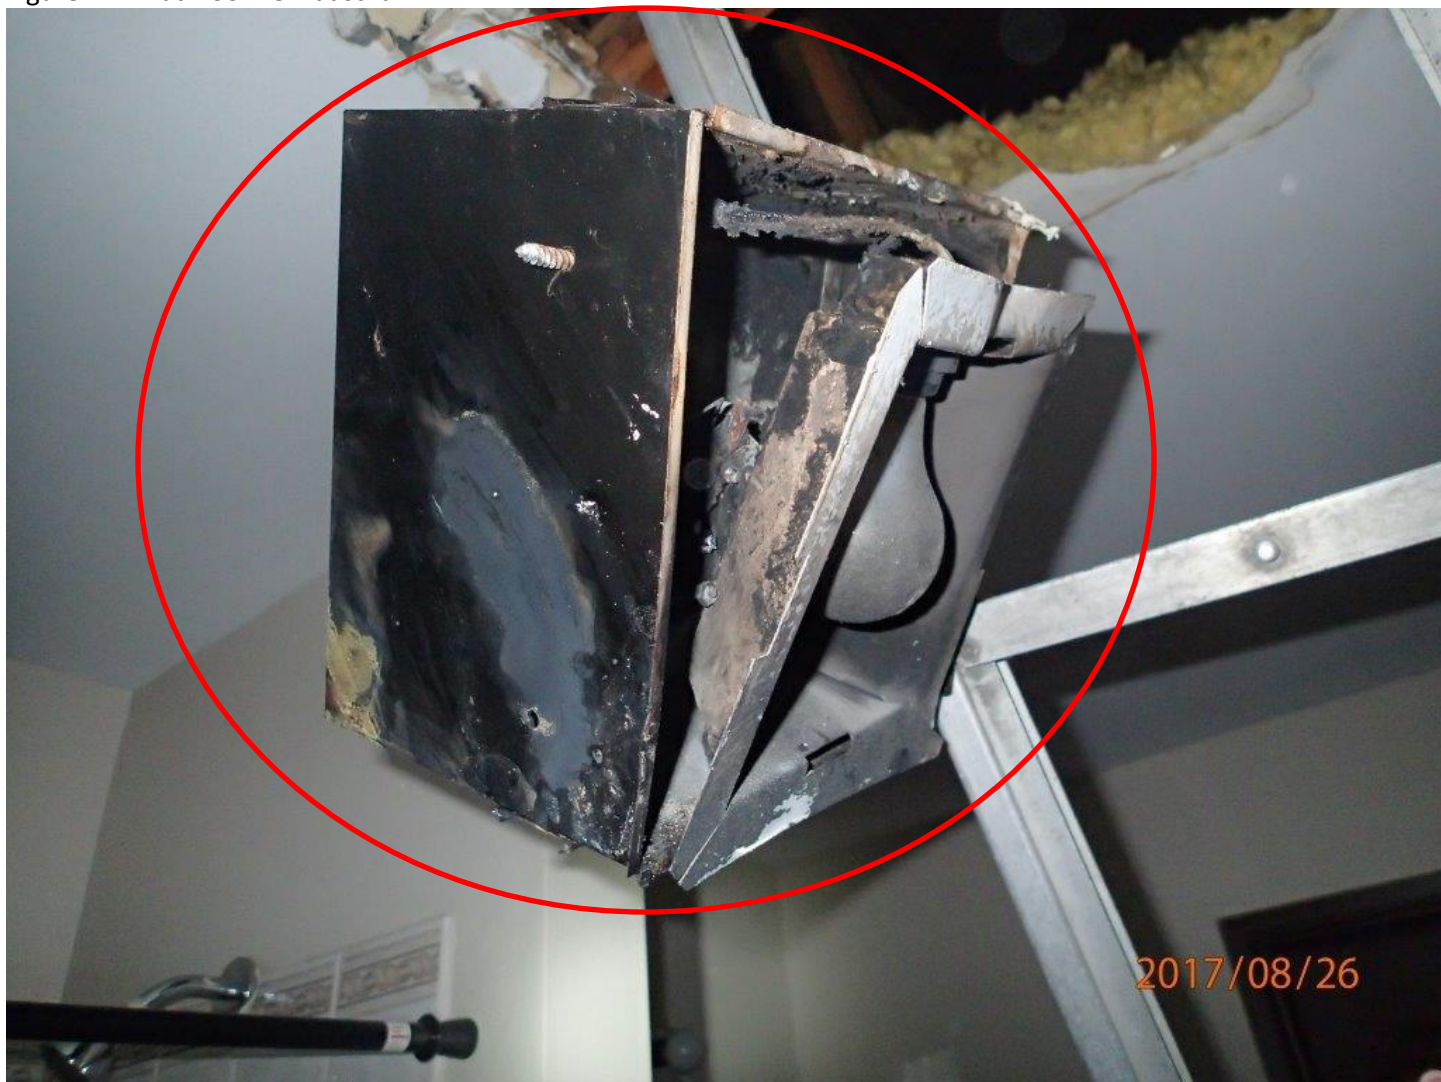
Figure #1 – Bathroom exhaust fan

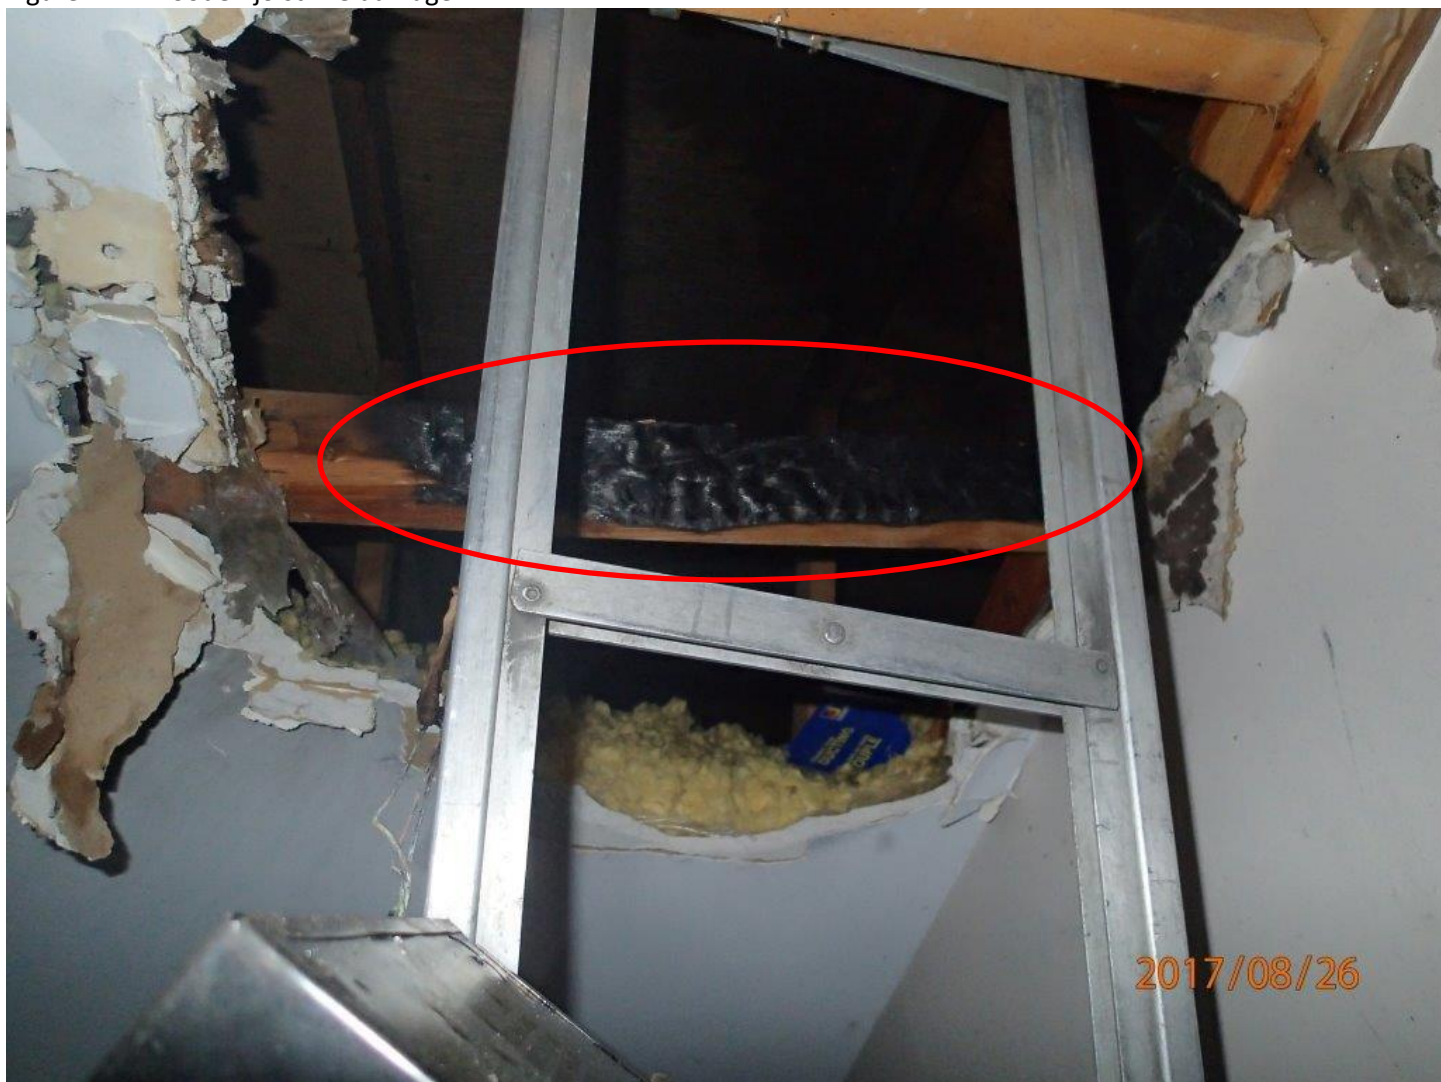
Figure #2 – Wooden joist fire damage

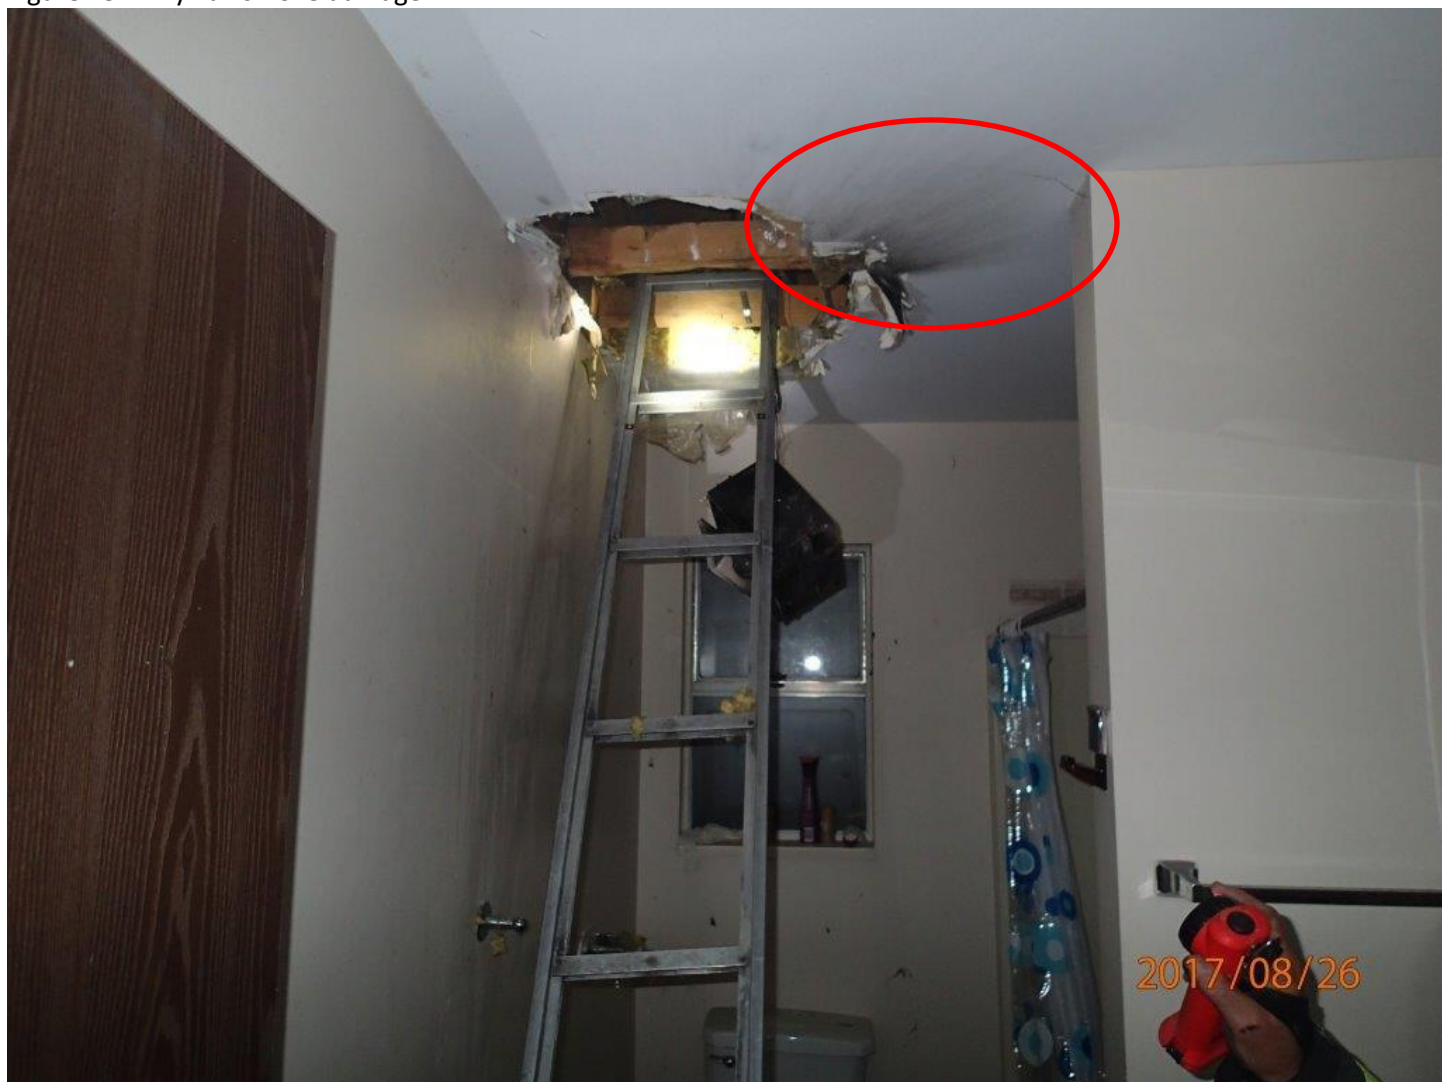
Figure #3 – Drywall smoke damage
