Incident Summary #II-1722810-2024 (#47597) (FINAL)

SUPPORTING INFORMATION	Incident Date	June 13, 2024	
	Location	Trail, BC	
	Regulated industry sector	Electrical - Low voltage electrical system (30V to 1000V)	
	Impact	Qty injuries	1
		Injury description	Worker was preparing to apply grease to machinery when, while reaching in, his arm contacted an abraded, energized cable supplying a 600V AC equipment drive motor.
		Injury rating	Minor
	Damage	Damage description	N/A
		Damage rating	None
Incident rating	Minor		
Incident overview	At an industrial facility, temporary wiring used to supply electrical energy to an equipment drive motor had deteriorated; the cable jacket abraded and exposing internal conductor insulation to further abrasion and consequential exposure of the energized conductor and electric shock to a worker.		
INVESTIGATION CONCLUSIONS	Site, system and components	<p>The facility employs 600V AC drive motors throughout the site, various horsepower sizes in various applications. Occasionally, temporary installations are completed to manage equipment failures, or to support alterations to the industrial process. Typically, the temporary installations are either removed or

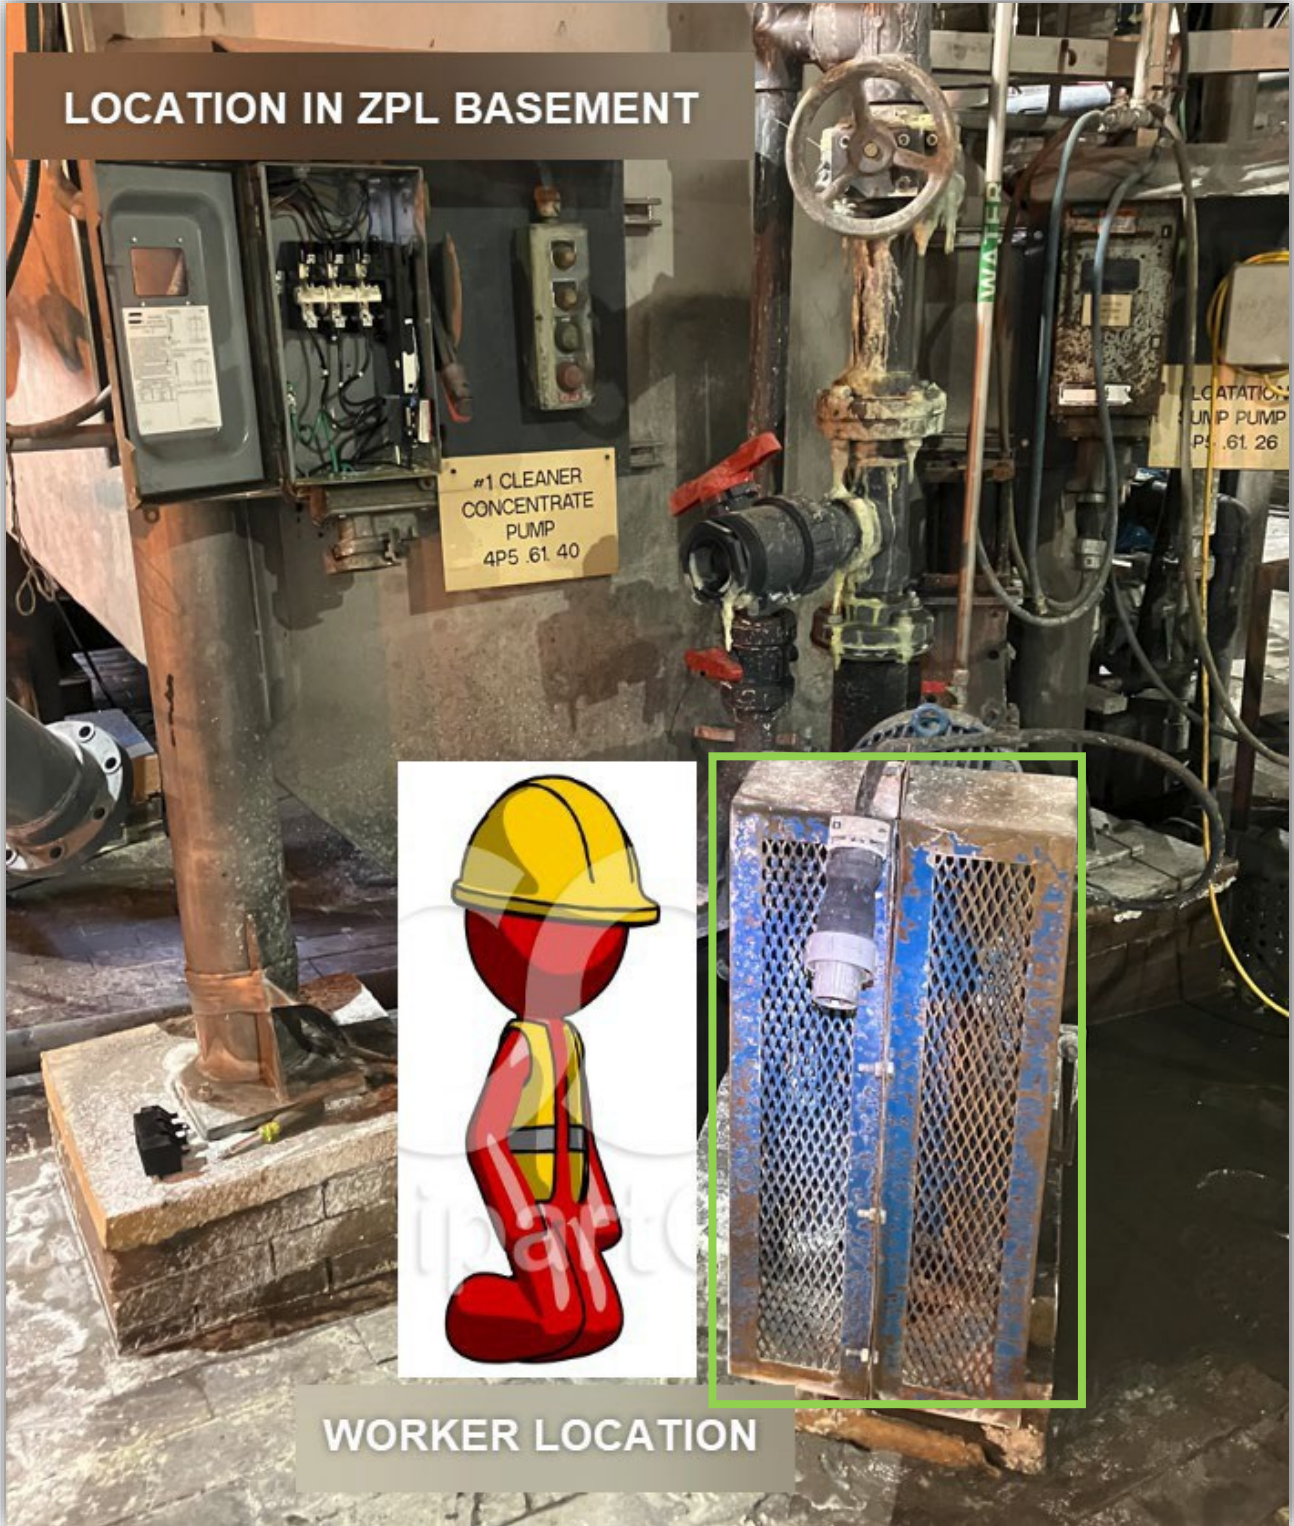
<p>Failure scenario(s)</p>	<p>A 600V AC equipment drive motor had been installed for a temporary application. A length of SOW type flexible cord was used as a temporary wiring method for the electrical supply. The temporary application was not adequately protected, never removed, never modified to reflect a permanent installation. Over time, the SOW flexible cord outer jacket and conductor insulation abraded while the machinery operated exposing the energized conductor. An employee was greasing a component near the electric motor and made contact with the damaged section of the cable and received an electrical shock.</p>
<p>Facts and evidence</p>	<p>Statements and images from the facility where shared and the data and information has been used to document the incident. The data and images identify:</p> <ul style="list-style-type: none"> • The motor was temporarily wired using flexible cable and was not changed to permanent wiring. • The location of the worker was by the motor when they were shocked. • The cable was found to have had a damaged outer jacket in the area the worker contacted it. • The insulation of one conductor inside the cable was found to be damaged as well exposing the energized wire inside. • The motor supply is 600V 3ph and the worker would have received a potential of up to 347V to ground from the one damaged conductor.

Image 1 - Temporary drive motor and the location of the worker when incident happened.

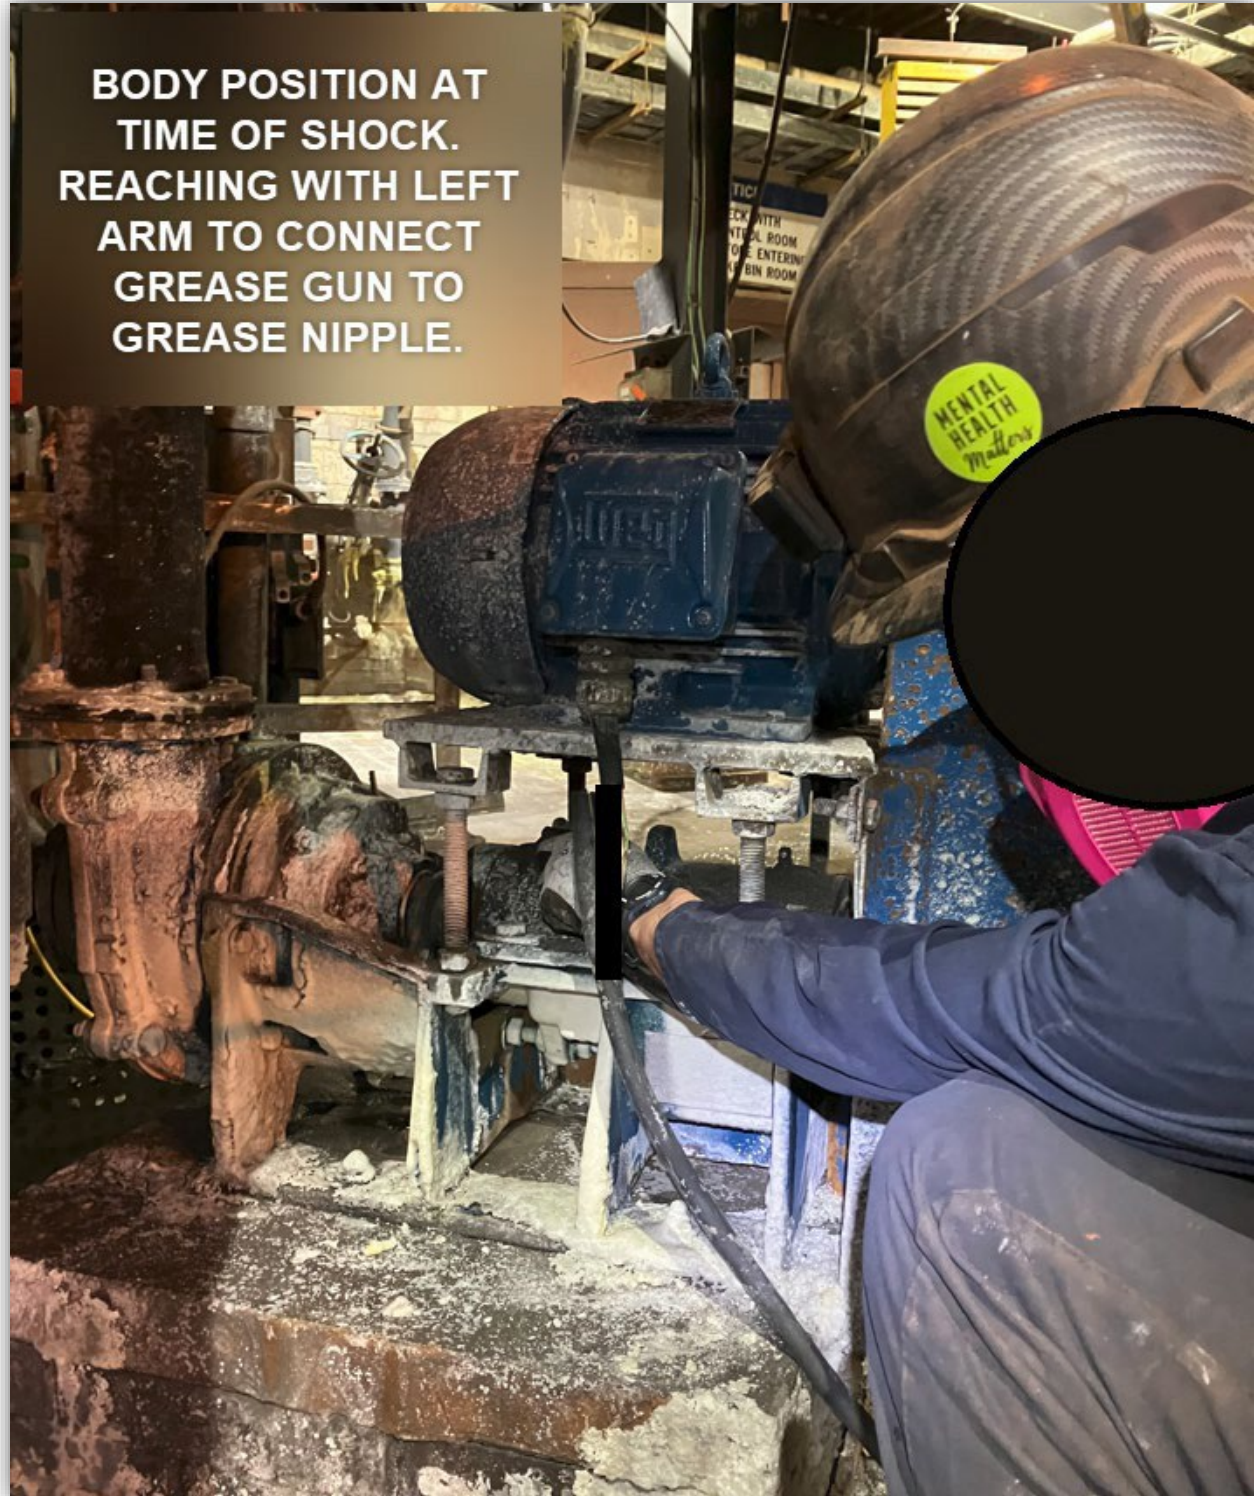
<p>Causes and contributing factors</p>	<p>Evidence determined the incident was caused by an exposed, energized conductor contacting the forearm of an employee while the individual was performing routine equipment maintenance.</p> <p>A failure to replace the temporary installations with permanent wiring and the flexible corbel not being adequately protected from damages contributed to the incident.</p>

Image 2 – Worker positioning.

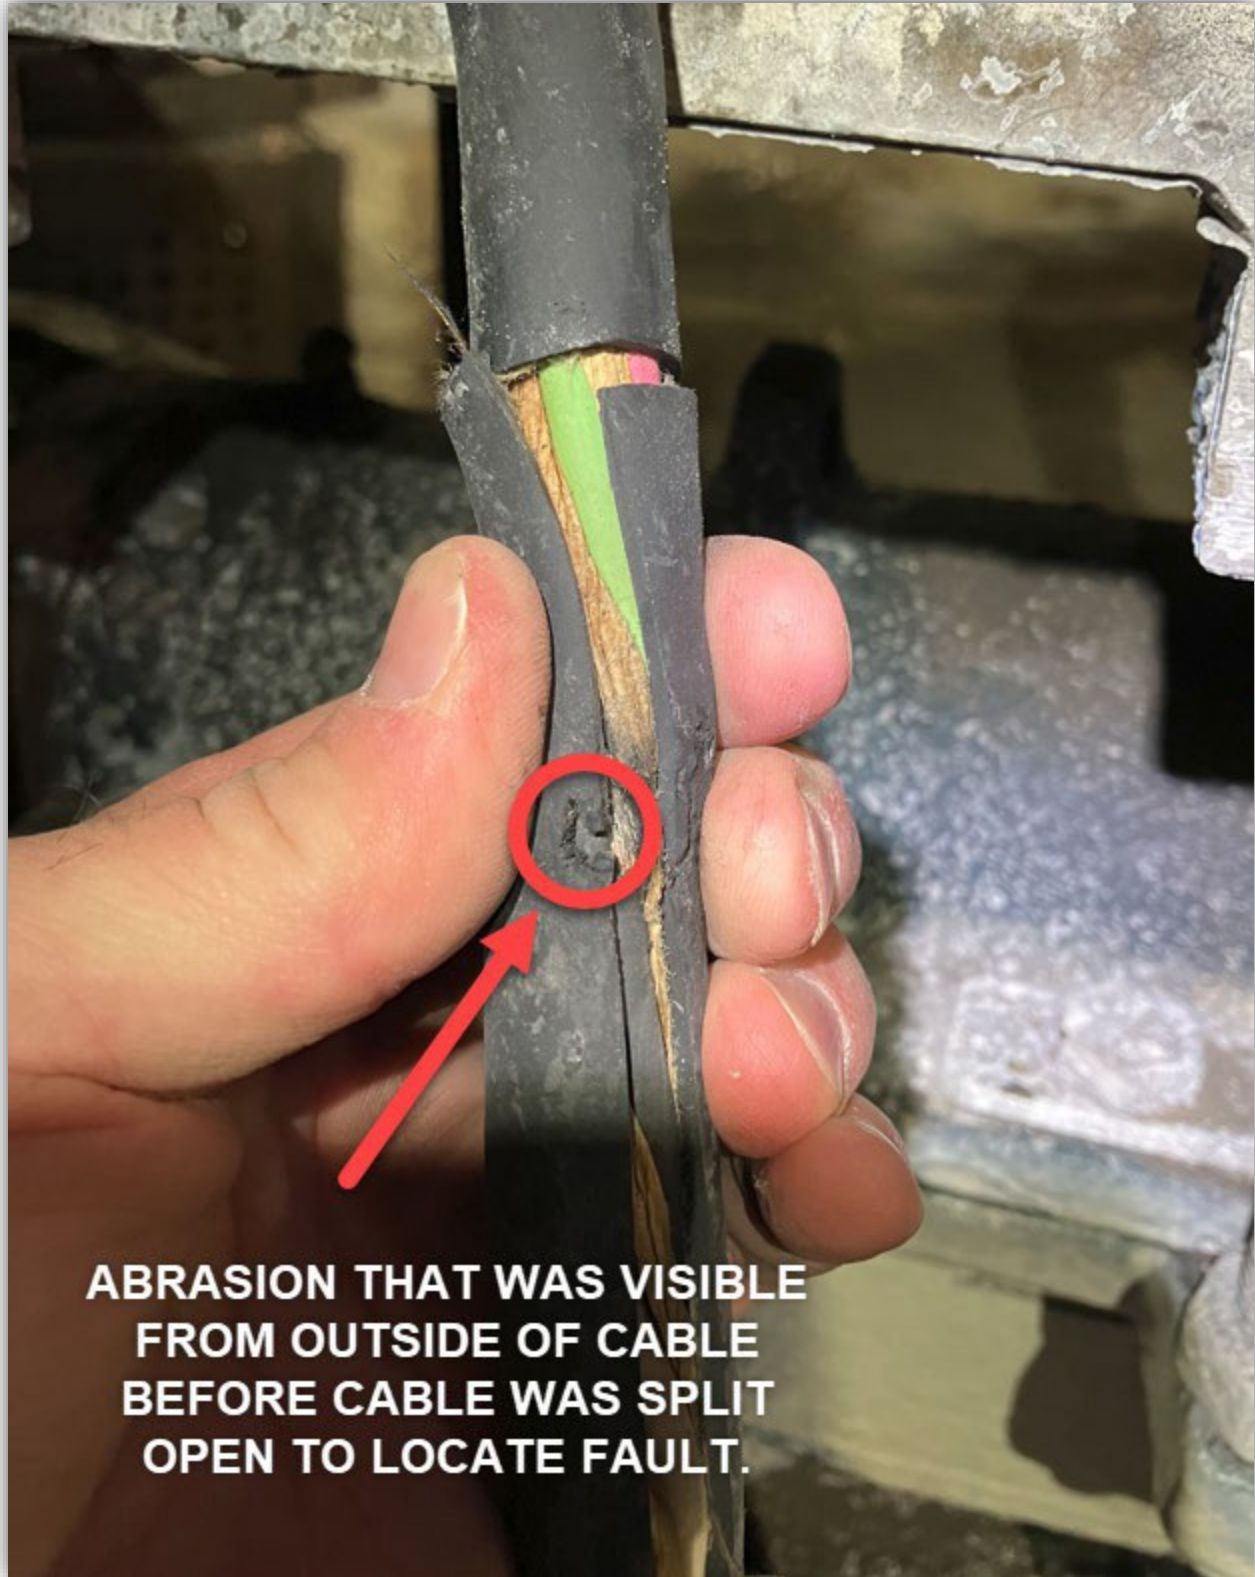
Image 3 – Abrasion on outside of cable.

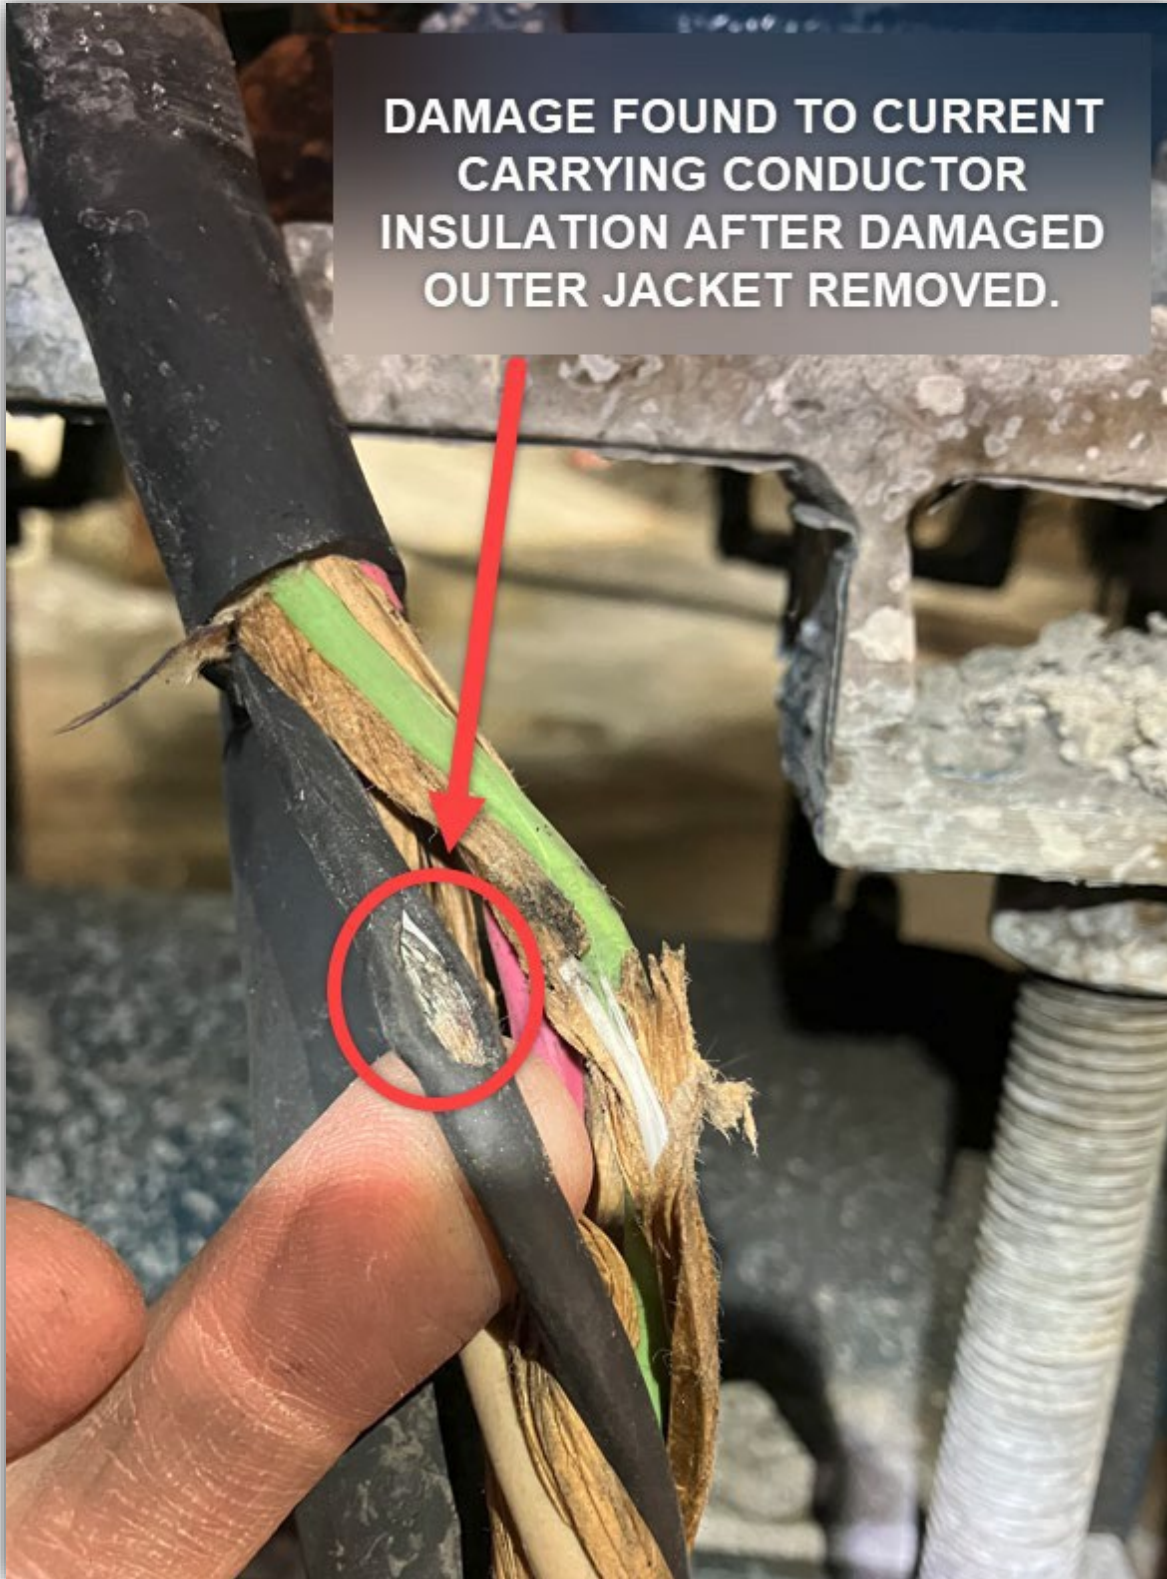
Image 4 – Damage found.
