Incident Summary #II-1655748-2024 (#42919) (FINAL)

SUPPORTING INFORMATION	Incident Date	December 21, 2023	
	Location	Penticton, BC	
	Regulated industry sector	Gas - Natural gas system	
	Impact	Qty injuries	0
		Injury description	N/A
		Injury rating	None
	Damage	Damage description	Melted boiler controls, Melted insulation on adjoining piping
		Damage rating	Minor
	Incident rating	Minor	
Incident overview	An atmospheric boiler overheated causing it to overheat and melt its controls and the insulation on the piping connected to it.		
INVESTIGATION CONCLUSIONS	Site, system and components	<p>When a boiler receives a call for heat it begins an ignition sequence where gas is supplied to burners through a metering orifice in an open-air venturi where it is entrained with air and burnt. The products of combustion pass over a collection of tightly interconnected, finned pipes called a heat exchanger. This flow of hot products of combustion heats the heating medium within to provide space or process heating down the line. The products of combustion then exit the boiler and building through the venting system. This flow of products of combustion over the heat exchanger and out the venting sys

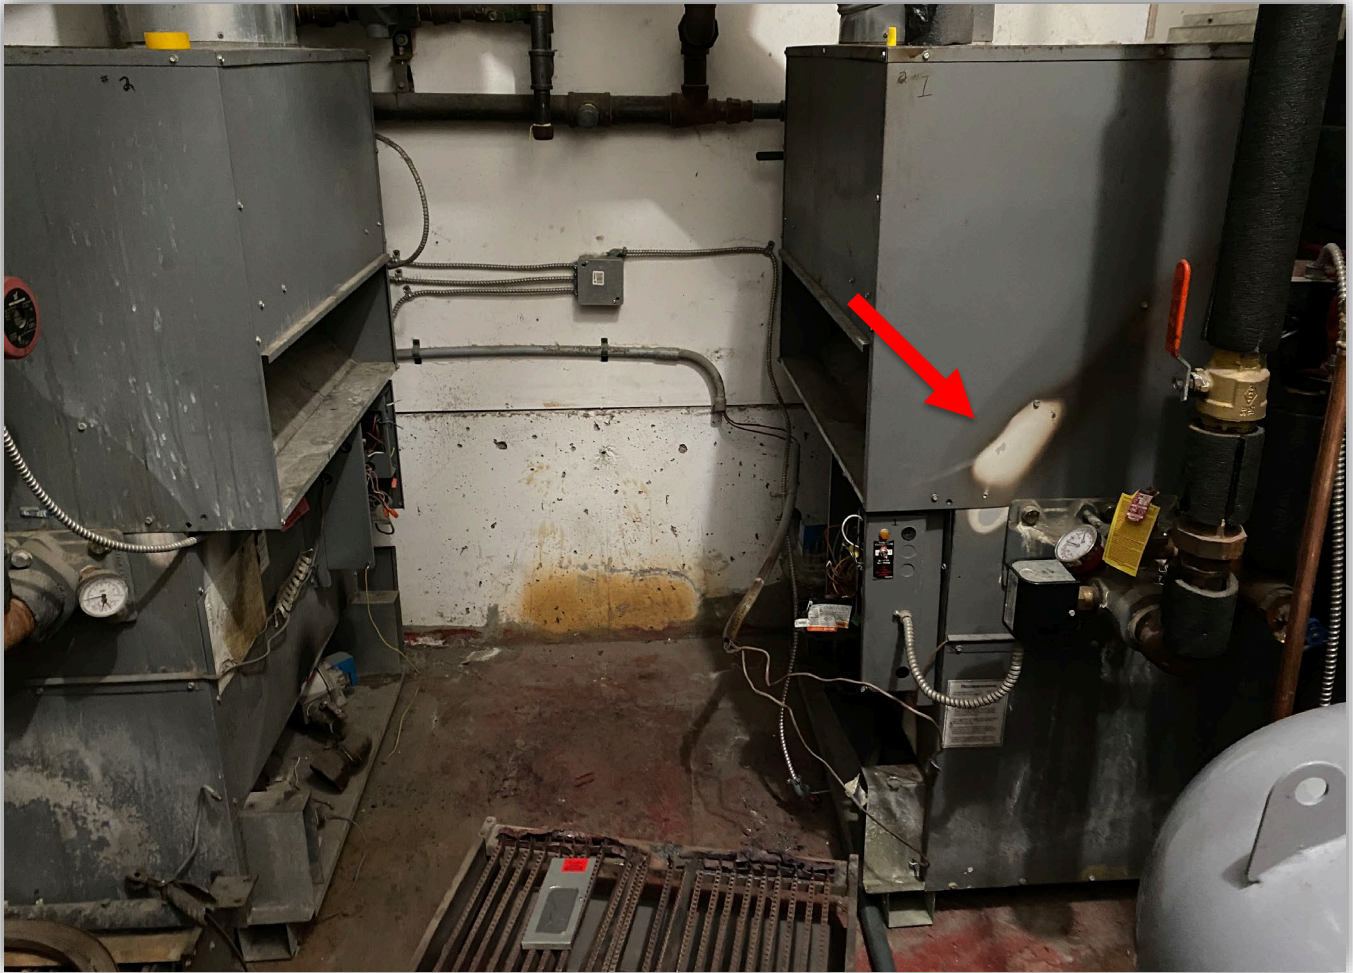
Image 1 - Scene when Safety Officer arrived on site. Arrow indicates hot spot found on side of boiler.

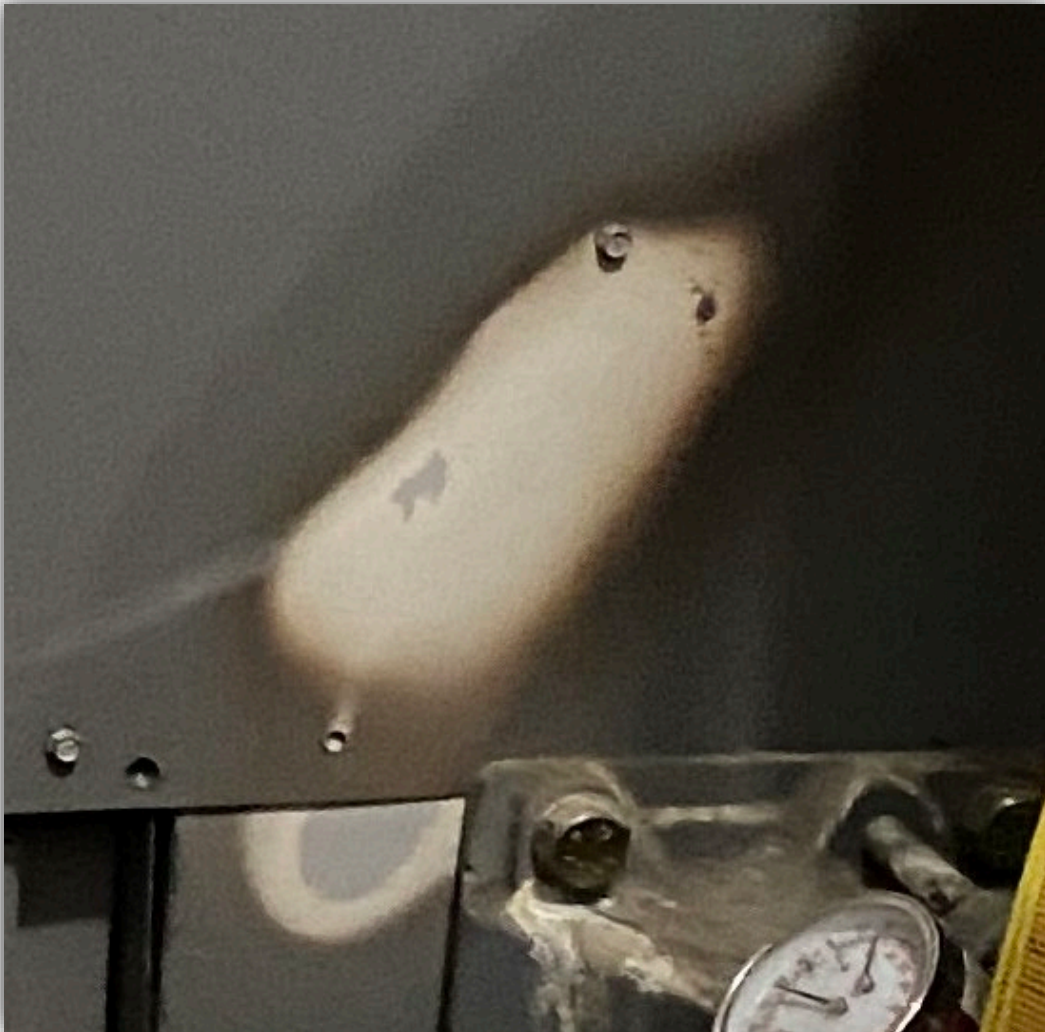
Image 2 – Close up of hot spot on the side of the boiler where flames became trapped in boiler sheet metal.

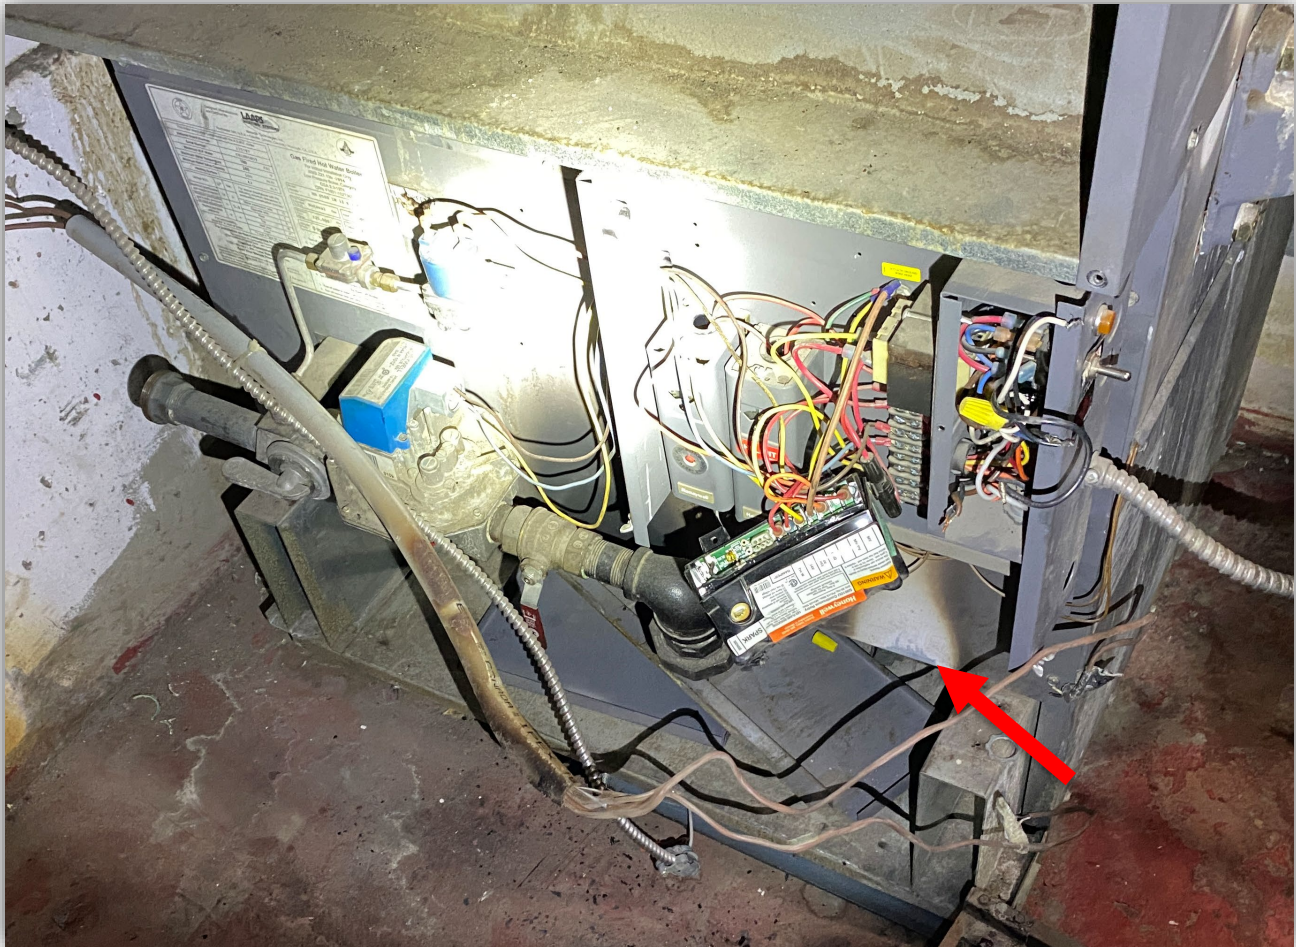
Image 3 - Front of boiler at time of investigation. Arrow indicates area where flames were found exiting the boiler.

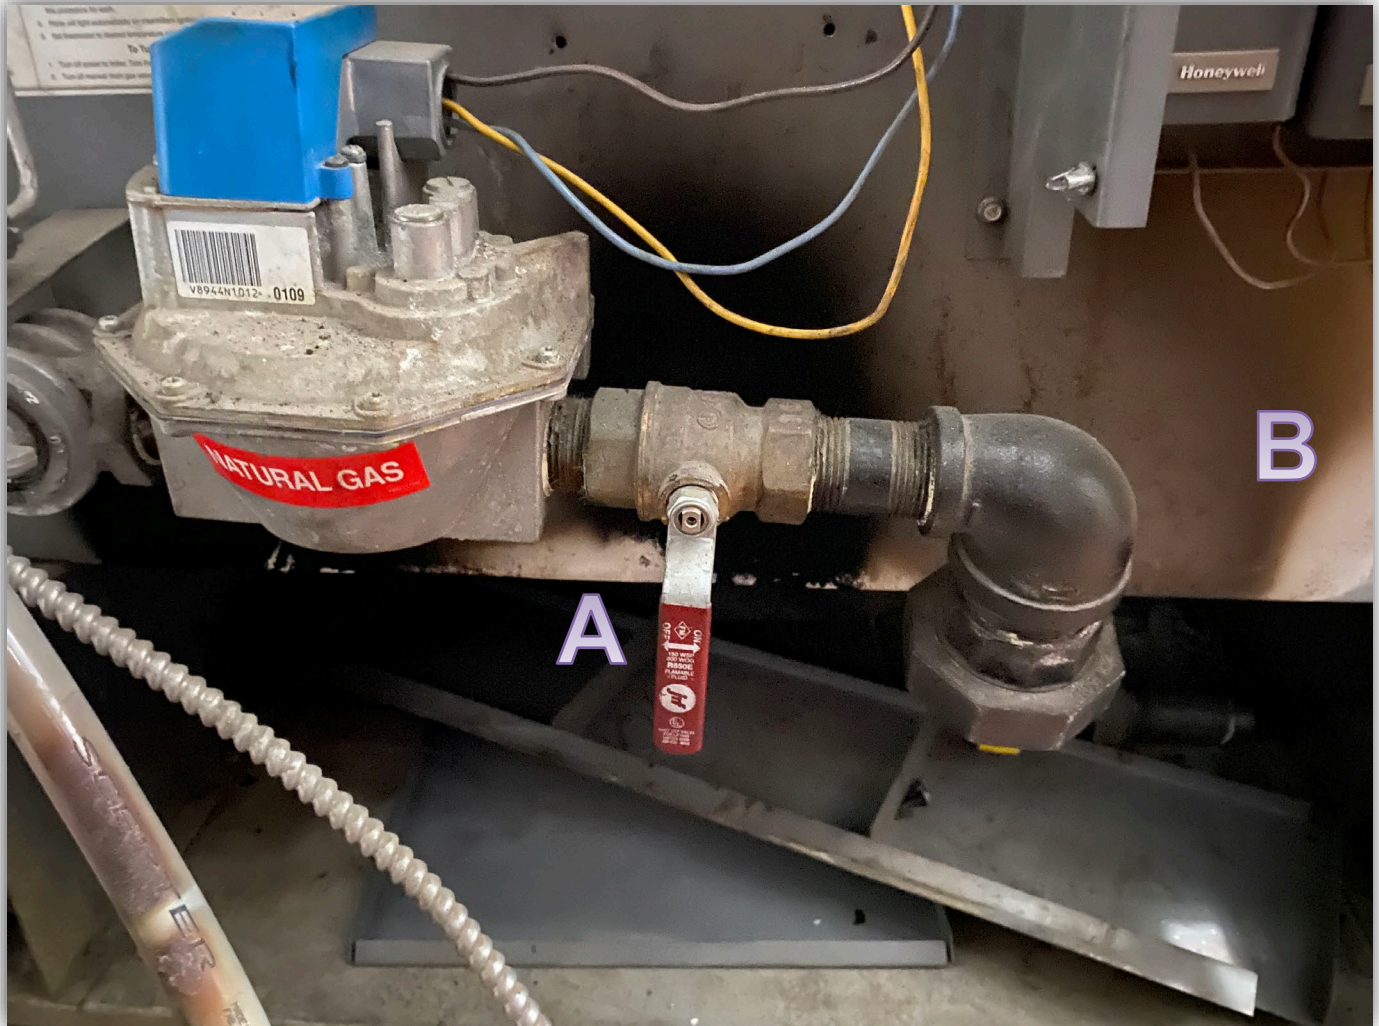
Image 4 - Boiler gas valve and combustion chamber at time of investigation. **[A]** Area where flame rollout was occurring. **[B]** Area where flames were seen exiting boiler.

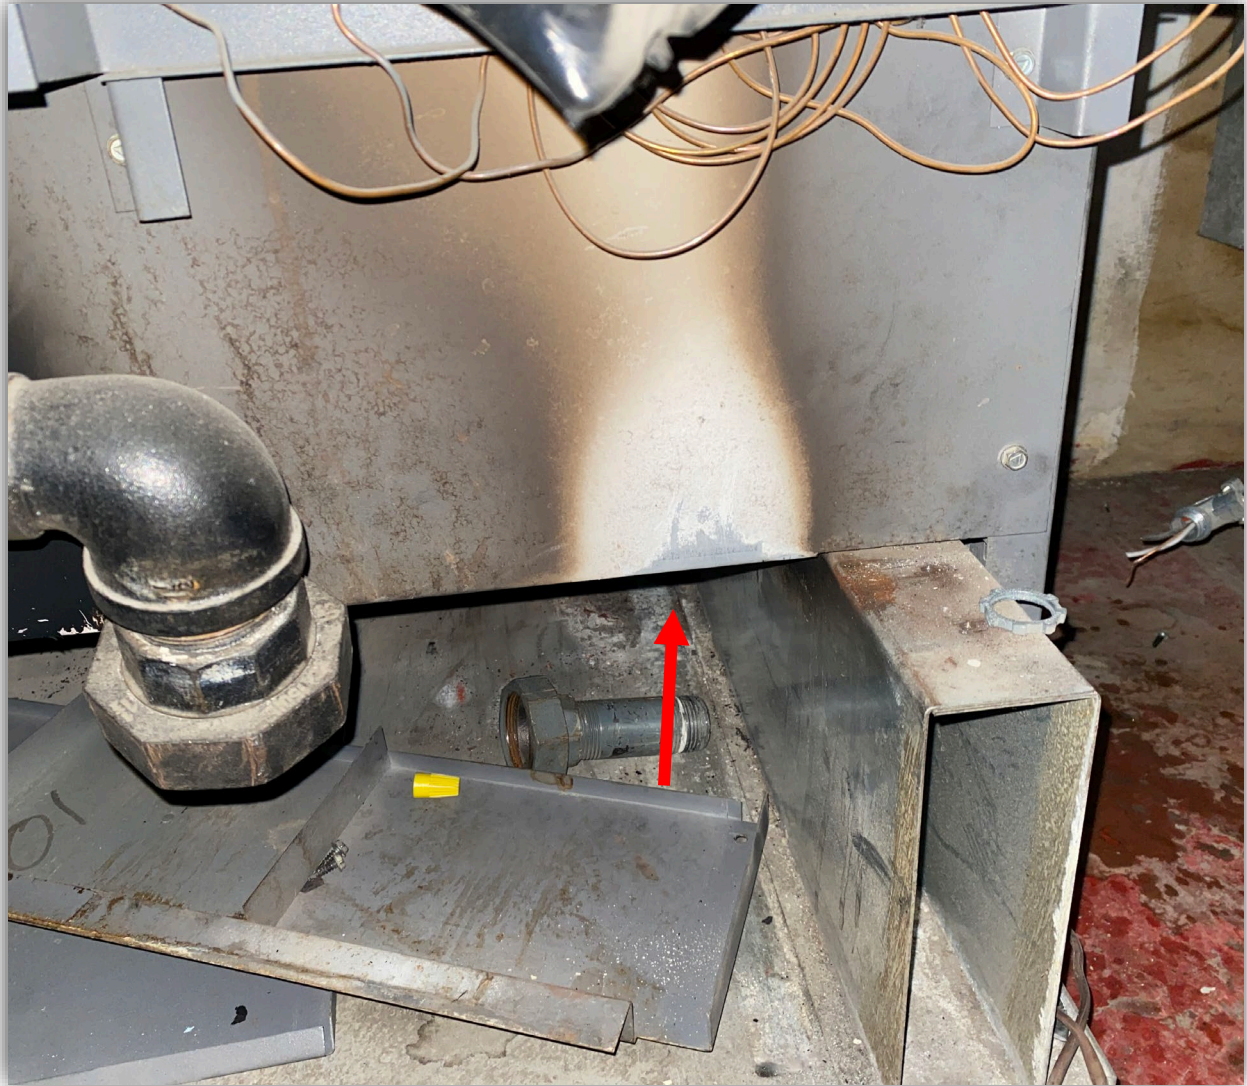
Image 5 - Boiler combustion chamber showing burn path where flames were found exiting the boiler.

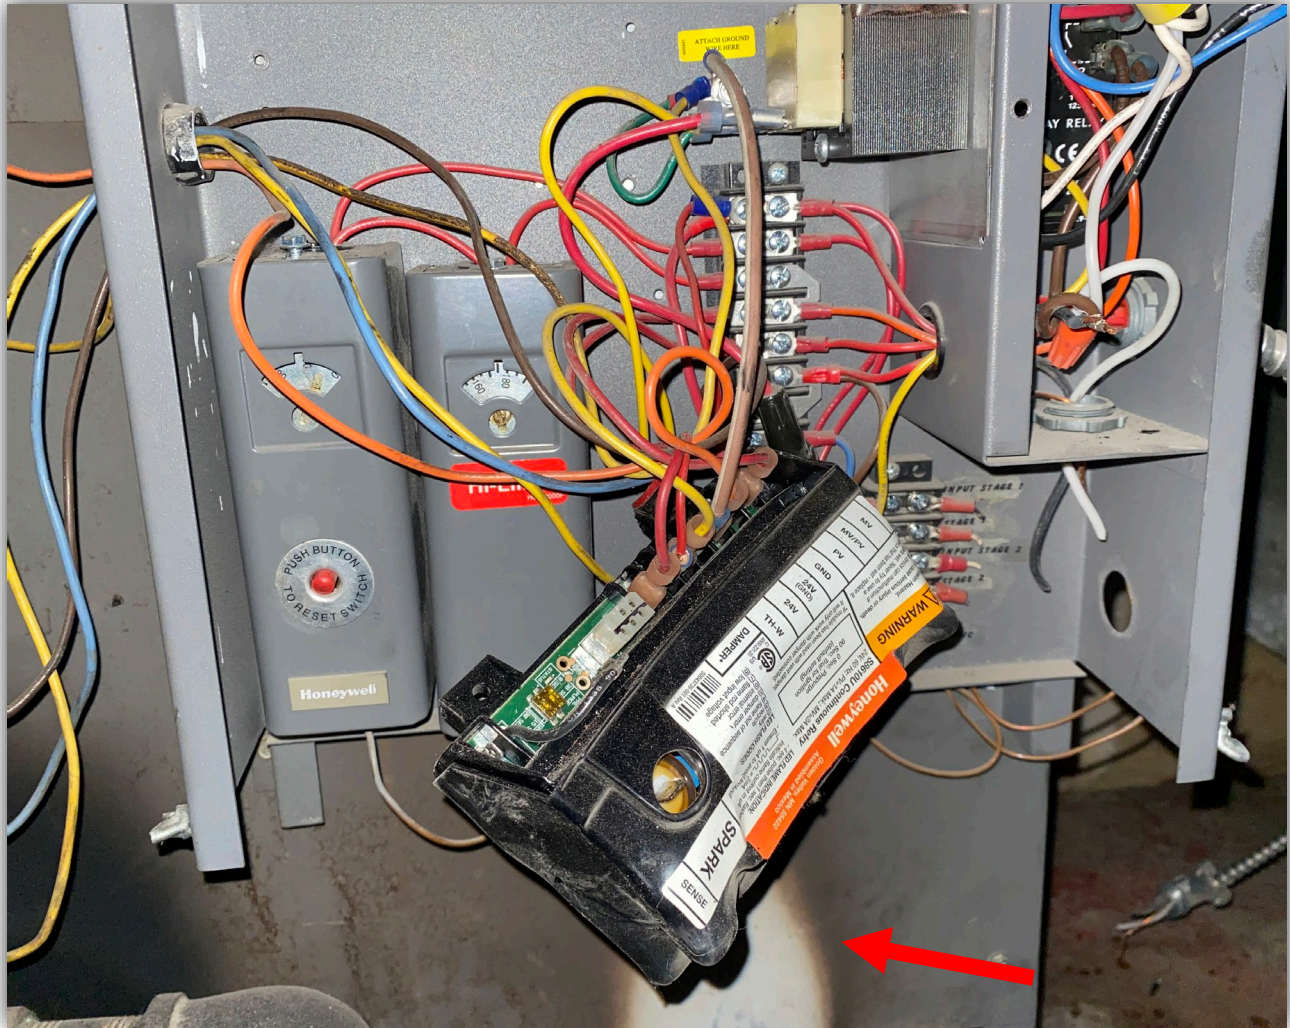
Image 6 - Melted ignition control box, arrow indicates where flames were exiting boiler travelling behind control panel.

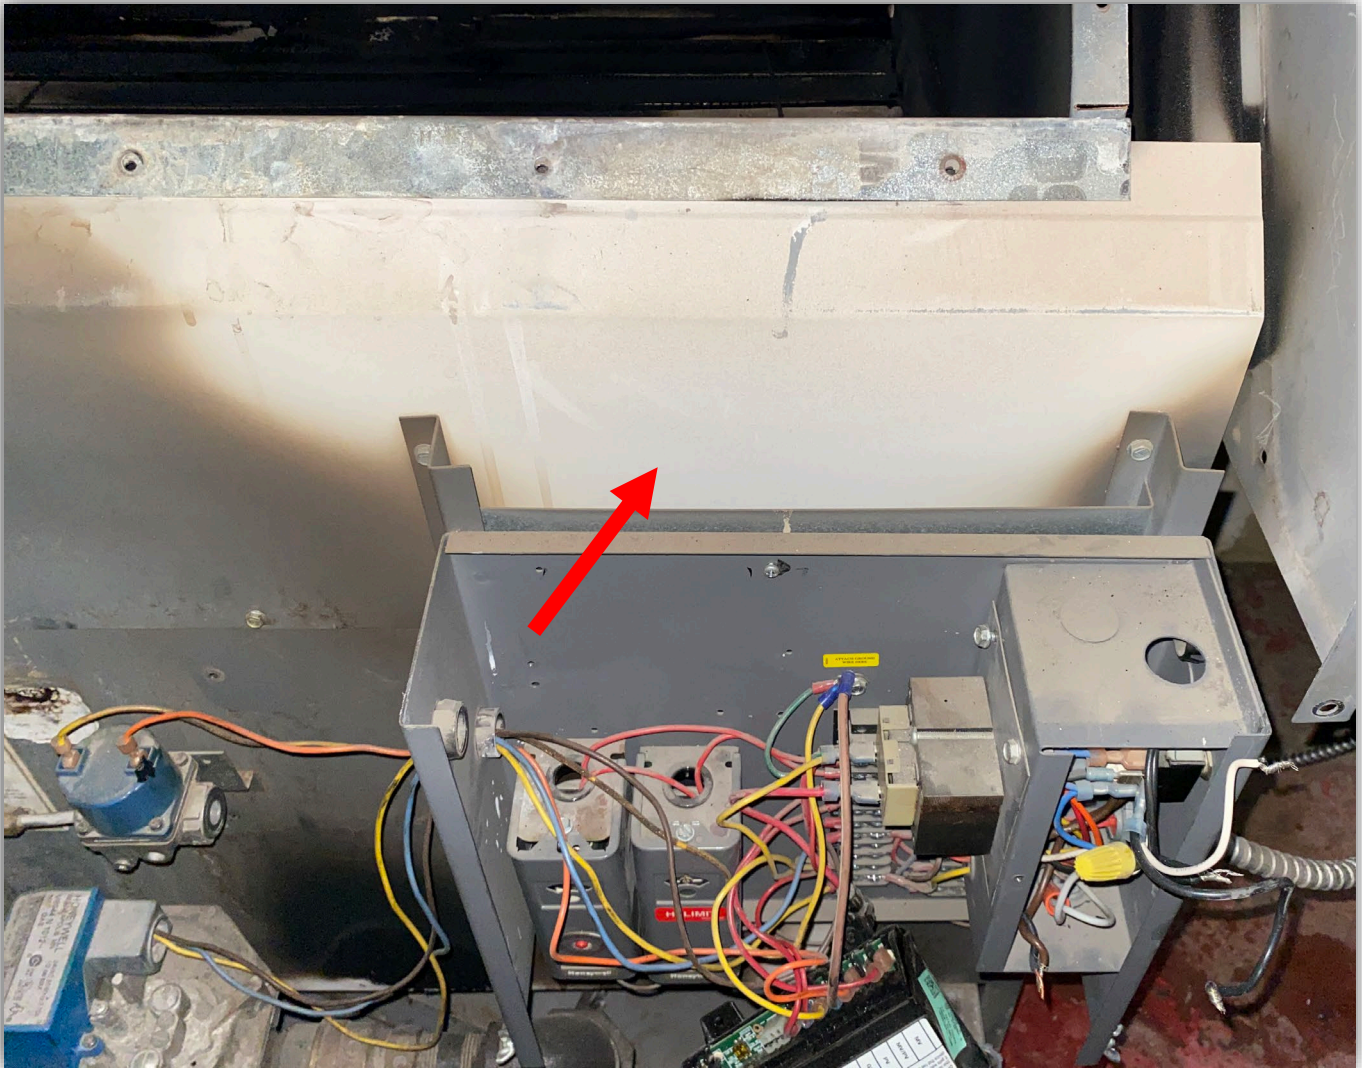
Image 7 - Top side of control panel, arrow indicates where flames came up behind control panel and became trapped in boiler sheet metal.

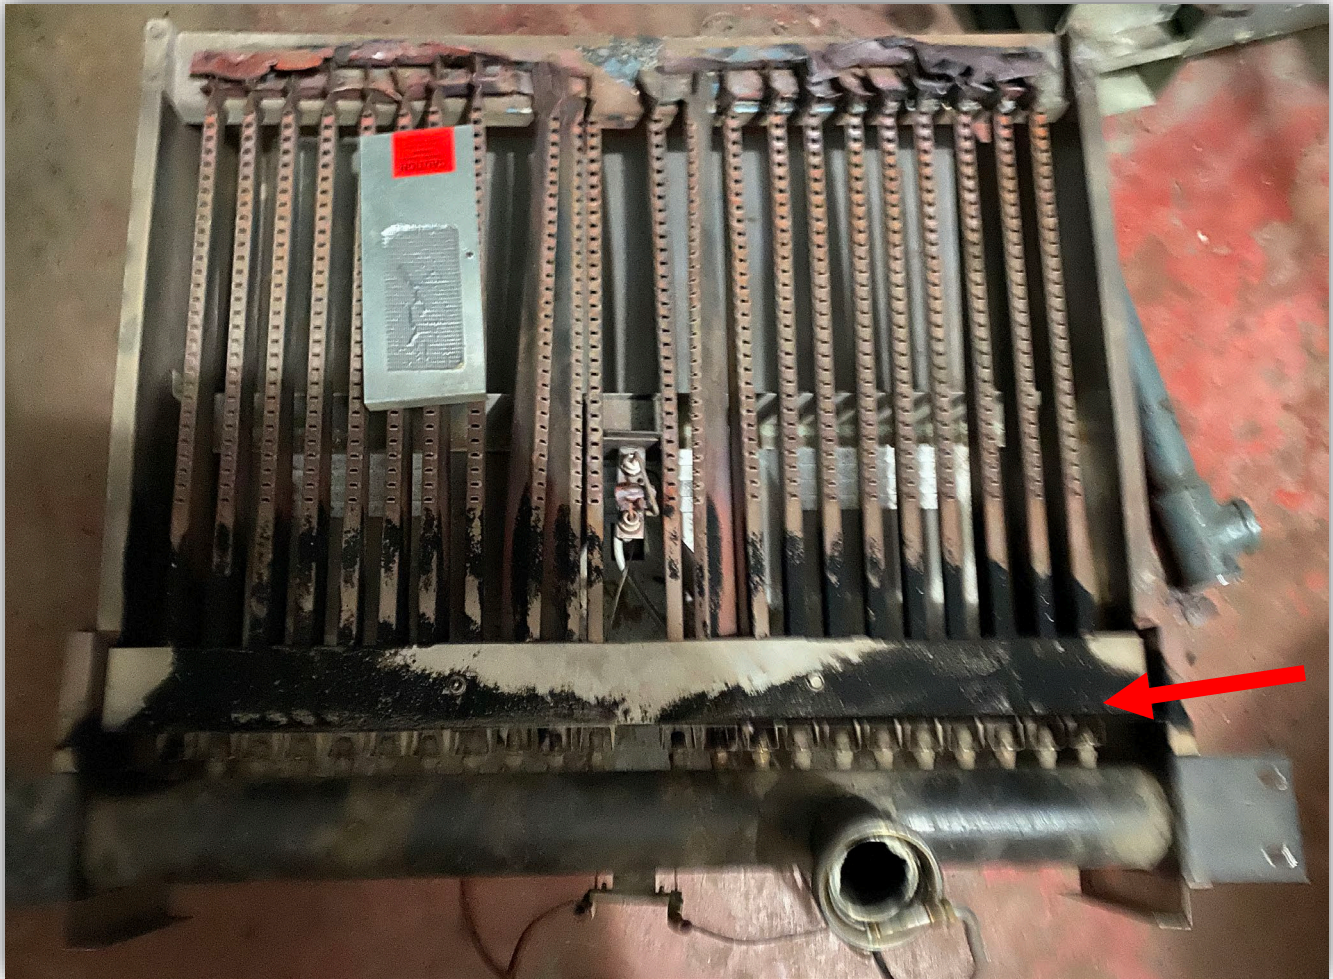
Image 8 - Boiler burner tray showing sooting from poor combustion. Arrow indicates burner orifice where flames exiting the boiler are believed to have come from.

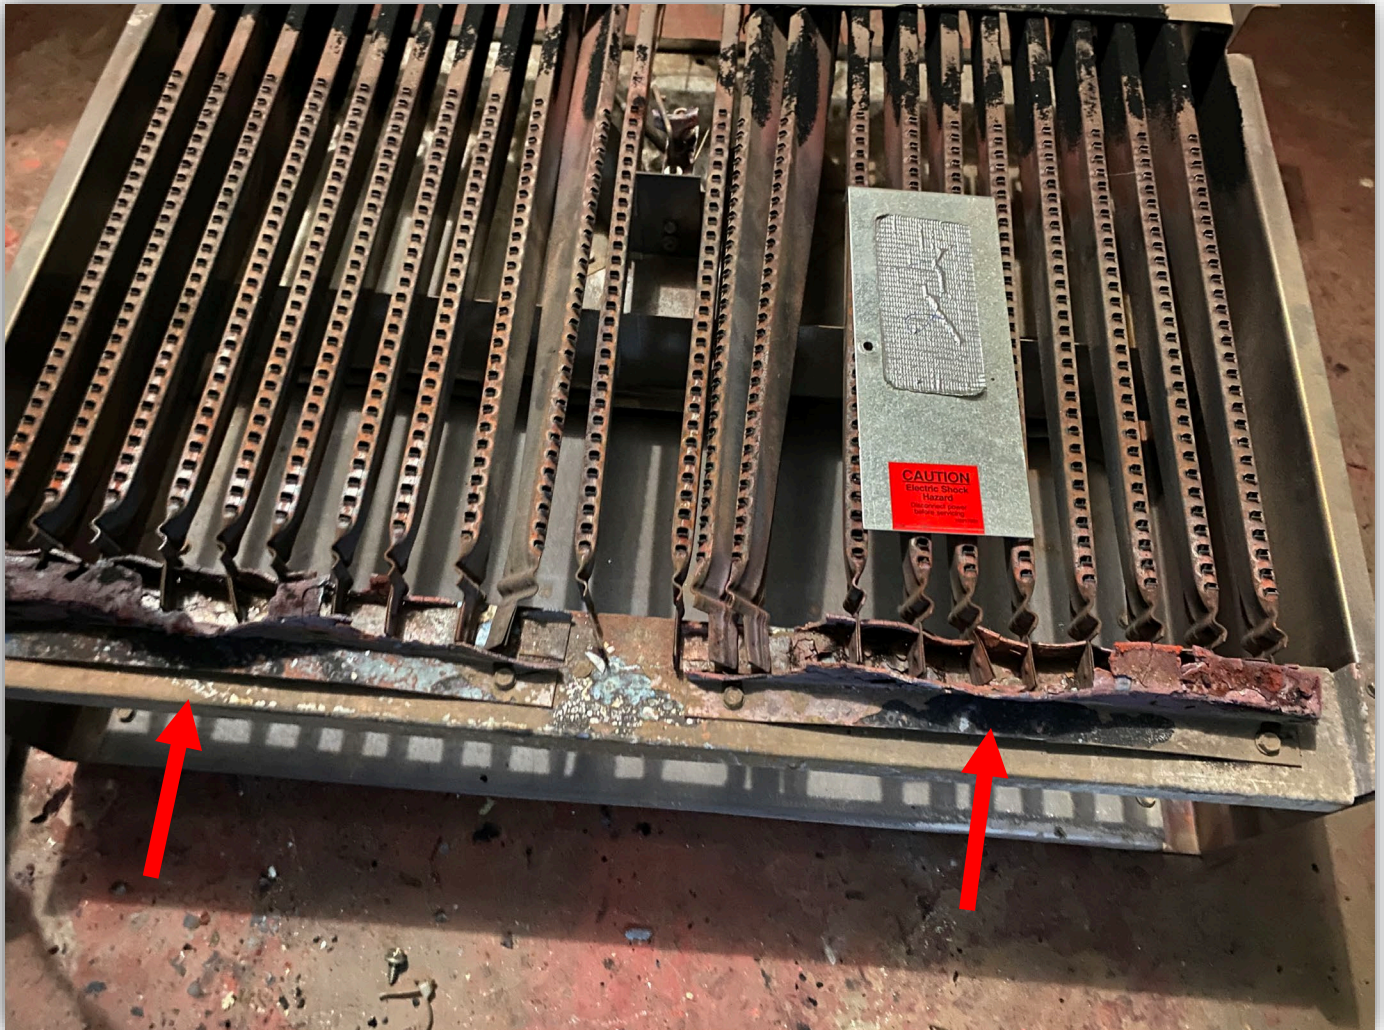
Image 9 - Interior side of burner tray. Arrows indicate where metal was deformed and destroyed by extreme heat within the combustion chamber. *Note: Burner tray was removed from appliance before investigation so burners may not be in the same orientation as when the incident occurred.*

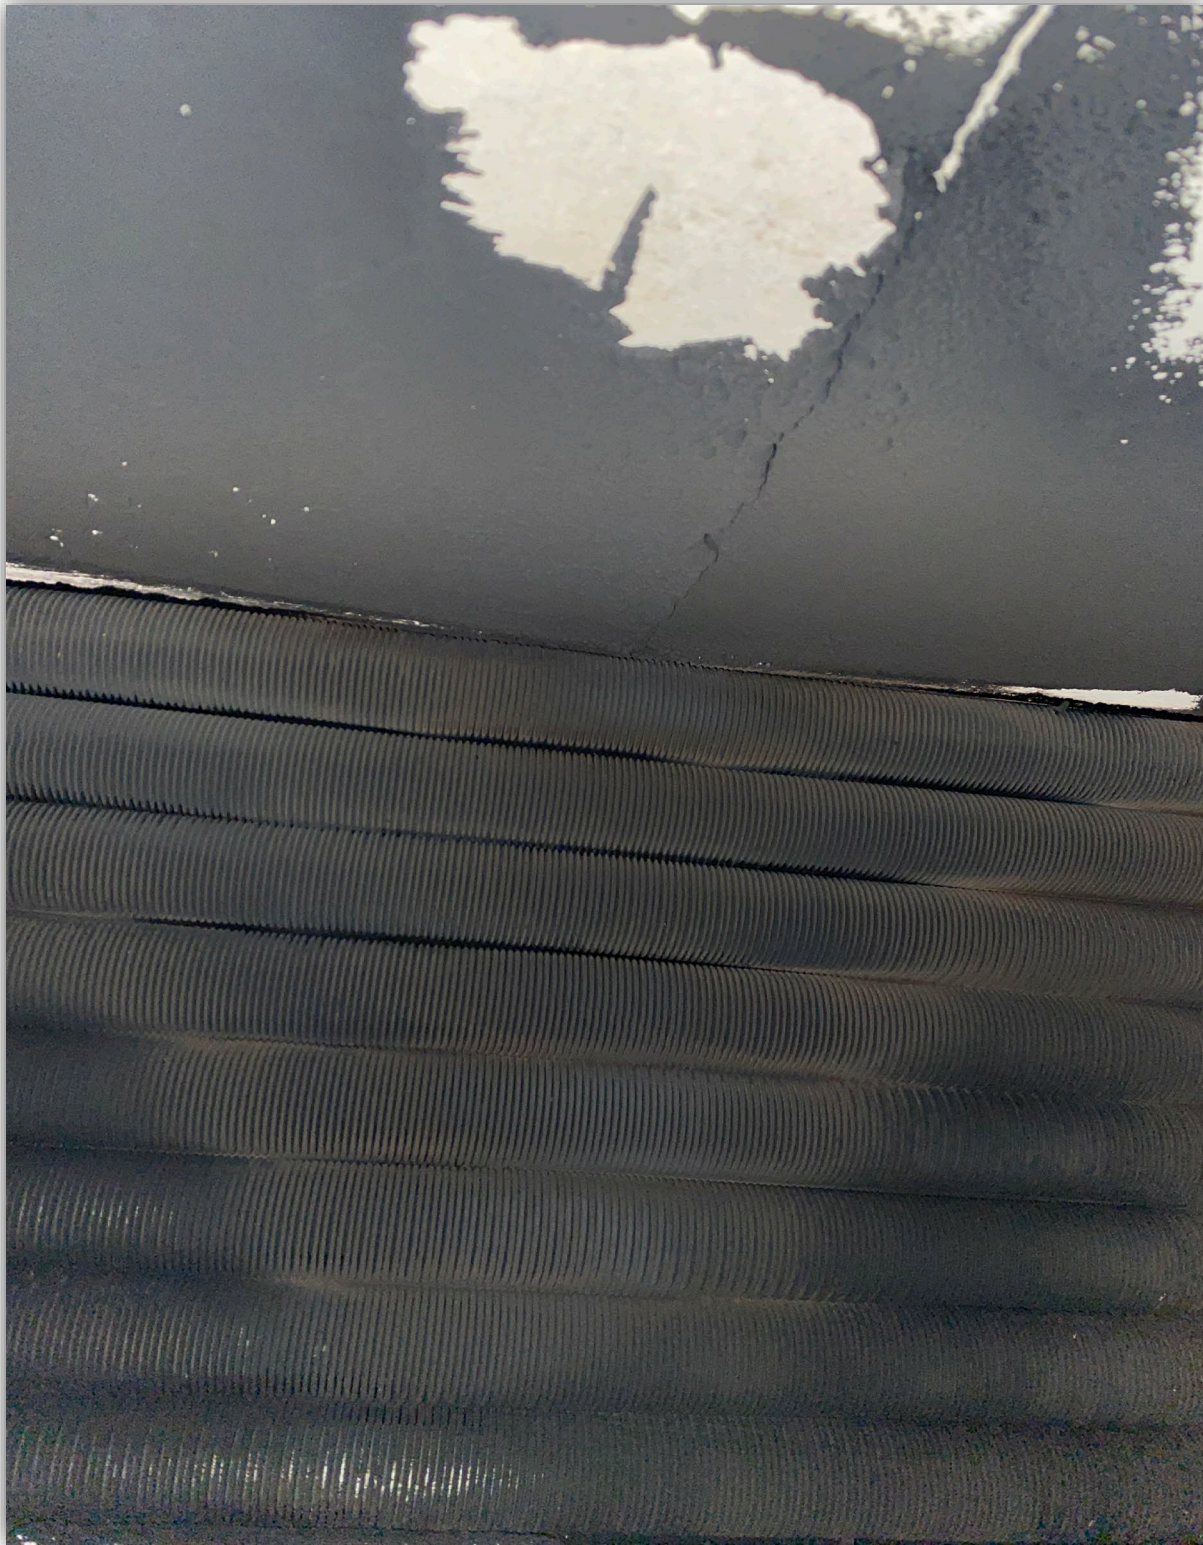
Causes and contributing factors	It is highly probable that a lack of maintenance to the boiler's heat exchanger allowed the boiler's heat exchanger to soot up, causing flames to roll out of the combustion chamber.

Image 10 - Underside of heat exchanger showing visible sooting and plugging.

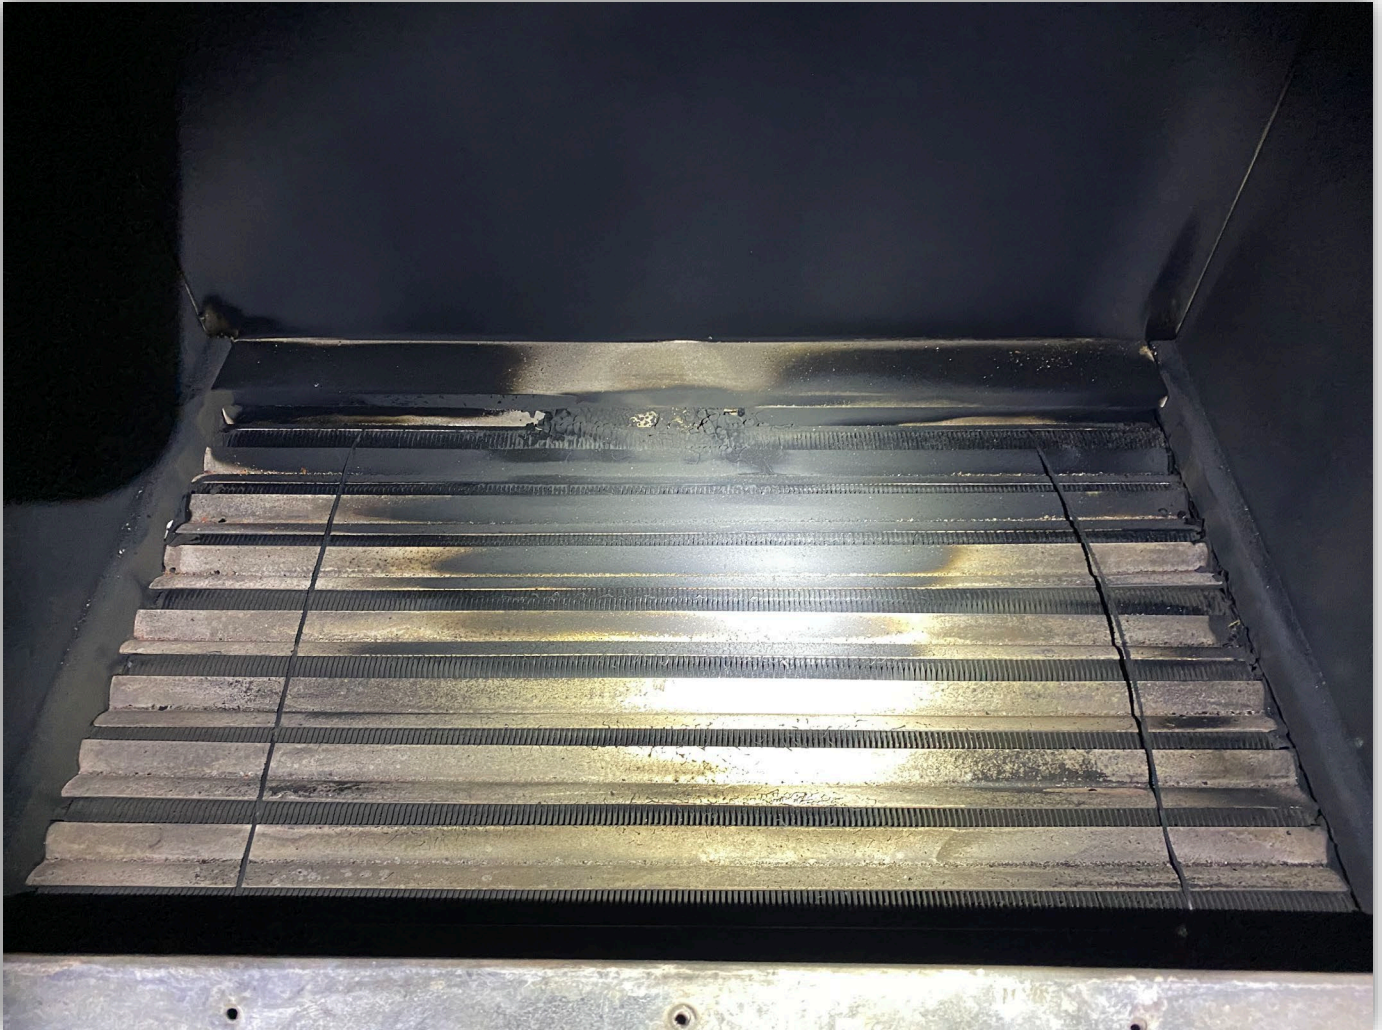
Image 11 - Top side of heat exchanger showing visible accumulations of soot causing plugging of the heat exchanger.

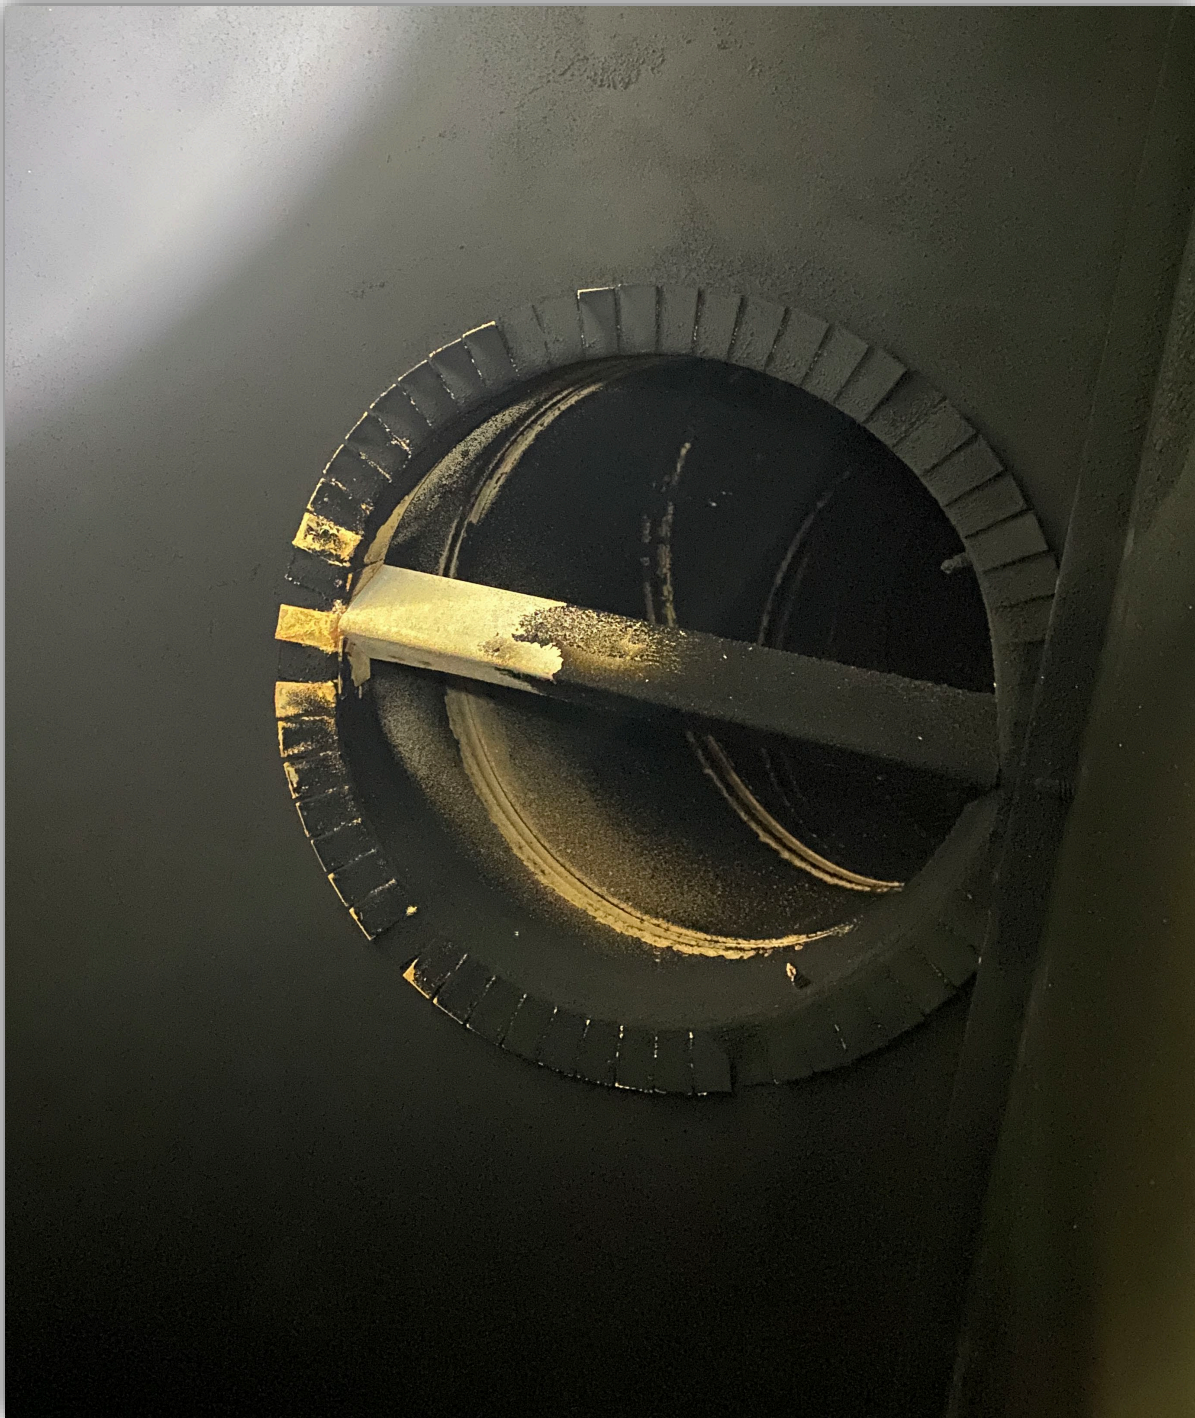
Image 12 - Boiler breeching where vent connects to the boiler showing signs of heavy sooting due to poor combustion.

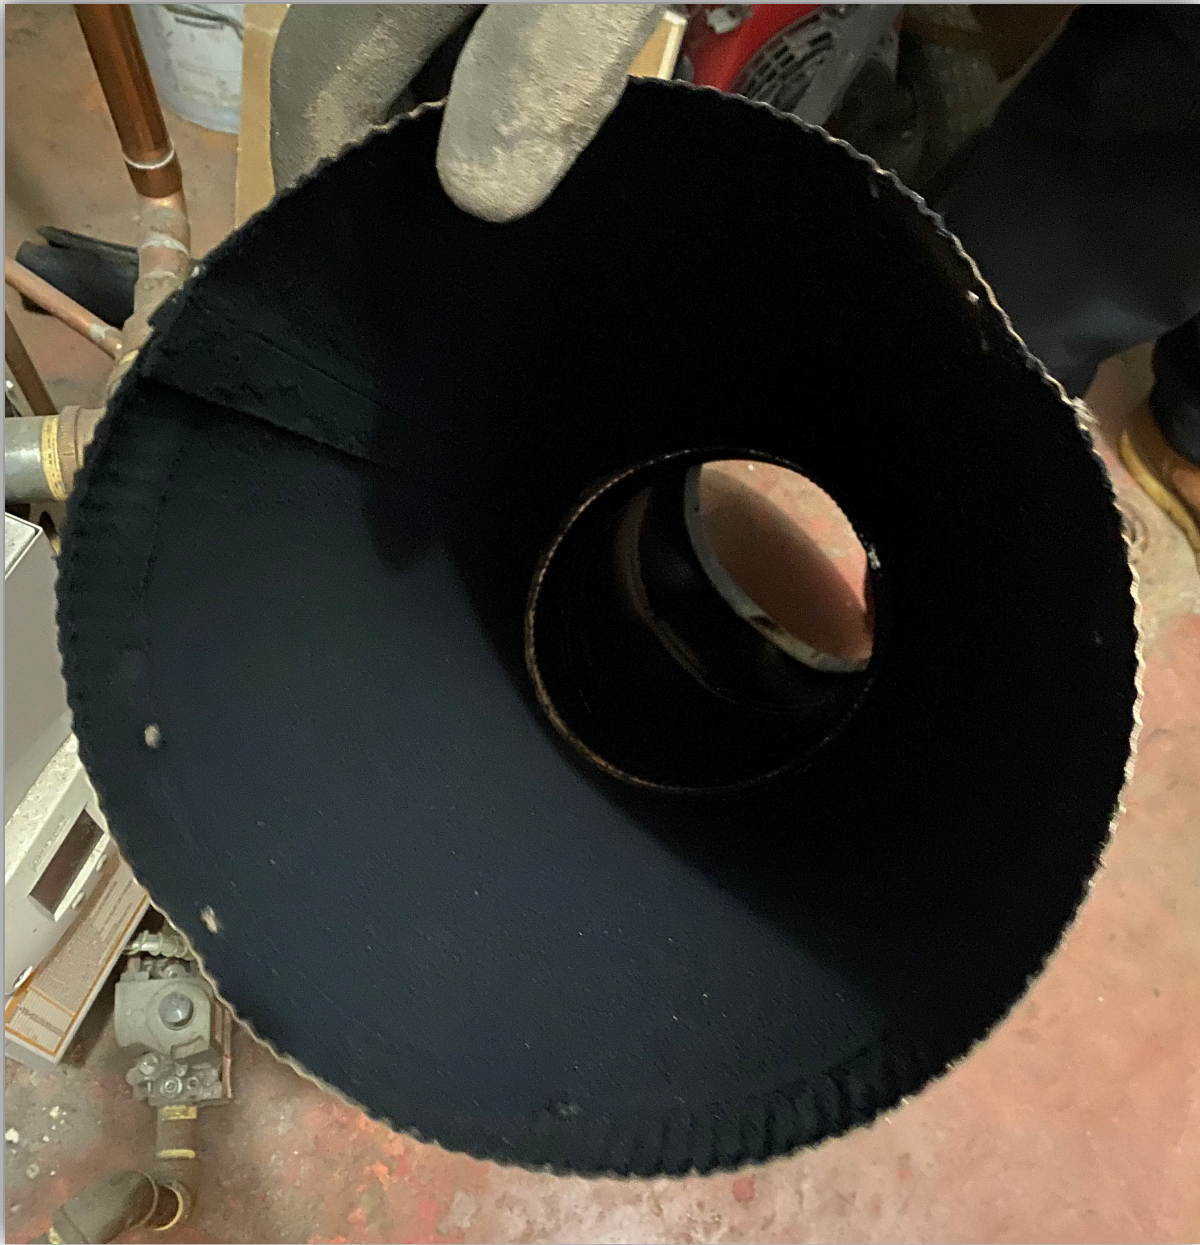
Image 13 - Interior of boiler venting showing heavy sooting due to poor combustion.

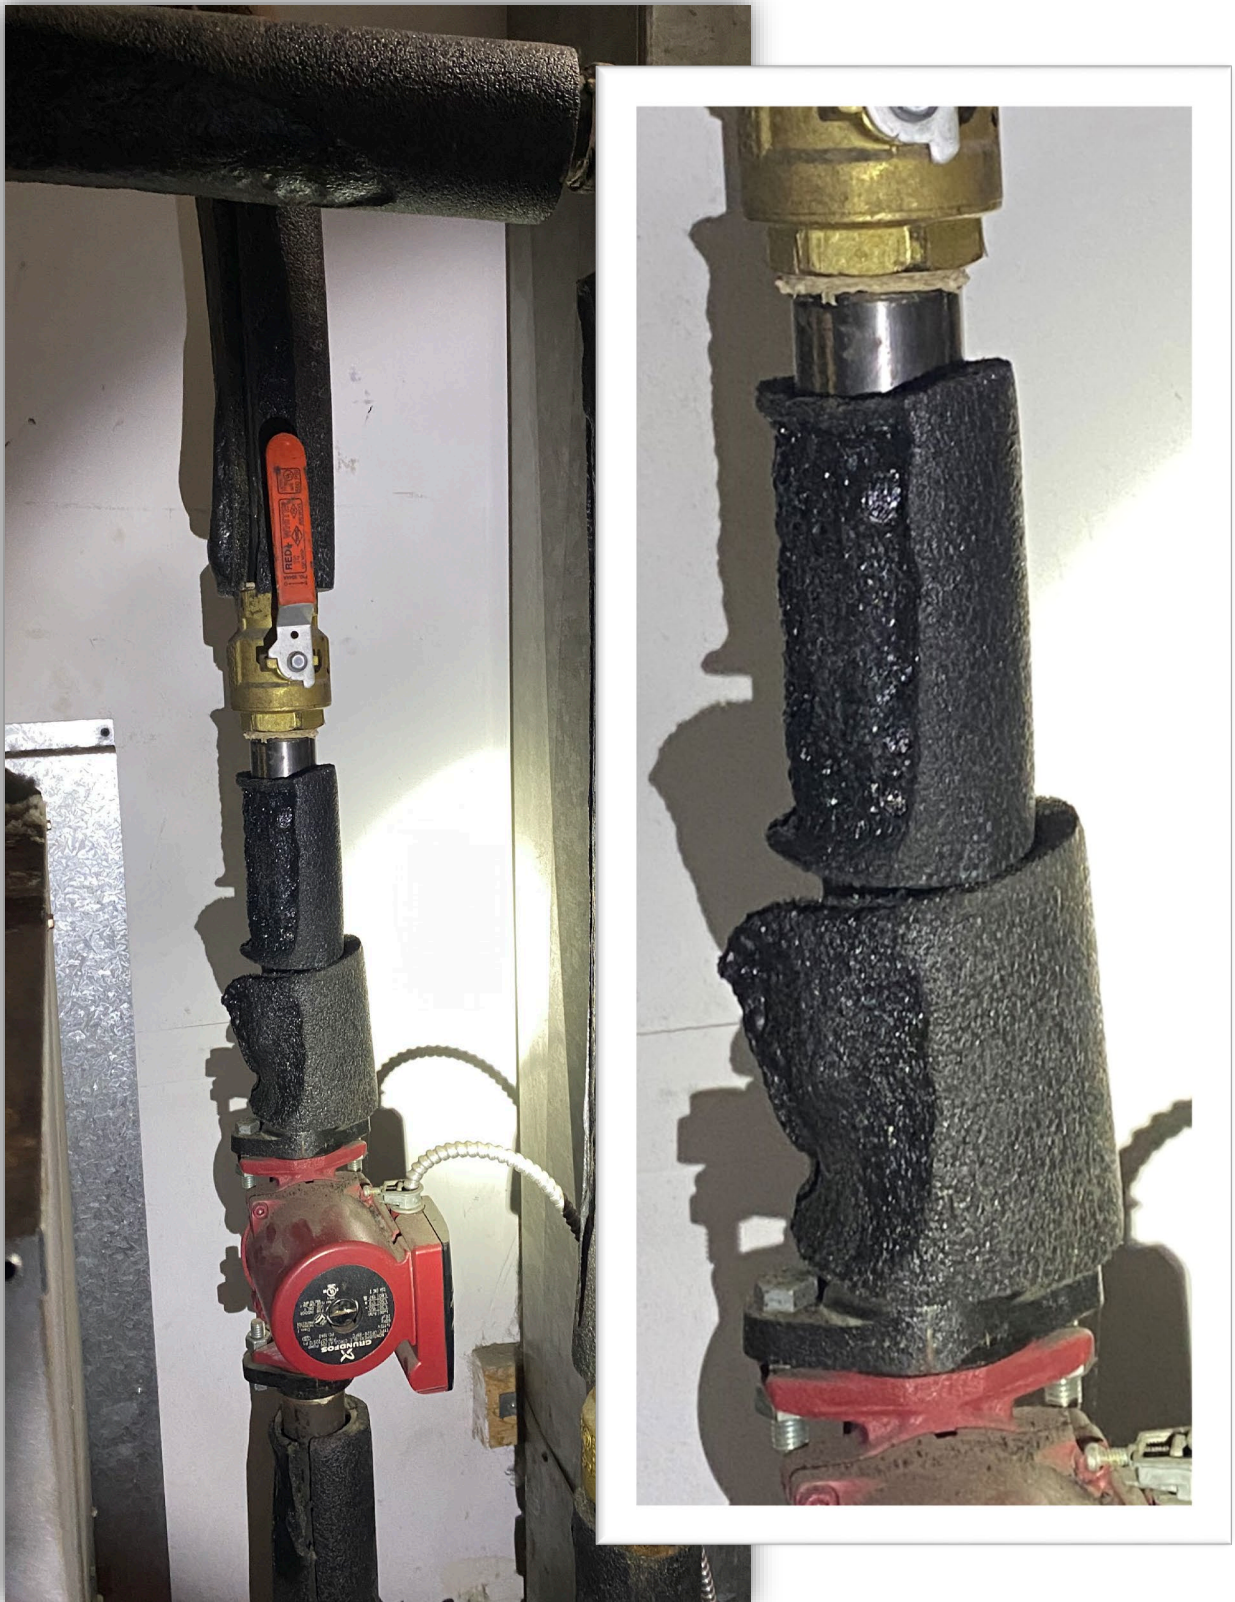
Image 14 - Boiler piping insulation, melted from heat radiated by hot spots on boiler sheet metal.

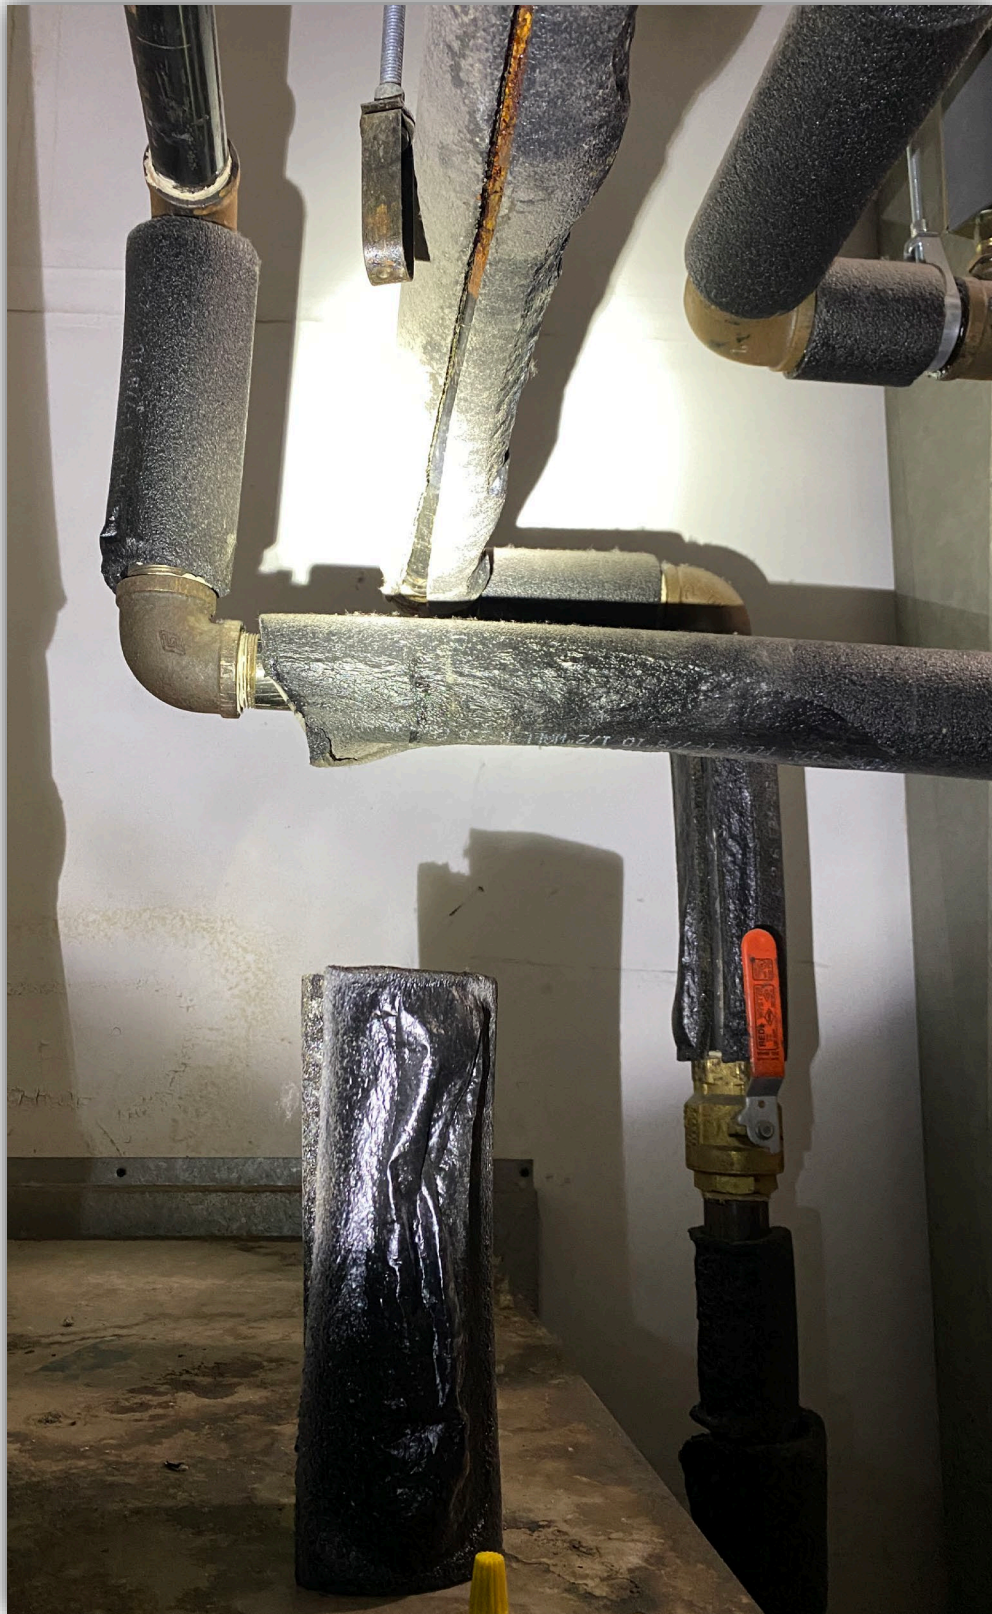
Image 15 - Boiler piping insulation melted by heat radiated from hot spots on boiler sheet metal.
