## Incident Summary #II-900379-2019 (#15064) (FINAL)

SUPPORTING INFORMATION	Incident Date	July 26, 2019	
	Location	Abbotsford	
	Regulated industry sector	Boilers, PV & refrigeration - Refrigeration system	
	Impact	Qty injuries	2
		Injury description	Two persons felt drowsy and light headed from exposure to ammonia.
		Injury rating	Minor
	Damage	Damage description	The evaporator within a refrigeration system failed and released ammonia that was intended to be contained within the evaporator and refrigeration system.
		Damage rating	Moderate
	Incident rating	Moderate	
	Incident overview	The evaporator within a refrigeration system of an industrial food processing facility failed and released ammonia in a cold storage room. Two workers suffered minor symptoms as a result of exposure to the released ammonia.	
INVESTIGATION CONCLUSIONS	Site, system and components	<p>Ammonia refrigeration systems are typically designed for maximum allowable working pressure of 250 psig on high pressure side and 150 psig on low pressure side. The refrigeration cycle contains four major components: compressor, condenser, evaporator and expansion devices. Refrigerant remains piped between these four compon

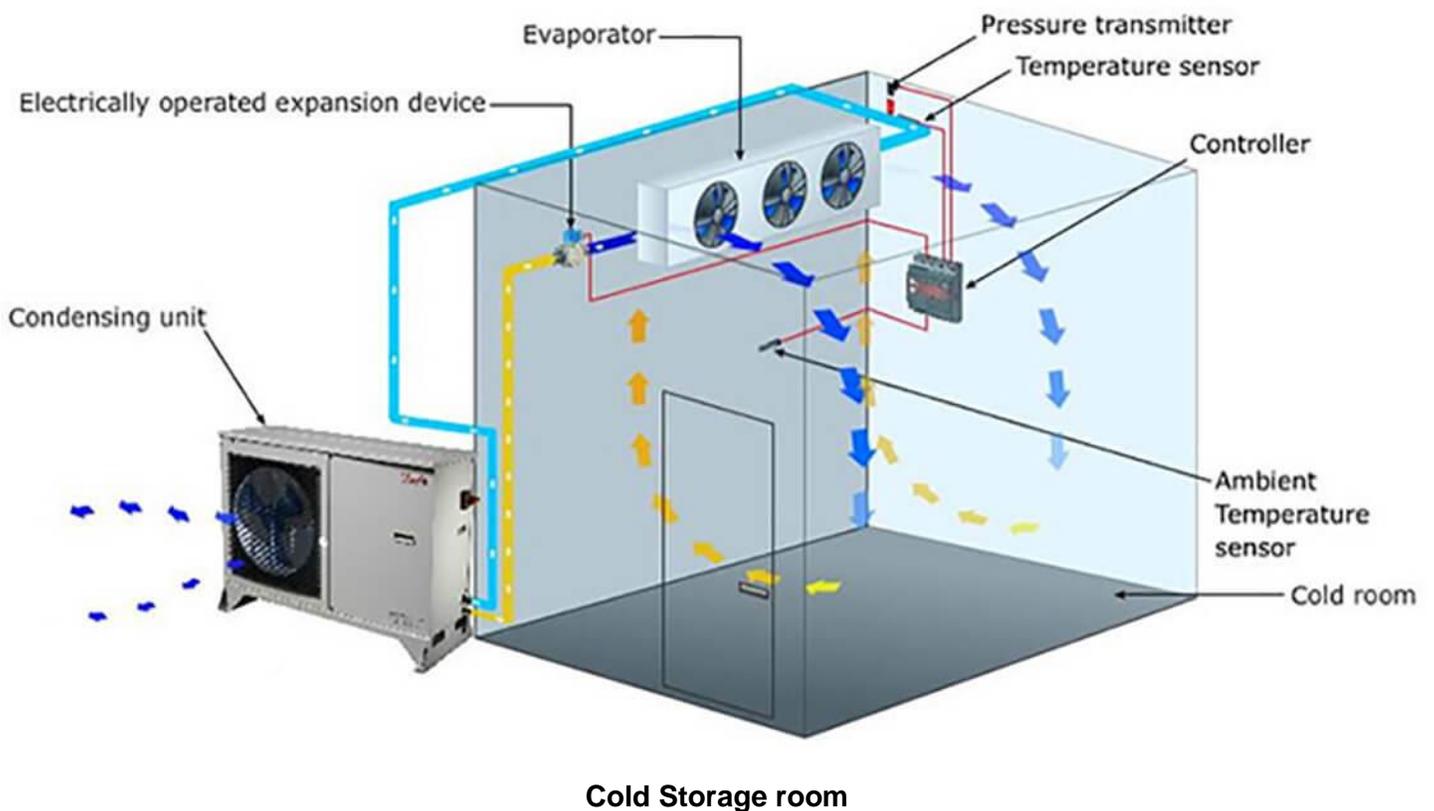
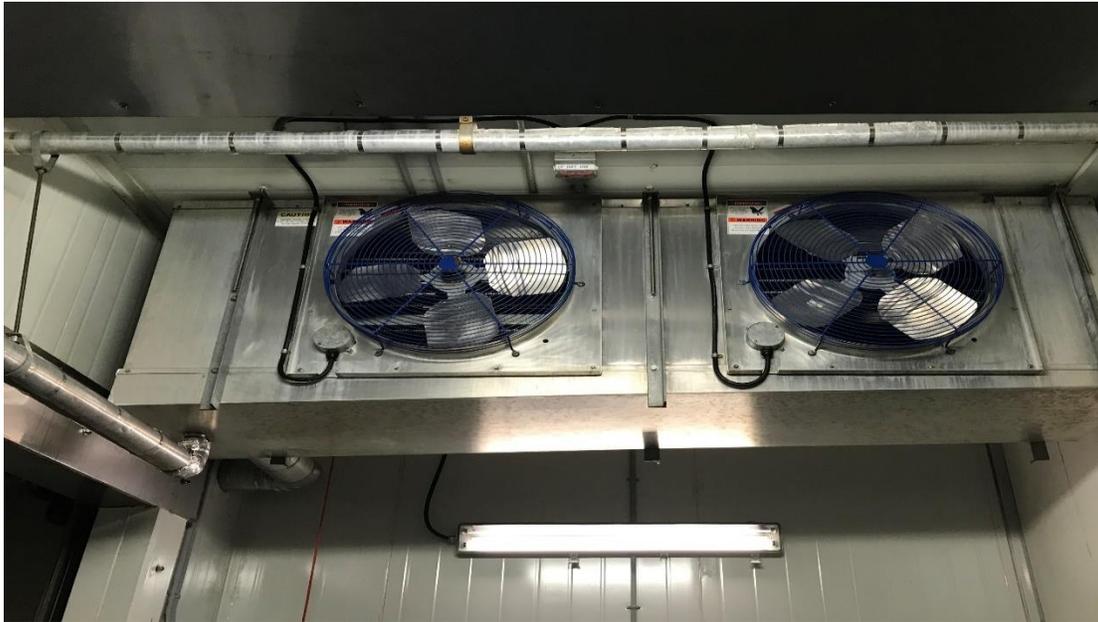
**Evaporator**

It is very likely that the evaporator failed because it was running for an extended period of time as the evaporator was meant to quickly chill small amounts of product rather than a large area, and resulted in a heavy frost built up on the surface of evaporator. Defrosting by using hot gas may have caused uneven heating and cooling of evaporator tubes, or thermal expansion and contraction of evaporator tubes and joints, which may have resulted in a damage inside the evaporator and resulted in an ammonia release.
