Incident Summary #II-1307372-2021 (#25577) (FINAL)

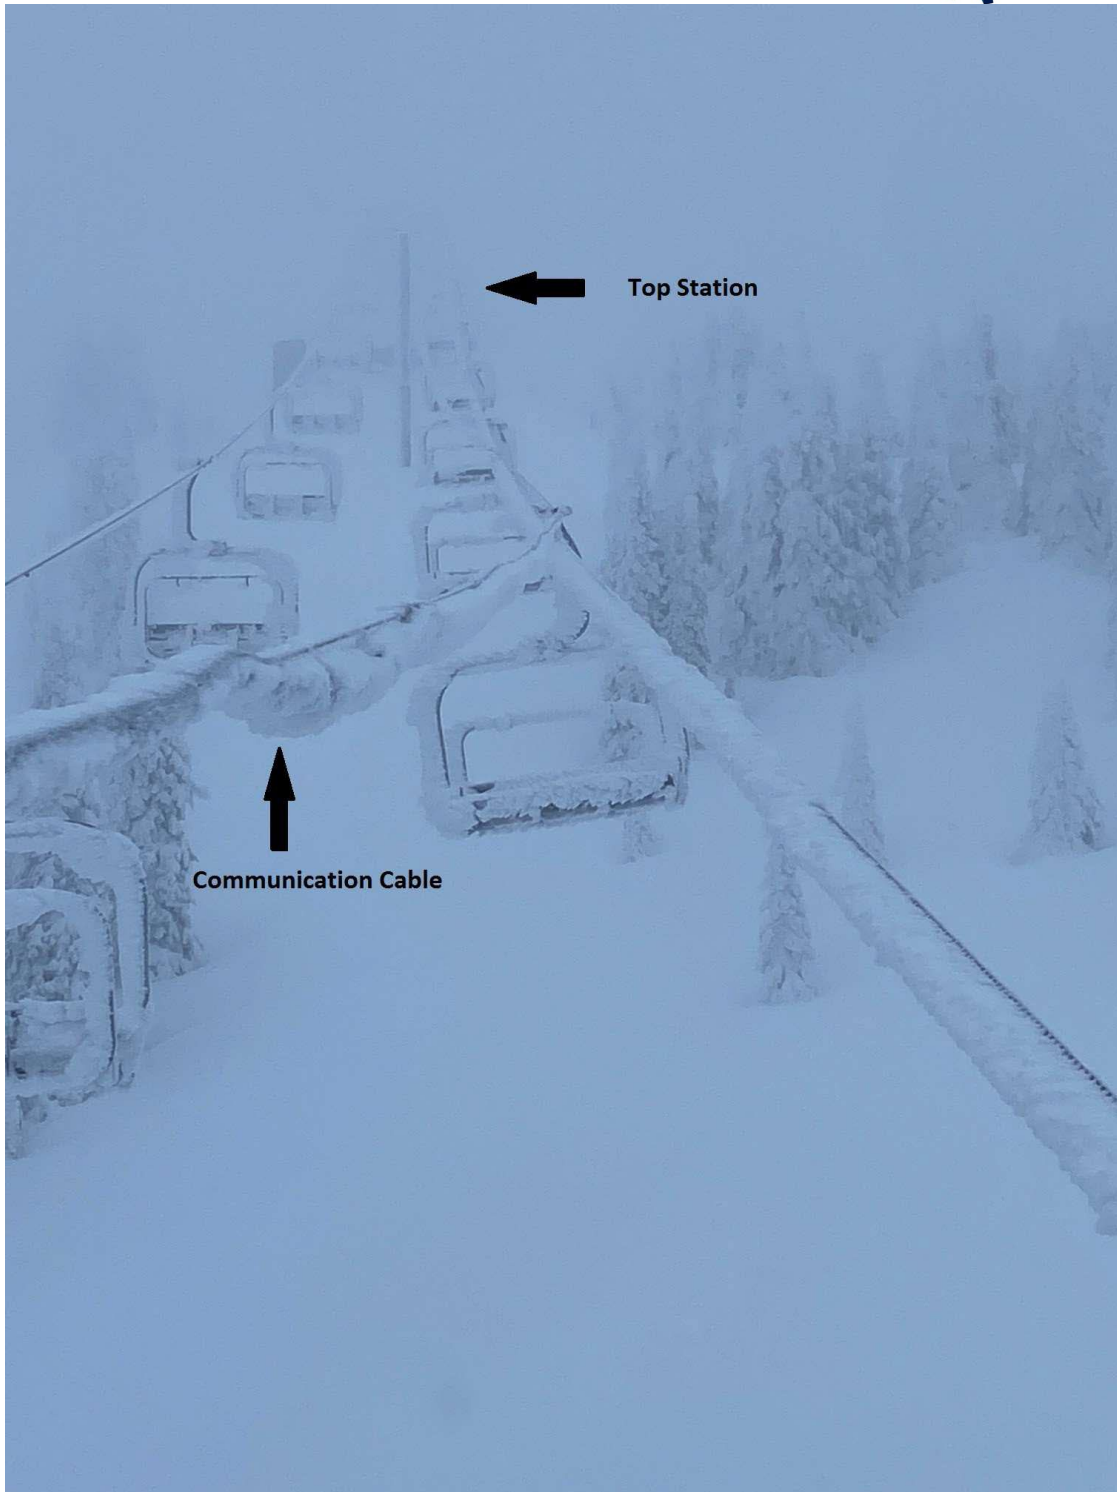
<ul style="list-style-type: none"> • The tower span where the communication cable and grip were entangled is the longest on lift line • Communication cable is fastened offset on the downhill side of the tower to the upper cross-member of the tower lifting frame • Build-up on communication cable makes the line sag more than usual • Crews did not visually inspect complete lift line prior to operating the ropeway • Ropeway had a clear safety system until deropement • Maintenance personnel inspected haul rope along with the tower & sheave assembly after deropement
<p>Causes and contributing factors</p>	<p>It is certain that the communication cable entangled on a downhill travelling grip of a carrier caused the haul rope to derope to the inside of a tower sheave assembly.</p> <p>The current and previous days weather conditions, followed by not visually inspecting the lift line before starting the ropeway are contributing factors.</p>

Image 1 - Communication cable hooked on grip of downhill travelling carrier.
