Incident Summary #II-1056017-2020 (#19079) (FINAL)

SUPPORTING INFORMATION	Incident Date	April 26, 2020	
	Location	Courtenay	
	Regulated industry sector	Electrical - Low voltage electrical system (30V to 750V)	
	Impact	Qty injuries	0
		Injury description	NA
		Injury rating	None
	Damage	Damage description	Electrical service panel fire
		Damage rating	Minor
	Incident rating	Minor	
Incident overview	On April 26, 2020 the owner of a dwelling went into his detached shop and found the main electrical panel on fire, as well as the plywood wall above the panel. The owner turned the main breaker off and used a fire extinguisher to put the fire out.		
INVESTIGATION CONCLUSIONS	Site, system and components	<p>Components:</p> <ul style="list-style-type: none"> • Main 240V 200A combination panel • 30A 2-pole breaker • Construction heater – 4800W 240V • #10/2 NMD-90 wire <p>Normal Operation:</p> <p>An approved electrical panel uses breakers that are approved by the manufacturer to be used within it. The breakers are designed to trip under a fault or overload condition. The 4800W heater would draw 20A on a 30A breaker</p>

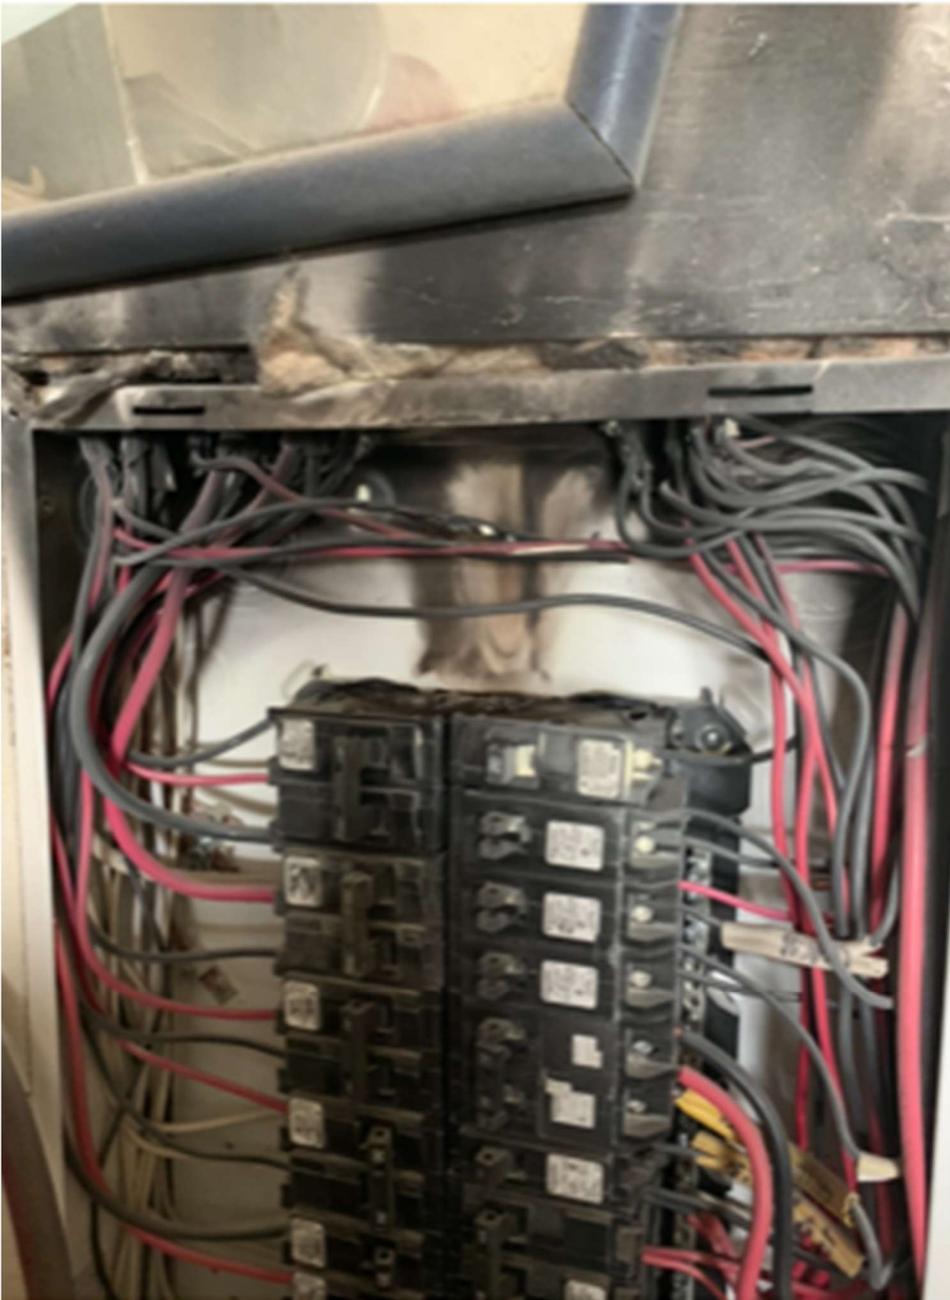
<p>Causes and contributing factors</p>	<p>The cause of this incident was very likely due to the overheating of the 4800W construction heater circuit, where the 30A breaker makes contact with the panels buss.</p> <p>It is very likely that because the 30A breaker installed was not approved for use in this panel, that the proper mechanical and electrical contact wasn't achieved. Although the heater had been installed for 6 years it was only used a few times; and therefore, probable that each time this substantial load was used, the electrical connection became worse until failure.</p>

Image 1 - Burnt panel and wood above. The 30A 2-pole breaker is top left

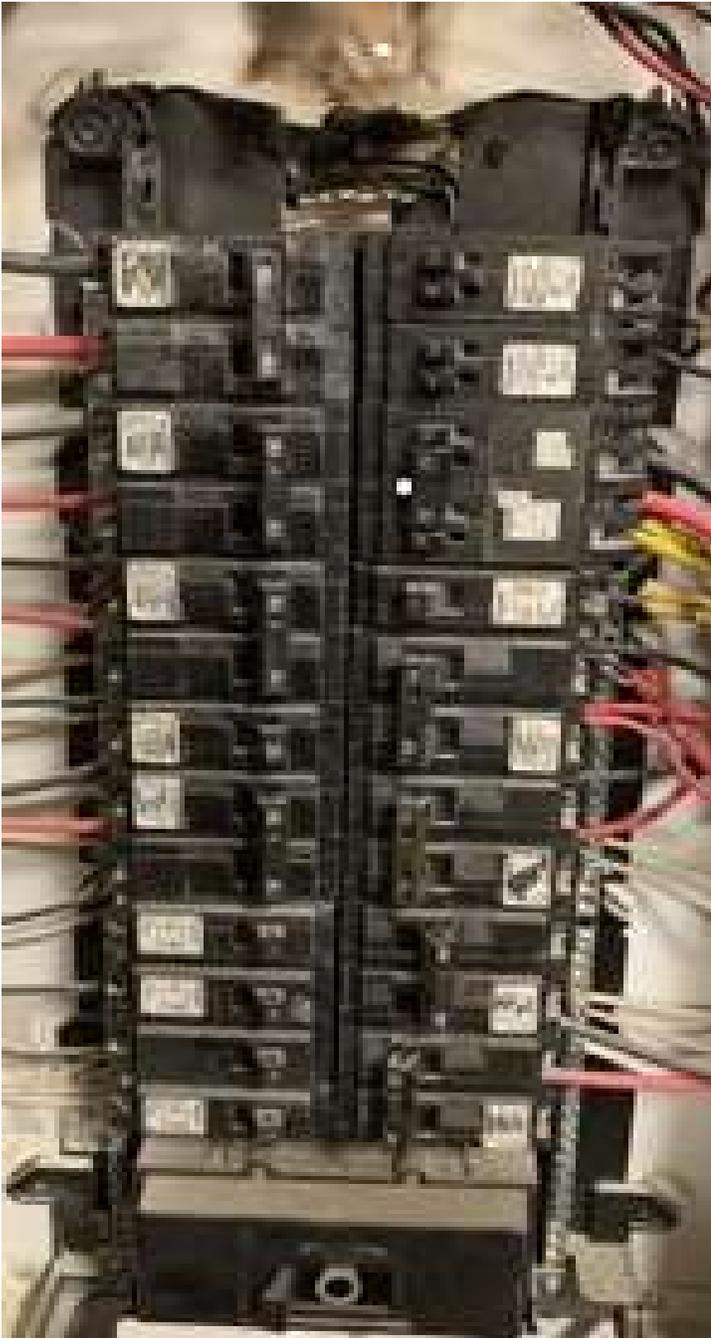
<p>1st Electrical contractor, interview:</p> <ul style="list-style-type: none"> This contractor originally installed the 200A service panel and was called to perform the repair after the fire. He found the 30A breaker for the heater in the tripped position. He found both the buss and breaker melted where they make contact; and observed that it was a Siemens brand breaker installed in a Homeline brand panel. <p>2nd Electrical Contractor, Interview:</p> <ul style="list-style-type: none"> This contractor installed the shop wiring and breakers to the existing panel. He said he did install the 30A Siemens breaker for the heating circuit to the Homeline panel. <p>Safety Officer Remote Observation:</p> <ul style="list-style-type: none"> 200A panel destroyed inside 30A breaker melted where it contacts the panels buss Panel buss melted where it contacts the 30A breaker. Siemens label on breakers installed in Homeline panel. Documentation from the panel manufacturer (Schneider Electric) stating Siemens breakers are not approved for use in Homeline panels.

Image 2 - Burnt Panel with 30A breaker removed. Note melted buss top left.

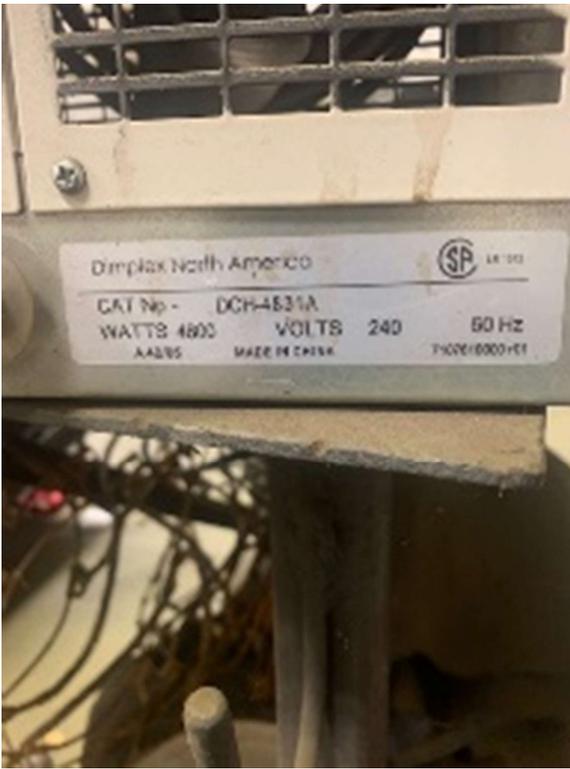
Failure scenario(s)	The 4800W construction heater in the dwellings detached shop was turned on for approximately 1hr. The heaters load, although within normal circuit ampacities, was very likely too much for a poor electrical connection where the 30A breaker contacts the panel buss bar. It is very likely that good contact between the breaker and the panels buss bar wasn't achieved because the brand of breaker installed wasn't approved for use in this brand of panel.	
	Facts and evidence	<p>Homeowner Interview:</p> <ul style="list-style-type: none"> • The owner said he turned the shop heater on and then went to the house for breakfast. He promptly returned to the shop and found his electrical panel on fire. He turned the panels main breaker off, put out the fire with an extinguisher, and called an electrical contractor. • The owner said that the 1st electrical contractor installed the service panel and later a 2nd electrical contractor was obtained and installed the shop wiring including the heater and its breaker. • The owner said that over the 6 years since this electrical system was completed, that the heater has only been used a few times.

Image 3 - Construction Heater – 4800W

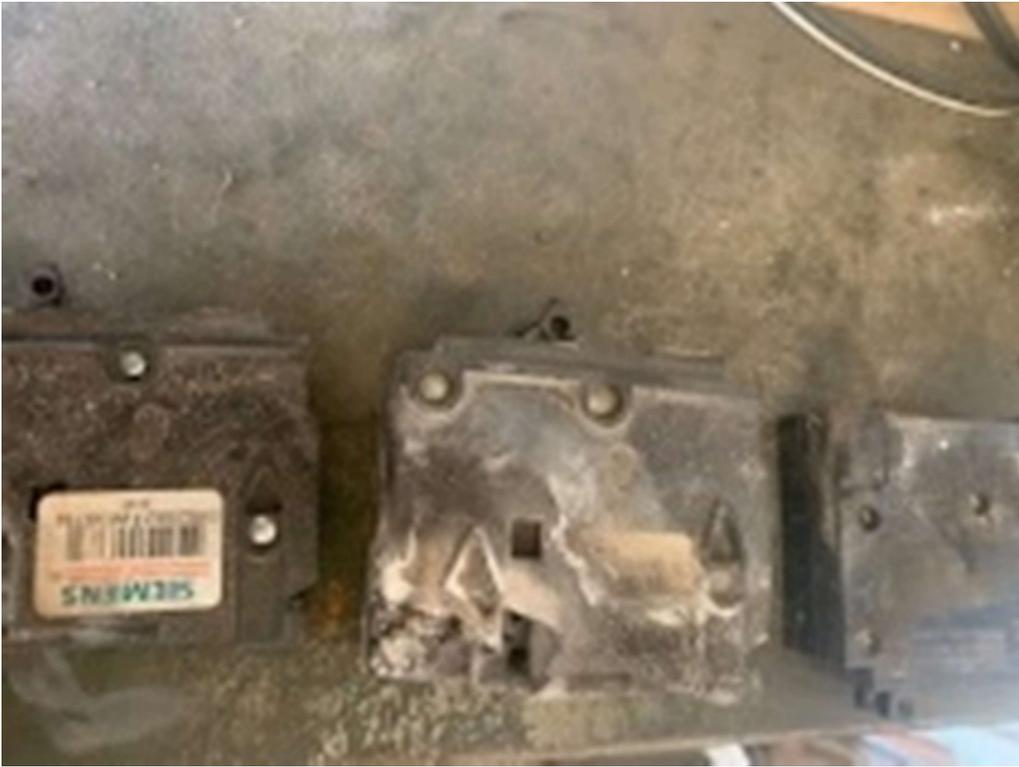
Image 4 -Siemens label on breaker installed to Homeline panel
