Incident Summary (Reference #5617320)

SUPPORTING INFORMATION	Incident Date		June 1, 2017	
	Location		Burnaby	
	Regulated industry sector		Gas – Natural gas system	
	Impact	Injury	Qty injuries	0
			Injury description	NA
			Injury rating	None
	Damage	Damage description	An underground ¾” steel gas line was pulled apart from a mechanical coupling resulting in an uncontrolled release of gas.	
		Damage rating	Major	
Incident rating		Major		
Incident overview		While a construction company was installing new storm and sanitary services in a residential back alley, one underground gas service line was damaged, resulting in the evacuation of 18 homes until the leak could be located and repaired by the utility.		
INVESTIGATION CONCLUSIONS	Site, system and components		<p>Natural gas is distributed by the utility through a series of underground trunk and branch lines to gas meters at customer locations. These lines can be steel or polyethylene plastic.</p> <p>The gas service at this location was a ¾” steel gas line that came off of the buried main running parallel down the alley. Before the steel gas service enters the property line a mechanical slip joint coupling is installed on the line. Th

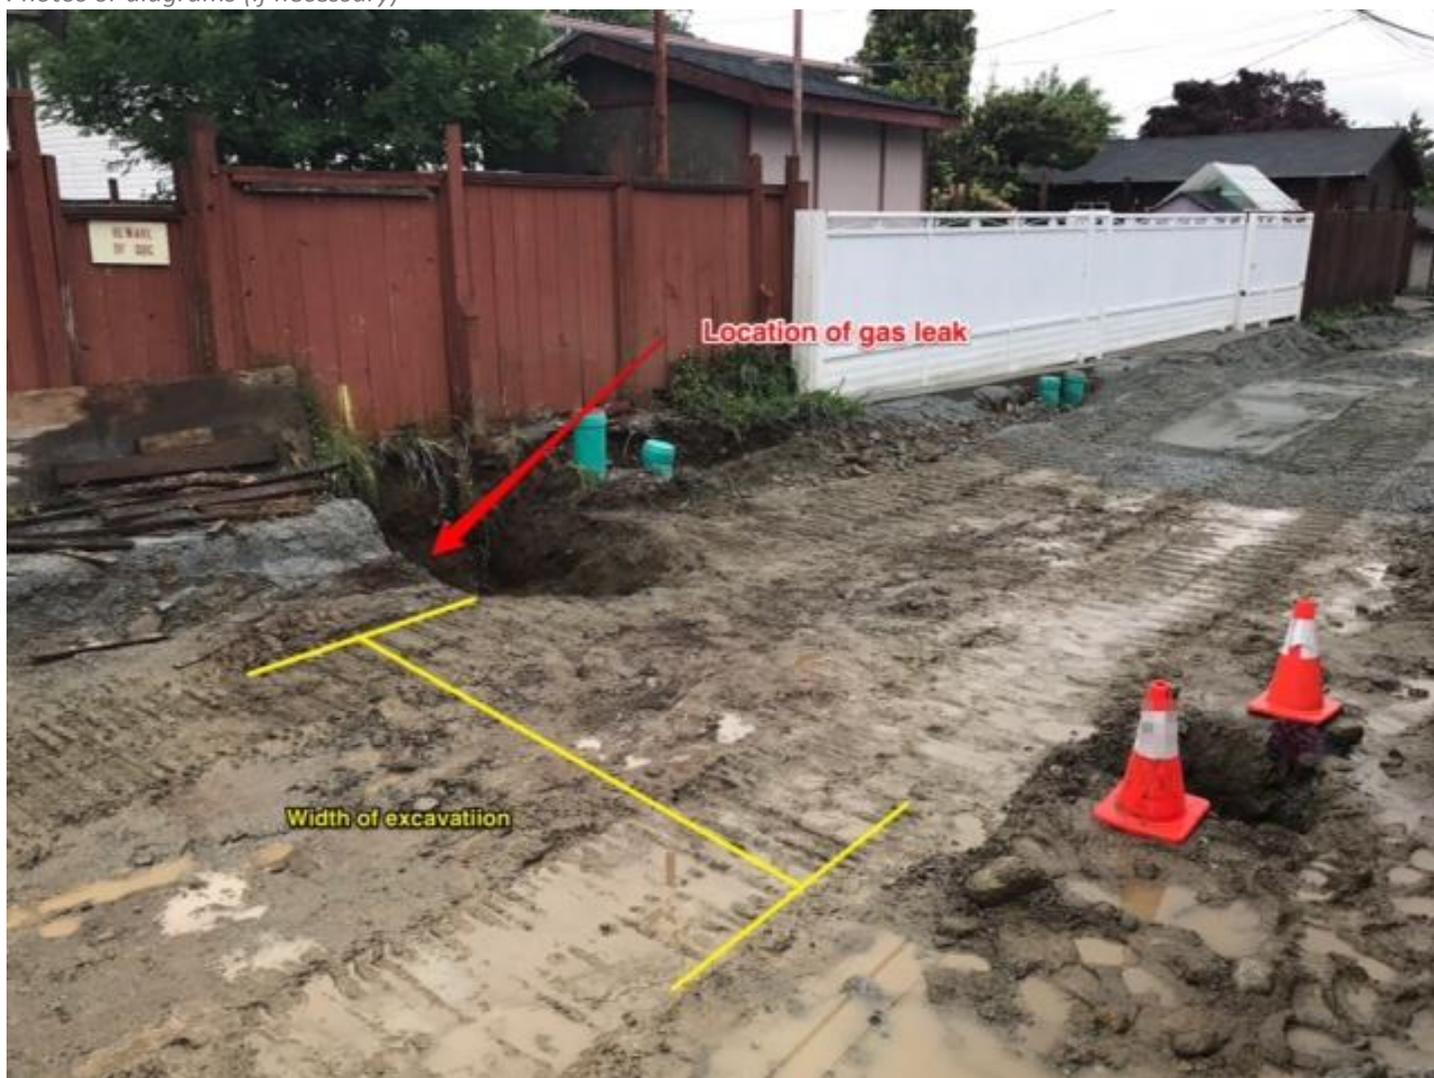
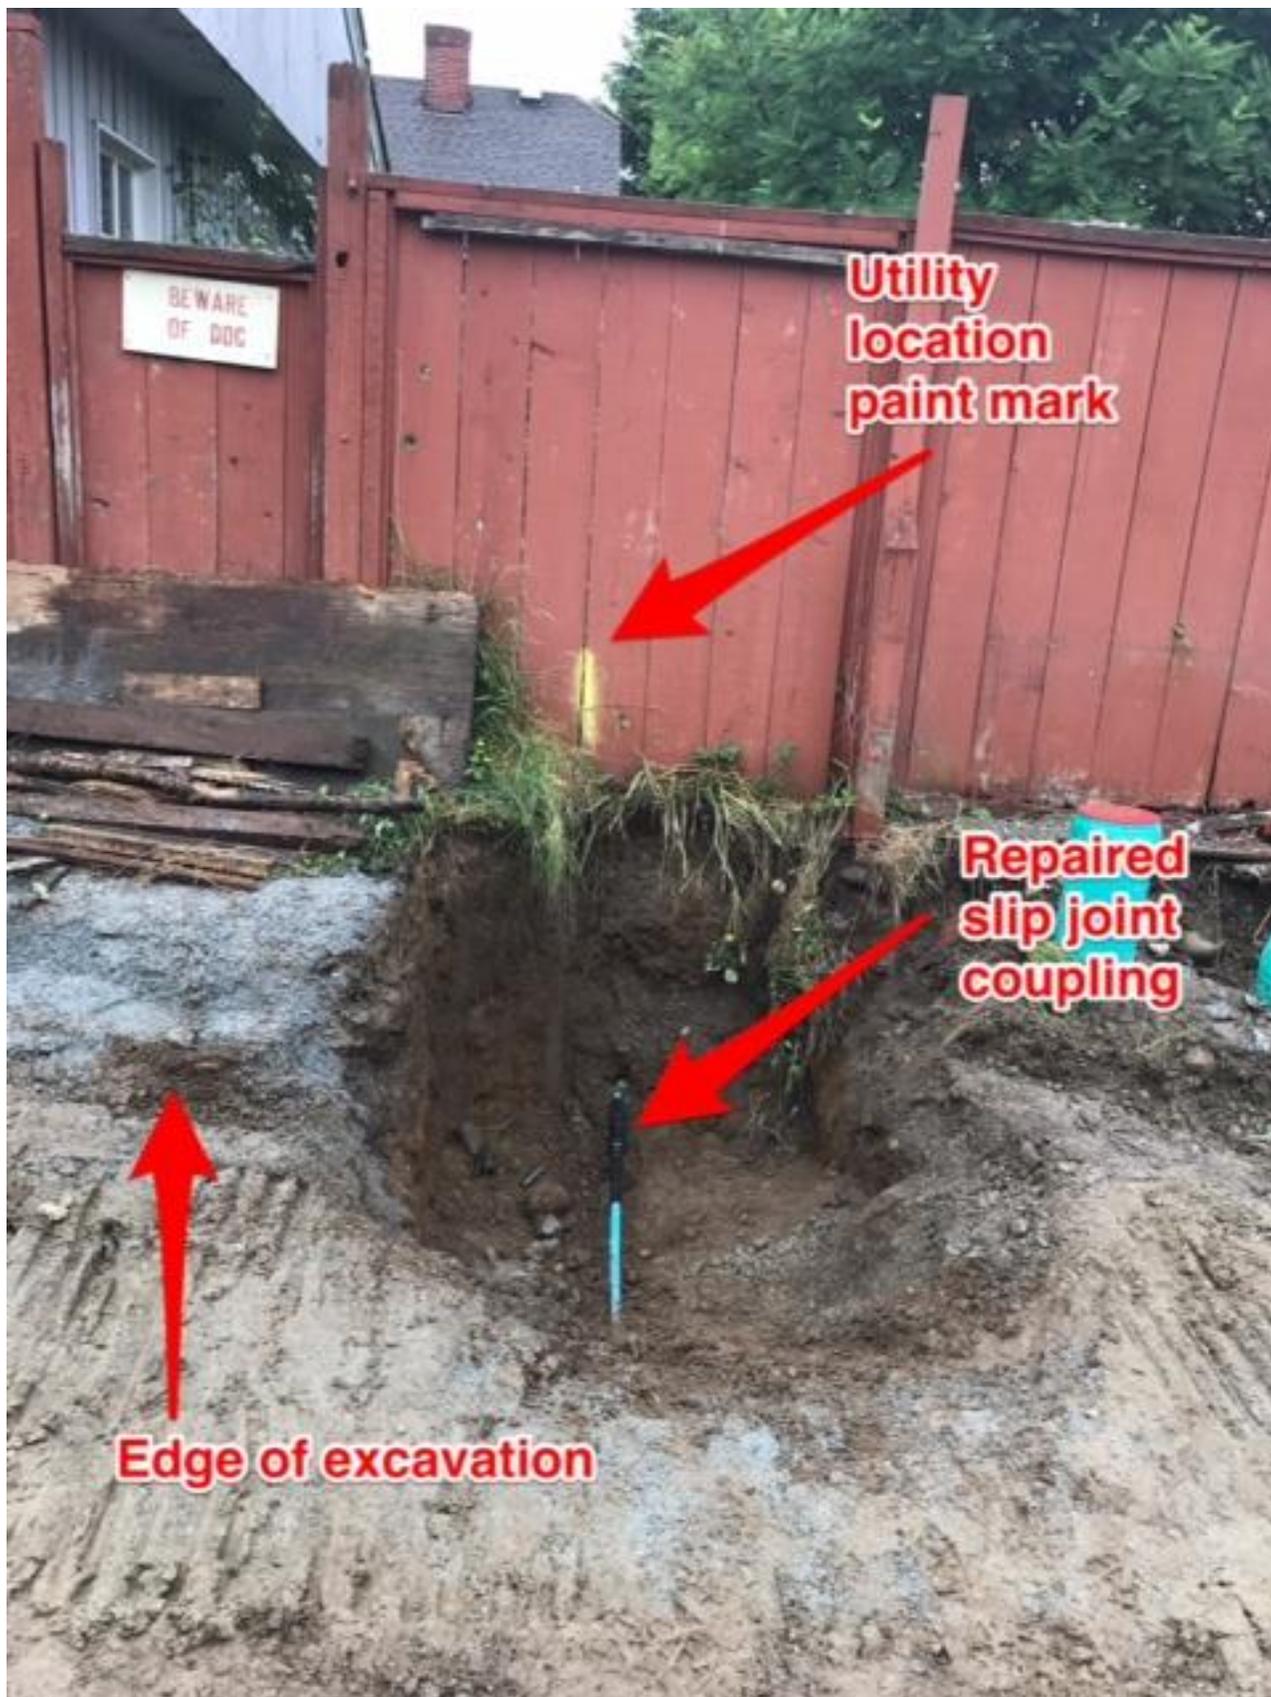
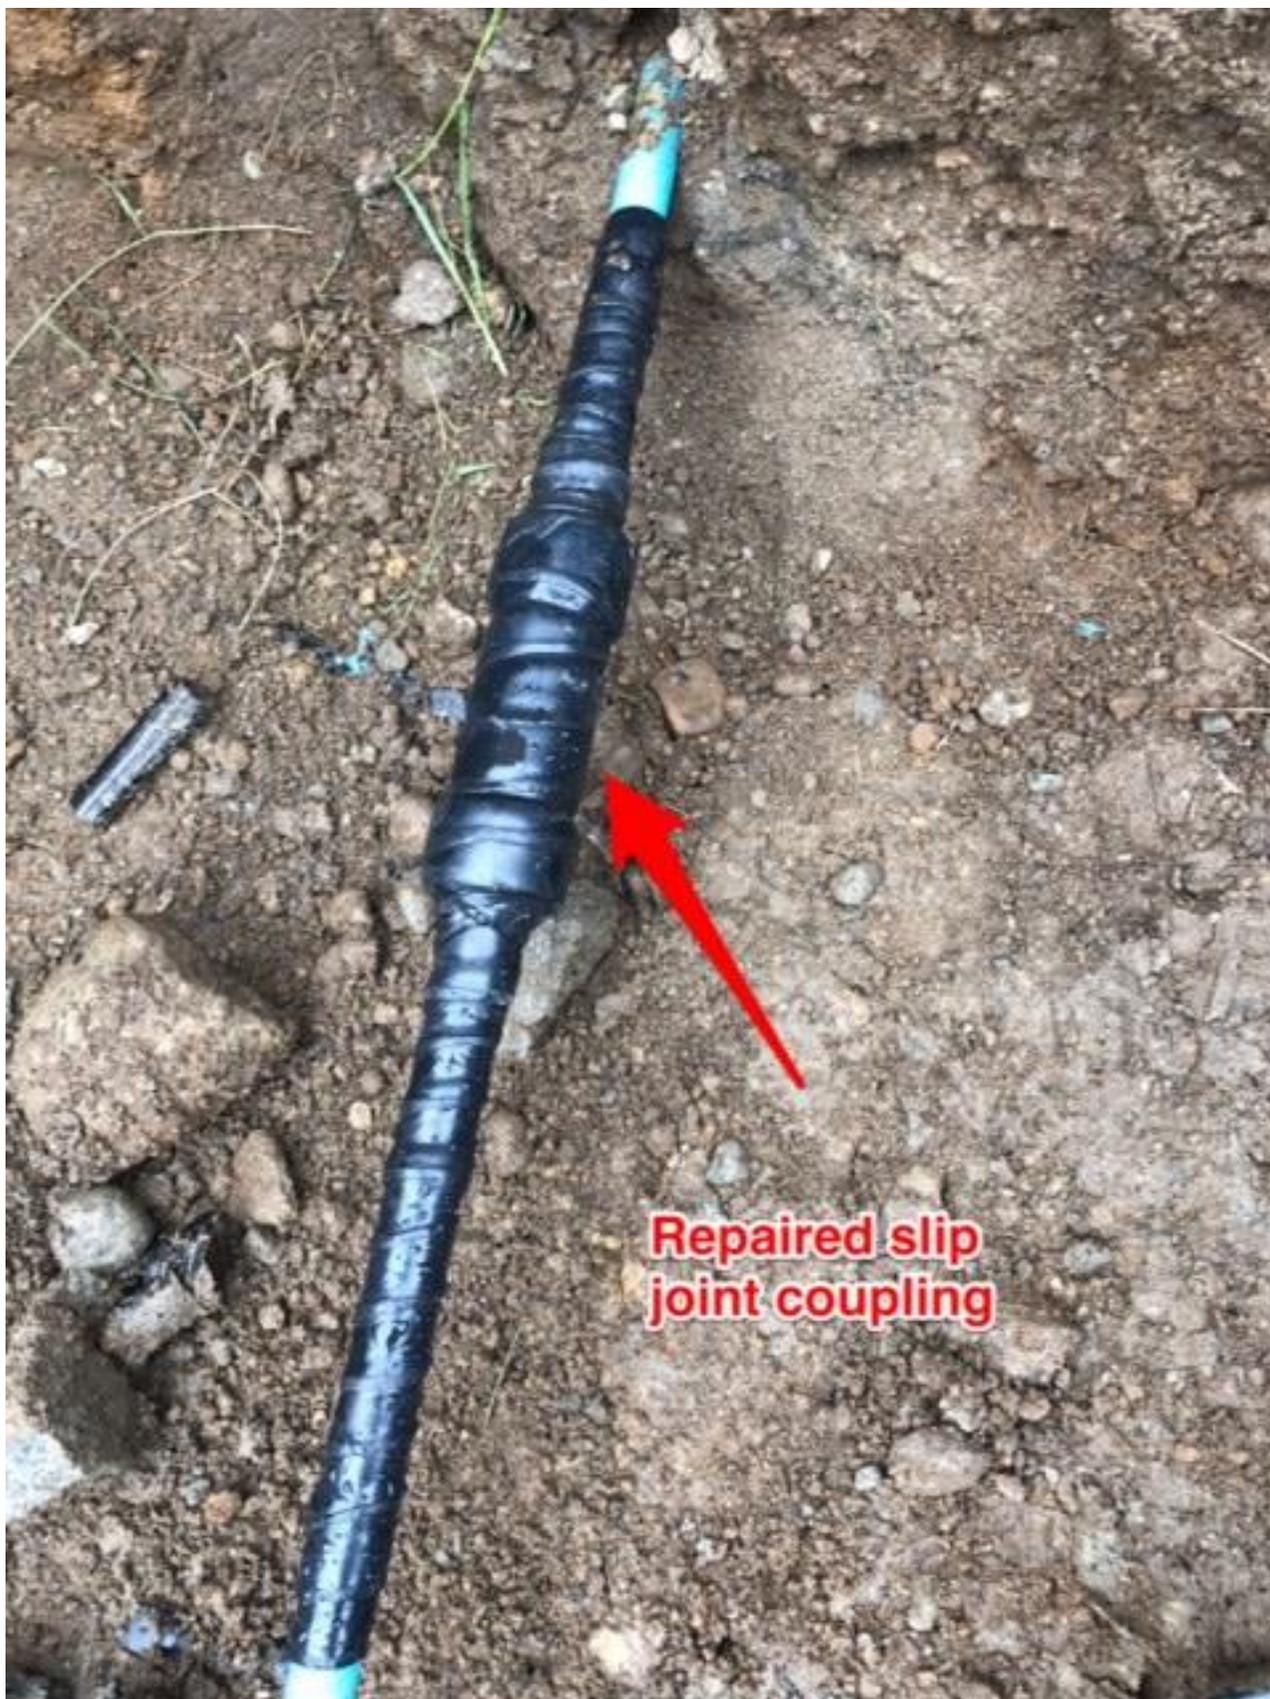
<p>line was identified with marking paint and the backfill material was compacted on either side with a hoe pack. The excavation was backfilled to a height of .5 meter above the gas service line. The backfilled excavation in the alley was then used for heavy equipment and dump truck traffic. The gas service line pulled out of the mechanical slip joint coupling underground approximately 1 meter outside of the excavation area.</p>
<p>Facts and evidence</p>	<p>Witness statements</p> <p>Site Supervisor- He told me that during construction work that day they had exposed the gas line and worked around it. He said that the line was not hit, pulled or compromised during the excavation procedure. He told me that they backfilled that portion of the excavation and were carrying on further down the alley. He said that later on that evening he received a phone call that there was a strong smell of gas in the alley behind the homes and that technicians from the gas utility were on site trying to find the source of the leak.</p> <p>Pipe Foreman He told me that when they backfilled around gas lines exposed during the excavation that he would identify the location of the gas line with construction marking paint and the equipment operator would not pack the area above the gas line with the vibratory packer on the excavator within 1 meter of either side of the marking.</p> <p>Gas Utility technician manager He told me that the utility technicians that were on site found the source of the leak was the steel gas line had pulled out of the slip joint coupling approximately 1 meter to the North of the edge of the prior excavation.</p> <p>Photos</p> <ul style="list-style-type: none"> • Location of slip joint coupling outside of excavation area • Original bury depth of line • Amount of backfill above line over excavated area • Heavy equipment tracks above backfilled line • Paint mark on fence identifying the location of the gas service <p>Email</p> <ul style="list-style-type: none"> • Construction companies request to the gas utility for locations of gas services in area <p>Utility Site report</p> <ul style="list-style-type: none"> • Detailed information of the location of the gas services in construction area <p>Construction companies Safe work procedure</p> <ul style="list-style-type: none"> • The companies detailed written procedures for locating, exposing and backfilling around utility services.

<p>Causes and contributing factors</p>	<p>It is very likely that insufficient care while backfilling the excavation around the gas line led to excessive downward force on the line from the heavy equipment travelling above it pulling the line out of the mechanical slip joint coupling causing the leak.</p>

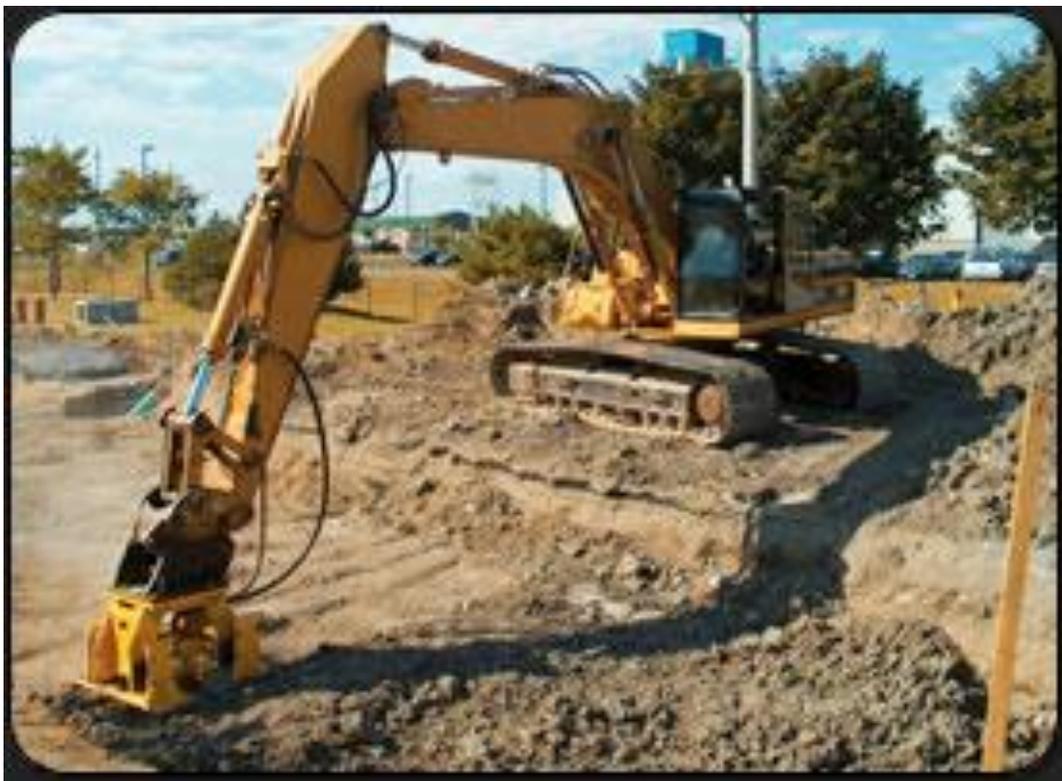
Example of a “hoe pack”
