## Incident Summary #II-1031540-2020 (#18557) (FINAL)

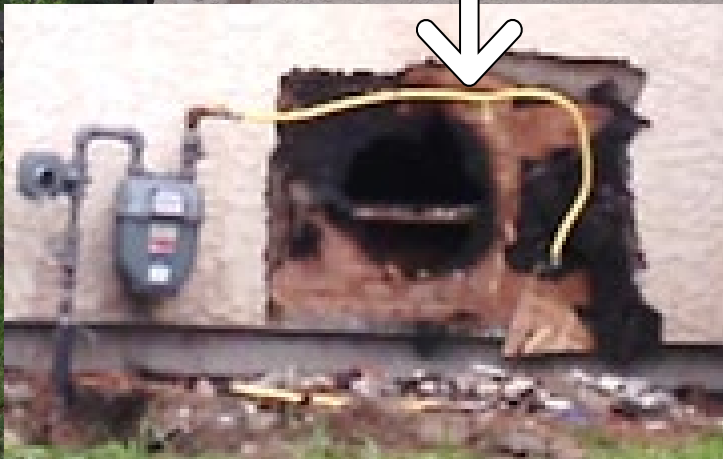
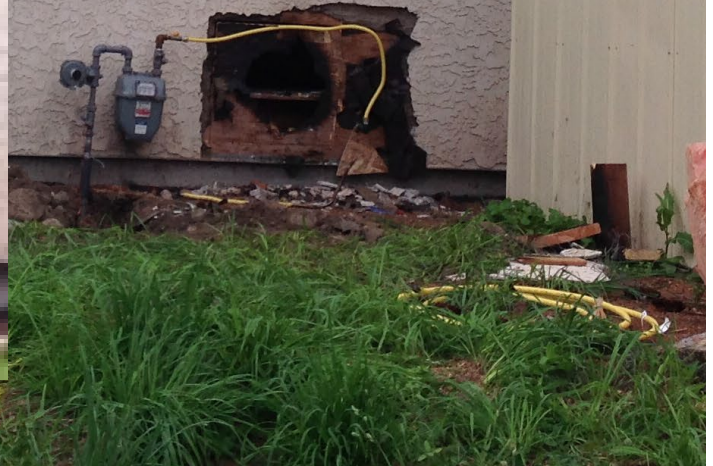
Failure scenario(s)		When the home was struck by lightning, an electrical path to ground arced between a metallic support clamp on the CSST and the wire mesh inside the stucco siding. This created a hole in the CSST and simultaneously ignited the escaping gas causing a small fire. The CSST was not bonded to ground.	
	Facts and evidence		<p>Statement from Power Line technician who came out to restore the power and discovered that the house was on fire. The gas line was in flames and had ignited the side of the home. The Power Line technician then extinguished the flames, turned off the gas and called the fire department.</p> <p>In an interview with the Fire department who attended site they stated that they found a hole in the CSST, and possible beading on stucco wire mesh.</p>	
	Causes and contributing factors		It is possible that the CSST that was supported to the stucco with metal support clamps allowed the lightning to arc creating the hole which allowed the gas to escape and be ignited, causing the fire. The CSST was not bonded to ground.

Area where the fire started. The yellow CSST that was not bonded when the lightning strike created a hole in the CSST.

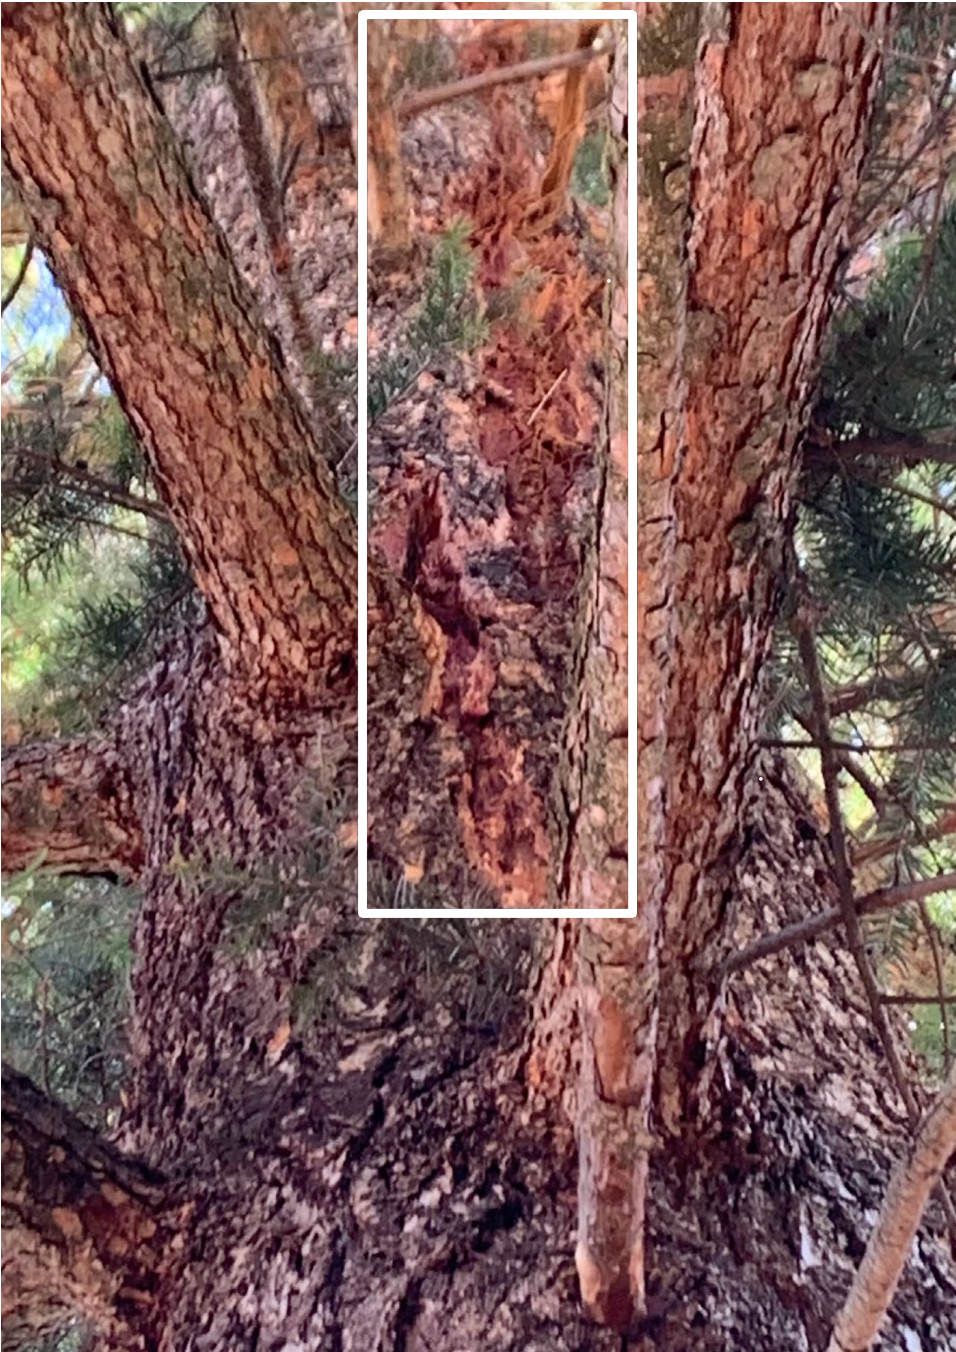
*Lightning path that was  
observed on the tree*
