Incident Summary #II-1014540-2020 (#17613) (FINAL)

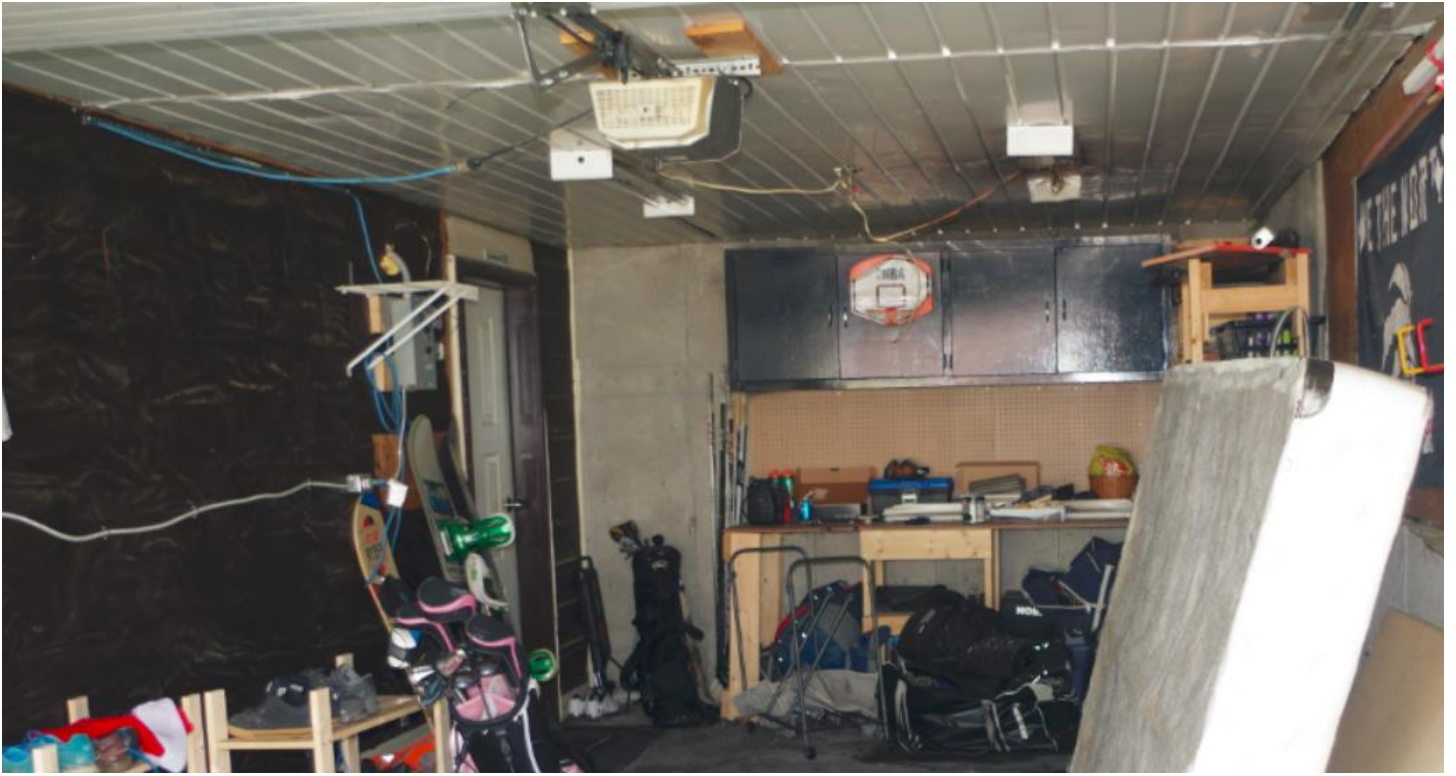
General interior view of garage

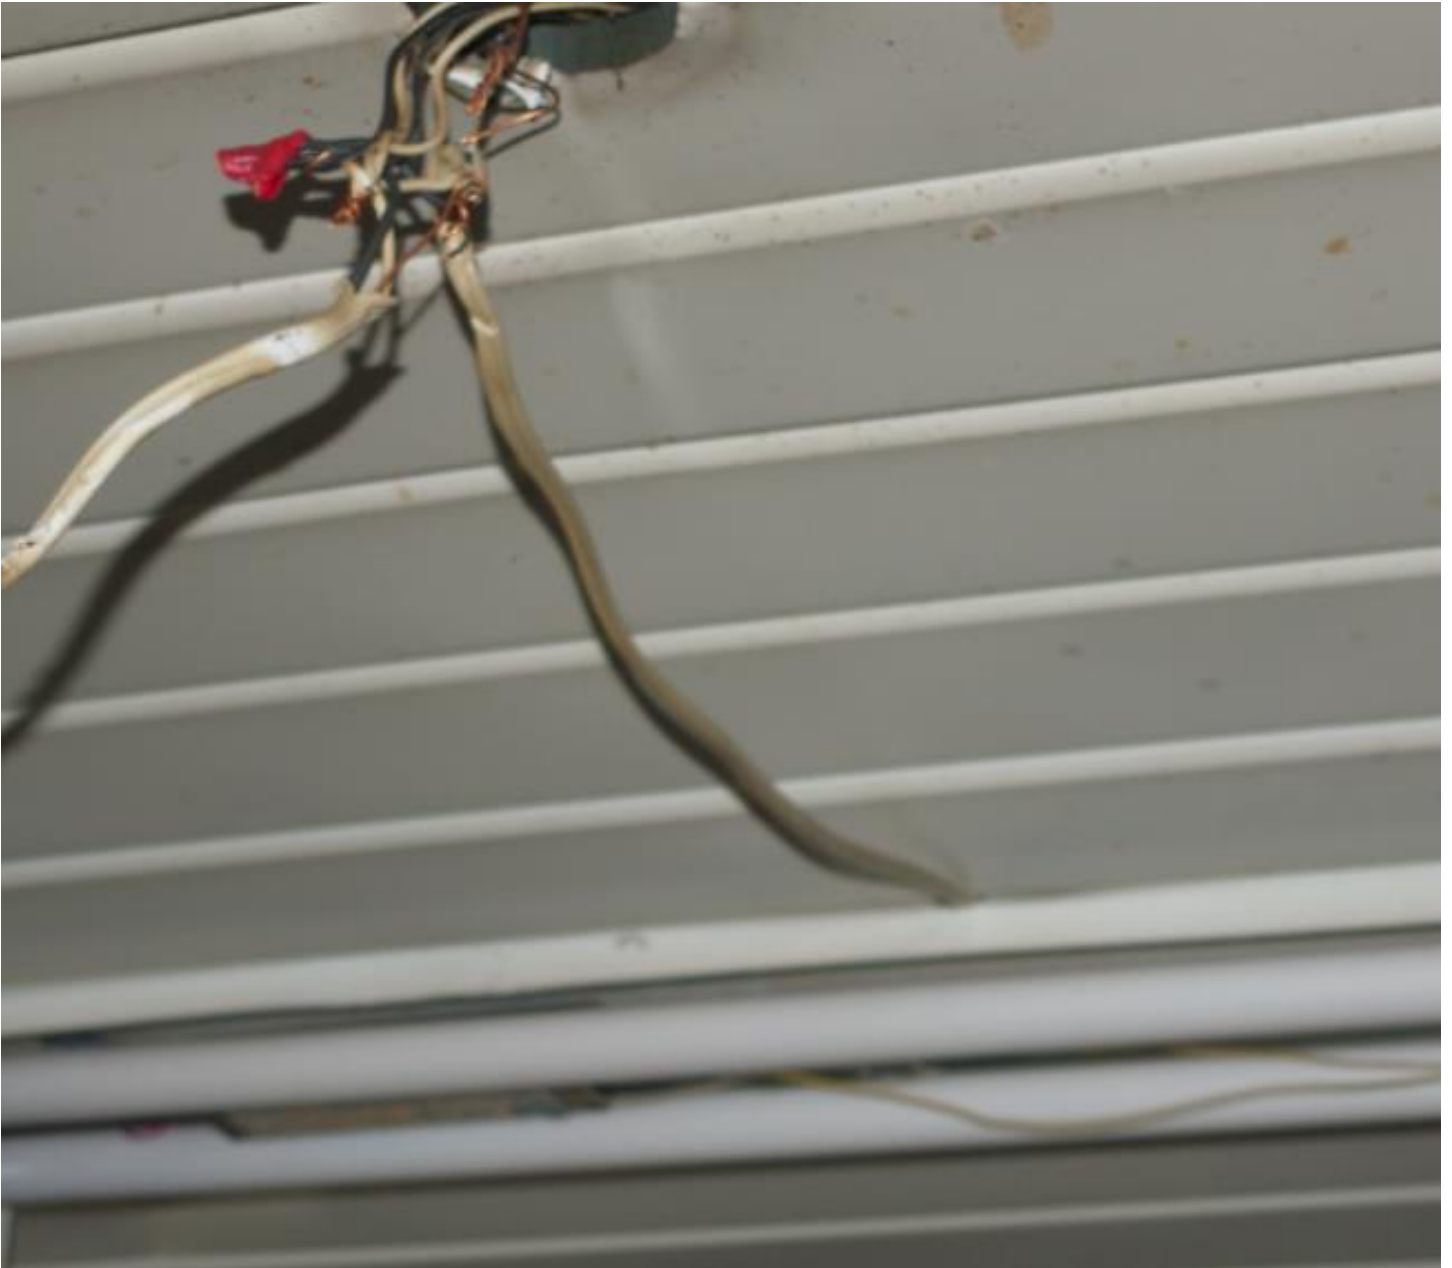
Connection of 2x ceiling mounted surface mounted lights to 'original' existing ceiling light junction box

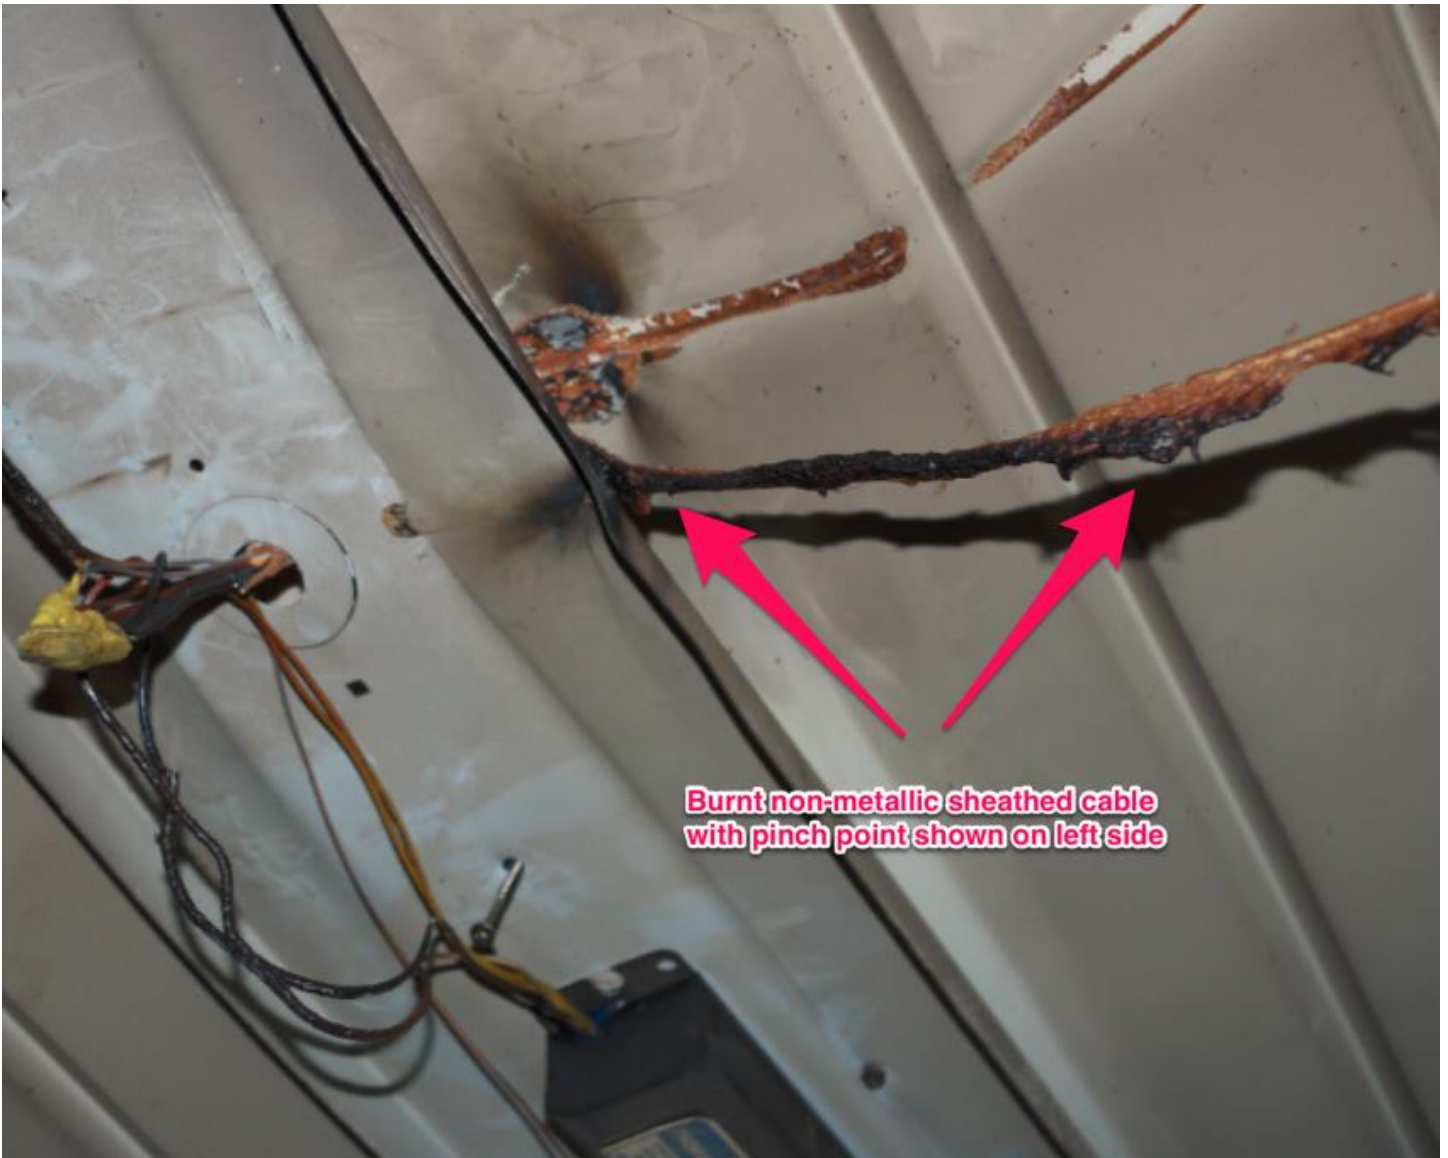
Failure scenario(s)	<ul style="list-style-type: none"> - The fixture was energized for a period of time that allowed the cable to heat excessively that lead to a fault that burnt wiring within the fixture and the cable shorting to the fixture enclosure. The wires and cable became overheated and caught fire 	
	Facts and evidence	<ul style="list-style-type: none"> - Discussion with the owner provided information that the lighting fixtures were existing when he purchased the dwelling approx. 3 years ago, he stated the dwelling was inspected and cleared by a home inspection at the time of purchase - 2 conductor non-metallic sheathed cable (NMSC) was run from an existing ceiling lighting box over to 2x florescent light fixtures added, the cable was 'pinched' between the metal fixture and the metal soffit ceiling at both fixtures and entered the top side of the fixture through a knock out with no connector, the cable provides evidence of shorting at the pinch point of the damaged location. - An adjacent fixture is installed with the same methods and was not affected, photos provides a clear view of how the fixtures were installed

View #1 of melted damaged NMSC

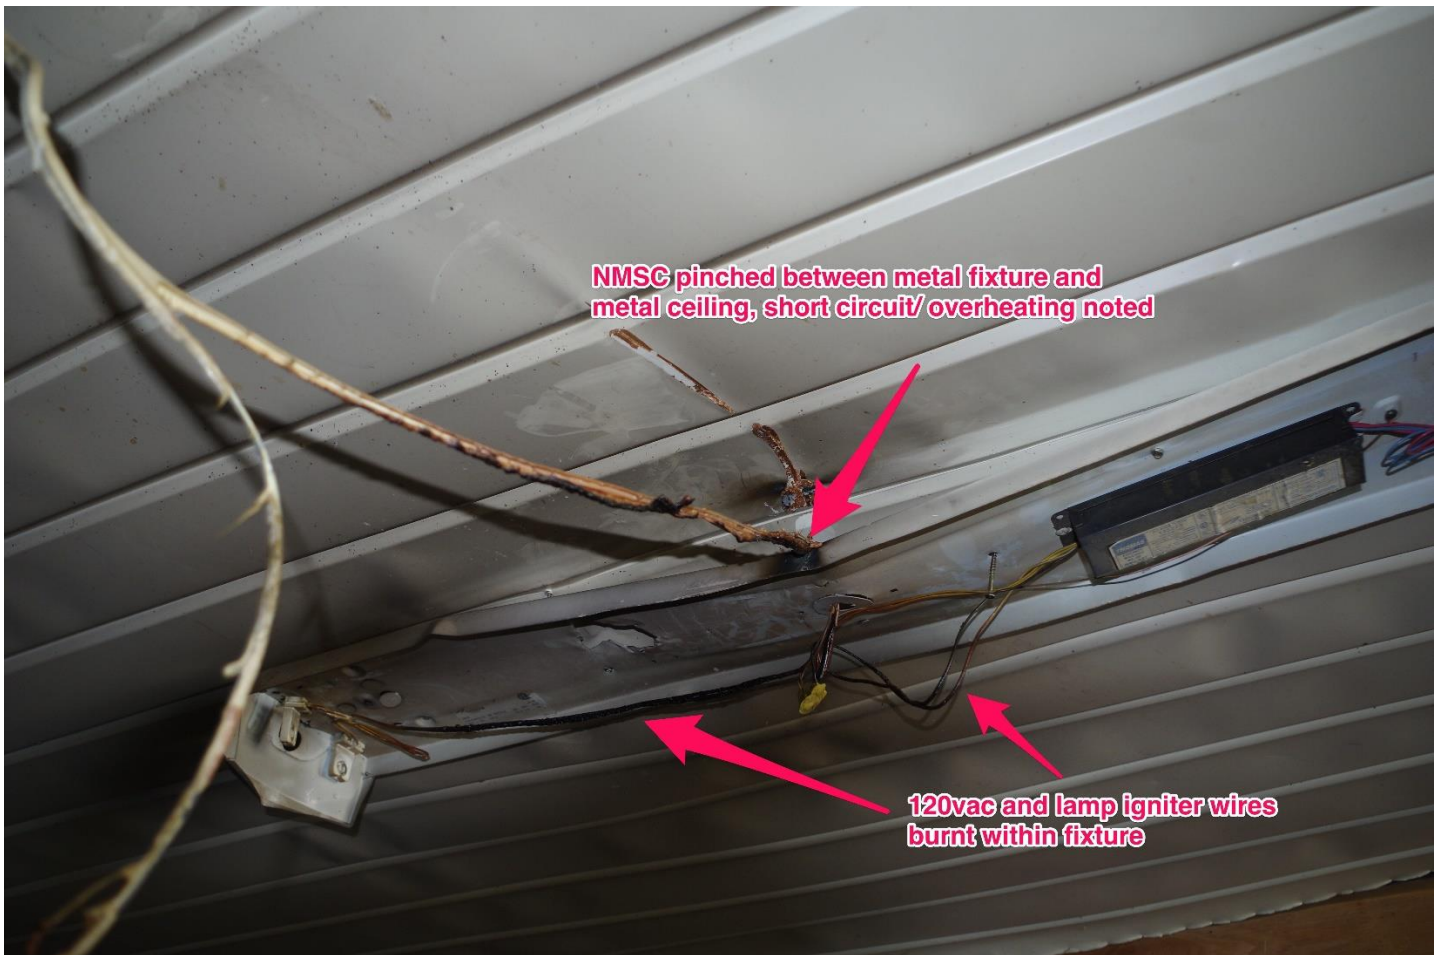
View #2 of melted damaged NMSC with notes

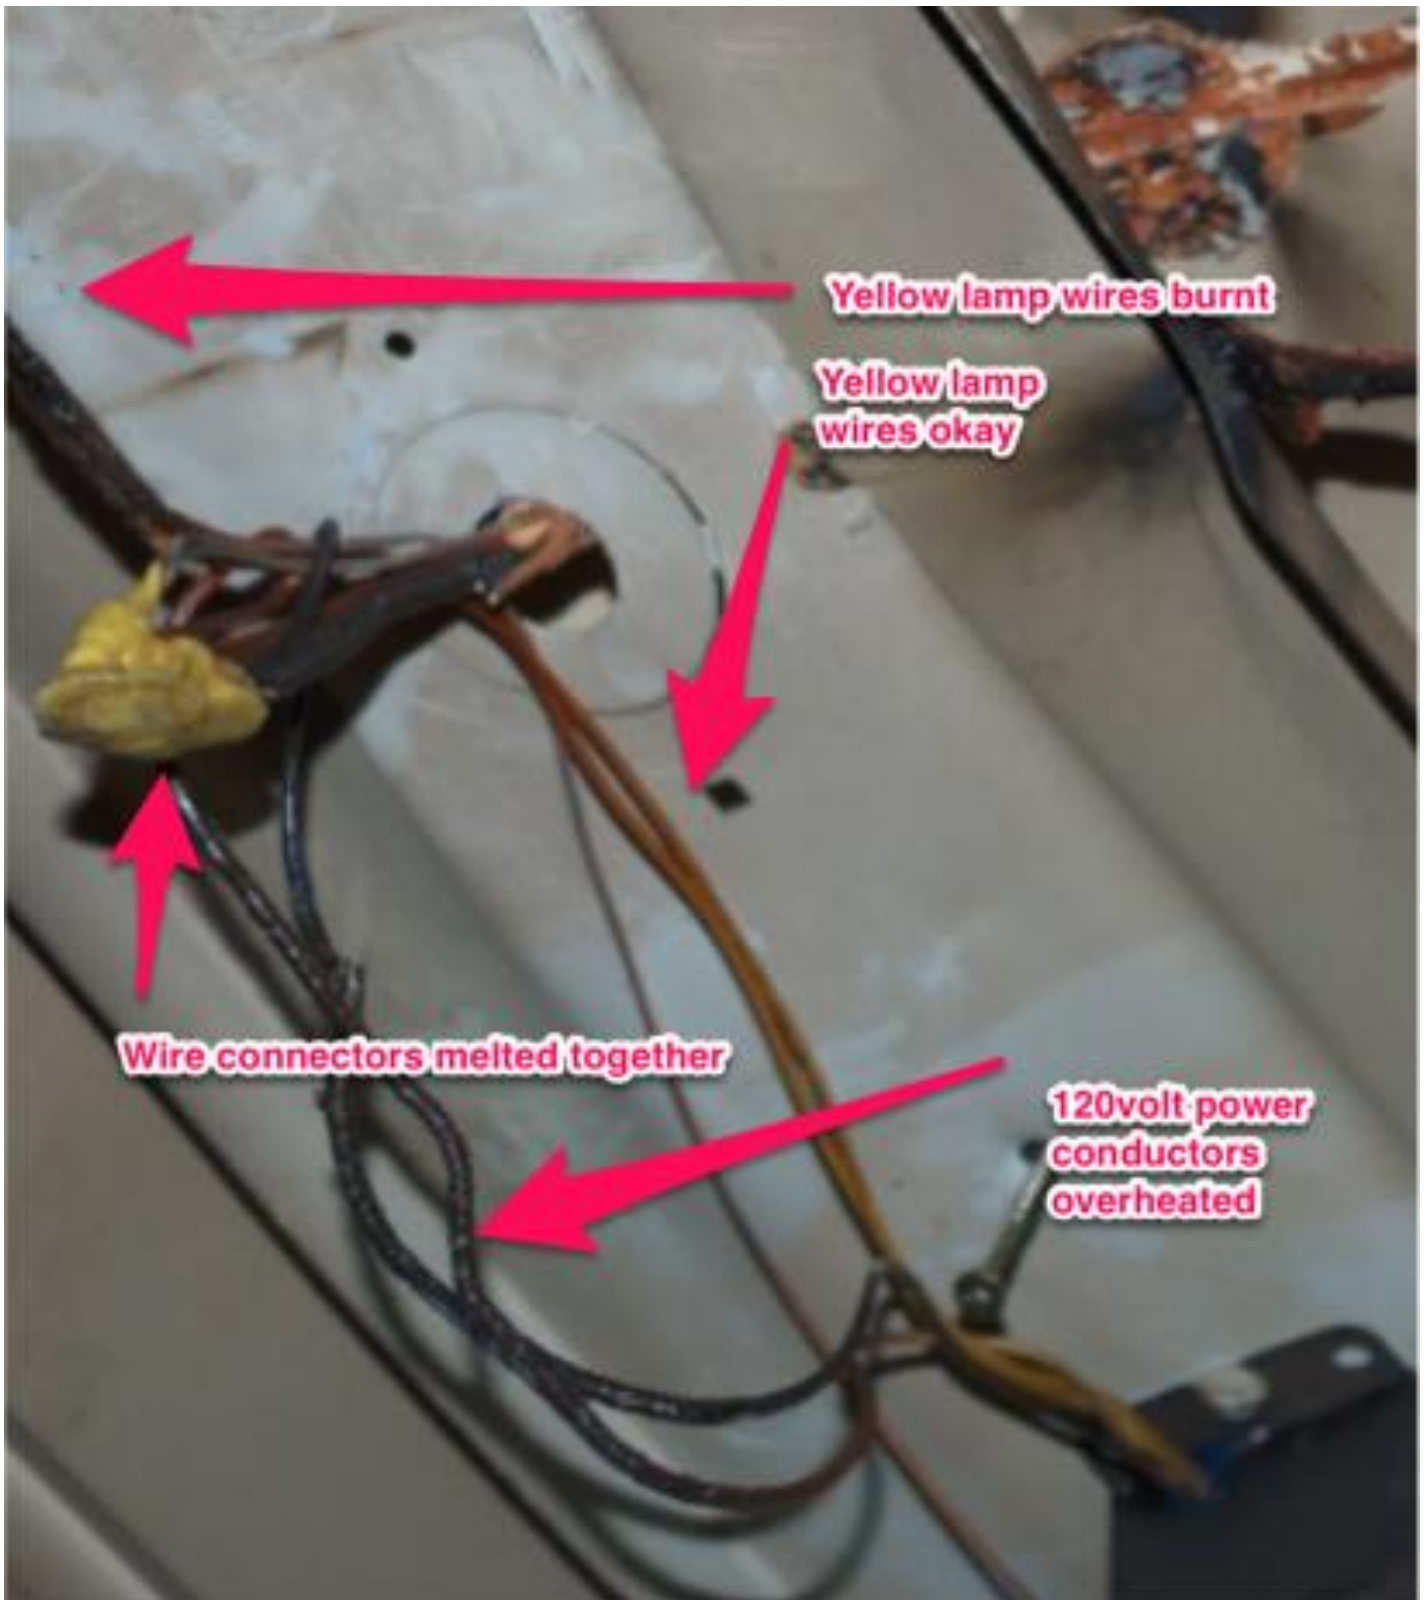
<ul style="list-style-type: none">- Evidence within the fixture provide burnt 120volt wiring from the wire nuts within the fixture to the ballast location, wire nuts show evidence of heating Plus the yellow conductors for lamp pre-heat connections have been burnt from the 120volt wire nut location to the lamp socket direction- The non-metallic sheathed cable installed from the original existing light box to the light fixture shorted between the fixture frame and the metal soffit ceiling at a pinch point causing the cable to overheat and melt- The overcurrent device did not trip during the incident and the Fire Department stated they had de-energized the circuit on site
Causes and contributing factors	<ul style="list-style-type: none">- With the photo evidence provided, the cause was certain to be electrical in nature. The source can be attributed to wiring within the lighting fixture near the 120volt connections where the line voltage wires/ connectors may have fused/ shorted to the extra low voltage lamp conductors acting as a low resistance load preventing the overcurrent device from tripping, over-heating all the line voltage wires to ballast, extra low voltage wires in directions to lamp sockets and non-metallic sheathed cable causing the NMSC to soften and heat, ending up shorting to metal at pinched location, this non-metallic sheathed cables insulation integrity had likely been compromised at the pinch point by the installation itself and years of vibration created form the upper floor being occupied.

Internal fixture connections view with notes
