Incident Summary #II-1626282-2023 (#40757) (FINAL)

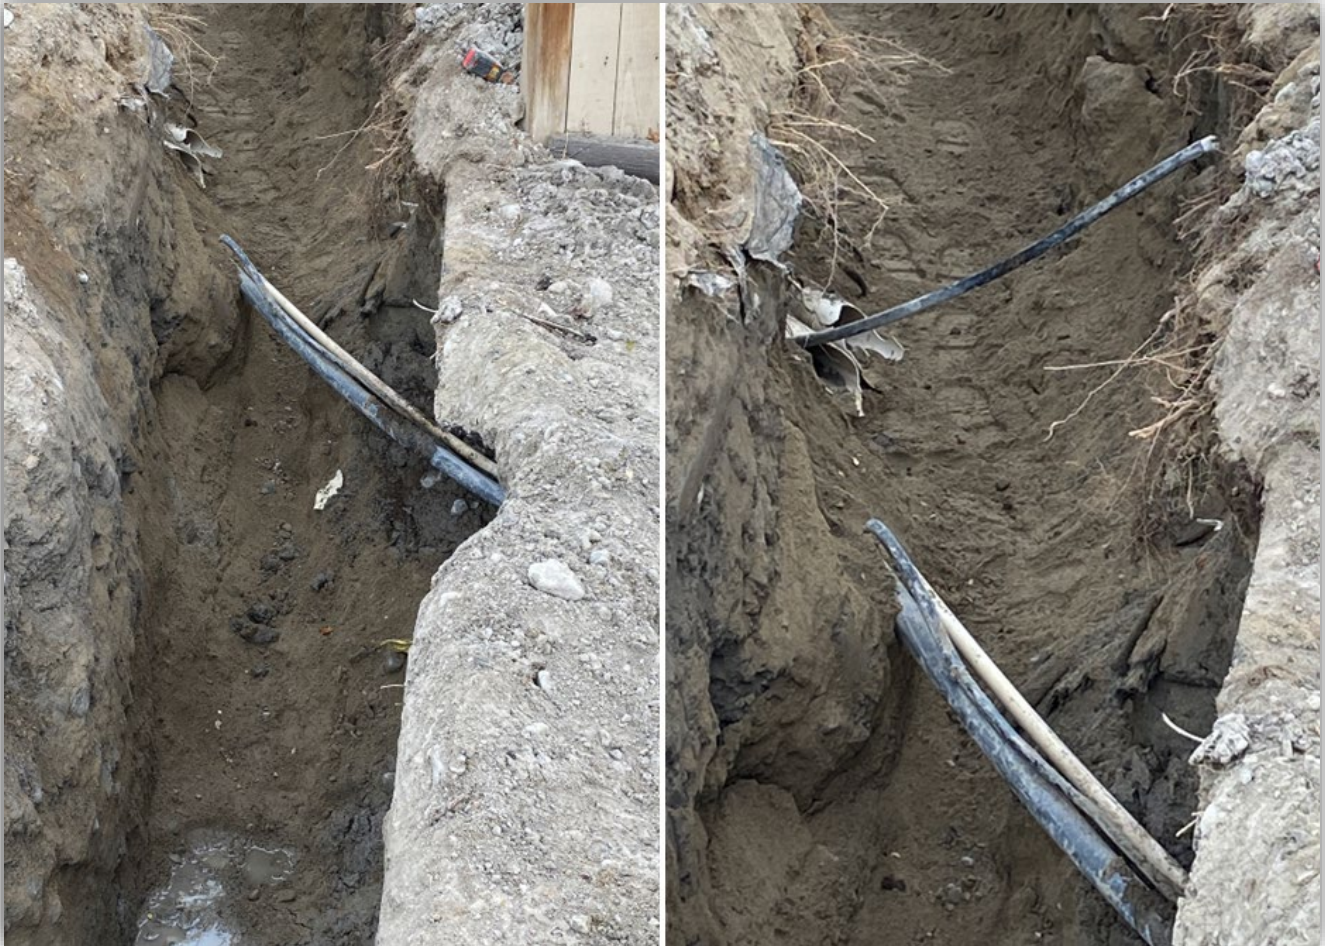
SUPPORTING INFORMATION	Incident Date	October 30, 2023	
	Location	Penticton	
	Regulated industry sector	Electrical - Low voltage electrical system (30V to 1000V)	
	Impact	Qty injuries	0
		Injury description	N/A
		Injury rating	None
	Damage	Damage description	The underground electrical cable was broken in half when hit by an excavator.
		Damage rating	Moderate
	Incident rating	Moderate	
Incident overview	During some landscaping and driveway alterations at a residential home, an underground electrical cable was contacted by the excavation equipment and broken.		
INVESTIGATION CONCLUSIONS	Site, system and components	When electrical cables are buried, they are to be bedded in sand and have a sand cover. During the concealment of the cable a caution tape is to be placed over the cable midway between the cable and the finished grade to alert any future workers who may be digging in the area that there are hazards below.

Causes and contributing factors	<p>The incident was very likely caused by no burial tape being installed above the cable.</p> <p>Contributing factors to the incident include:</p> <ul style="list-style-type: none"> The privately owned cable was not located identified during the BC One Call location of underground services. The contractor did not utilize any other means of identifying underground serviced prior to digging. There wasn't any bedding material around the cable that may have warned the spotter or excavator operator of a possible underground service while excavating.

Image 1 - Broken Cable.

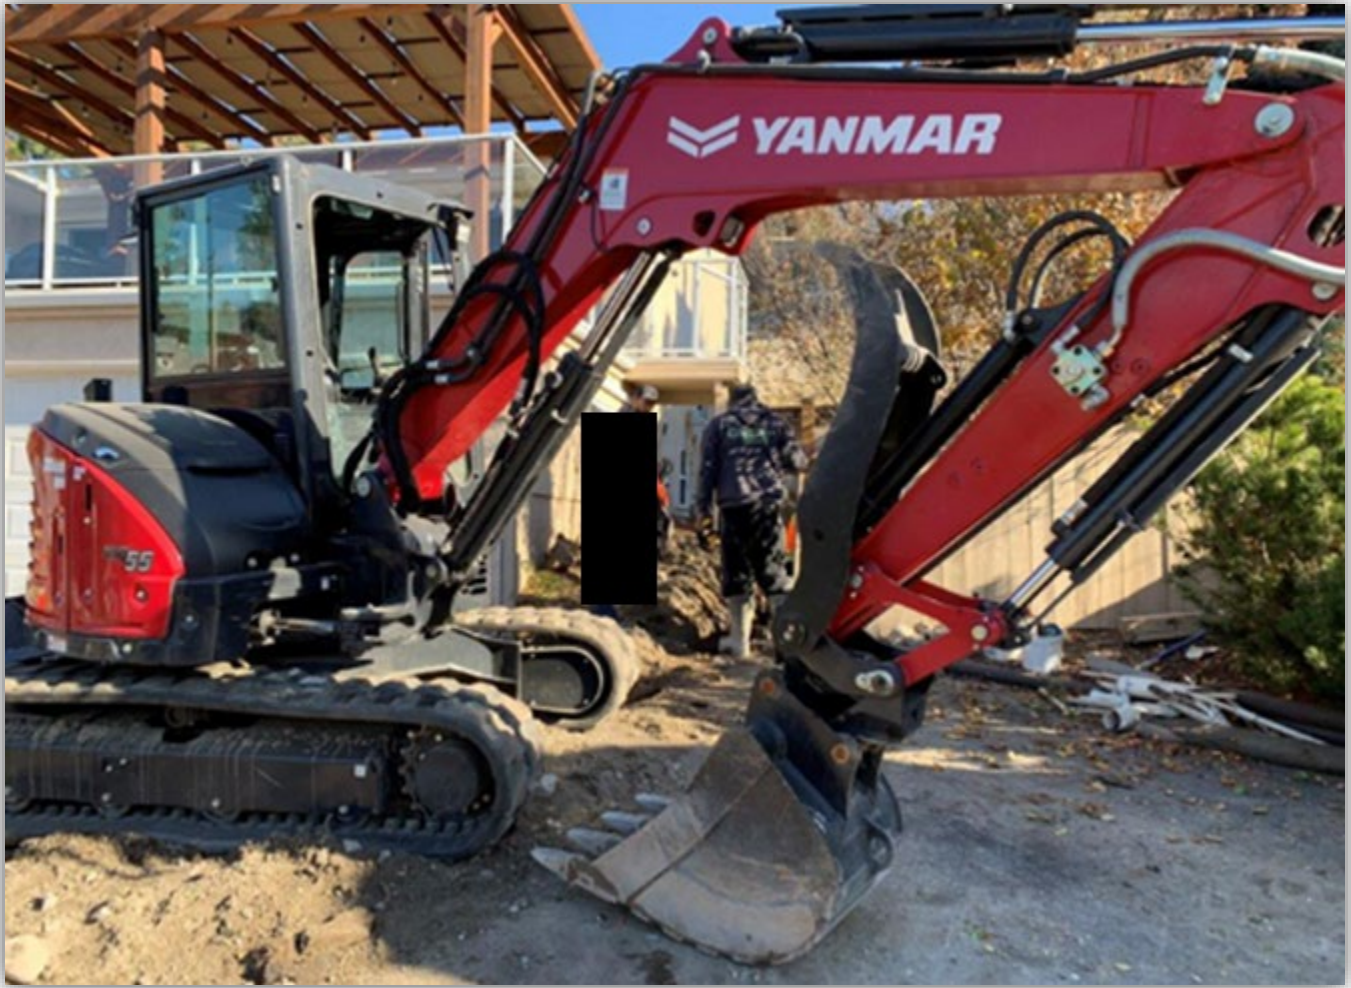
Image 2 - Excavator Used for digging.

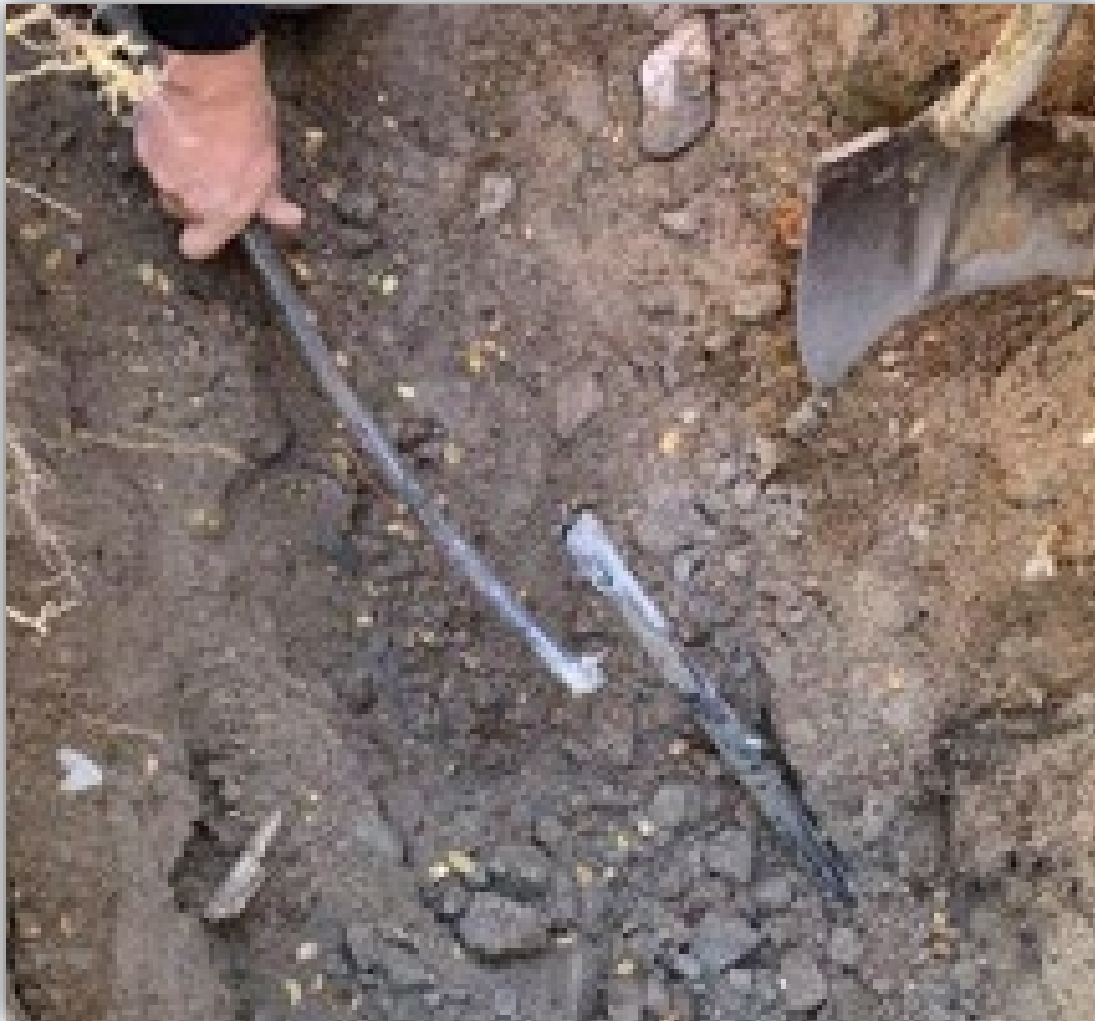
Image 3 – Location where cable was once joined.
