Incident Summary #II-858266-2019 (#12804) (FINAL)

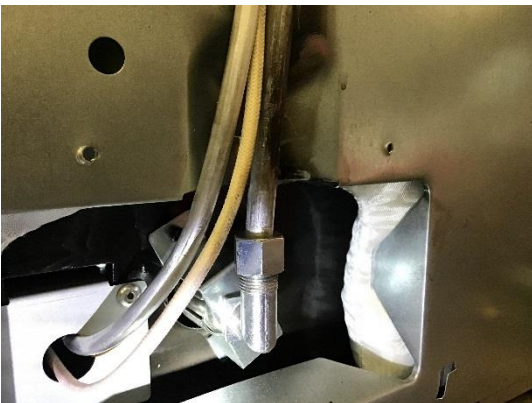
Failure scenario(s)	The compression nut/sleeve assemble for the main burner was found to have been loose and allowed gas to be released between the back of the range and the interior compartment/counter top. This occurred when the dial was moved from pilot to oven as the pilot and oven are supplied by separate gas lines.	
	Facts and evidence	Compression nut was found loose on main burner orifice assembly. This type of fitting has a compression sleeve which fits over the exterior portion of the tubing which is compressed into both the machined portion of the fitting and tubing. If the nut is not properly tightened, the joint is not sealed resulting in a leak. As this fitting is located down stream of an appliance control valve, a leak would not be identified unless the appliance was in use and the range was removed from its enclosure. It was not determined if this fitting was misassembled in the field or the factory.

Causes and contributing factors	The incident was likely due to a nut that appeared to have been cross threaded when assembled. Nut was removed and correctly threaded back onto the fitting and leak test while on the test bench.

Photo 3: Close up of leaking fitting.
