Incident Summary #II-1539440-2023 (#34696) (FINAL)

SUPPORTING INFORMATION	Incident Date	April 23, 2023	
	Location	Vernon	
	Regulated industry sector	Electrical - Low voltage electrical system (30V to 1000V)	
	Impact	Qty injuries	0
		Injury description	N/A
		Injury rating	None
	Damage	Damage description	A detached electrical service building had a fault that caused a fire and destroyed the structure and regulated electrical equipment.
		Damage rating	Major
	Incident rating	Major	
Incident overview	A fire ignited in a detached structure that housed an 800amp 120/208volt electrical service and sub-distribution equipment on west half of structure and a mechanical room on east half of structure that provided power to an agricultural operation in a separate detached building. The fire destroyed the building, the regulated electrical equipment and the utilities pad mount transformer and cabling.		
INVESTIGATION CONCLUSIONS	Site, system and components	An 800amp 120/208 volt 3-phase 4-wire service and sub-distribution was in a detached and dedicated service building and used to provide power to various distribution panel boards located in a separate structure to operate lighting, heating/c

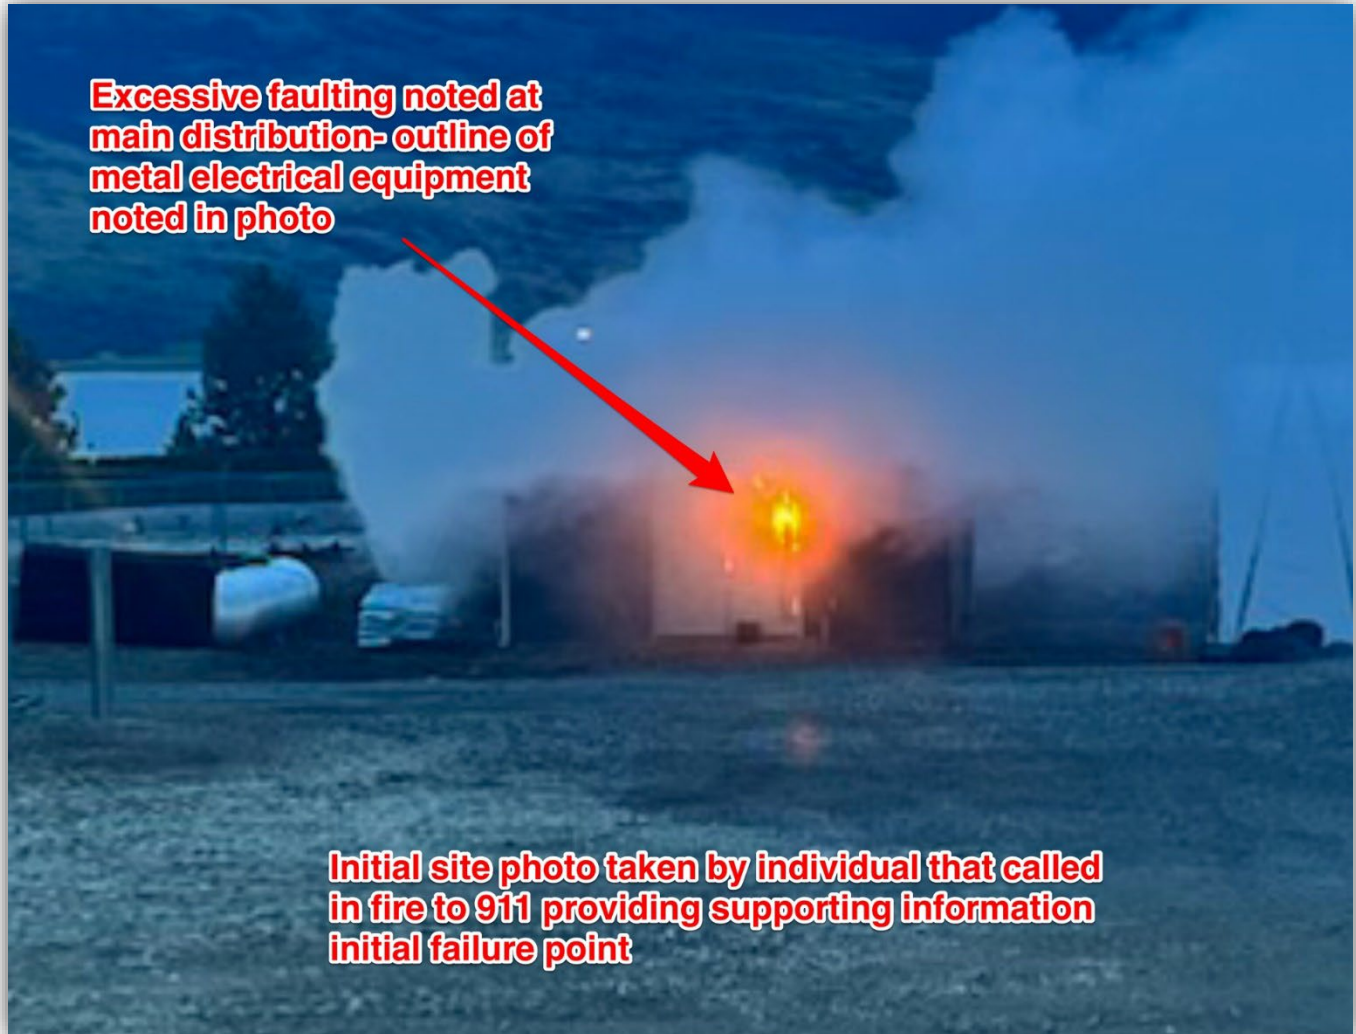
Image 1 – This image was provided by first person on scene taken at time when 911 was called. This provides supporting evidence source of ignition at main service equipment area.

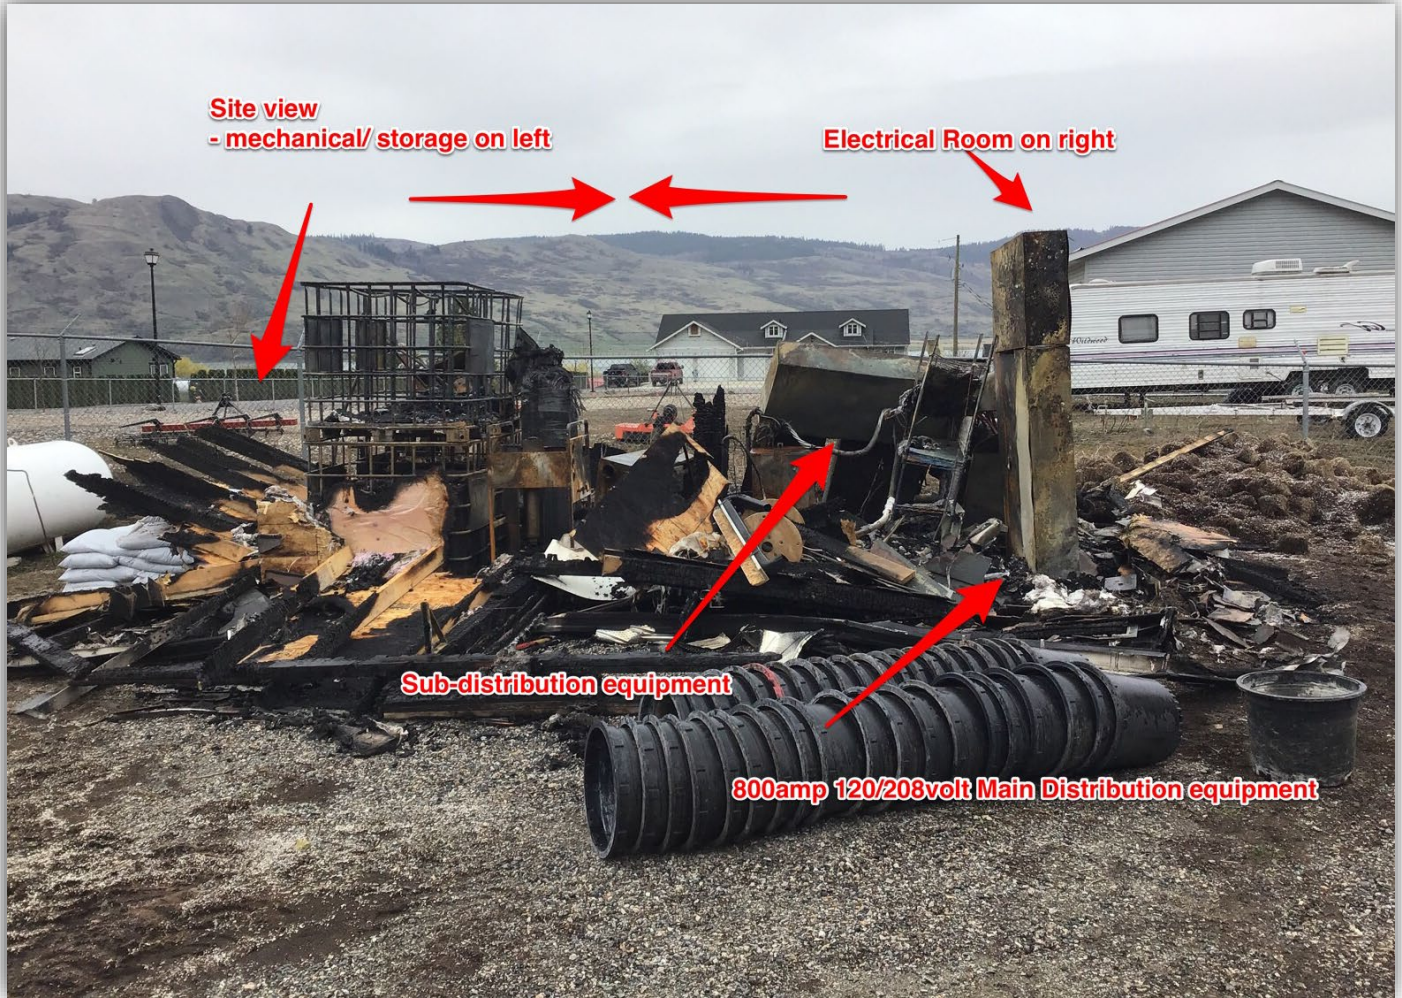
Image 2 – Site view facing south of as-found site review.

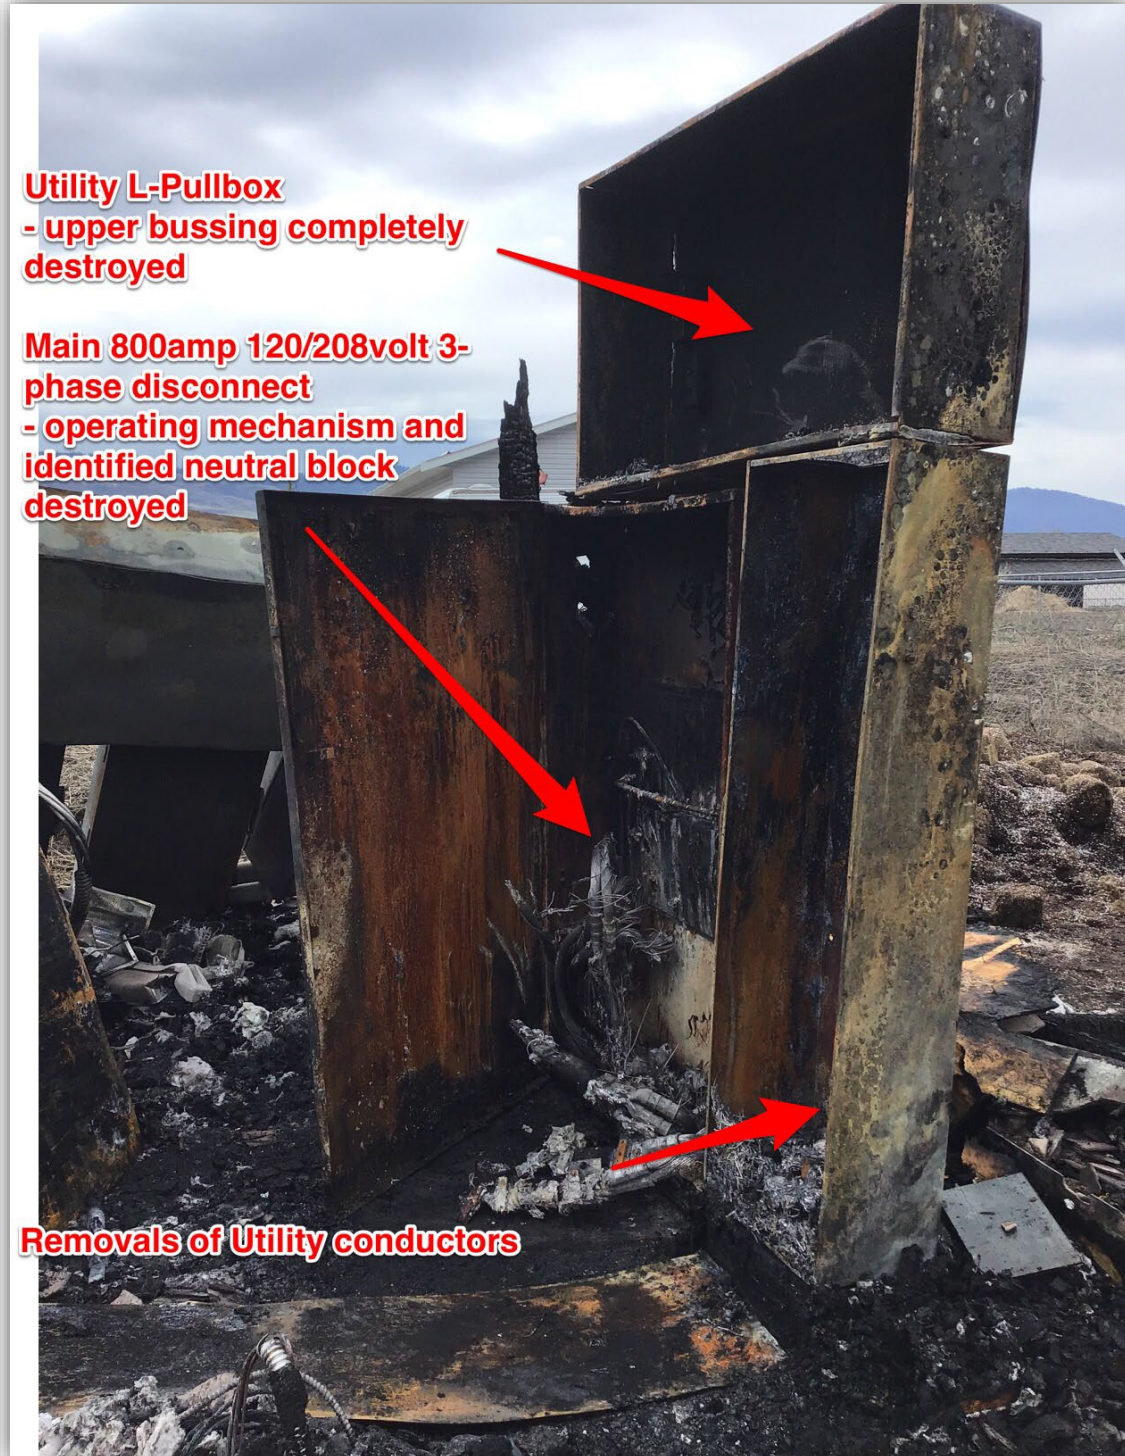
Image 3 – Main Service entrance equipment:

- Vertical Utility pull box/splitter section has all conductors and conductor mounting hardware destroyed. This is where the unfused utility conductors enter the building from the pad mount transformer.
- Upper Utility Pull-box splitter portion has all the 'bussing and conductors destroyed.
- 800amp Main fused disconnect operating hardware and conductors are destroyed.

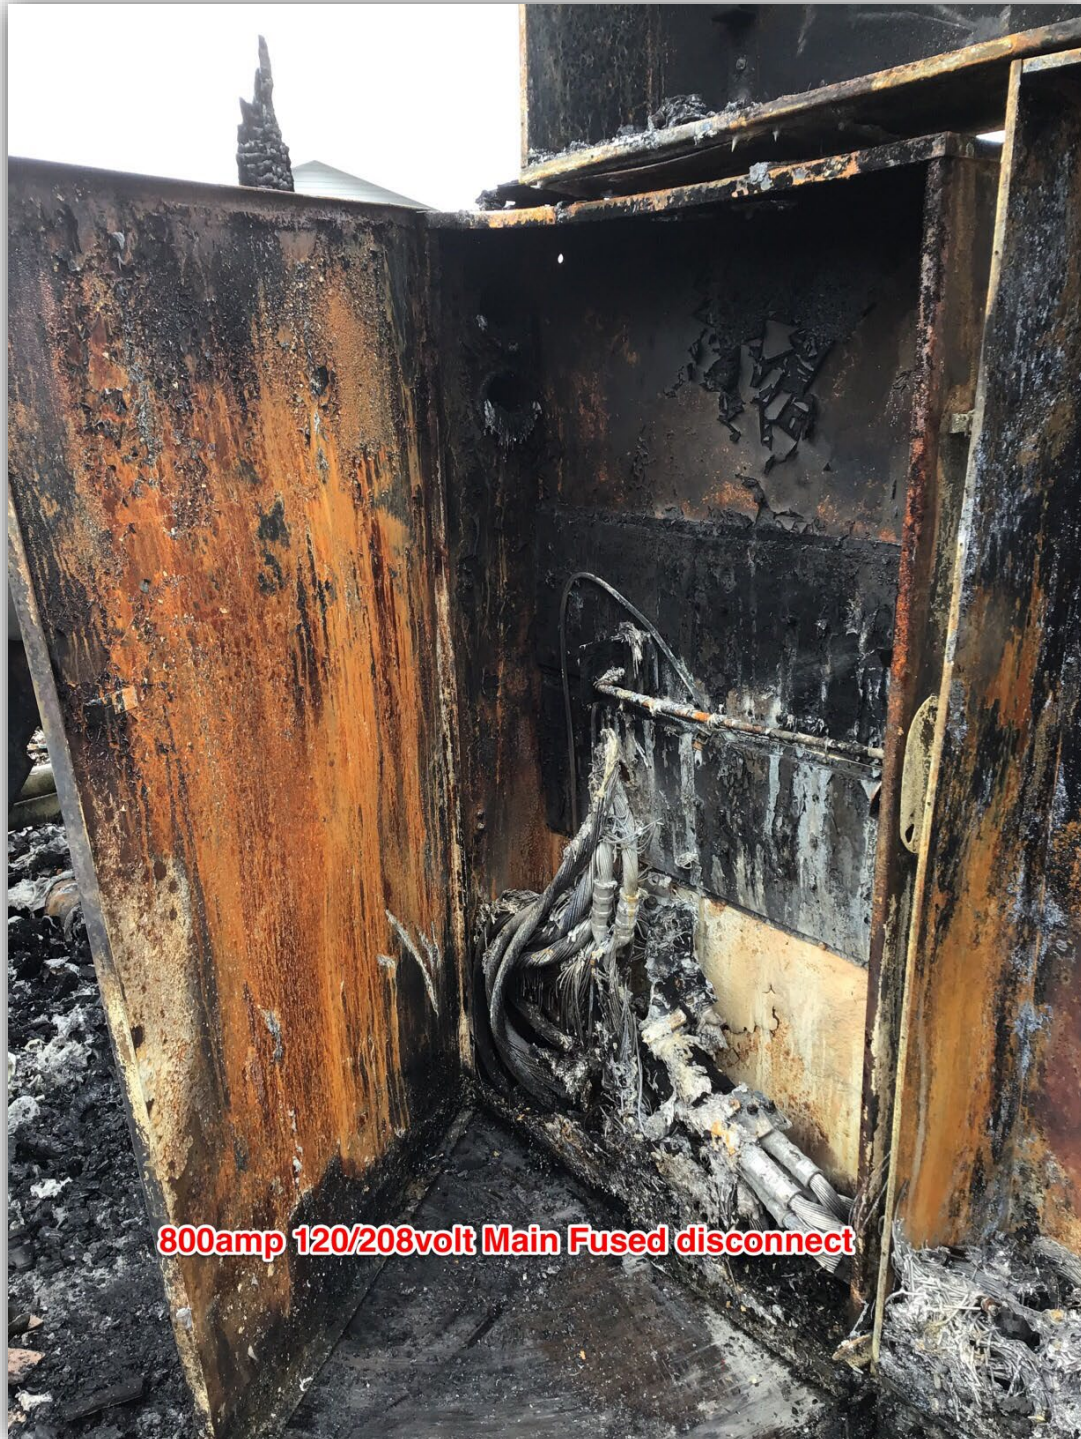
<p>Causes and contributing factors</p>	<p>The cause of the incident likely originated within the main fused disconnect and may be directly related with the operation of the disconnect prior to the incident.</p> <p>Overtime, the safe operation of a fused disconnect switch can be affected by the electrical loading on the fused disconnect switch and the excessive heat within the room that could cause the factory installed grease to dry out on the blades of the fused disconnect switch and/or weaken the spring-operated mechanism causing the fused switch blades to not fully engage/close.</p> <p>The interior connections within the upper utility pull-box may be attributed to the incident as the unfused conductors from the utility transformer may have failed post initial incident which contributed to the faulting creating the heat and flames destroying the rest of the electrical equipment and burning the structure.</p>

Image 4 – Interior of the 800amp fused disconnect switch, with the load side fusing laying in bottom with lugs still attached, all line side operating hardware mechanisms, and all conductors are destroyed.

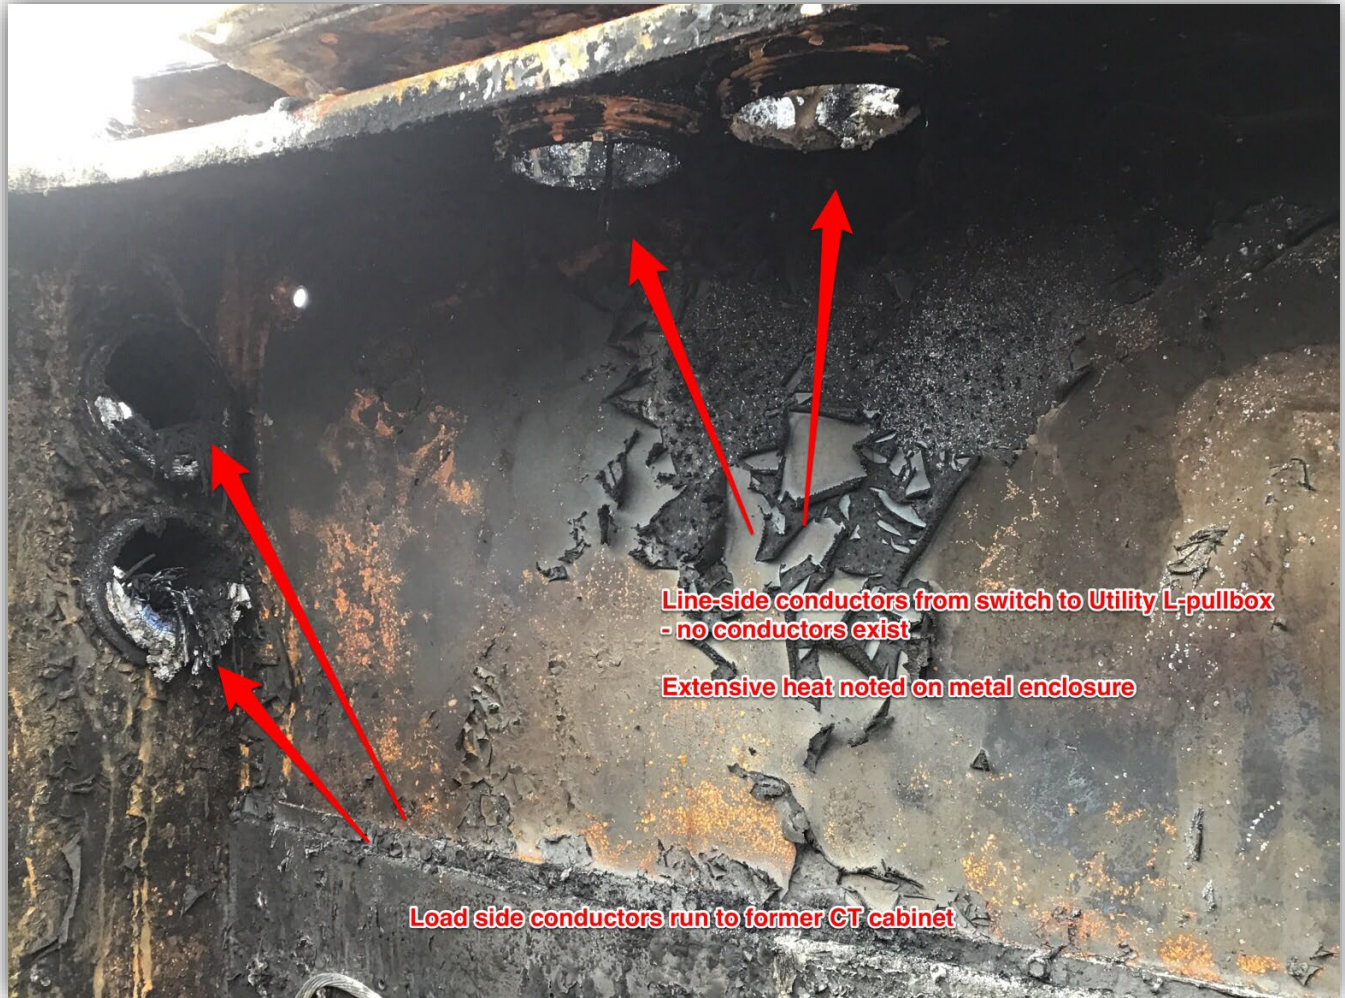
Image 5 – Main Upper interior view of 800amp main fused disconnect switch, all conductors are destroyed, evidence of excessive interior arc-faulting occurrence.

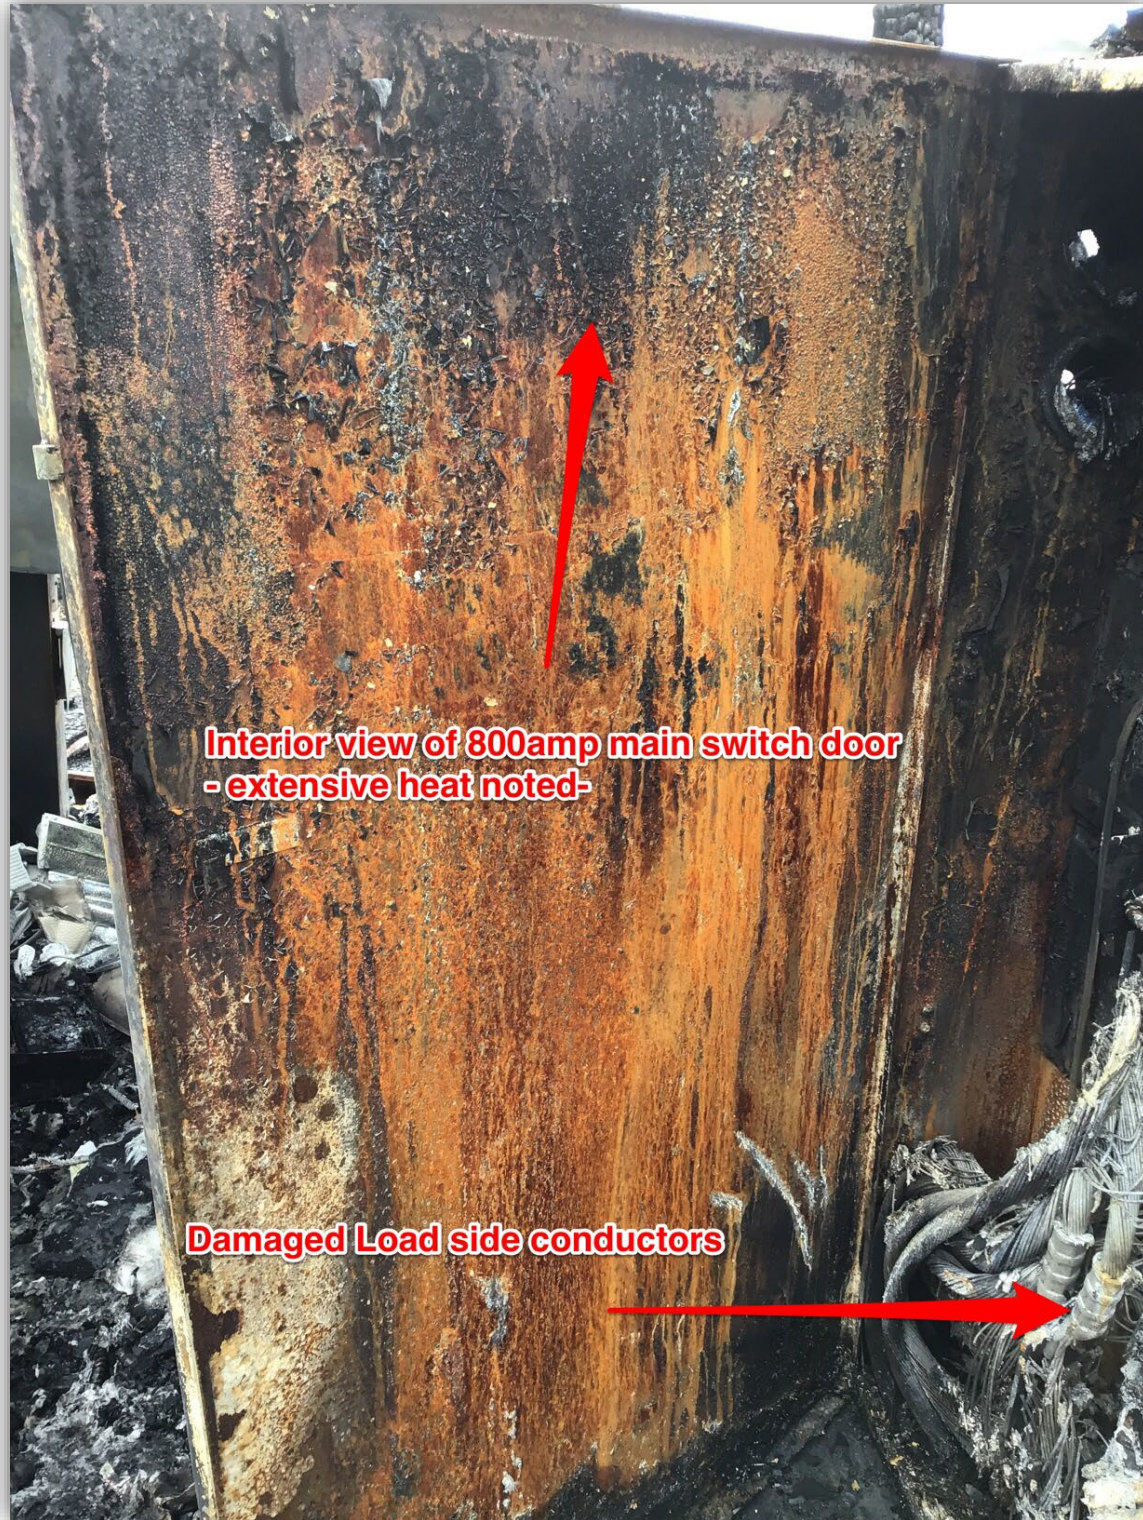
Image 6 – Interior view of 800amp main fused disconnect door providing evidence of arc-faulting occurring within main switch.

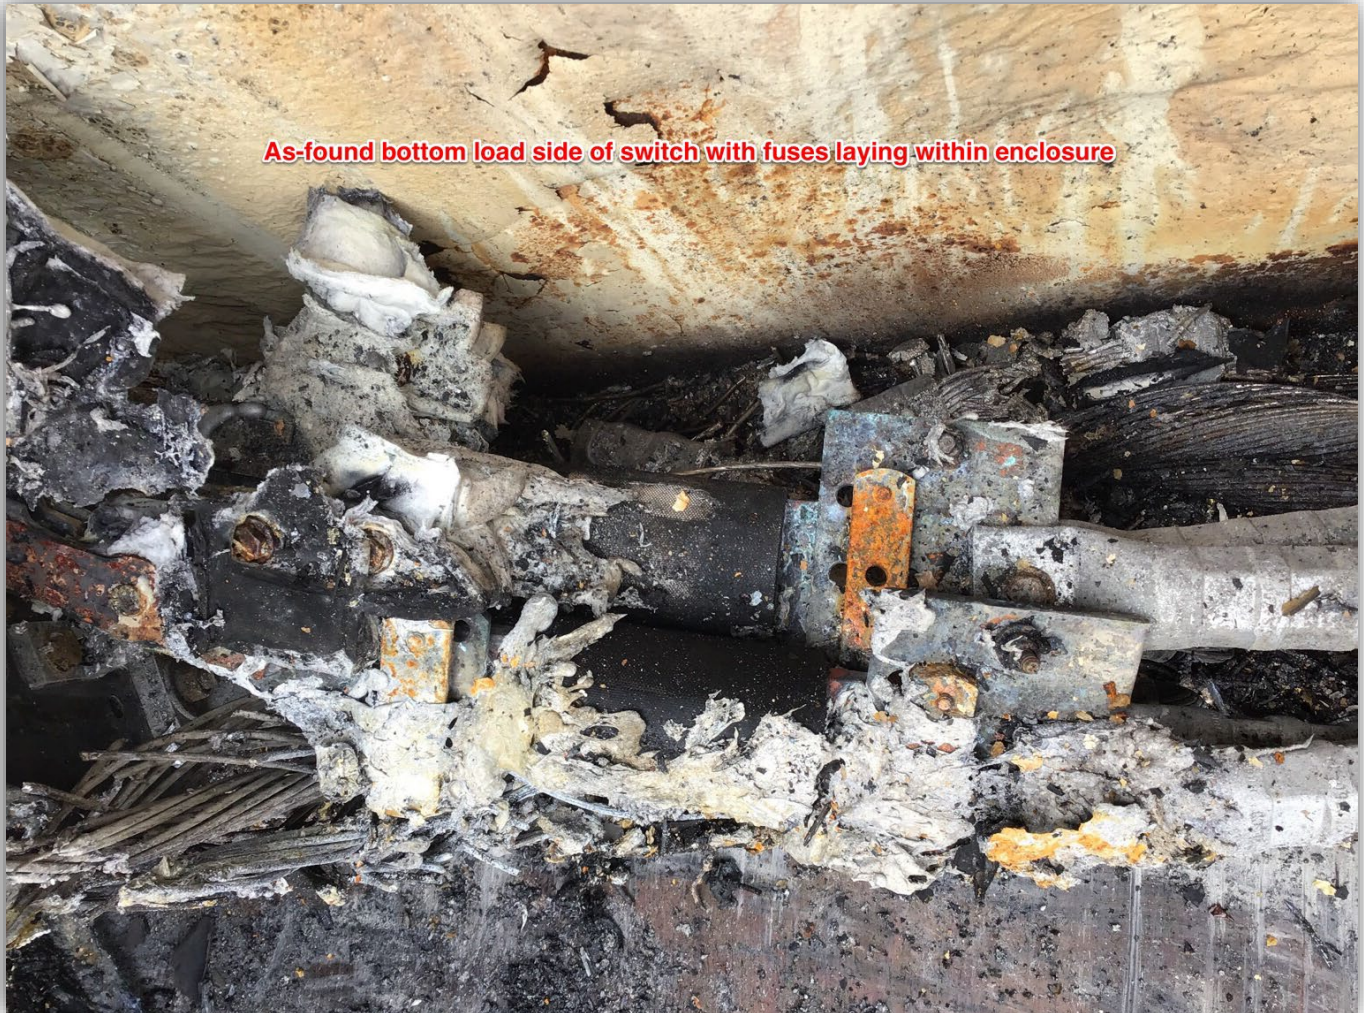
Image 7 – As-found view of fuses laying in bottom of 800amp main fused disconnect switch.

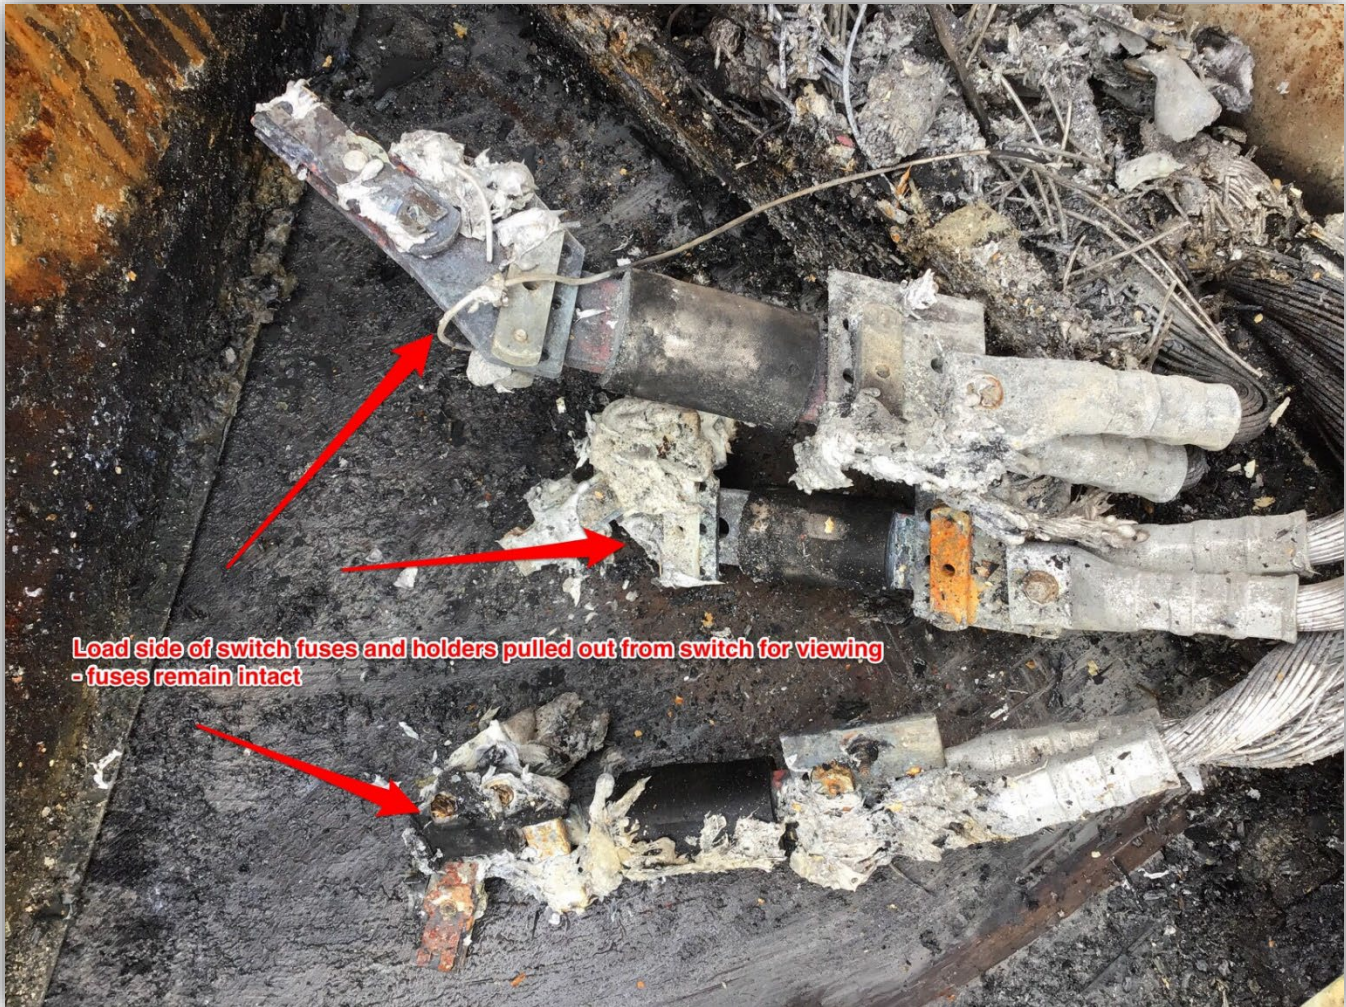
Image 8 – Main 800amp fuses pulled out from disconnect for viewing noting damaged load side fuses/connections remain with partial pieces of switching hardware connect to line side.

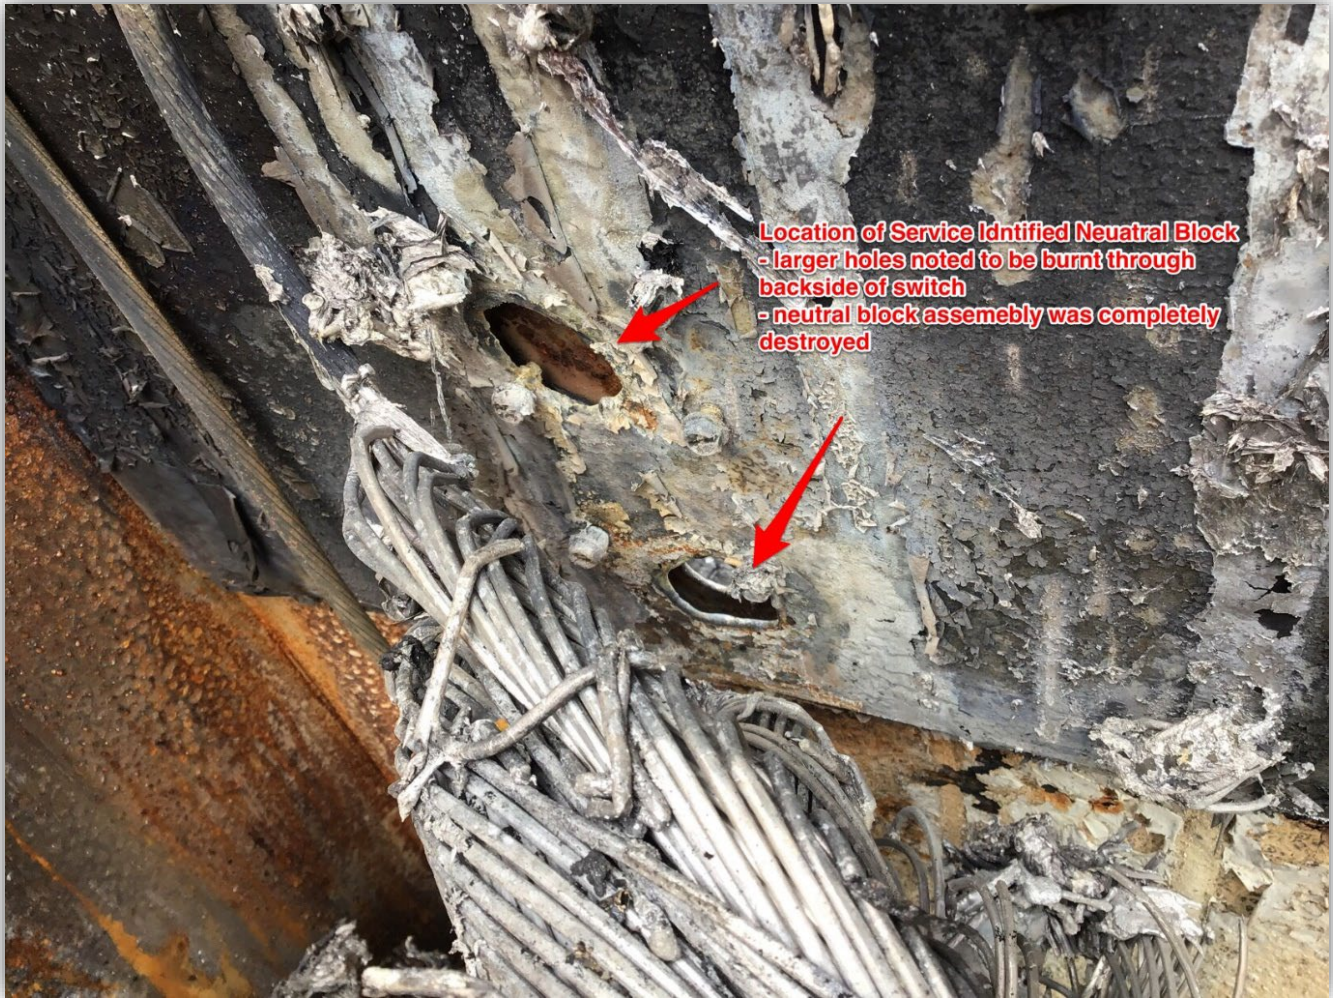
Image 9 – Interior view of main 800amp fused disconnect switch and the location where neutral block would be installed. Excessive heat noted with melting of metal enclosure noted.

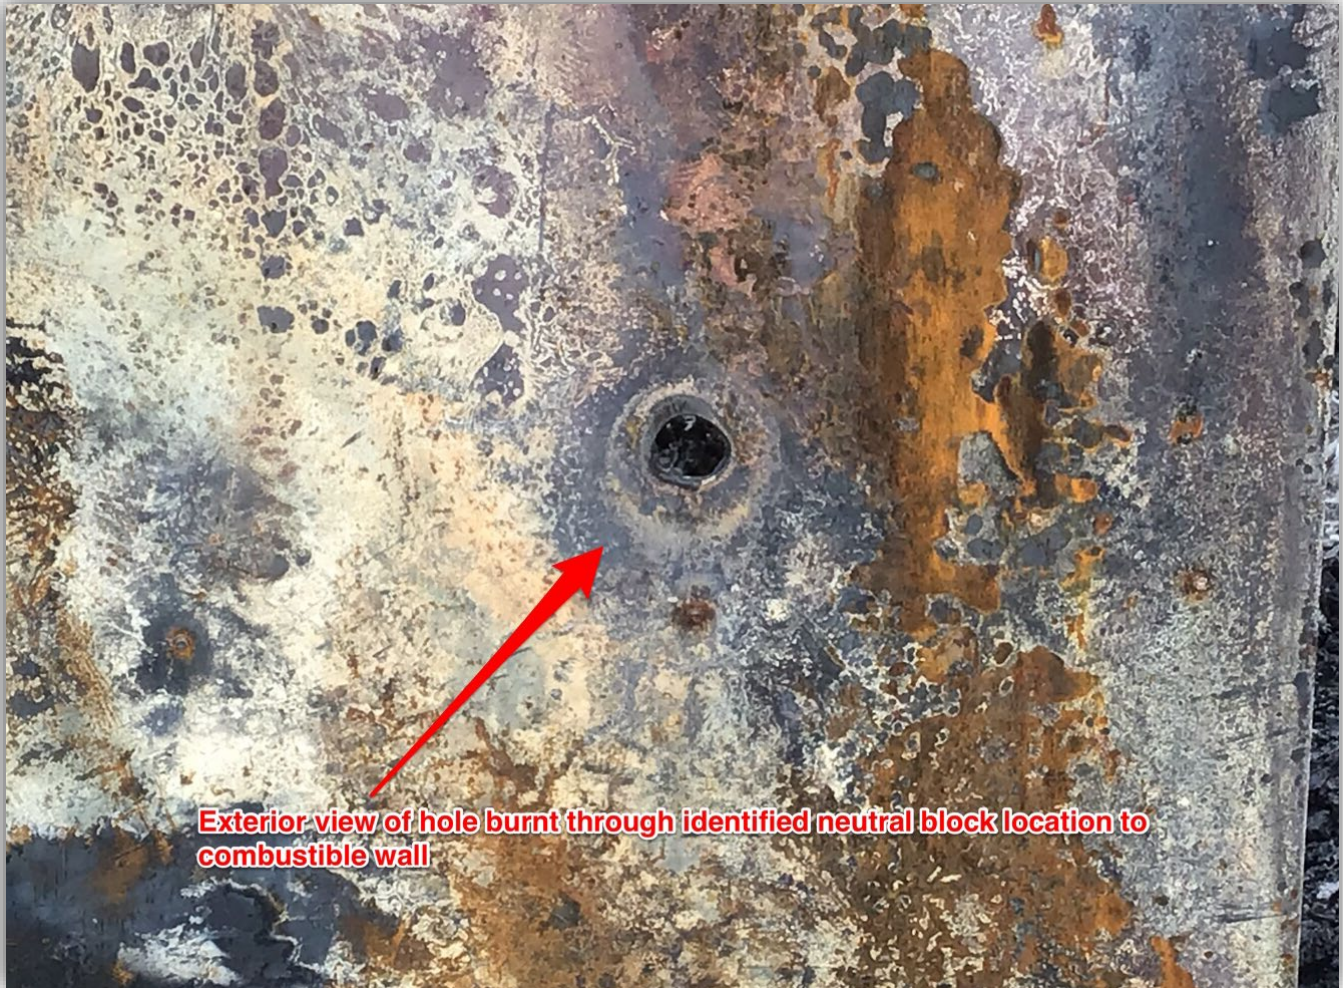
Exterior view of hole burnt through identified neutral block location to combustible wall

Image 10 – Hole burnt through backside of 800amp fused main disconnect switch located at neutral block mounting position.

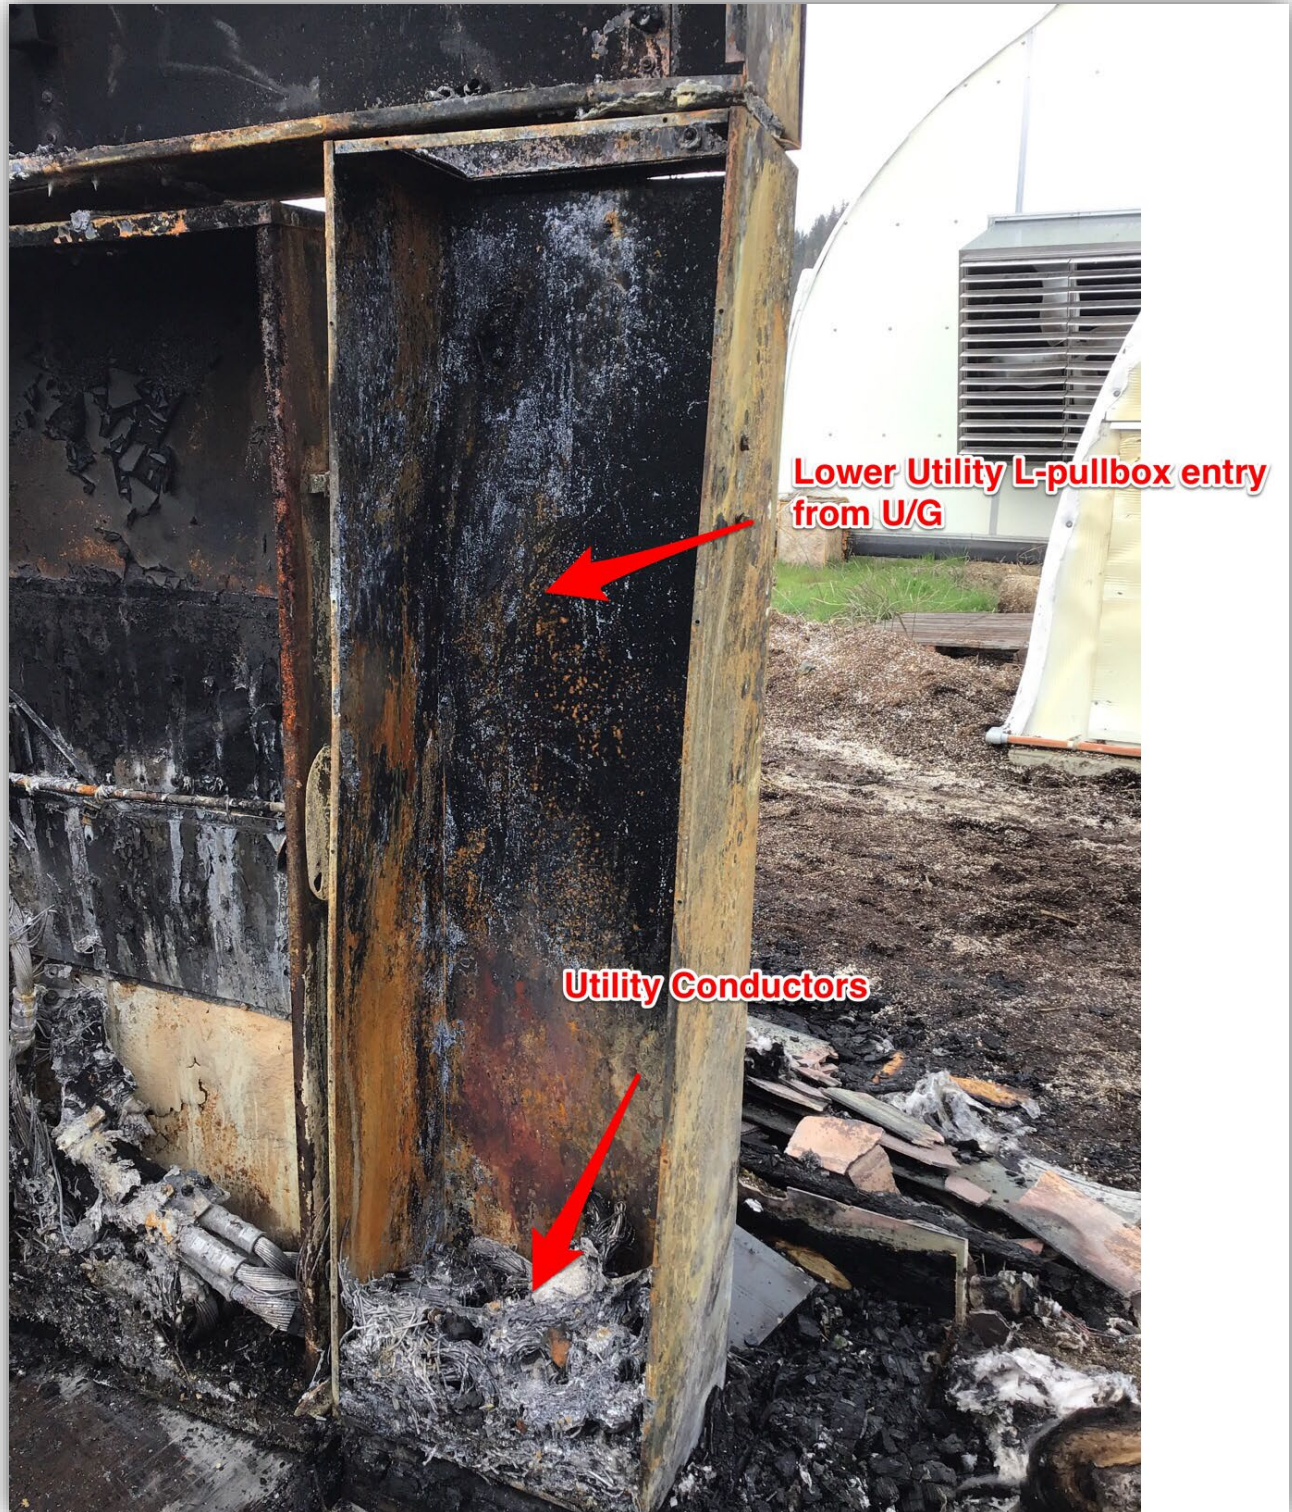
Image 11 – Utility 'L' Pull-box vertical section. This section provides cable mounting blocks for utility to support incoming underground conductors from utility pad mount transformer.

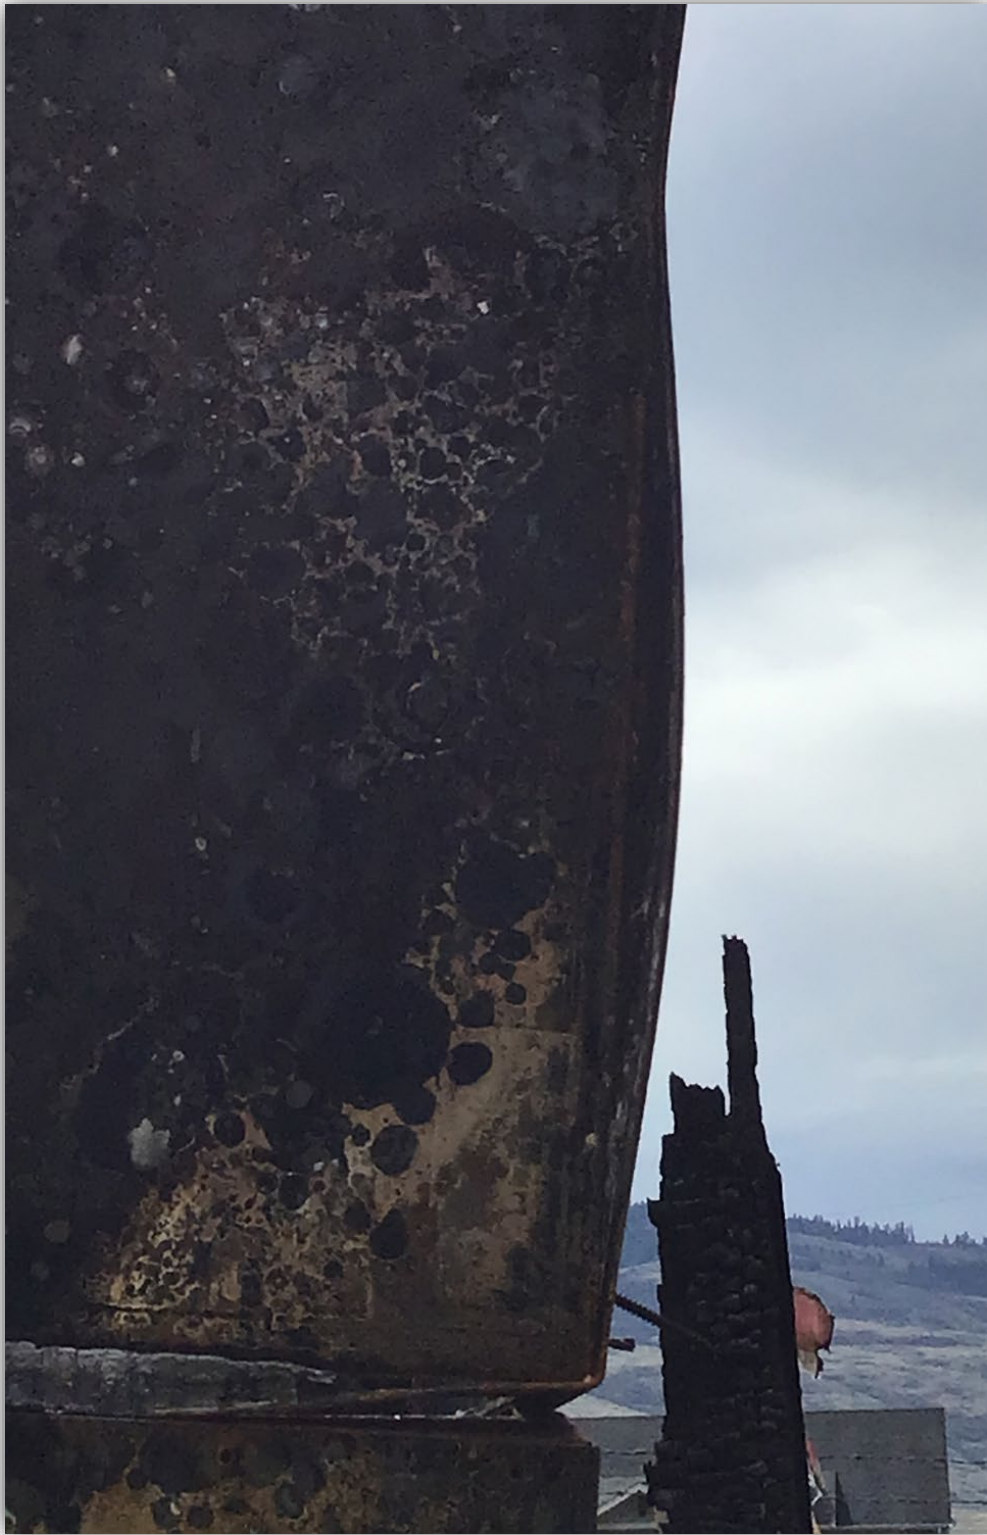
Image 12 – Backside edge view of upper utility pull-box showing signs of deformation from interior fault allowing excessive arcing to release from cabinet. Intense heat within utility L-pull box deformed joints, creating openings for heat/sparks/flames to escape to combustible walls.

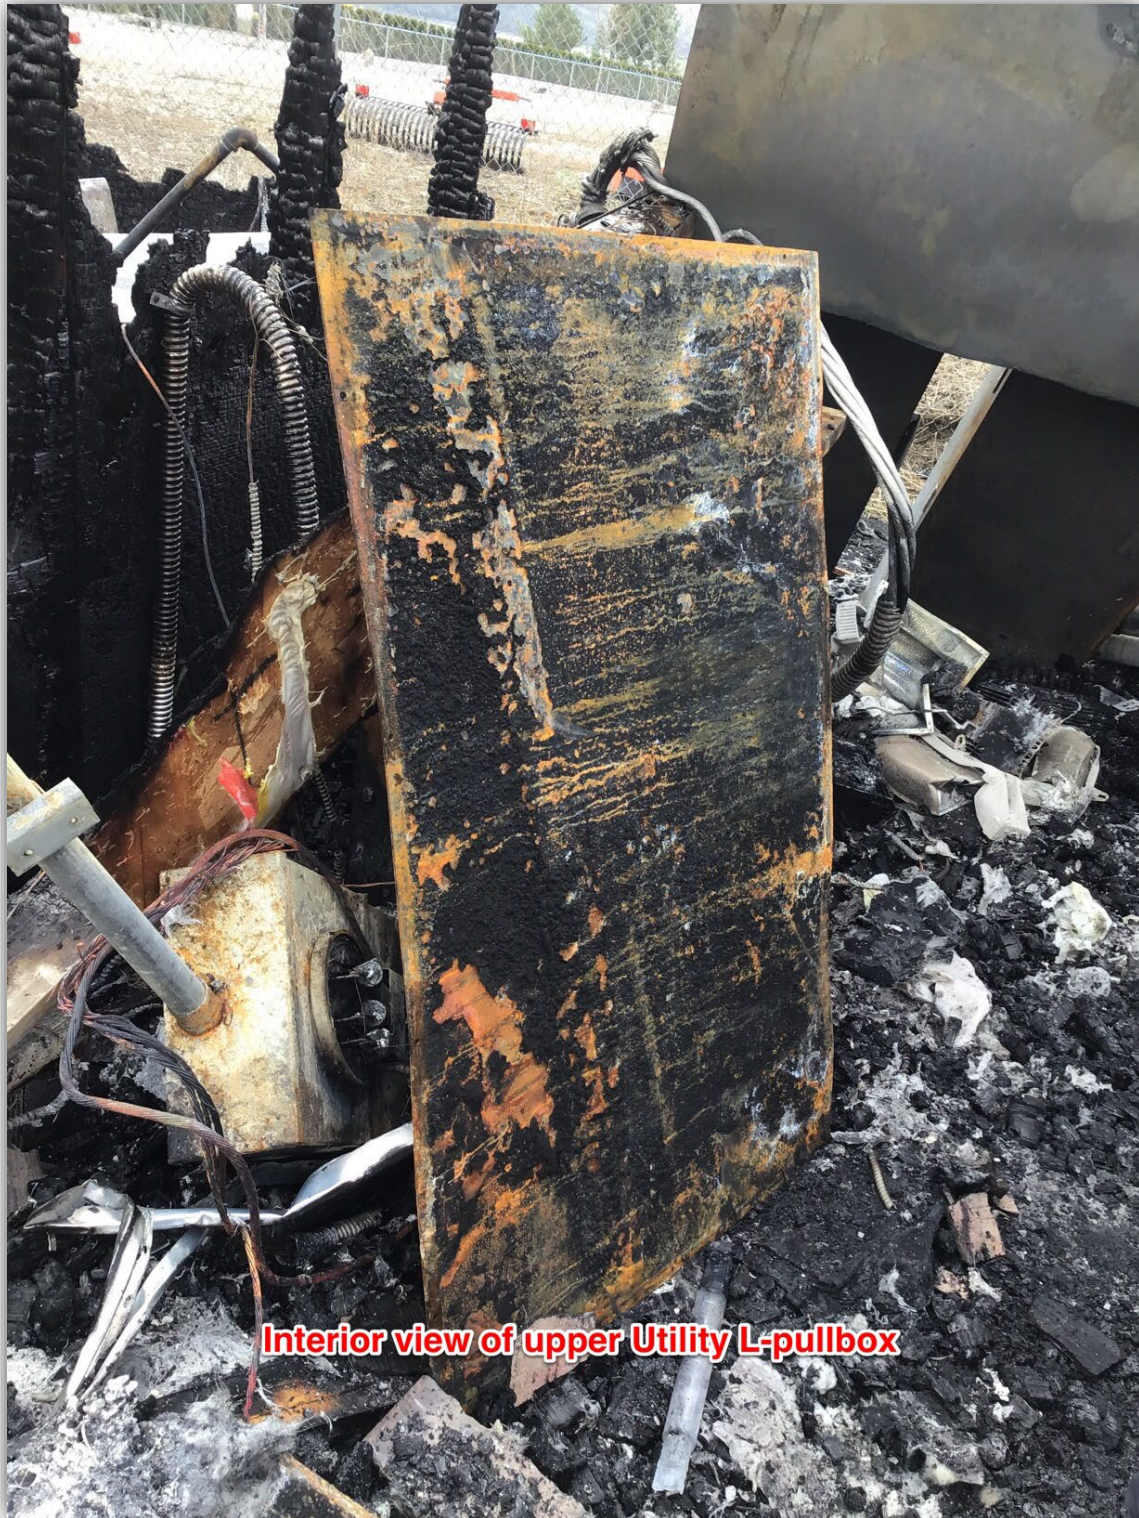
Image 13 – View of interior of upper utility pull box showing excessive interior electrical faulting.

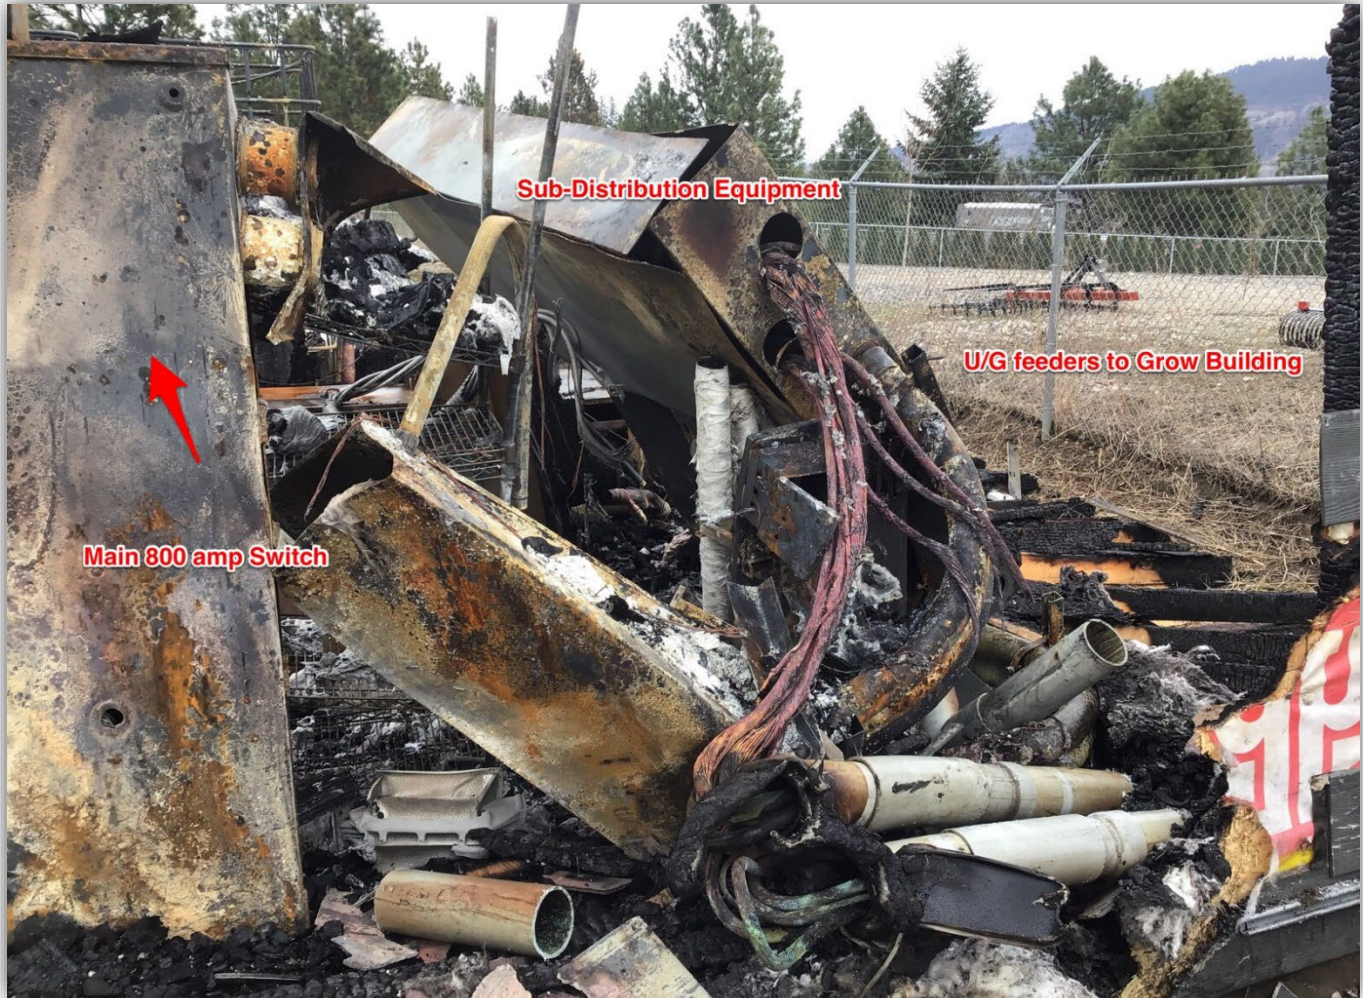
Image 14 – View from outside of the electrical room building on the westside, showing the damage to the sub-distribution equipment, the existing splitter and feeder conductors. Main 800amp fused disconnect switch viewed on left, and utility CT cabinet at lower mid area fell during fire.
