Incident Summary #II-1539440-2023 (#34696) (FINAL)

SUPPORTING INFORMATION	Incident Date	April 23, 2023	
	Location	Vernon	
	Regulated industry sector	Electrical - Low voltage electrical system (30V to 1000V)	
	Impact	Qty injuries	0
		Injury description	N/A
		Injury rating	None
	Damage	Damage description	A detached electrical service building had a fault that caused a fire and destroyed the structure and regulated electrical equipment.
		Damage rating	Major
	Incident rating	Major	
Incident overview	A fire ignited in a detached structure that housed an 800amp 120/208volt electrical service and sub-distribution equipment on west half of structure and a mechanical room on east half of structure that provided power to an agricultural operation in a separate detached building. The fire destroyed the building, the regulated electrical equipment and the utilities pad mount transformer and cabling.		
INVESTIGATION CONCLUSIONS	Site, system and components	An 800amp 120/208 volt 3-phase 4-wire service and sub-distribution was in a detached and dedicated service building and used to provide power to various distribution panel boards located in a separate structure to operate lighting, heating/c

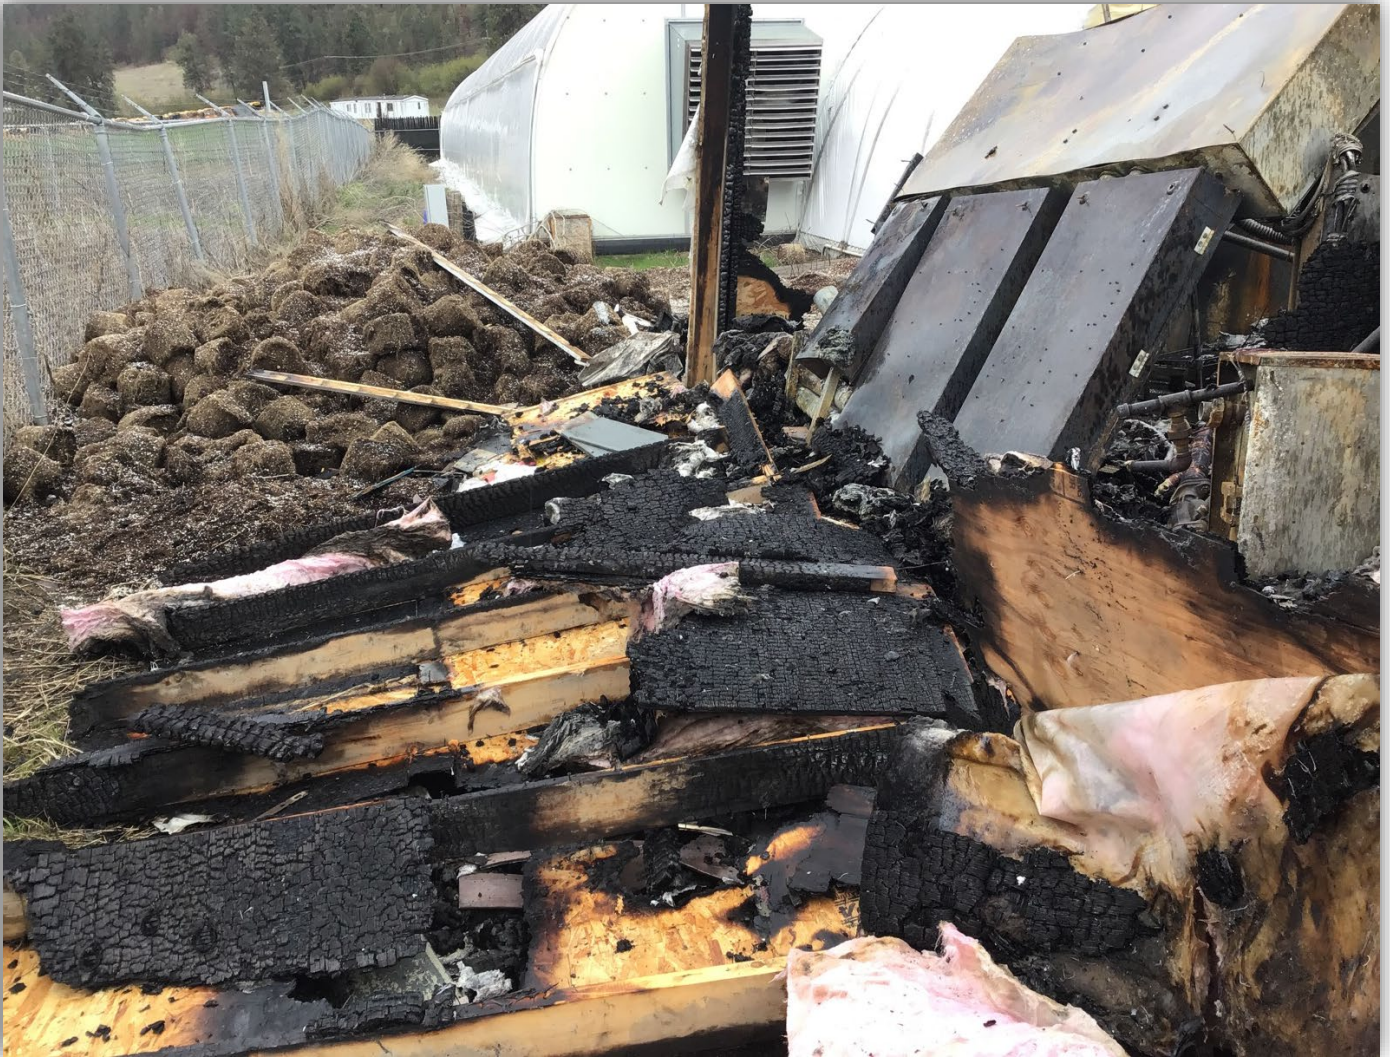
Image 15 – South backside exterior wall of electrical room that sub-distribution was secured to laying on ground with studs and sheathing showing fire damage with areas not burnt.

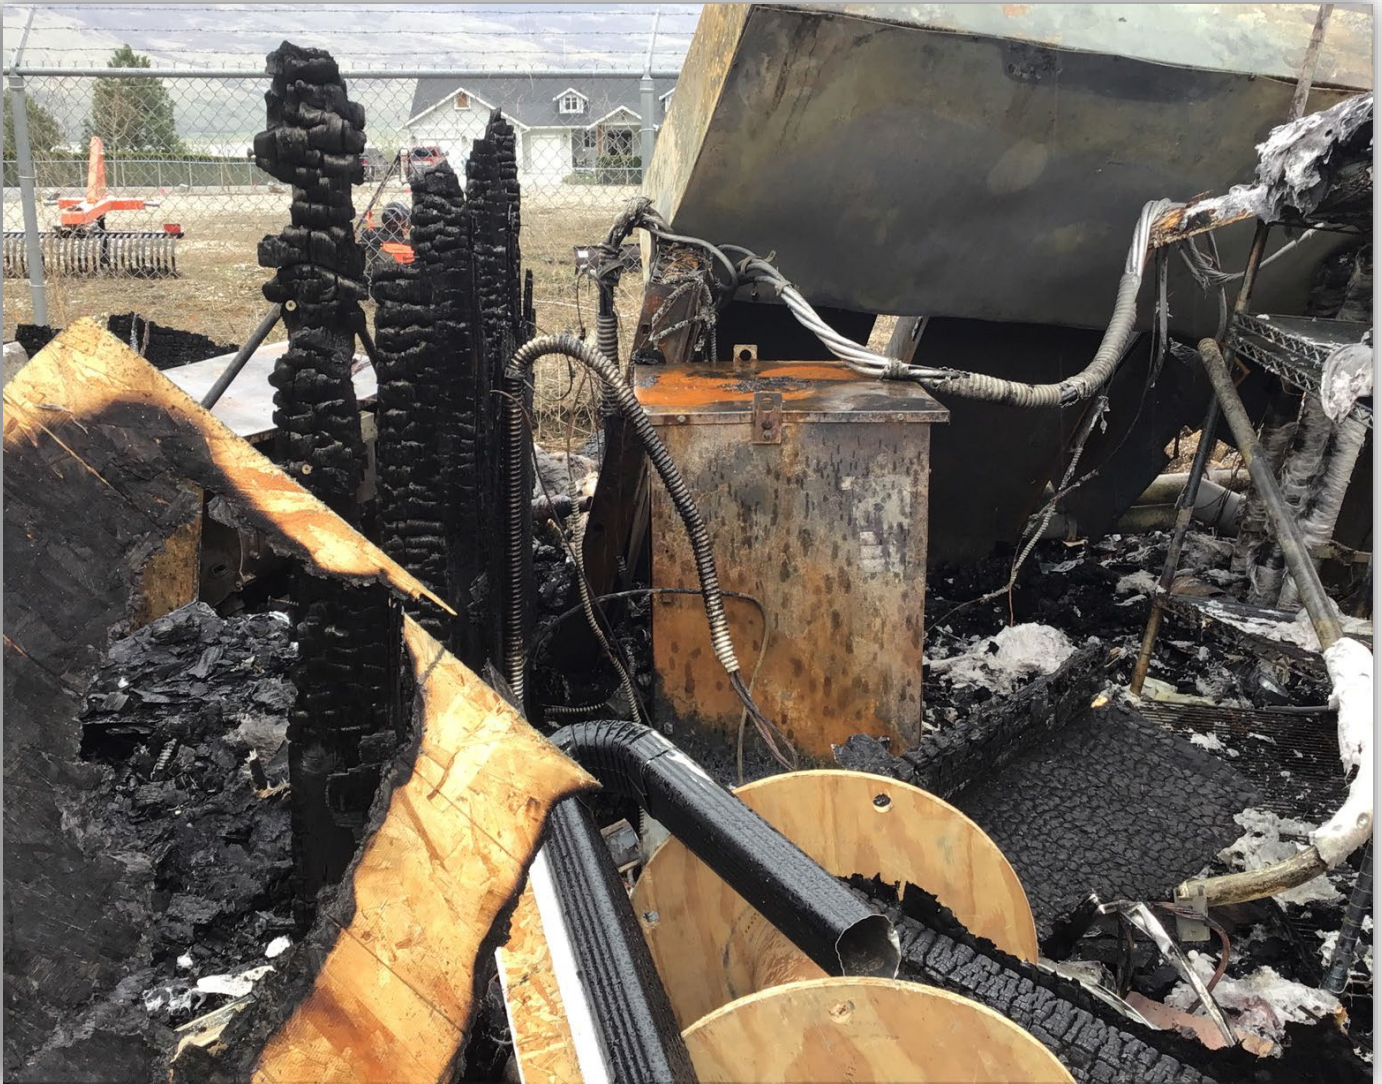
Image 16 – Internal view of electrical room looking south note burnt studs to left standing which was the separation wall between electrical and mechanical areas of the structure.

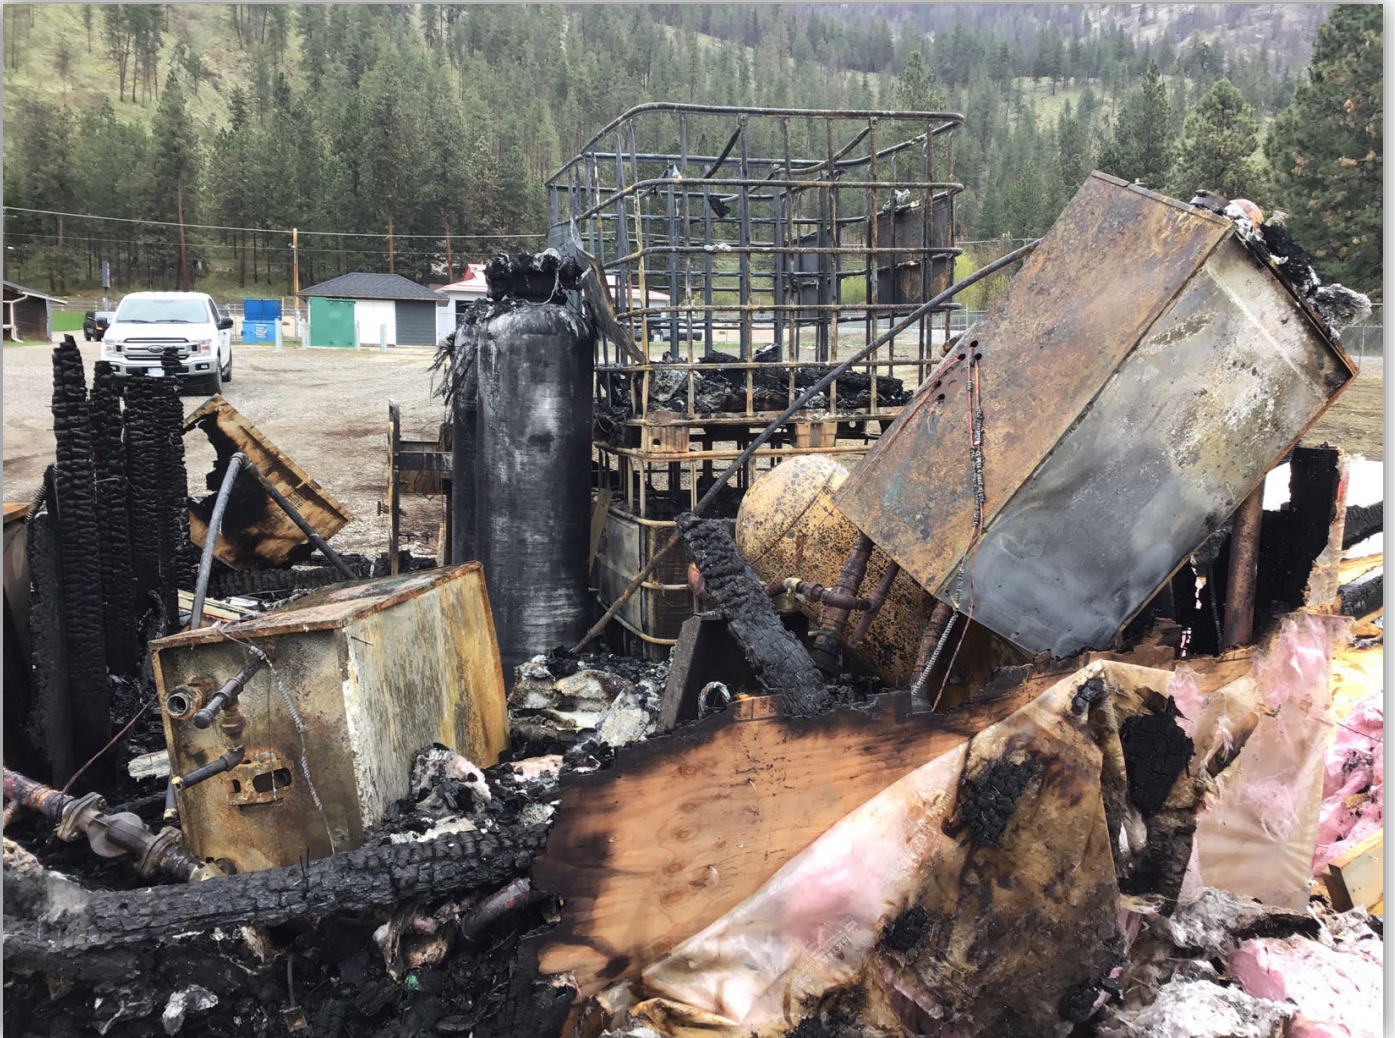
Image 17 – View of Mechanical room from south side, evidence of structure plywood and insulation not fully destroyed. Boiler noted at upper-right of photo. Metal water racks still standing, plastic interior water containers destroyed.
