## Incident Summary #II-934425-2019 (#15805) (FINAL)

SUPPORTING INFORMATION	Incident Date	October 24, 2019	
	Location	Mara	
	Regulated industry sector	Electrical - Low voltage electrical system (30V to 750V)	
	Impact	Qty injuries	0
		Injury description	N/A
		Injury rating	None
	Damage	Damage description	A fire was found on an exterior wall of a dwelling where a Generator was located with a coolant heater cord plugged in. The fire extended to within the wall space and damaged various electrical and structure
		Damage rating	Minor
	Incident rating	Minor	
	Incident overview	A fire that caused damage to an exterior receptacle where a 1500watt generator coolant heater was plugged into burnt the exterior and interior wall with additional interior wiring for a Hot Tub, exterior Air Conditioning unit and speaker wiring were badly damaged	
INVESTIGATION CONCLUSIONS	Site, system and components	<p>A dwelling had</p> <ul style="list-style-type: none"> <li>A- a 17kw 120/240volt back up Generator installed that had a 1500watt 120volt coolant heater with thermostatic control installed to keep the Generator block warm to allow the Generator to start within a safe operating temperature to provide

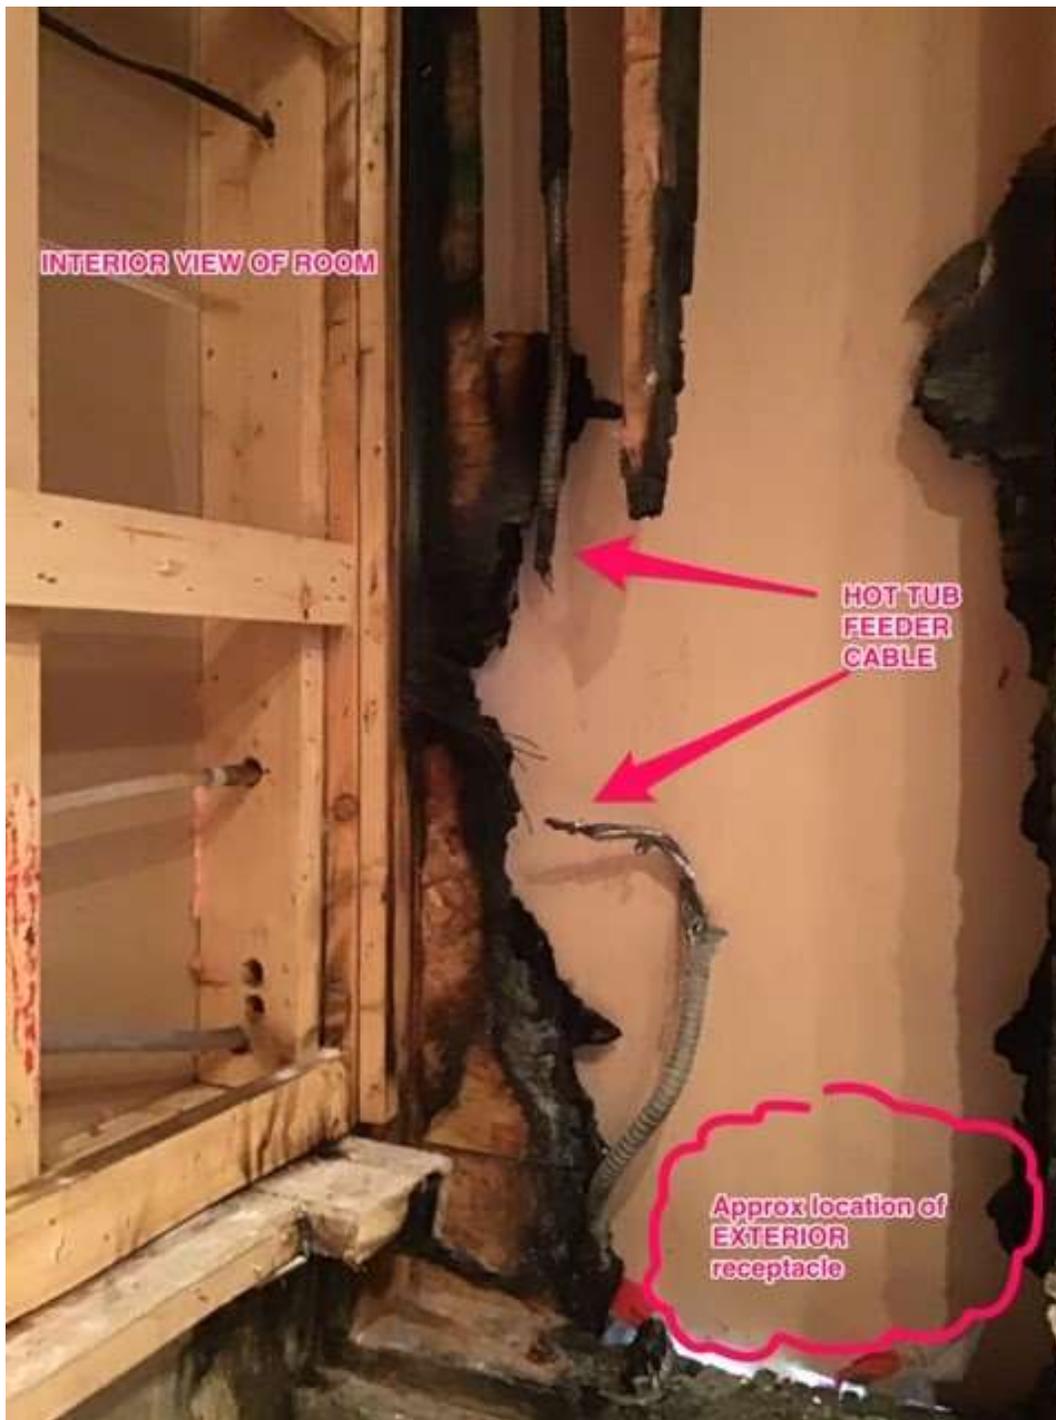
Interior view of wall, various pieces of evidence have already been disturbed. Exterior wall has plywood installed to close off the exterior.

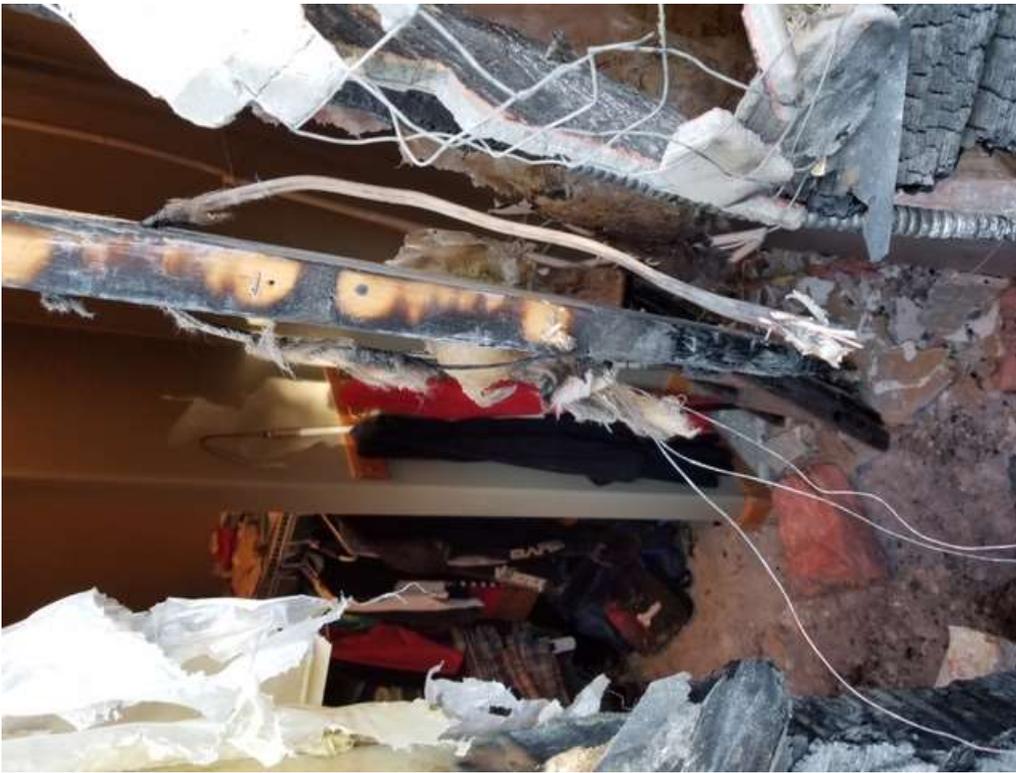
photo provided by Contractor showing pic from exterior of dwelling. The Hot Tub cable is burnt off at below right side of photo and the exterior receptacle branch circuit cable is strung through burnt stud

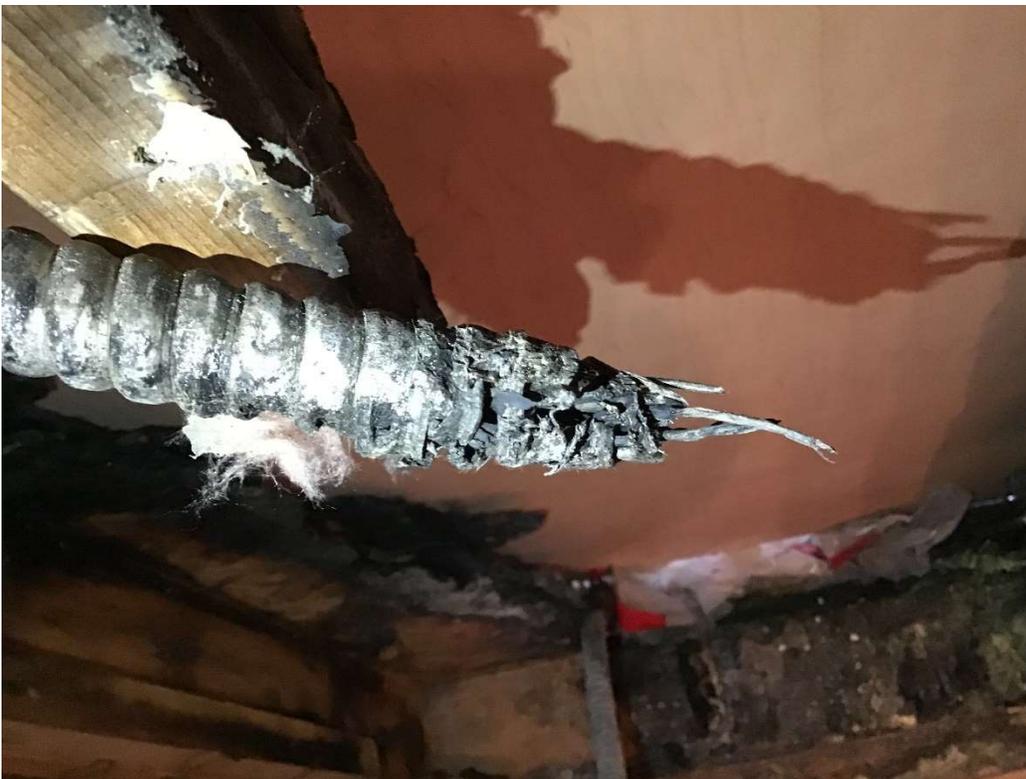
- Interior wiring of speaker wiring not applicable
- Interior wiring of Hot Tub feeder cable badly damaged Approx 4-5'. The damage to the Hot Tub feeder is significant with excessive signs of heat/ arcing noted. The armour of the cable is missing approx. 600-900mm, conductors shorted.

2- HOT TUB BRANCH CIRCUIT CABLE, The option of the Hot Tub cable is less likely the issue but cannot be ruled out due to the damage of the cable was significant in comparison to the wood structure damage. Once the power was restored, the Hot Tub was cooled and required the 44amps of power when the cable faulted within the wall shorting and causing the fire fitting with the time frame of the fire starting

Hot Tub feeder 'line side' of cable melted with approx. 600-900mm of armour melted away and cables fused together

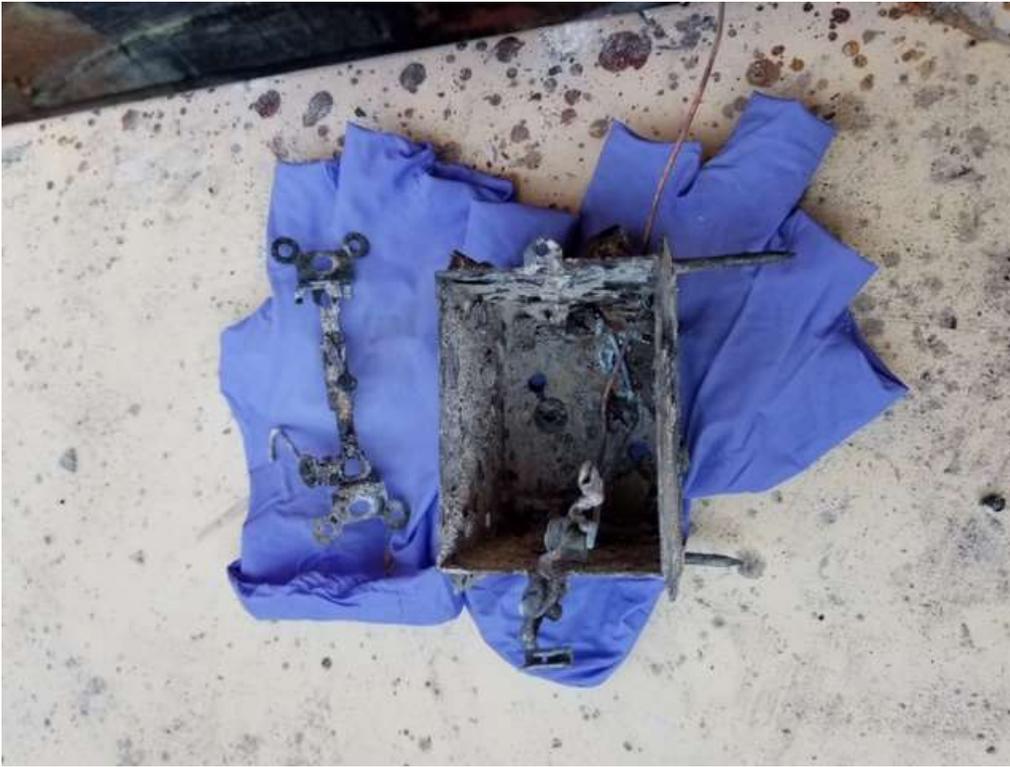
- Call was received by Fire/Rescue approx. 1-1.5 hours after power was restored
- The location of the exterior receptacle was no longer attached however pics of the receptacle provided significant damage with receptacle completely destroyed however a green tinge was noted on the bonding conductor which applies evidence of possible oxidization

1- EXTERIOR RECEPTACLE (A) initiated by an faulty cord connection to the exterior receptacle. The damage of the receptacle has slight green tinge noted on the conductor and this may have been evidence that the cord connection 24hours/ day created some oxidization from moisture and this could have led to a poor electrical contact on the receptacle and/or (B) the heater 'was' utilizing power and overheated the cord connection or

remains of exterior receptacle box. Slight tinge of green noted on copper conductor near the bottom of the pic showing possible signs of oxidization.

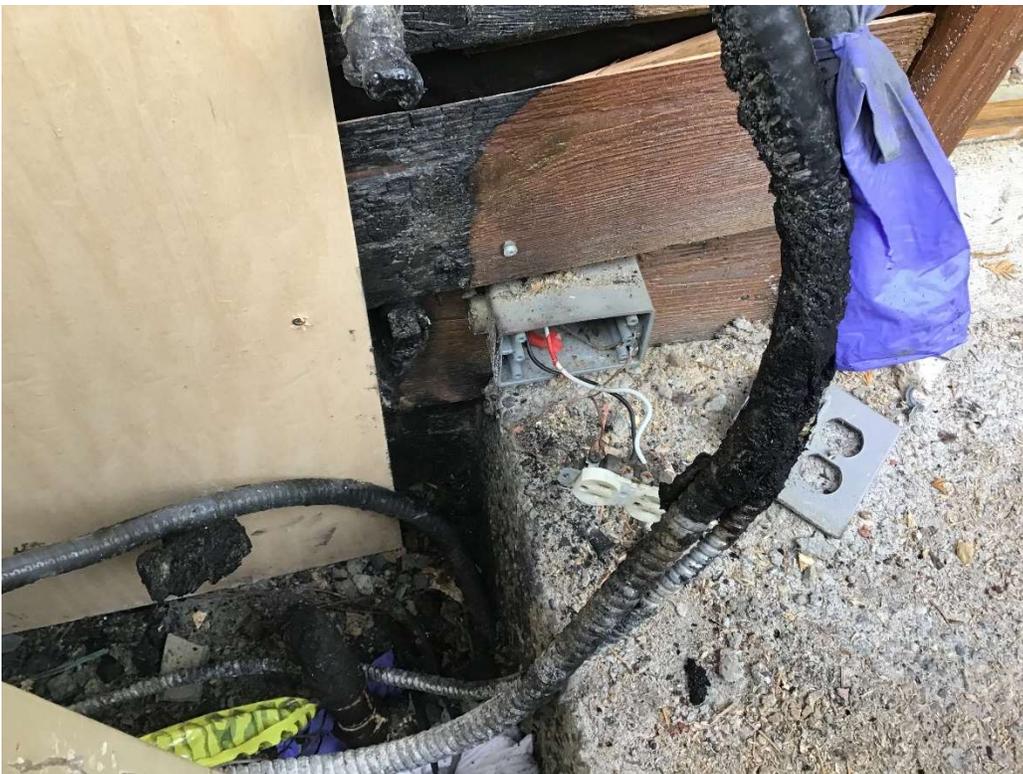
Exterior view of installed Block heater receptacle 'not used' opened up, and Air Conditioning cable damaged

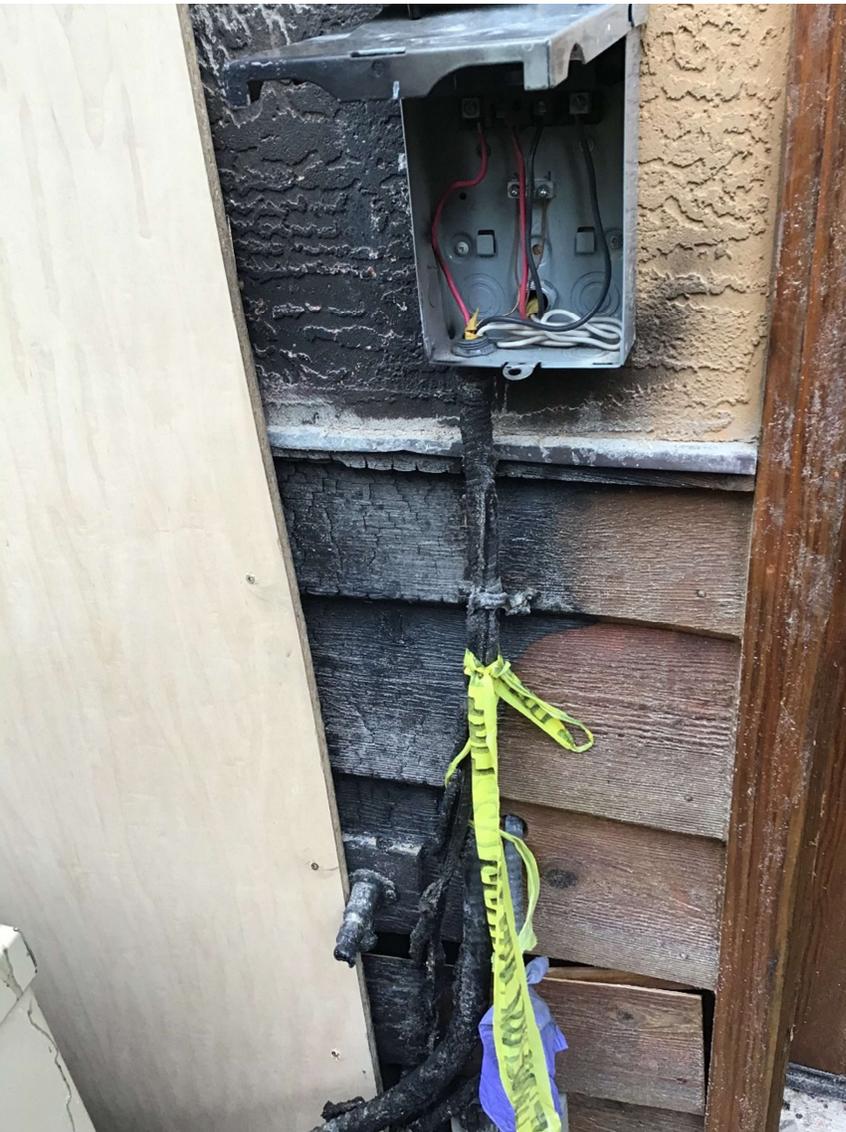
Air Conditioning disconnect location next to Generator, load side cable fire damaged

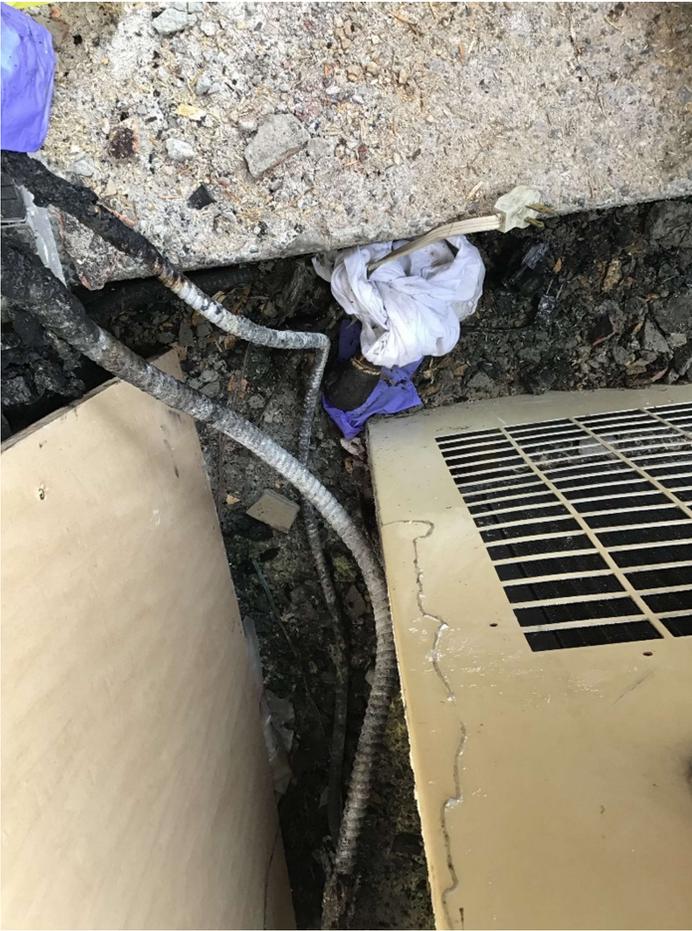
downward view between the generator and exterior wall. Cables damaged shown include the generator power feed (larger one) and the Air Conditioner cable (smaller one). The Generator location is approx. 10"-12" from dwelling exterior wall

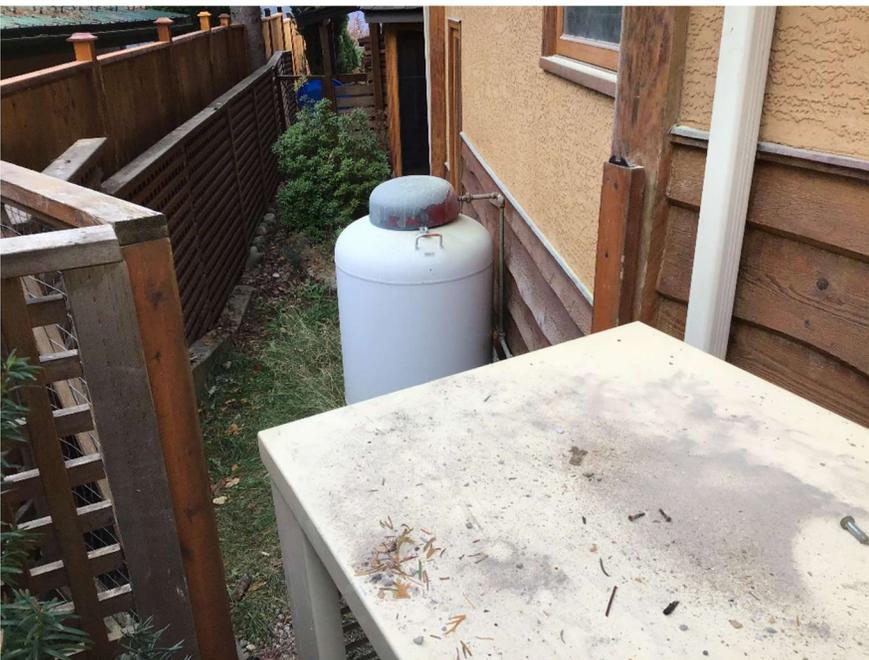
general view down side of house past point of ignition. Generator shown at bottom of picture

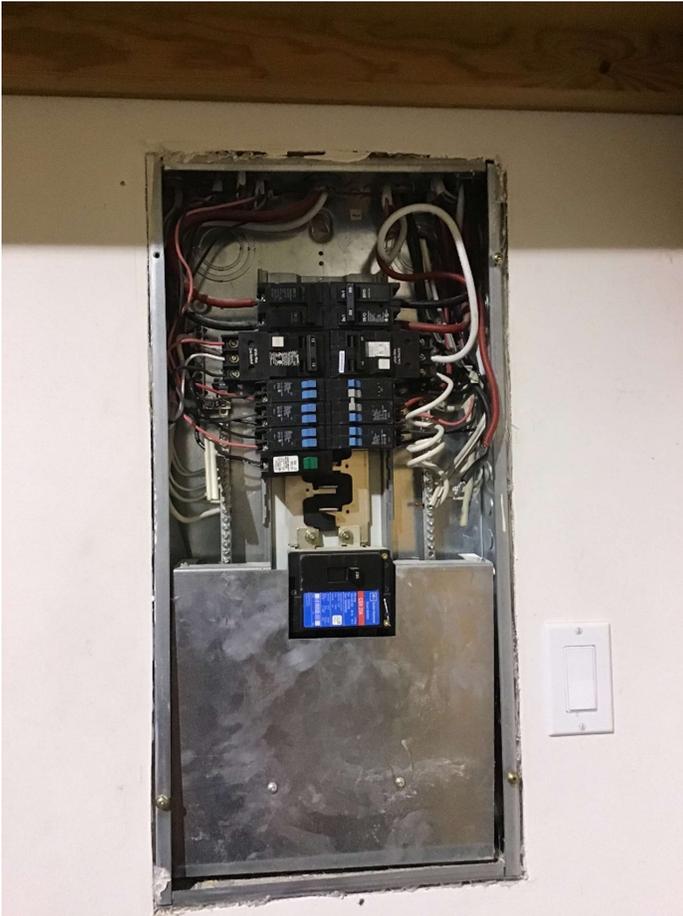
Main Electrical Panel located in garage.

- Existing 15amp 120volt exterior receptacle circuit used to power generator coolant heater
- Sub-feed for back up power panel
- 2p60amp GFCI for Hot Tub

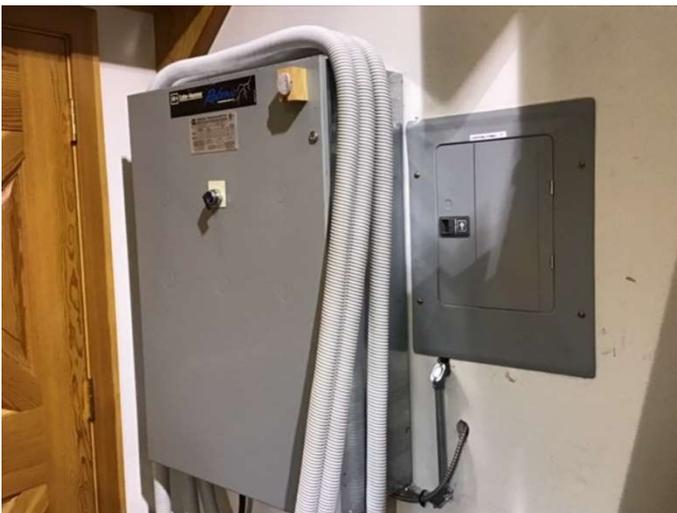
Back up power Auto-transfer Switch and panelboard located just inside door exiting to Generator location.
