## Incident Summary #II-1458612-2022 (#30234) (FINAL)

SUPPORTING INFORMATION	Incident Date	October 27, 2022	
	Location	Saltspring Island, BC	
	Regulated industry sector	Electrical - Low voltage electrical system (30V to 750V)	
	Impact	Qty injuries	0
		Injury description	none
		Injury rating	None
	Damage	Damage description	Smoke, arcing and melting of metal and melted breaker in main distribution panel
		Damage rating	Moderate
	Incident rating	Moderate	
	Incident overview	Breaker for heat pump branch circuit overheated and melted. Main buss in distribution panel also melted.	
INVESTIGATION CONCLUSIONS	Site, system and components	<p><b>Site:</b></p> <p>Single family dwelling 3900 square feet approximately 13 years old. 200-Amp / 240-Volt overhead service with 200-Amp combination distribution panel located in utility room within dwelling.</p> <p><b>Components:</b></p> <ul style="list-style-type: none"> <li>• Combination distribution panel 200-Amp / 240-Volt (<a href="#">Photo 1</a> and <a href="#">2</a>)</li> <li>• Two push-on type quad breakers with two 15-Amp circuits and one two-pole 40-Amp circuit</li> <li>• #8 AWG 2 wire NMD90 copper conductors rated for 50-Amps</li> <li>• 3R ra

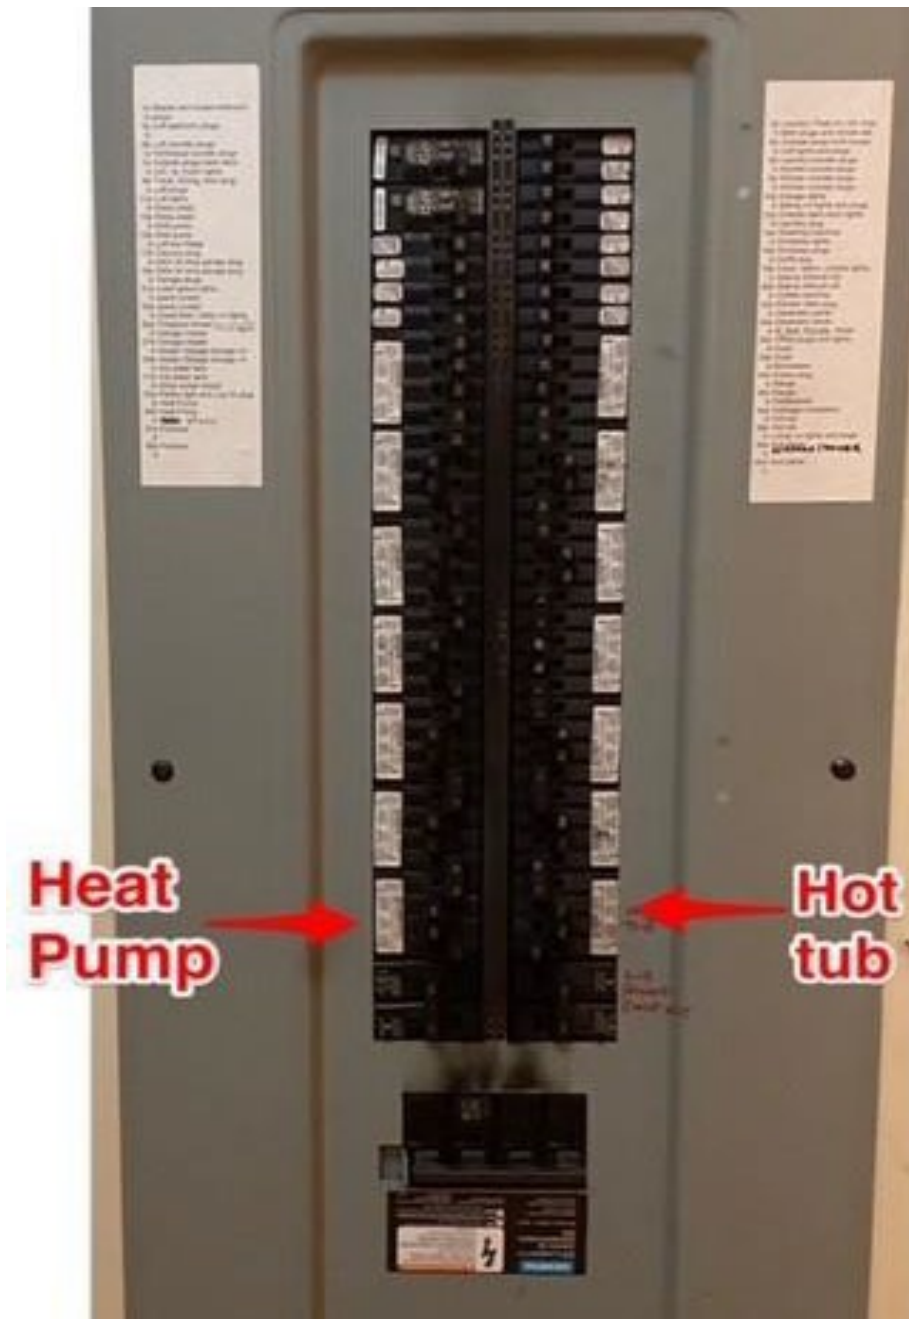
Photo 1 – 200-Amp combination distribution panel. Smoke damage visible above main 200-Amp breaker

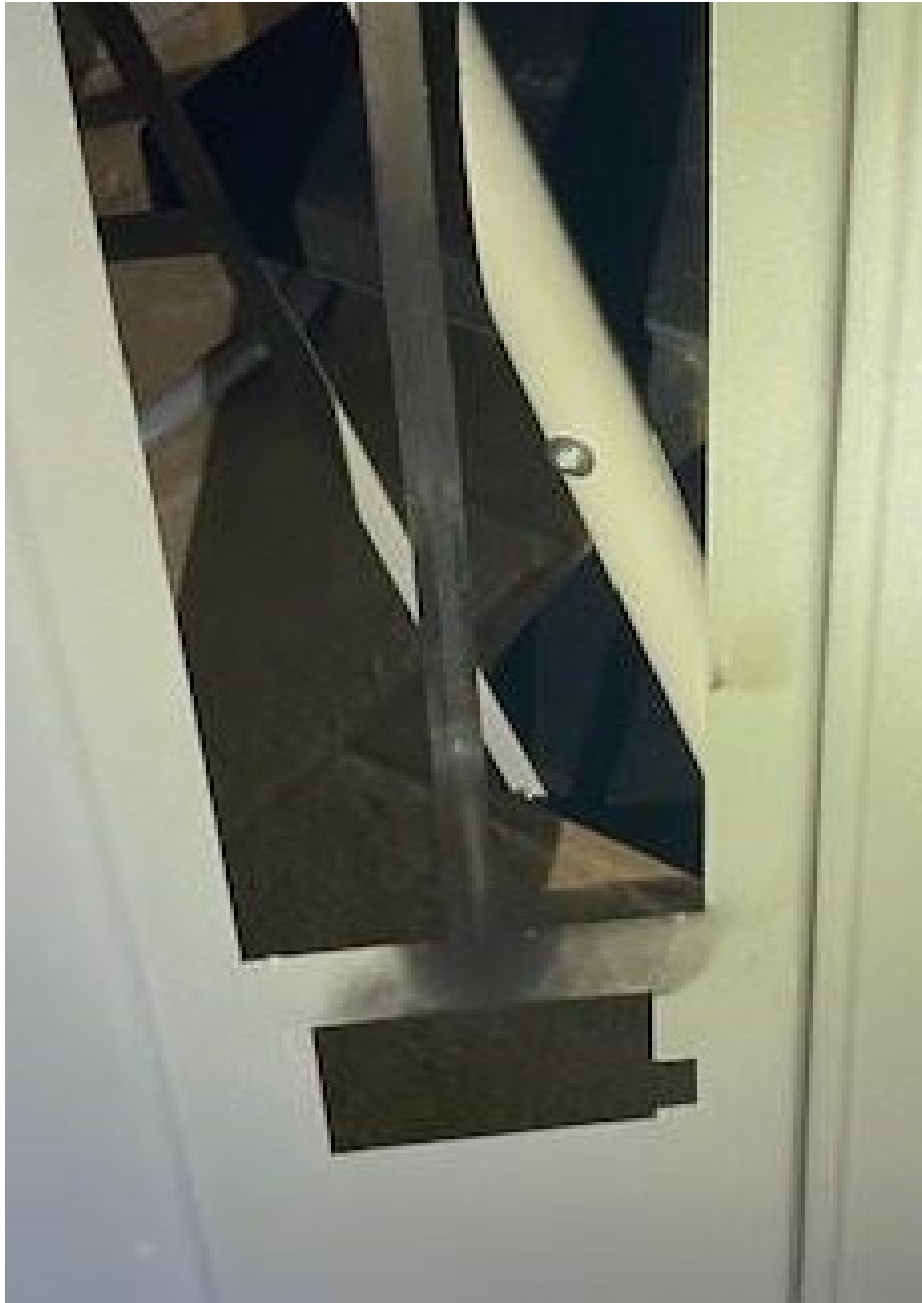
Photo 2 - Back side of cover from distribution panel with smoke damage

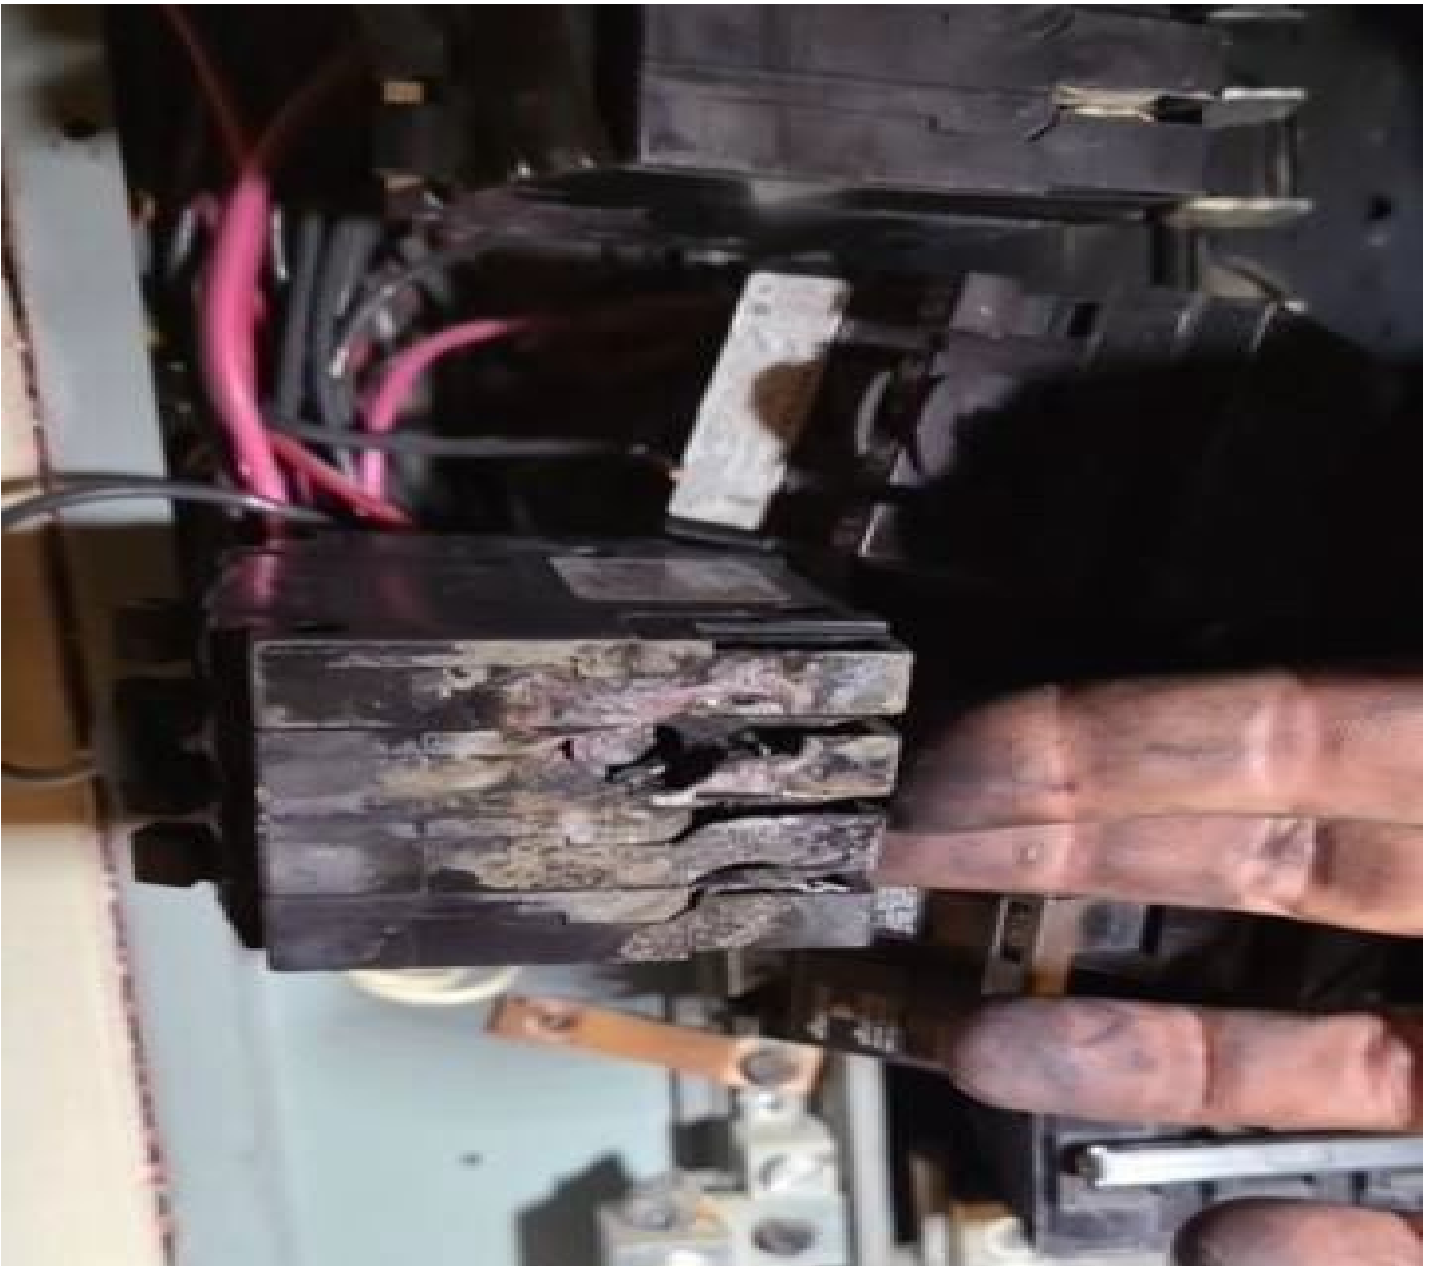
<p>Causes and contributing factors</p>	<p>It is possible that the breaker being under sized for the heat pump requirement contributed to the failure of the equipment. The repeated resetting of the breaker and the new compressor motor also may have contributed to the failure. Having both Quad 40-Amp breakers for heating loads (Heat pump and Hot tub) on the same buss location may have also contributed to the failure of the equipment. It is also possible that the push on style breaker was making poor contact due to a loose-fitting connection to the buss. It is most likely that a combination of all the above situations resulted in the ultimate failure of the electrical equipment.</p>

Photo 3 - Quad 2 pole 40-Amp heat pump breaker

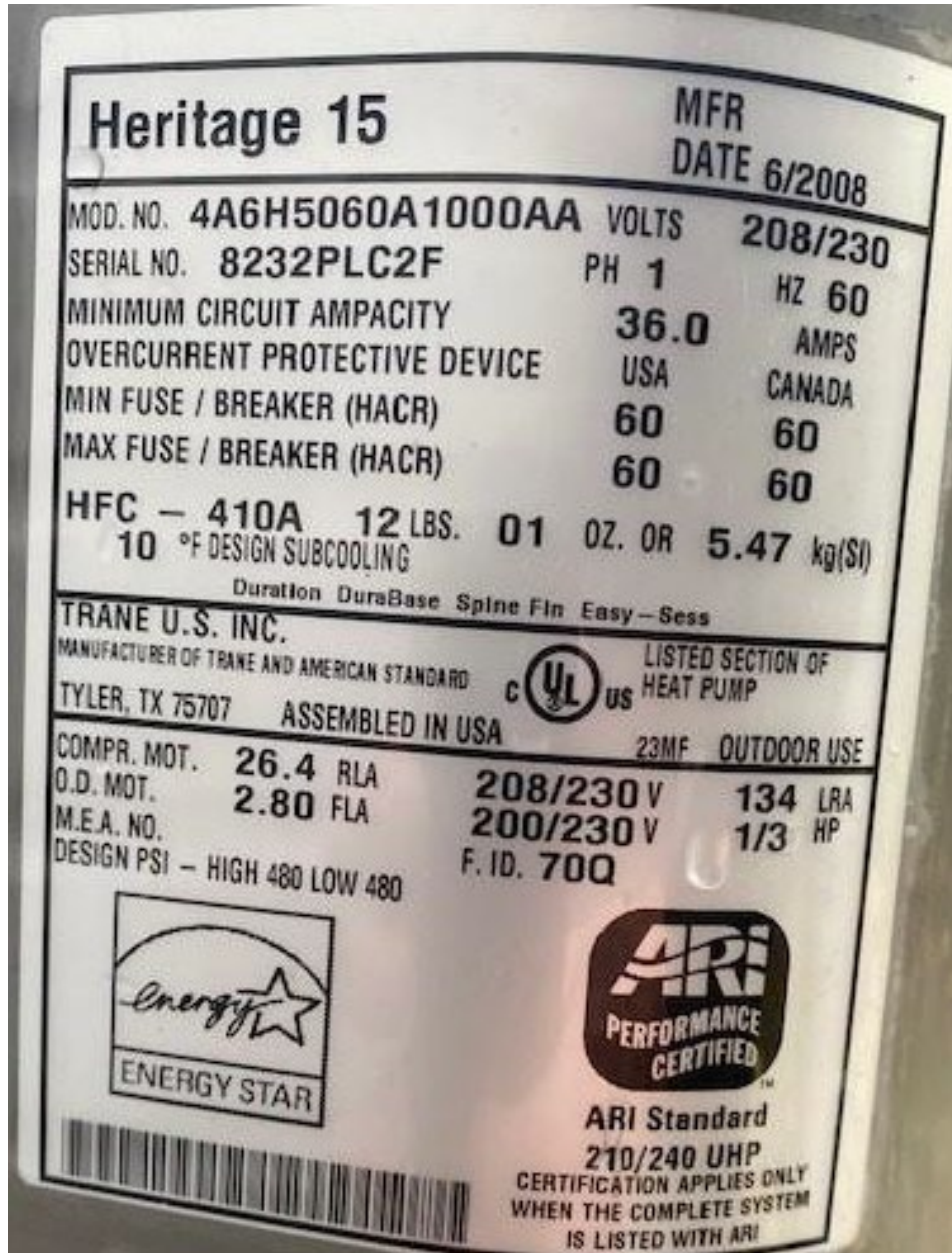
Failure scenario(s)	<p>A heat pump was connected to a branch circuit NMD90 #8 AWG copper conductors terminated to a 40-Amp two pole breaker. The heat pump manufacturer (<a href="#">Photo 4</a>) requires a minimum circuit ampacity of 36-Amps and breaker size of 60-Amps. The heat pump breaker had been tripping in August and September 2022 and reset by the homeowner. The homeowner obtained services of a refrigeration company.</p>

Photo 4 - Heat pump nameplate with breaker size requirement and minimum circuit ampacity

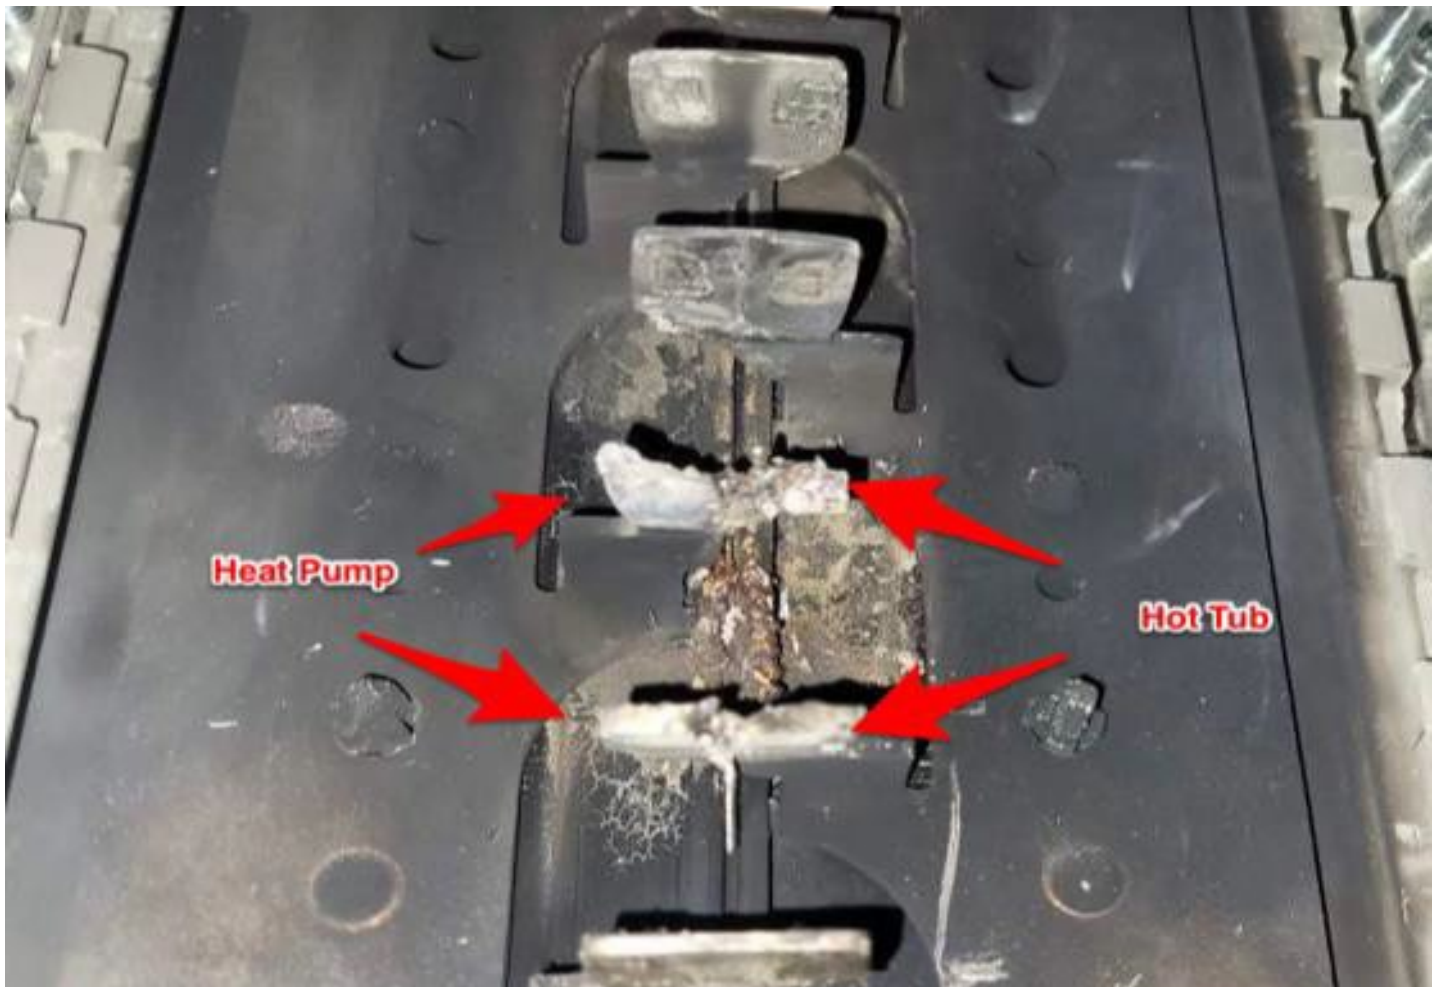
<p>The refrigeration company diagnosed a faulty compressor motor and replaced it with a new one. The heat pump breaker continued to trip and be reset after motor had been replaced.</p>
<p>Facts and evidence</p>	<p><b>Homeowner statement:</b></p> <ul style="list-style-type: none"> <li>• Heat pump breaker had been tripping on an ongoing basis</li> <li>• They had been away and returned home and turned heat up to 21 degrees C</li> </ul> <p><b>Refrigeration company statement:</b></p> <ul style="list-style-type: none"> <li>• September 12, 2022, replaced compressor motor in heat pump as it had shorted to ground</li> <li>• Breaker in panel had tripped</li> <li>• Reset breaker and system operated as expected</li> </ul> <p><b>Safety Officer observations:</b></p> <ul style="list-style-type: none"> <li>• Heat pump manufacturer specifications requires 60-Amp breaker</li> <li>• 40-Amp two pole breaker was installed for heat pump</li> <li>• Minimum conductor was sized correctly for heat pump</li> <li>• Push on quad breaker with two pole 40-Amp circuit melted (<a href="#">Photo 3</a>)</li> <li>• Distribution panel buss melted at location of breaker</li> <li>• Remainder of panel buss undamaged</li> <li>• Push on quad breaker with two pole 40-Amp for hot tub on same buss location as heat pump (<a href="#">Photo 5</a>)</li> </ul>

Photo 5 - Location of Heat pump and Hot tub breakers on main buss
