Incident Summary #II-1128363-2021 (#20427) (FINAL)

SUPPORTING INFORMATION	Incident Date	January 9, 2021	
	Location	Port Coquitlam	
	Regulated industry sector	Electrical - Low voltage electrical system (30V to 750V)	
	Impact	Qty injuries	2
		Injury description	Burns in varying degrees: 1 st to 3 rd to the head, neck, shoulders, chest, arms, and hands were sustained by one person. Chest pain and breathing difficulties were reported by a second person.
		Injury rating	Major
	Damage	Damage description	Melting and smoke damage occurred in the main distribution center (MDC). Damage ranged from MDC bus bar jumpers and insulators being melted beyond repair to the MDC circuit breakers, covers and surrounding walls incurring burn and smoke damage.
		Damage rating	Moderate
Incident rating	Major		
Incident overview	An arc flash exploded out from an energized 600 Volt 4000 Amp 3 phase MDC in a commercial warehouse while an experienced electrician was removing energized components. As a result of the arcing fault, an arc flash including intense heat and molten copper sprayed out and burned the electrician.

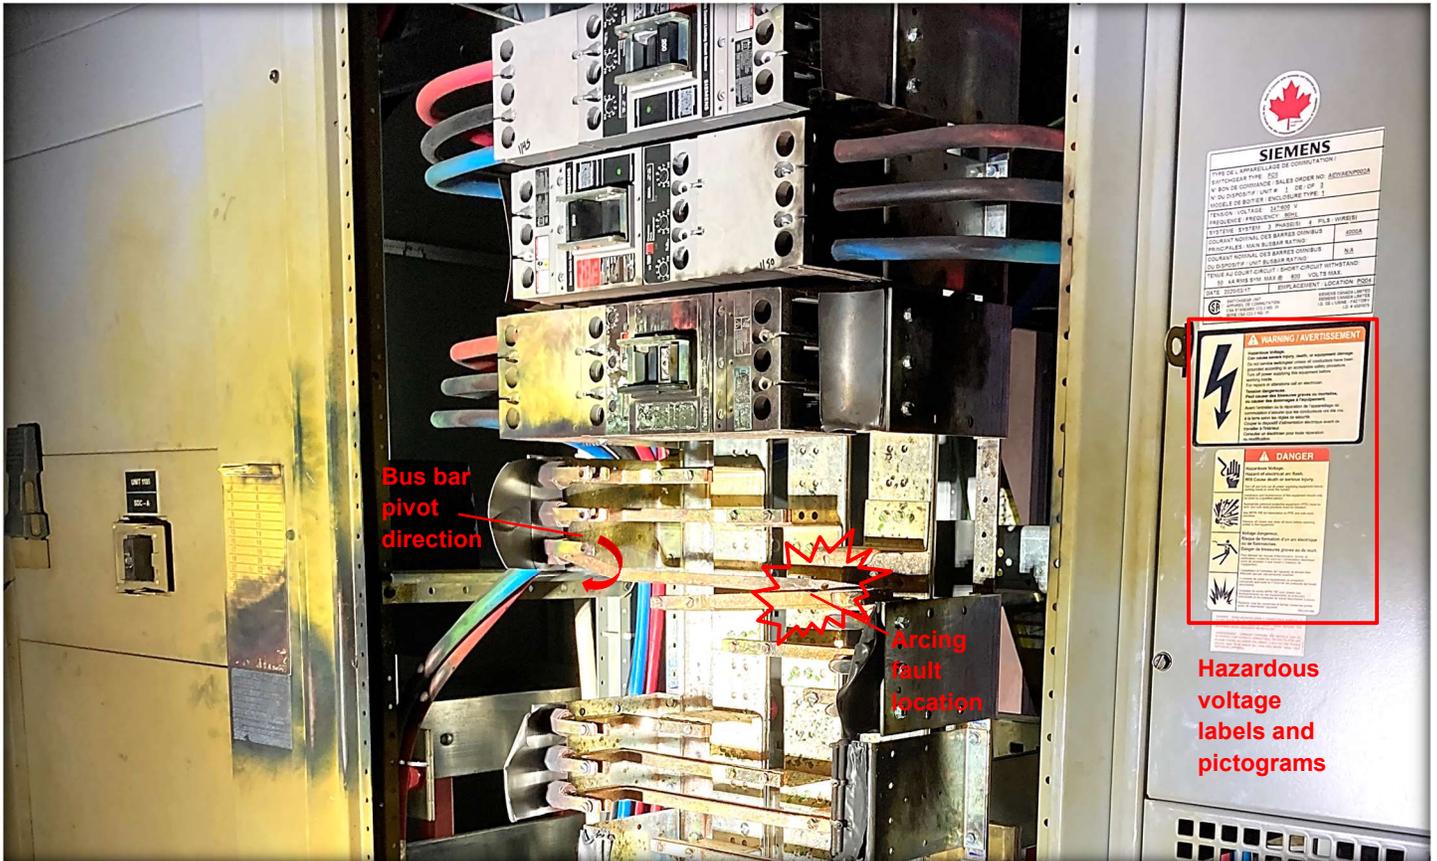
Figure 1 - Condition of MDC after incident (top): Arcing fault location (explosion symbol), Bus bar pivot direction (arrow). Arc flash labels (rectangle) and various components with smoke (yellow) and melting damage.

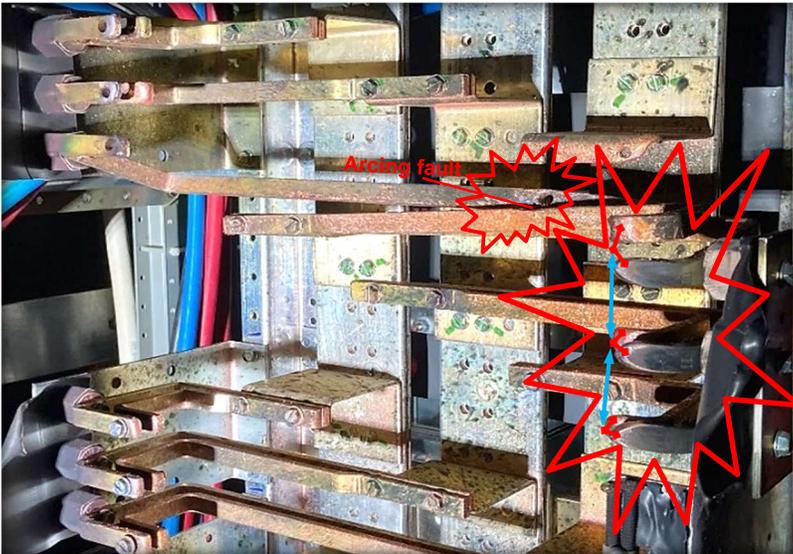
Figure 2 - (bottom left) Arc flash energy released at the ends of the bus bar jumpers, 3 phase arc flash through ionized air (blue arrows)

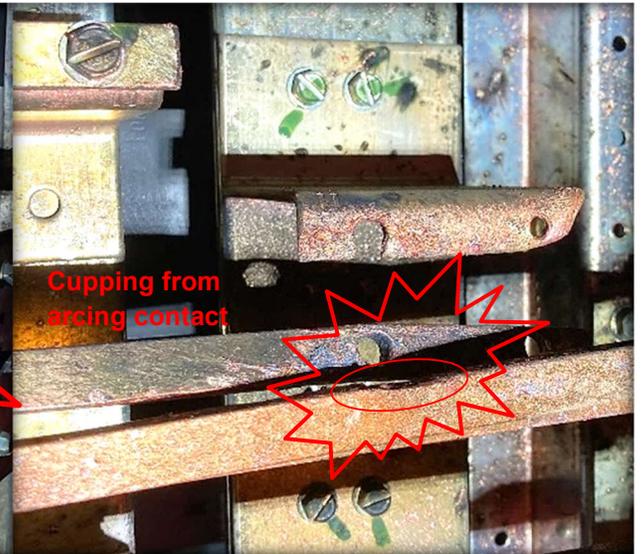
Figure 3 - (bottom right) Cupping from arcing contact and open holes where the bus bar jumper bolts attached

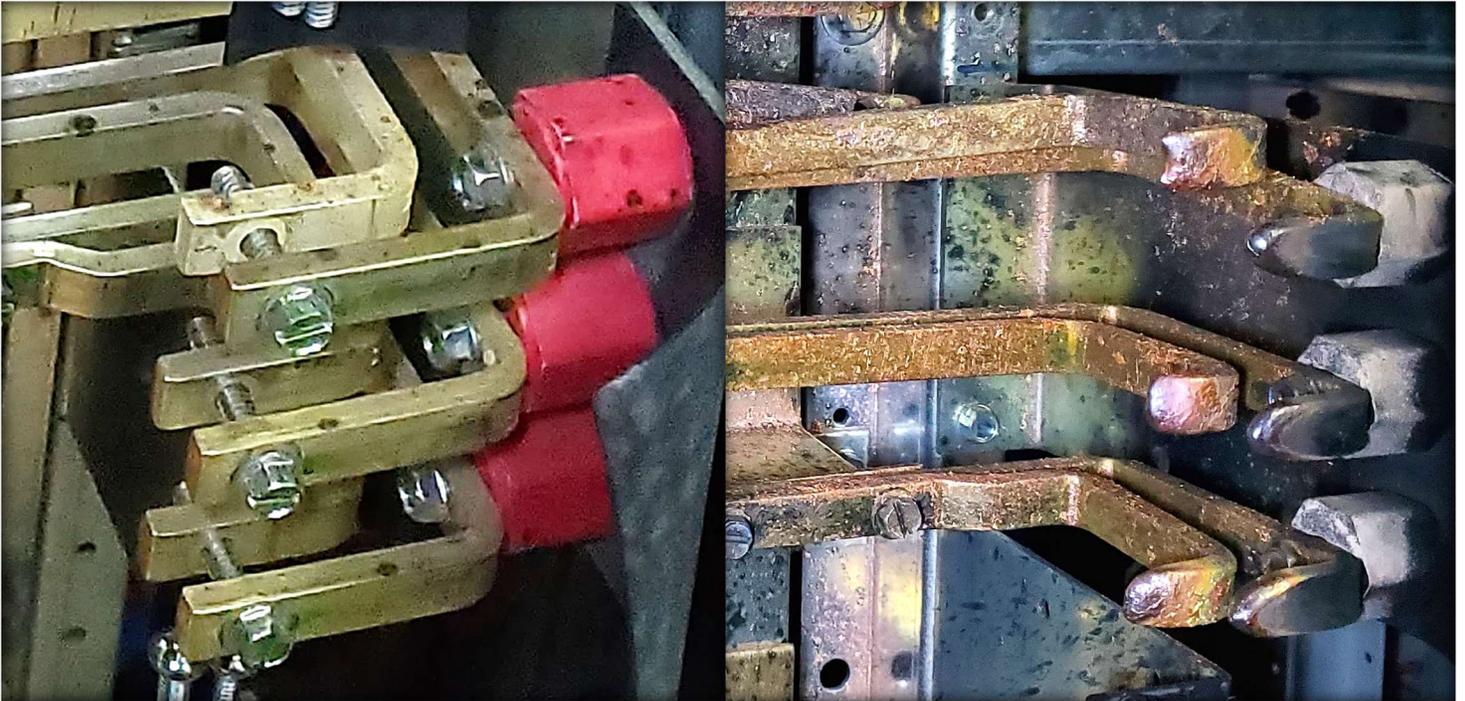
Figure 4 – Before (top left) un-melted bus bar jumper ends

Figure 5 - After (top right) bus bar jumper ends melted from arcing.

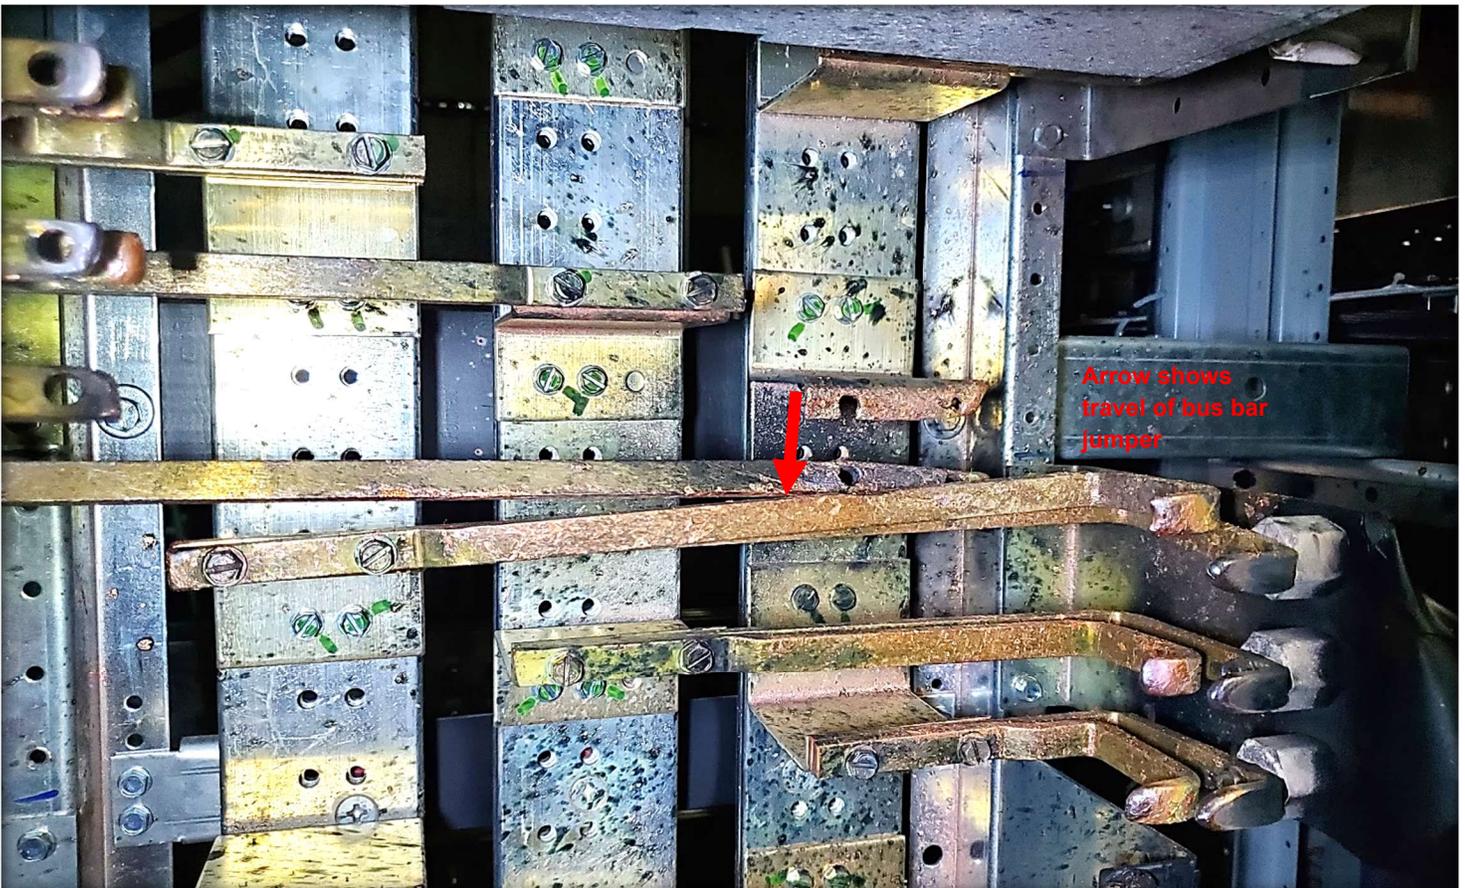
Figure 6 (bottom) – General area of arc flash showing damage to and travel of bus bar jumpers (arrow), and burn marks from arc flash

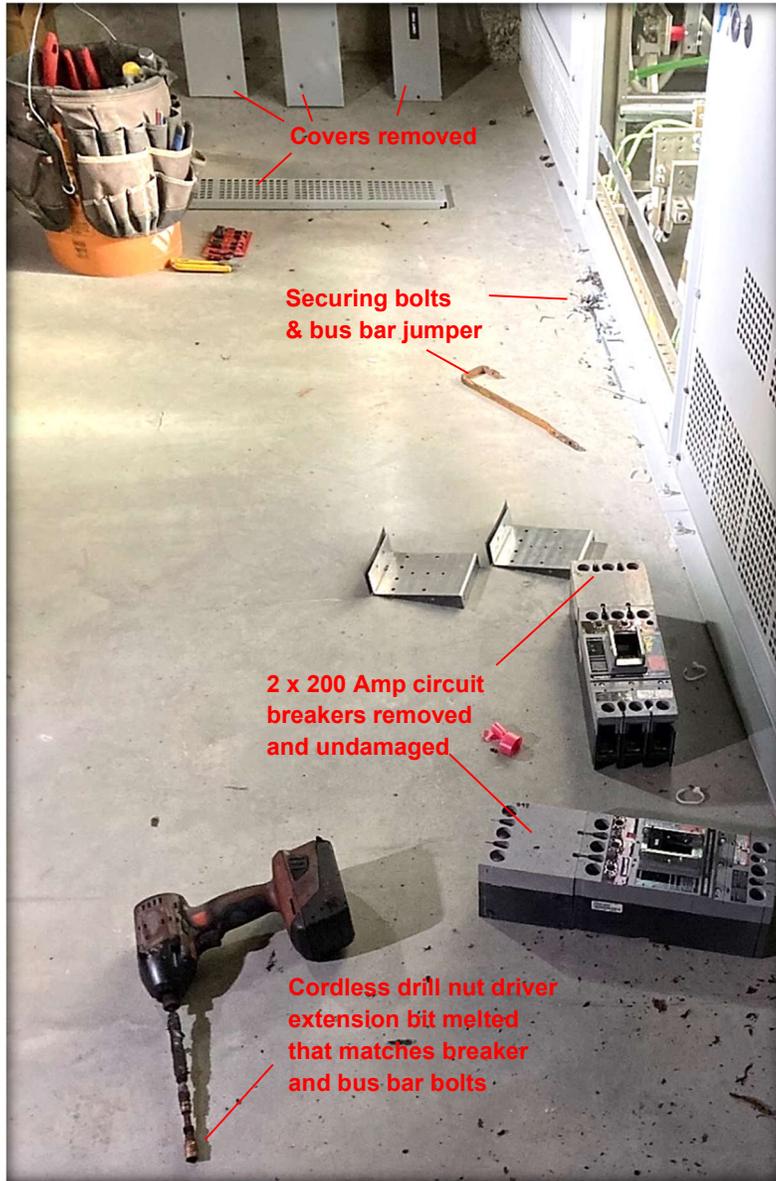
- The two 200 Amp circuit breakers have bolts that connect directly to the ends of the bus bar jumpers, but the area where those bolts connect had no damage from arcing. The removed circuit breakers had no damage whatsoever from arcing or dropping.

Figure 7 – (left) General work area: Covers removed, securing bolts and bus bar jumper, 2 x 200 Amp circuit breakers removed and undamaged, cordless drill nut driver extension bit melted that matches breaker and bus bar bolts.

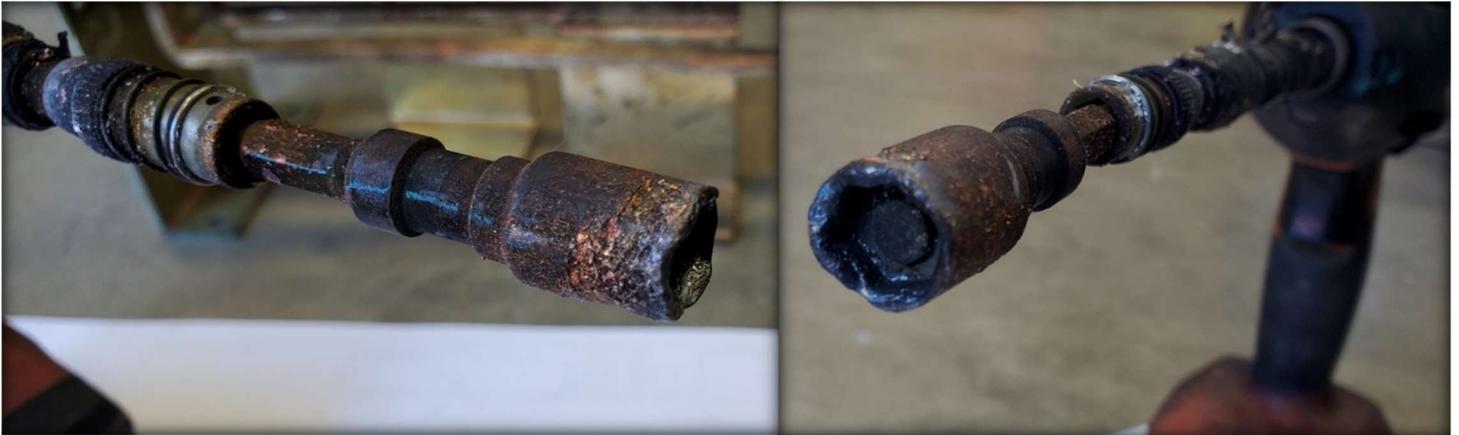
- The nut driver bit in the cordless drill directly below the incident location had melting damage indicating it was at the point of arc flash. It was also found to match the size of the bolts that secured the bus bar jumpers and the removed circuit breakers.

Figure 9 a, b - Nut driver end melted on the side and at the end from arcing to energized component(s)

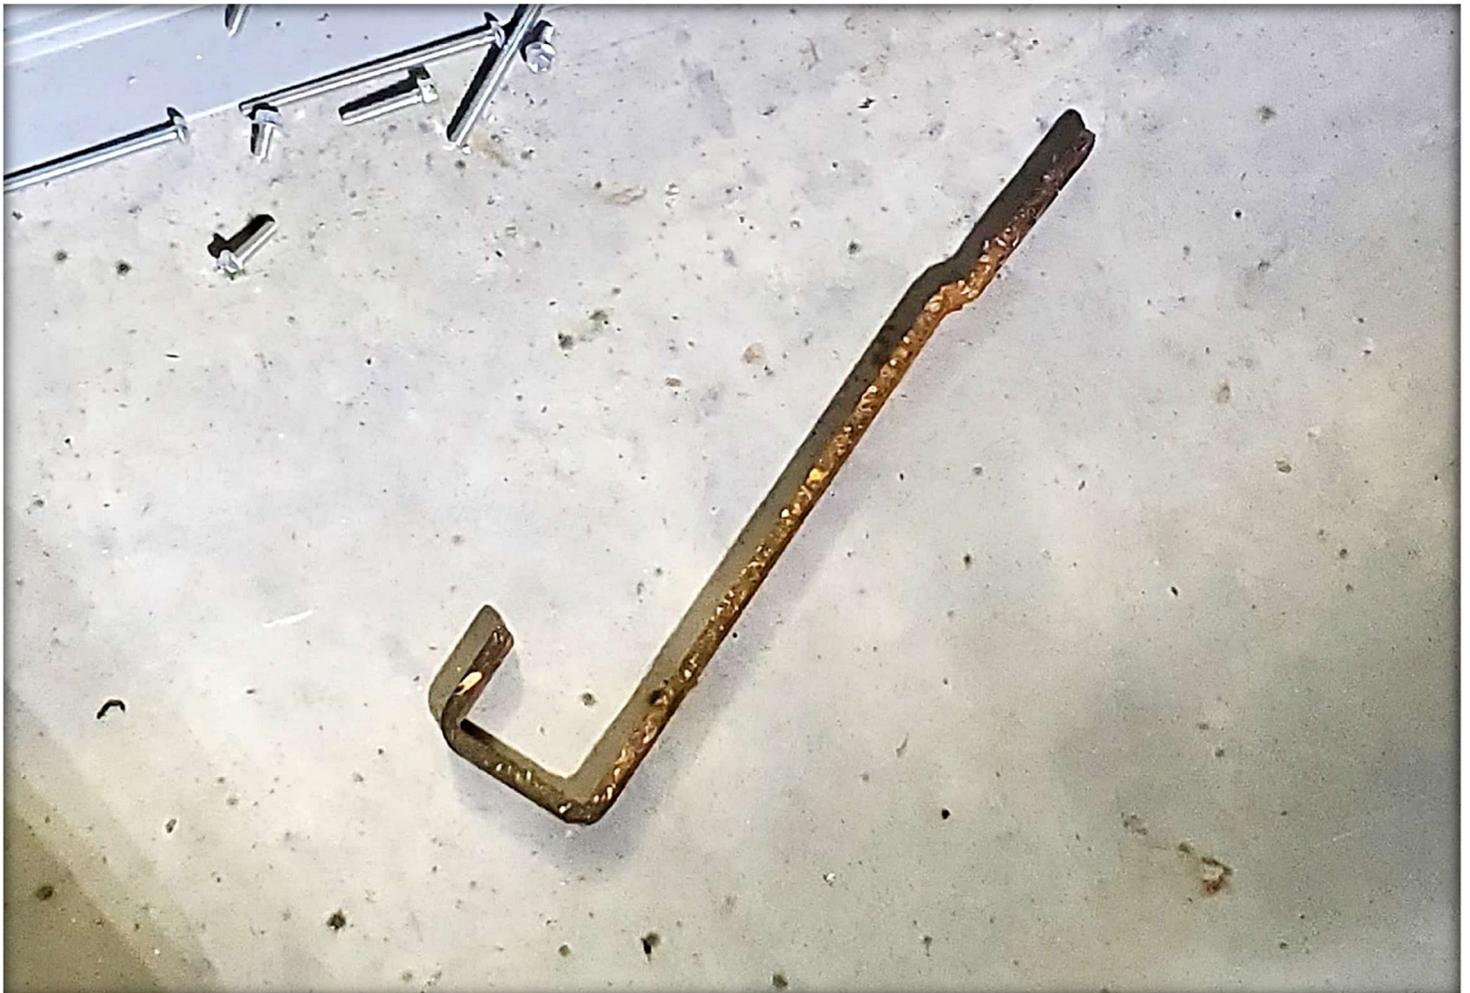
Figure 10 - Bus bar jumper showing signs of melting damage on the floor in front of the MDC

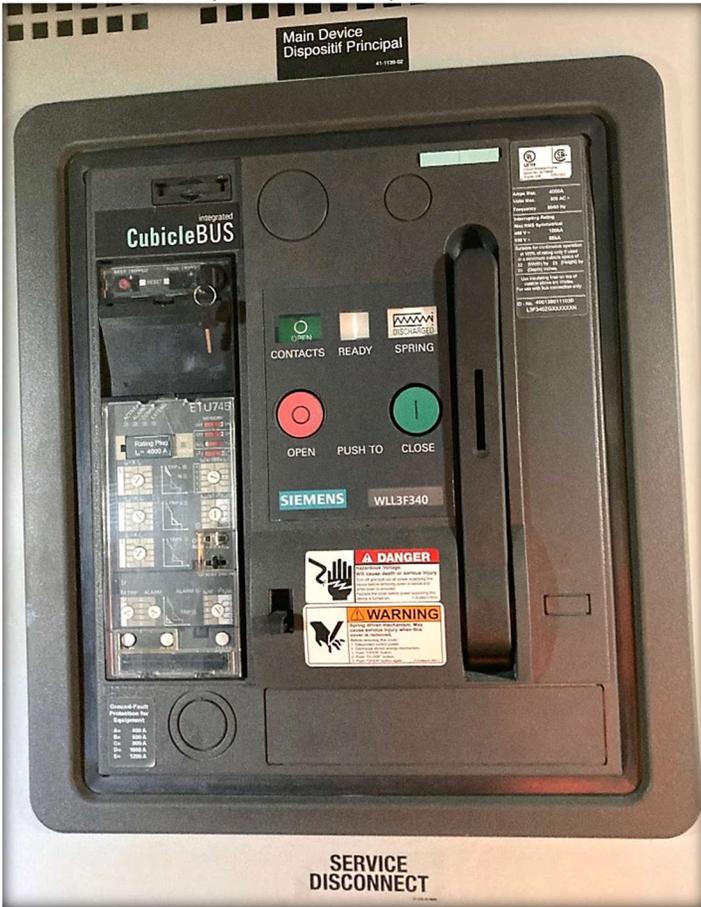
- Upon inspection after the incident, there were no signs that the 4000 Amp breaker had been locked out at the time of the incident.
- The electrical supervisor was on site and in an area close to the incident but without a direct line of sight.

Figure 11 (top left) 600 Volt 4000 Amp MDC main breaker (Lockout location)

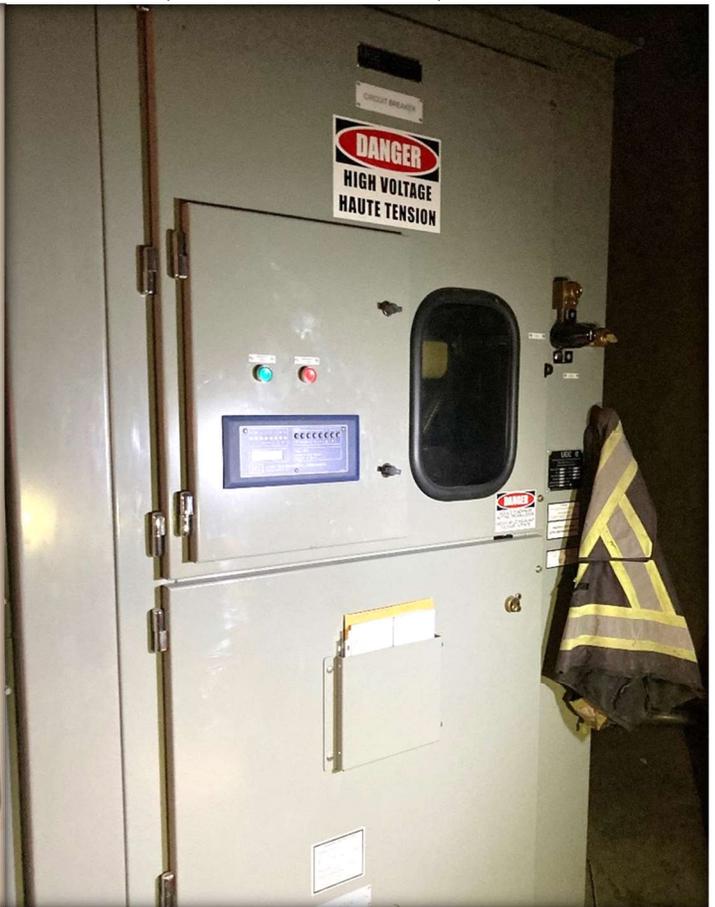
- The main high voltage service switch was found in an energized state after the incident.

Figure 12 (top right) 25,000 Volt service switch (Alternate lockout location)

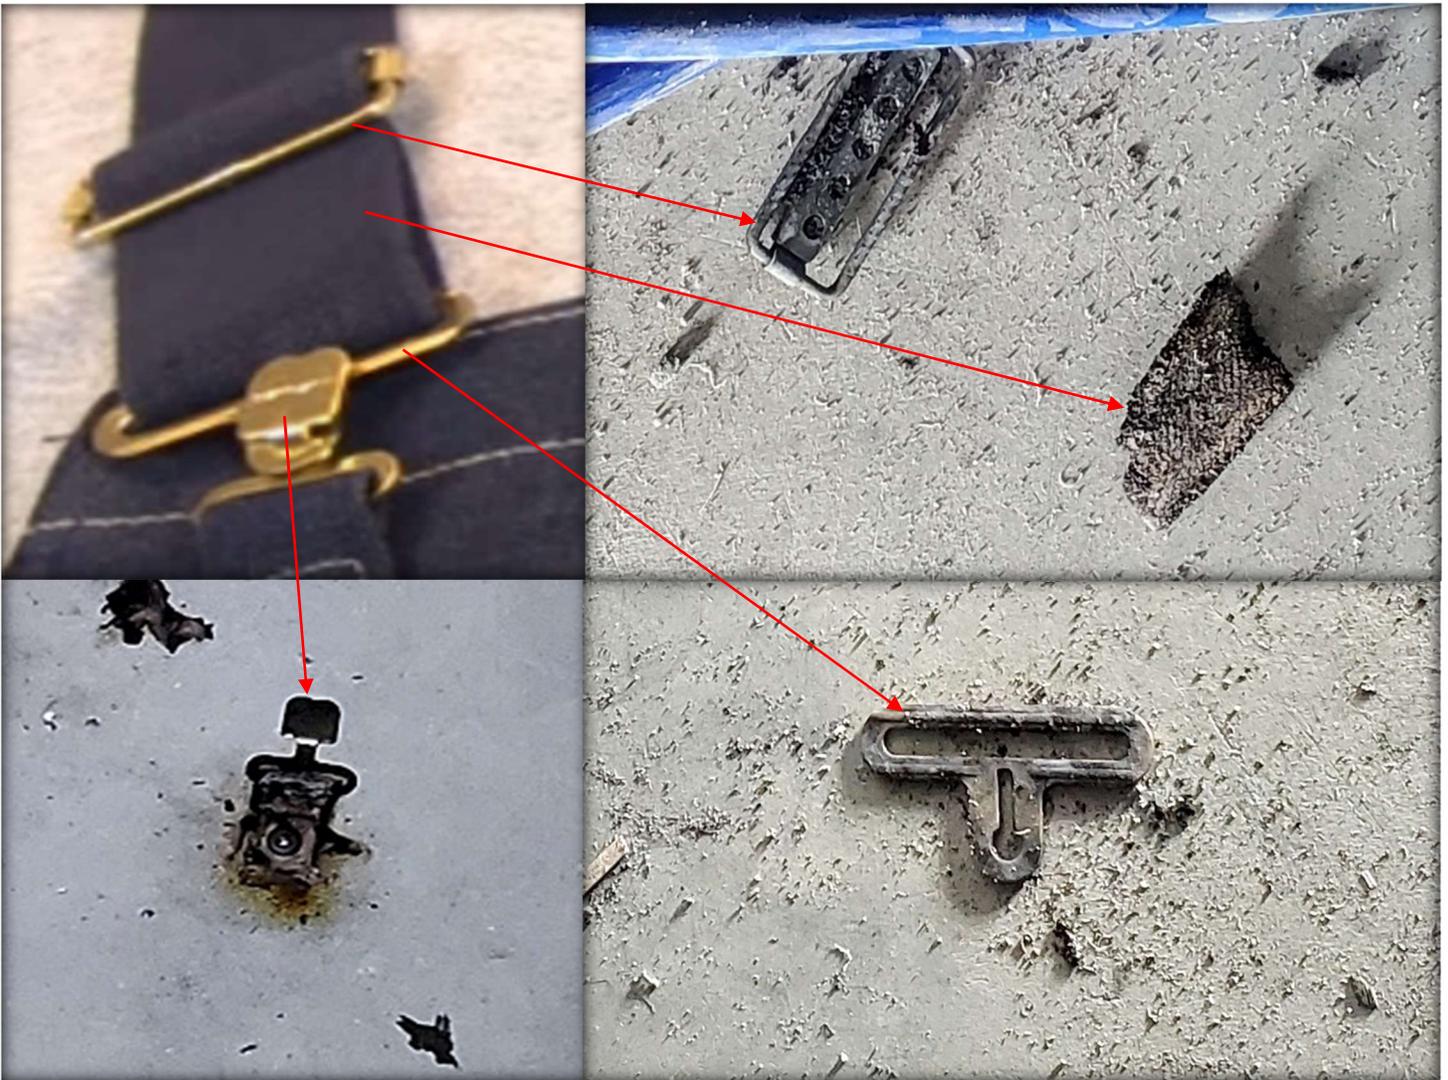
Figure 15 a, b, c, d - Coverall clips and band example (top left) and burnt items on the floor in area of incident

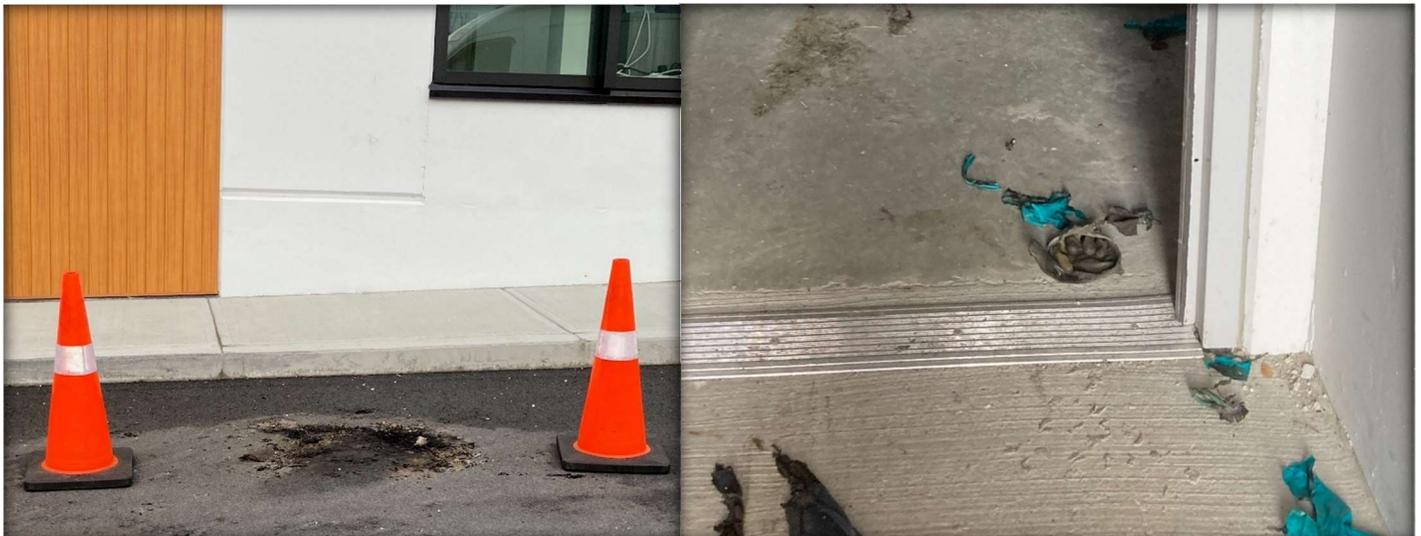
Figure 16 (top left) Workers burnt clothes

Figure 17 (top right) Workers burnt gloves
