Incident Summary (II-613449-2017) (Final)

SUPPORTING INFORMATION	Incident Date	<i>November 9, 2017</i>	
	Location	<i>Madeira Park, Sunshine Coast</i>	
	Regulated industry sector	<i>Electrical – Low Voltage Electrical System (30V – 750V)</i>	
	Impact	Qty injuries	<i>None</i>
		Injury description	<i>None</i>
		Injury rating	<i>None</i>
	Damage	Damage description	<i>Arcing & burn marks located on the interior and exterior of electrical equipment housing circuit breakers in the main electrical room of an institution.</i>
		Damage rating	<i>Minor</i>
	Incident rating	<i>Minor</i>	
	Incident overview	<i>One of the three main fuses at an educational facility opened under a short circuit condition. The incident prompted the immediate closure of the educational facility due to the resulting power failure.</i>	
INVESTIGATION CONCLUSIONS	Site, system and components	<i>The main electrical room of the educational facility houses a main electrical panel-board with circuit breaker positions. When a qualified worker installs a new circuit breaker into a main electrical panel-board, the individual disconnects the source power feeding that panel-board. The main electrical panel-board in the educati

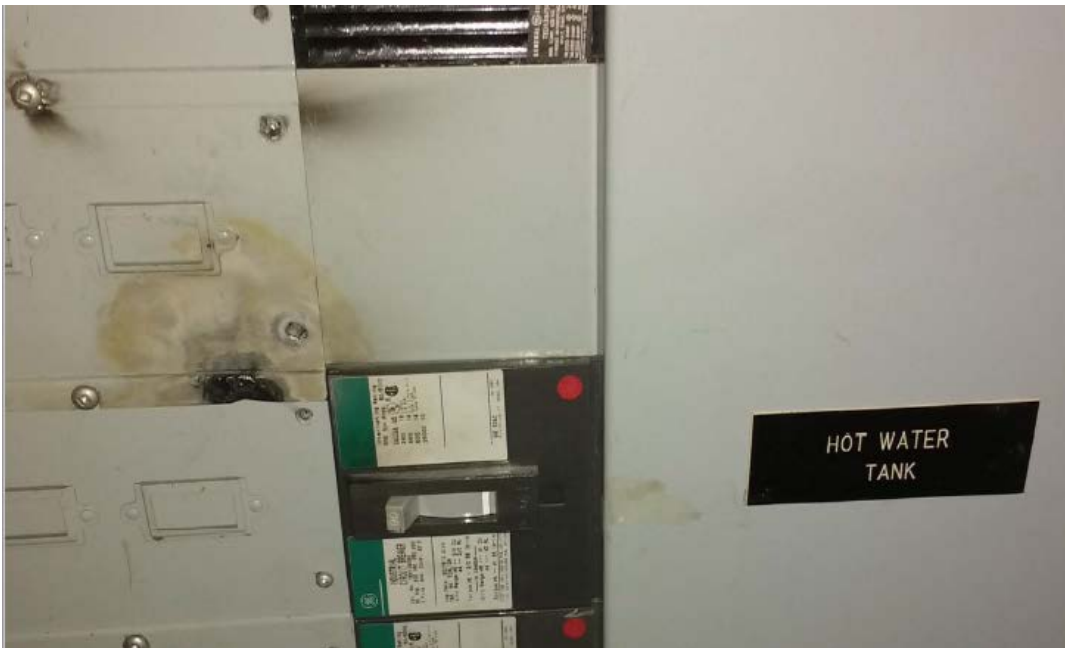
Burn mark on exterior from screwdriver making contact with energized electrical parts and grounded panel-board enclosure

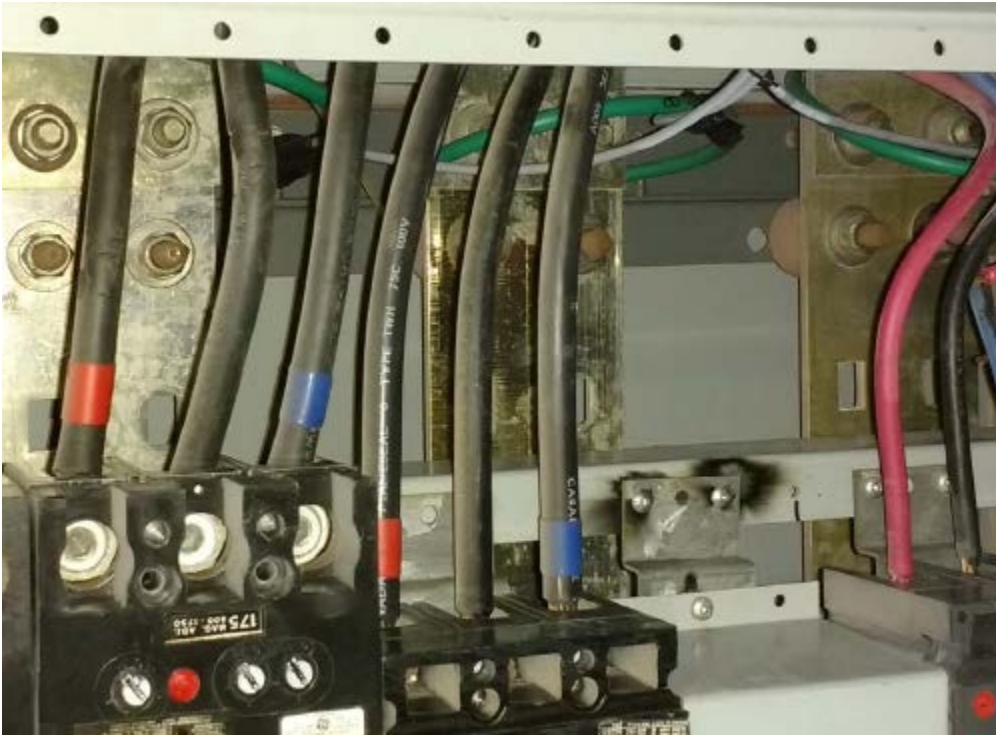
Burn mark on interior of panel-board enclosure
