INVESTIGATION REPORT

# AMMONIA RELEASE

ARCTIC GLACIER - KAMLOOPS

DATE OF INCIDENT: MAY 26, 2022

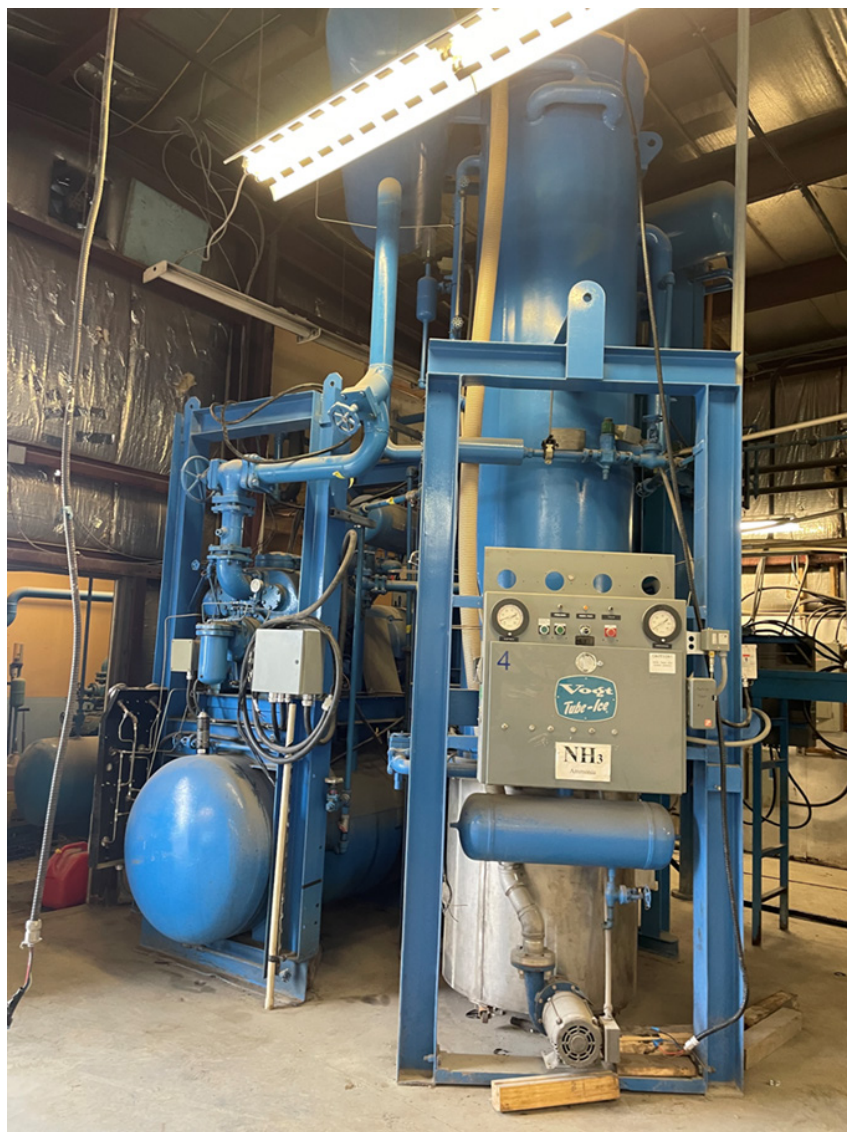
**Image #1:** The P34 system on May 25, 2022, prior to removal (Photograph taken by the Buyer).

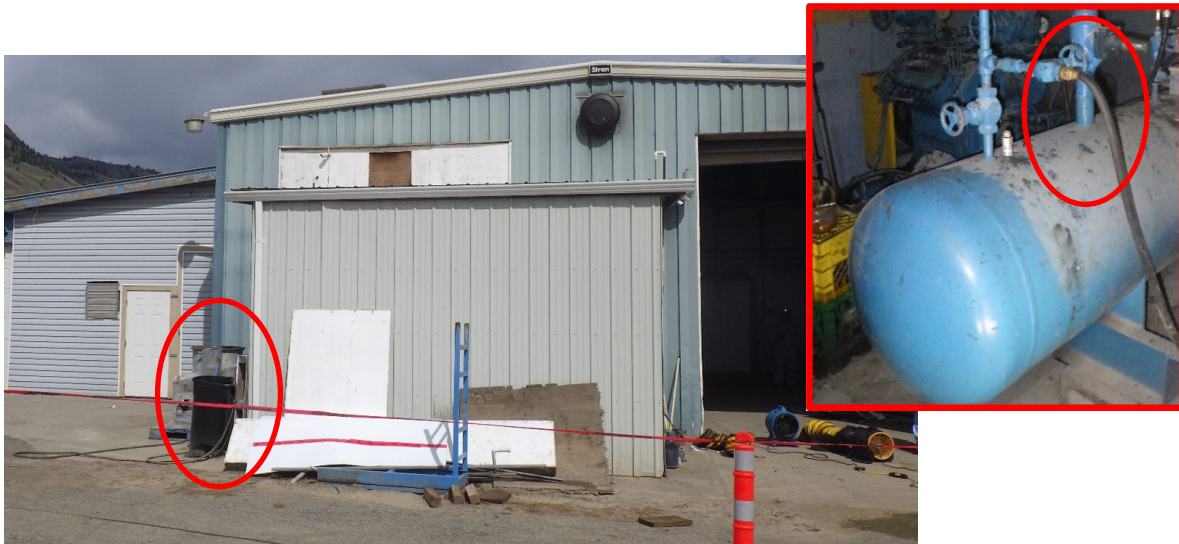
**Image #2** - Purge vessel and hoses that were in place prior to the incident. Hoses were connected to a water source and the ammonia receiver (red square) in the side building.

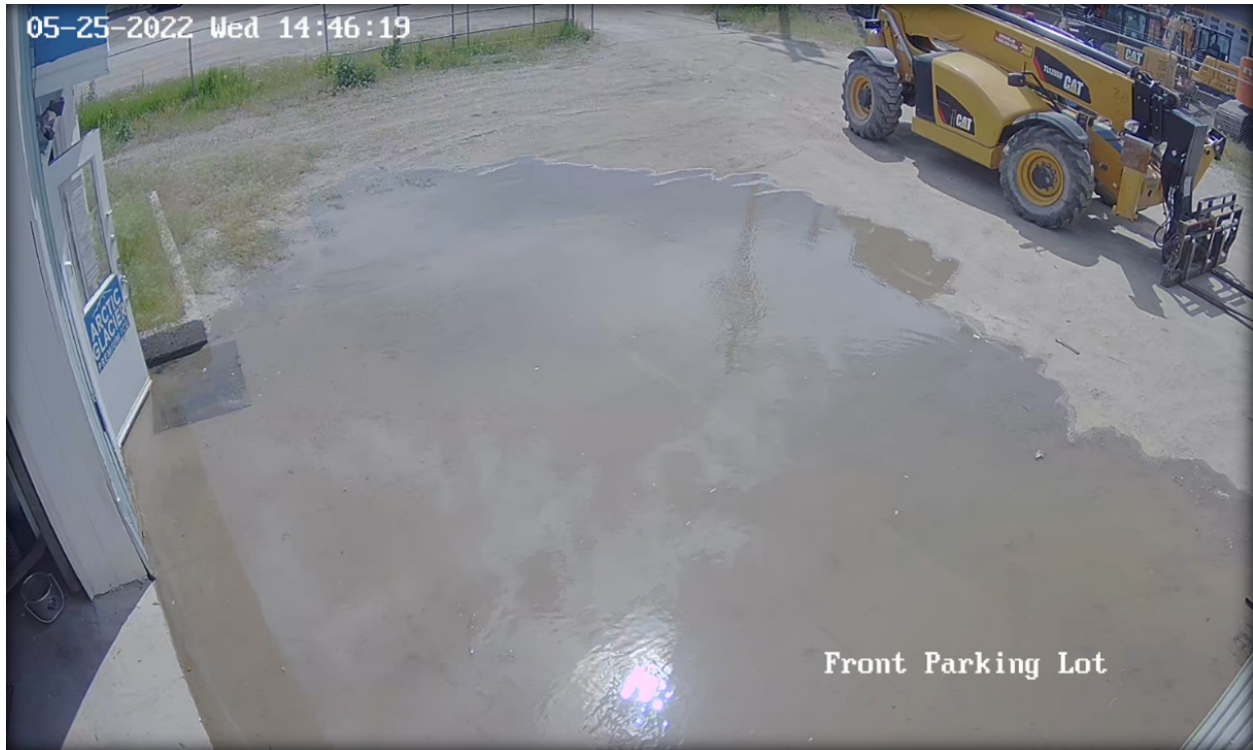
**Figure 2** - Flooded parking lot from the “purging” of the P24 system

It is likely that the purging operation removed what would have been the entire operating charge of ammonia from the P24 system. A timeline analysis of the water/ammonia mixture released into the parking lot revealed that the purging likely lasted for approximately 16.5 hours before being shut-off so workers could continue disassembling the next day (Appendix H – Ammonia purge timeline). In addition, the Riggers stated that the purging operation was done overnight. An independent engineering report that analyzed the purging operation concluded that a full operating charge of ammonia (up to 1000 lbs) could have been removed based on the provided timeline (Appendix I – Engineering analysis by Laporte Engineering Ltd). A review of documentation and correspondence from the years leading up to the incident found that there was no record of the systems being emptied completely of ammonia. The refrigeration mechanics that worked on the system following its shut-down stated that they did not remove the charge of ammonia. Even after the purging occurred Technical Safety BC’s investigation found that approximately 100 lbs of liquid ammonia was still present in the P24 system (Appendix J – Complete climate control report).

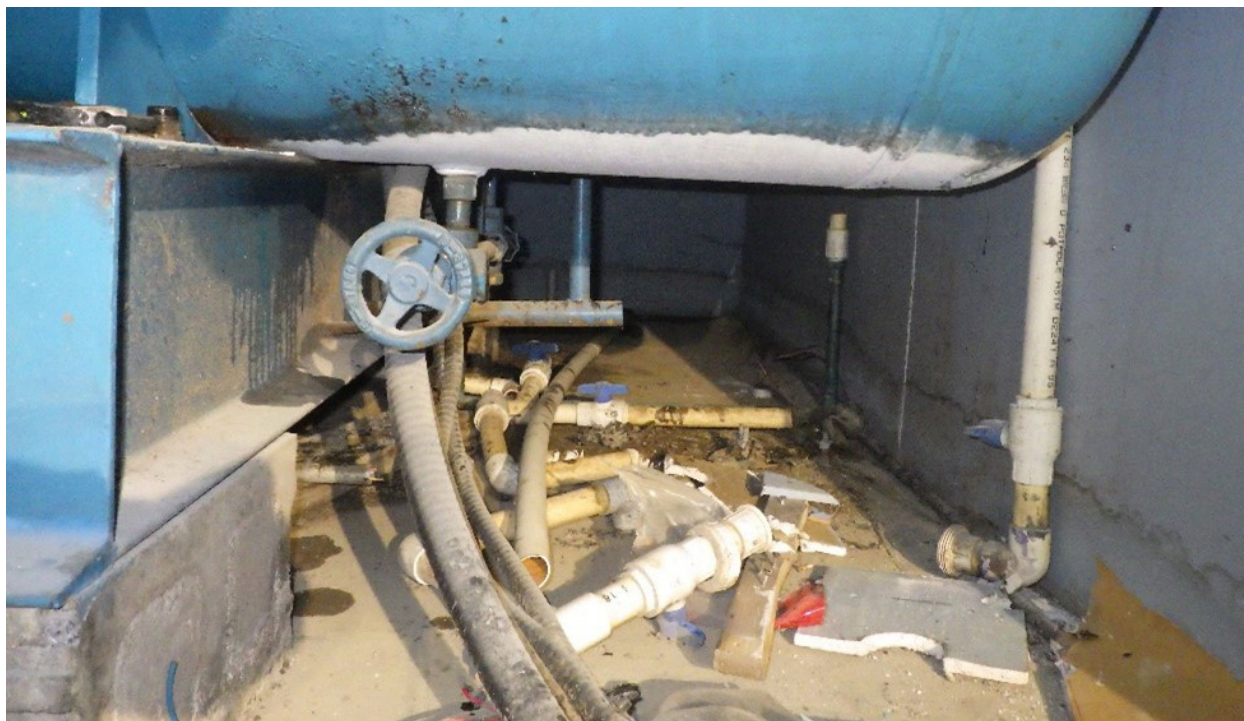
**Figure 3** - Distinct frost line showing liquid ammonia levels in the P24 system during purging by Technical Safety BC post-incident..

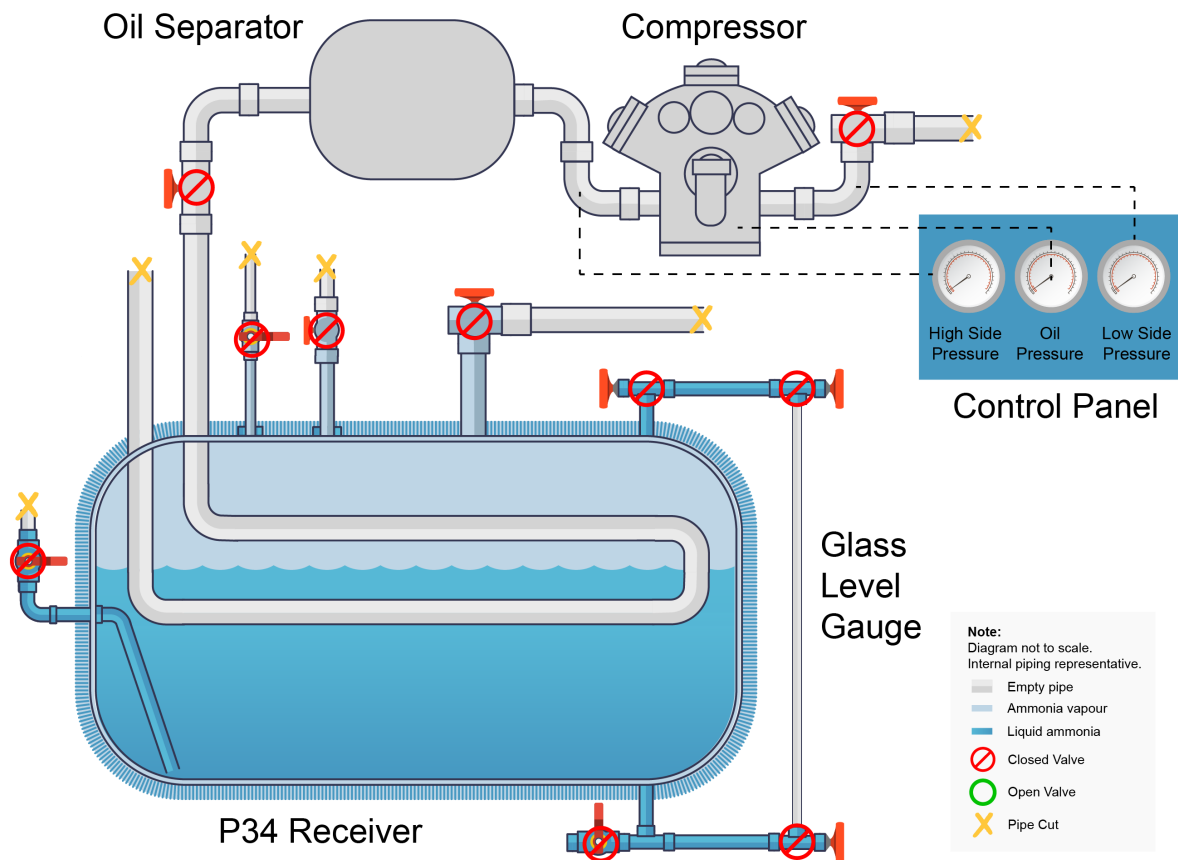
**Figure 4** - The configuration of the P34 Receiver on May 25, 2022

The assessments done on the receiver in this partially disassembled configuration led to the incorrect conclusion that the P34 system was empty. When asked why Refrigeration Mechanic A thought it was empty, he stated ***“Oh because the pipes were cut open and there was nothing in ‘em.”*** Similarly, the Buyer stated ***“That vessel . . . that tank was completely, they had already cut all the lines on that. That was completely already isolated from the system.”*** The Riggers stated that the assessment had gone one step further and considered the gauges. One Rigger stated ***“before we’d done anything we’d walked around and looked***

At the time of the incident on May 26, the system was already partially disassembled with open and cut pipes. This partially disassembled configuration was incorrectly interpreted as indicating an empty system. The investigation found that the indicators deemed by those on site to verify the system was empty did not accurately reflect the pressure or contents of the receiver.

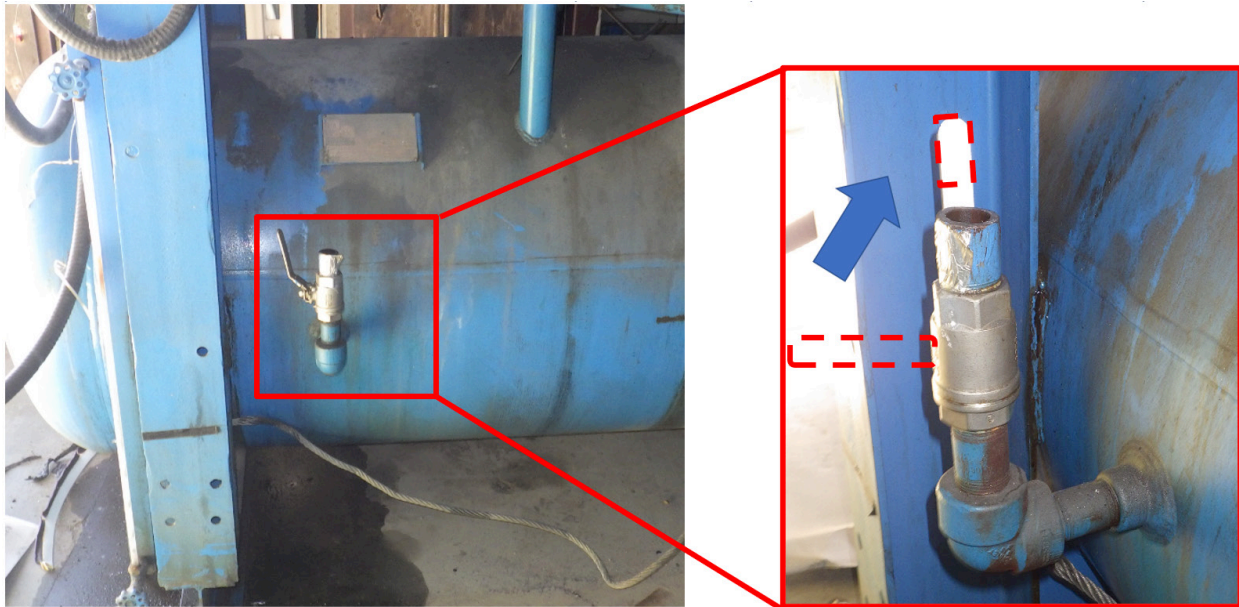
**Image #3** - Ammonia receiver after the incident with the side view of the stainless-steel ball valve in the red rectangle. The valve was found in the open position post incident as shown. The red dashed lines indicate the valve handle position in the closed position. The valve handle would have extended past the steel frame.

Technical Safety BC's investigation found that the valve did not malfunction in the incident and the receiver would have been capable of holding pressure. For investigation purposes, the valve that was opened was removed from the P34 receiver and retained for further testing (Appendix L – Valve Specification Sheet). A leak test was done to determine whether the remaining pipes and valves connected to the receiver could hold pressure. The receiver held pressure with no leaks (Appendix M – Leak test report). The valve that was removed was then brought to an independent engineering laboratory for testing. The engineering lab found that the valve had not failed and held pressure (Appendix N – Acuren laboratory analysis report).

The investigation found that no physical failure of the refrigeration equipment or its components contributed to the cause of the incident. The investigation concluded that the ball valve was opened by the Broker as it interfered with the rigging of the equipment. Independent testing confirmed that the valve did not fail and operated as the manufacturer intended.

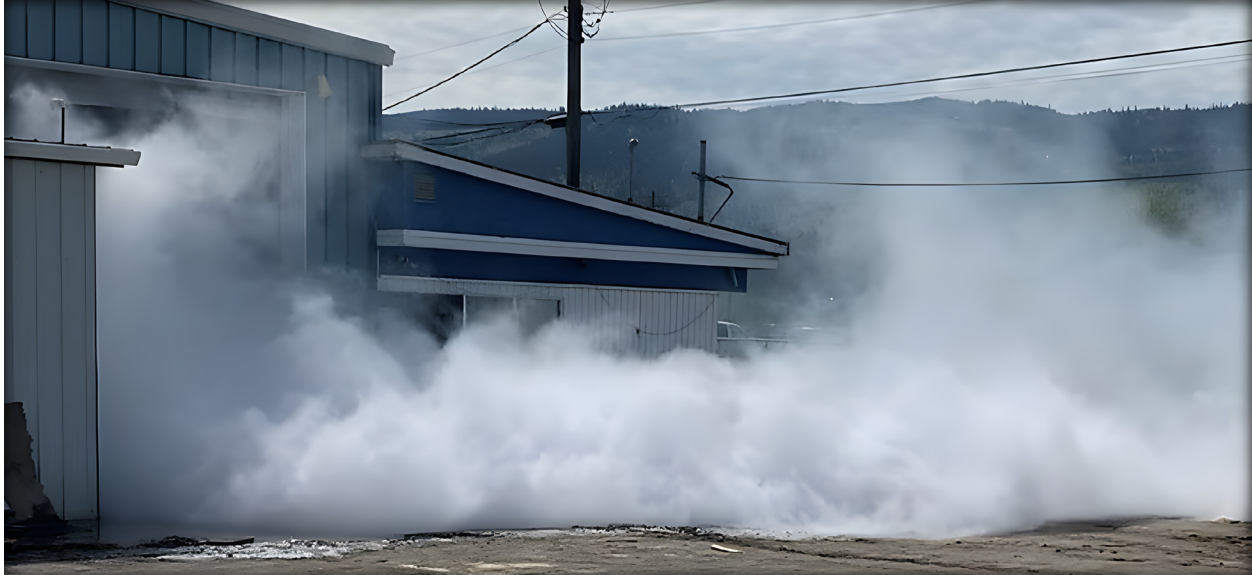
**Image #4** - Ammonia cloud billowing out of the building at the West open shutter door at 10:18am on May 26, 2022.

The release resulted in a large cloud of ammonia that propagated to neighbouring businesses and exposed a number of individuals. The resulting cloud was also ignited within the building, causing a deflagration which damaged the facility.
