## Incident Summary #II-1312877-2022 (#25753) (FINAL)

SUPPORTING INFORMATION	Incident Date	January 11, 2022	
	Location	Revelstoke, BC	
	Regulated industry sector	Electrical - Low voltage electrical system (30V to 750V)	
	Impact	Qty injuries	0
		Injury description	N/A
		Injury rating	None
	Damage	Damage description	A fire destroyed the electrical wiring and panel board within single wall space of a dwelling where the electrical panel board is located
		Damage rating	Major
	Incident rating	Major	
Incident overview	A fire occurred within a wall space where an electrical panel and associated feeder and branch wiring was located destroying all the wiring within the wall space and charring the wood structure. Additionally, the electrical panel, interior wiring and overcurrent devices were also badly fire/ heat damaged. The power was disrupted to a dwelling unit making the area unsafe and unusable.		
INVESTIGATION CONCLUSIONS	Site, system and components	An electrical service provides a suitably sized electrical power feed from a fused service to a panel board located within a stand-alone residential dwelling structure with numerous circuits connected to individual over-current devices. A

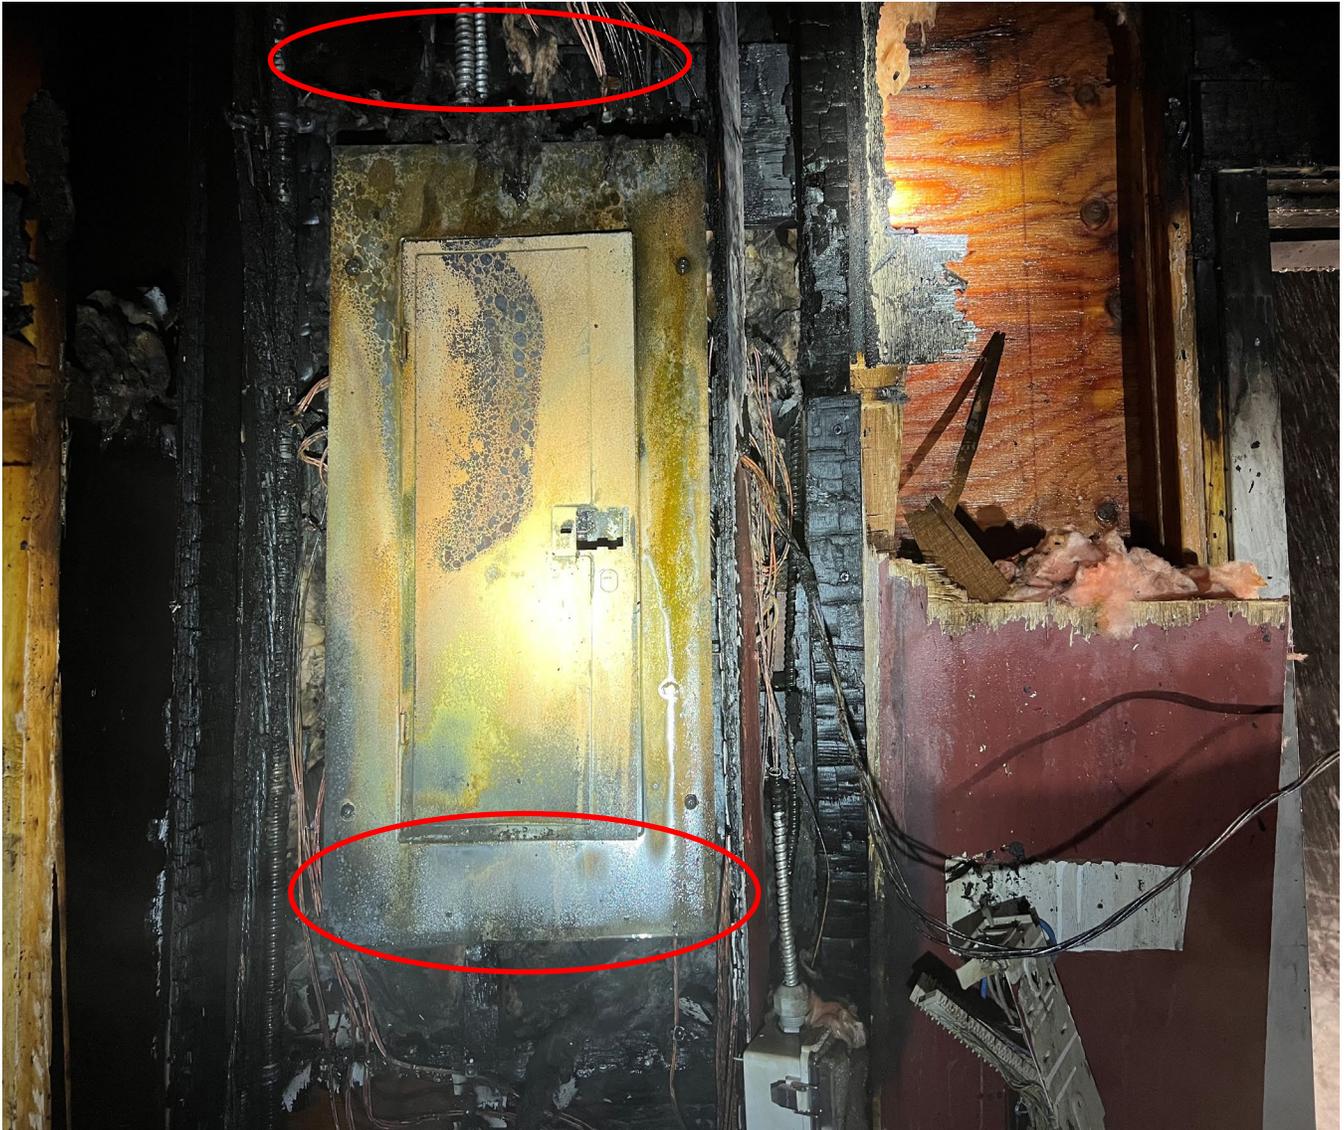
- The burn pattern of the structural portion shows deeper charring of the wood blocking near to bottom of the wall and the pattern went vertical with the majority running up the right side of the panel and into the upper portion of the wall. Building insulation is evident behind wiring above the panel and behind burnt cabling below the panel location.

Image 1 - Fire damage above and below the electrical panel and contained in the stud space of panel and cables

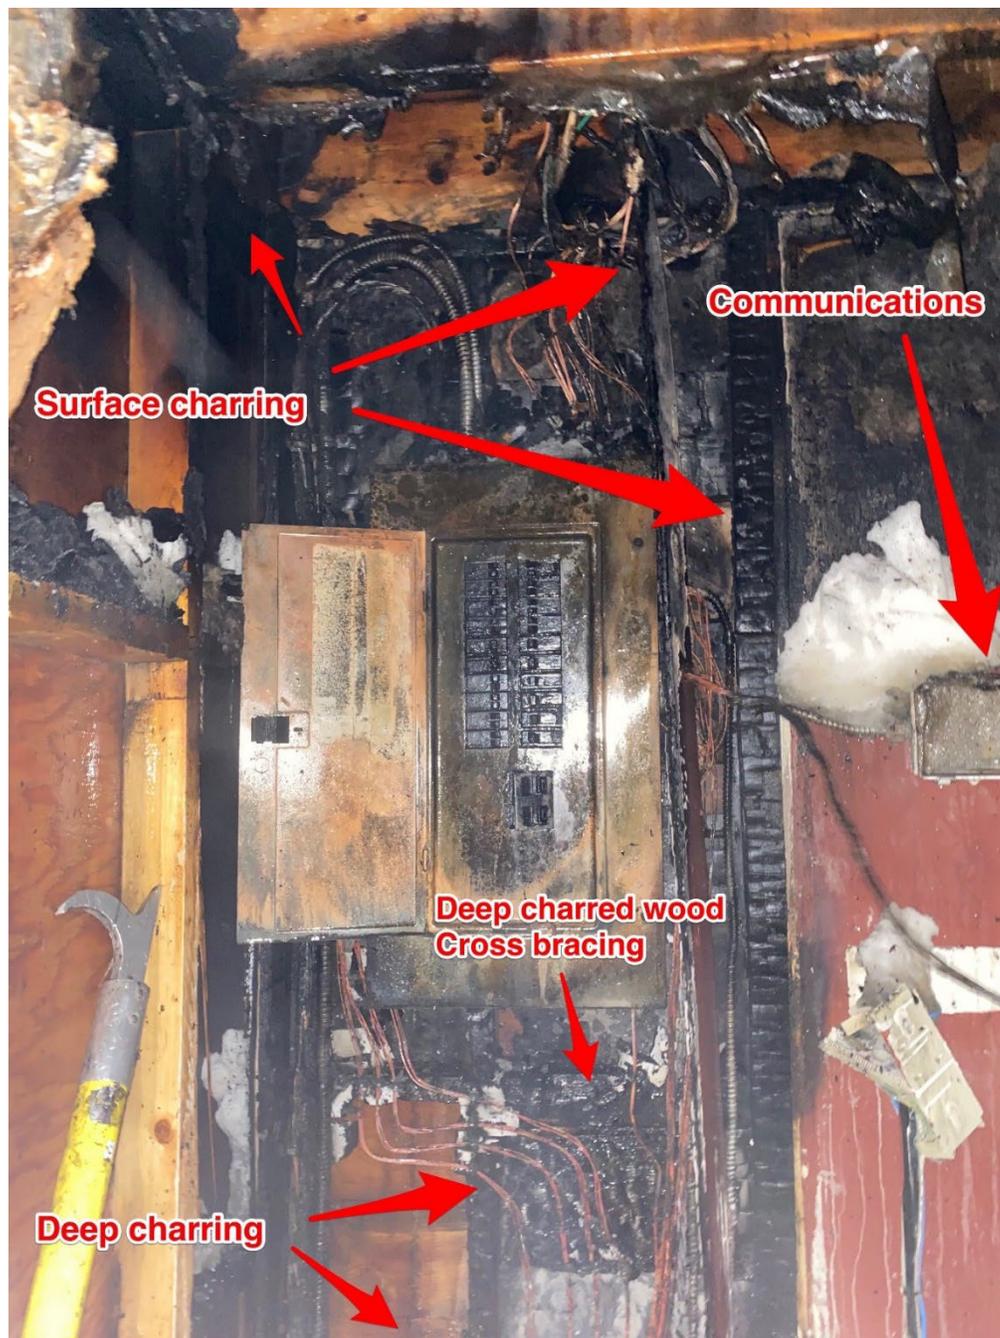
- Wiring above the panel had the non-metallic sheathed cabling jacketing up to just below the wall top plate completely burnt with a minor amount visible. The armoured cabling had the thermoplastic jacket burnt off with the metal armour exposed. Area above wall in ceiling space has heat damage evident but cabling insulation is still intact.

Image 2 - The upper thermoplastic armoured cabling was noted to have had the plastic covering melted away, but the armour is still intact. Upper ceiling area, non-metallic sheathed cables noted to still have areas with outer jacket still intact. Fire damage to structure at top end of wall not as evident as lower section of wall

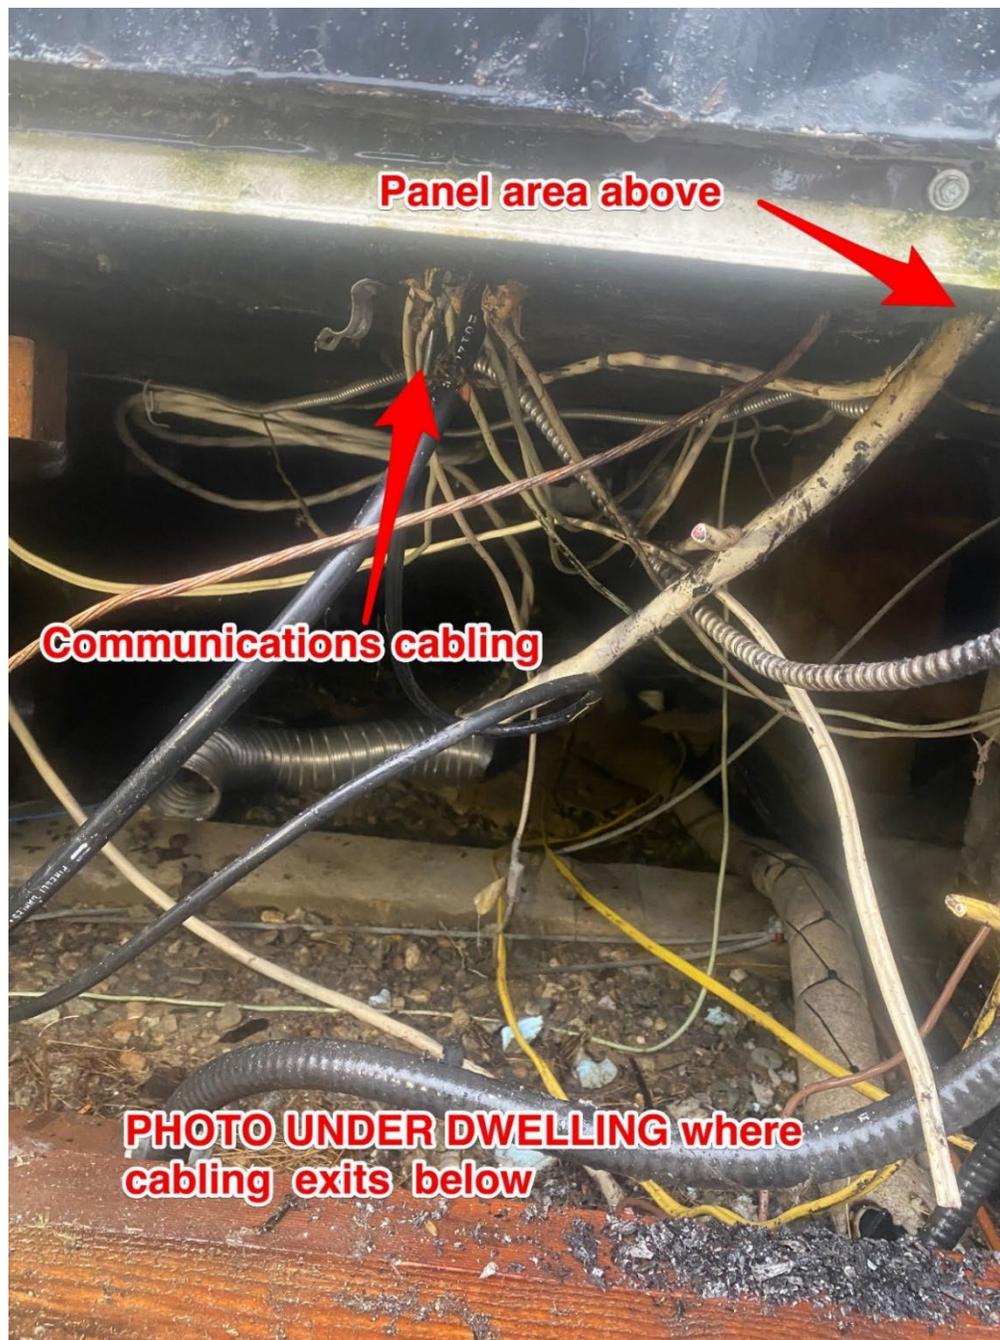
Image 3 – The crawlspace below the dwelling unit where cables are drawn into the finished wall space below the electrical panel. No evidence of fire noted in this area.

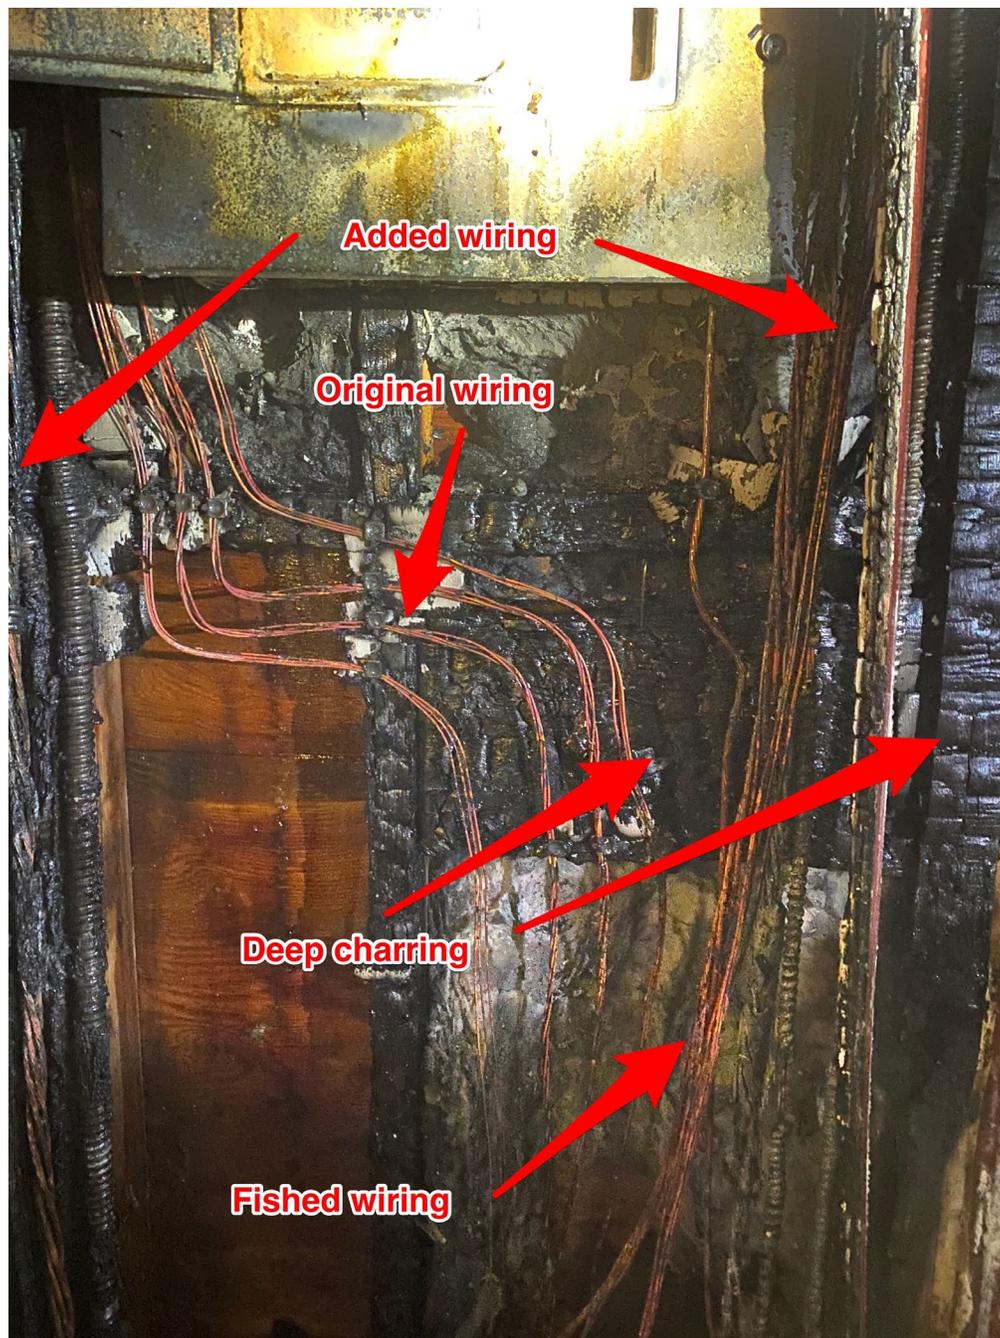
- the heaviest structural burn is noted located at the lower section of the wall below the panel on a 'cross brace' between the vertical studs on either side. There are several cables that are strapped or fished tightly together in this area.

It is likely the fire ignited due to damage to cables located within the wall space near the bottom of the panel as multiple cables were added and drawn past existing cables attached to wooden cross bracing within the wall. The space required to pull cables was limited. This tight space can easily damage cable insulation with rubbing with existing cables damaging the jacketing of the cable and conductor insulation. This could cause a weaker insulation value of the conductors that could have overheated and ignited.

Image 4 - Lower wall area provides evidence of the deepest charring of the wall and damage to electrical cabling. There is evidence of a combination of original wiring strapped in position as well as multiple added 'fished' cabling installed. Fished cabling added seems to include non-metallic sheathed and metal armoured cables. Sections of armoured cabling seems to have armour damage.

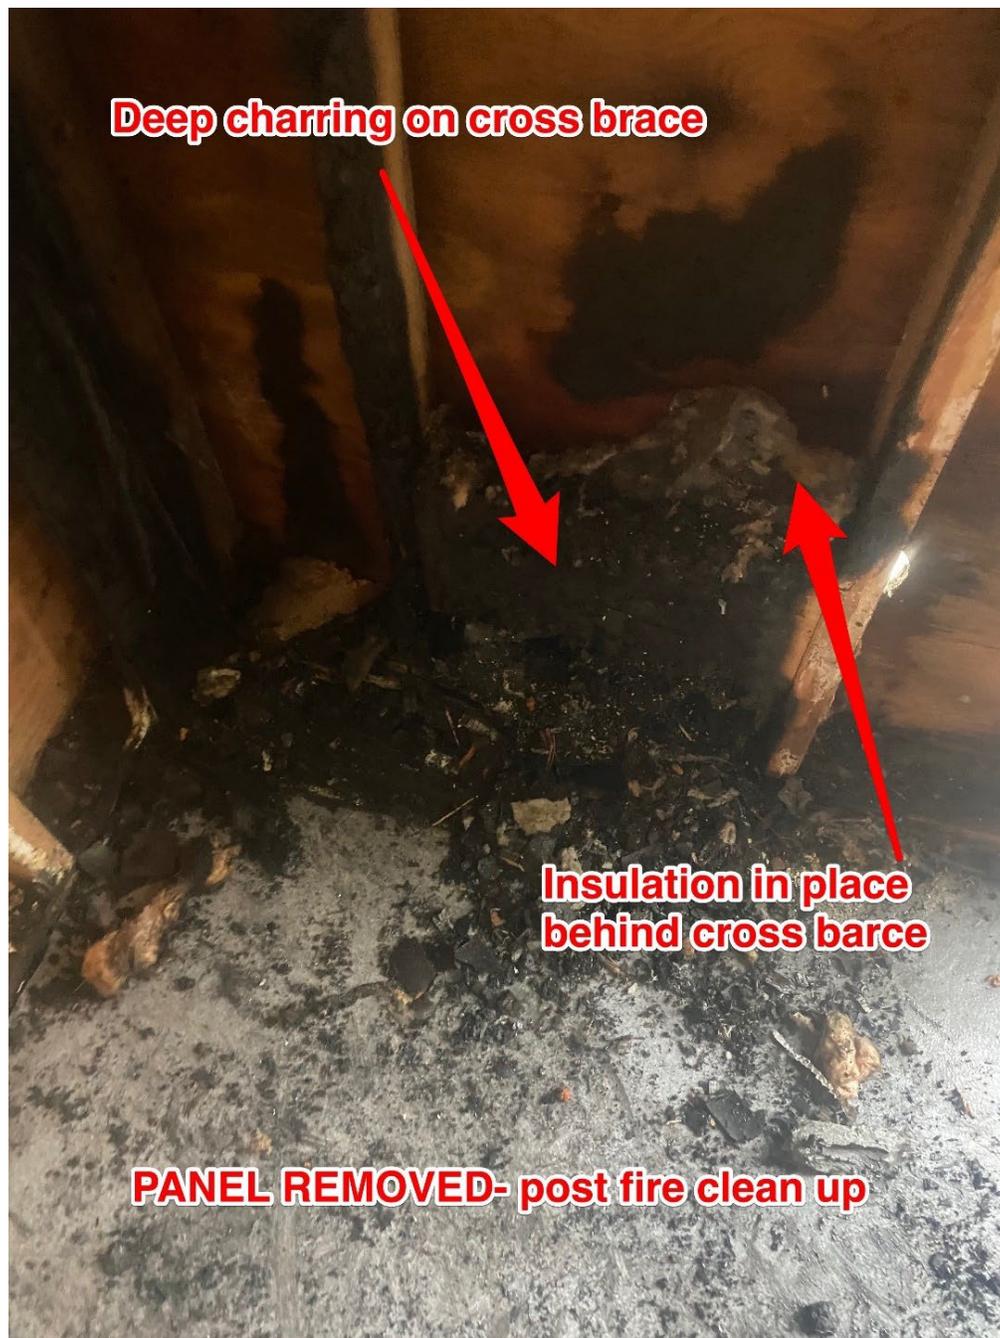
Image 5 - Lower section of wall - Area had original wiring and fished cabling run through this area with some in a tight space. A cross brace was in place leaving little depth for added cabling installed. Some insulation is noted behind lower cross brace

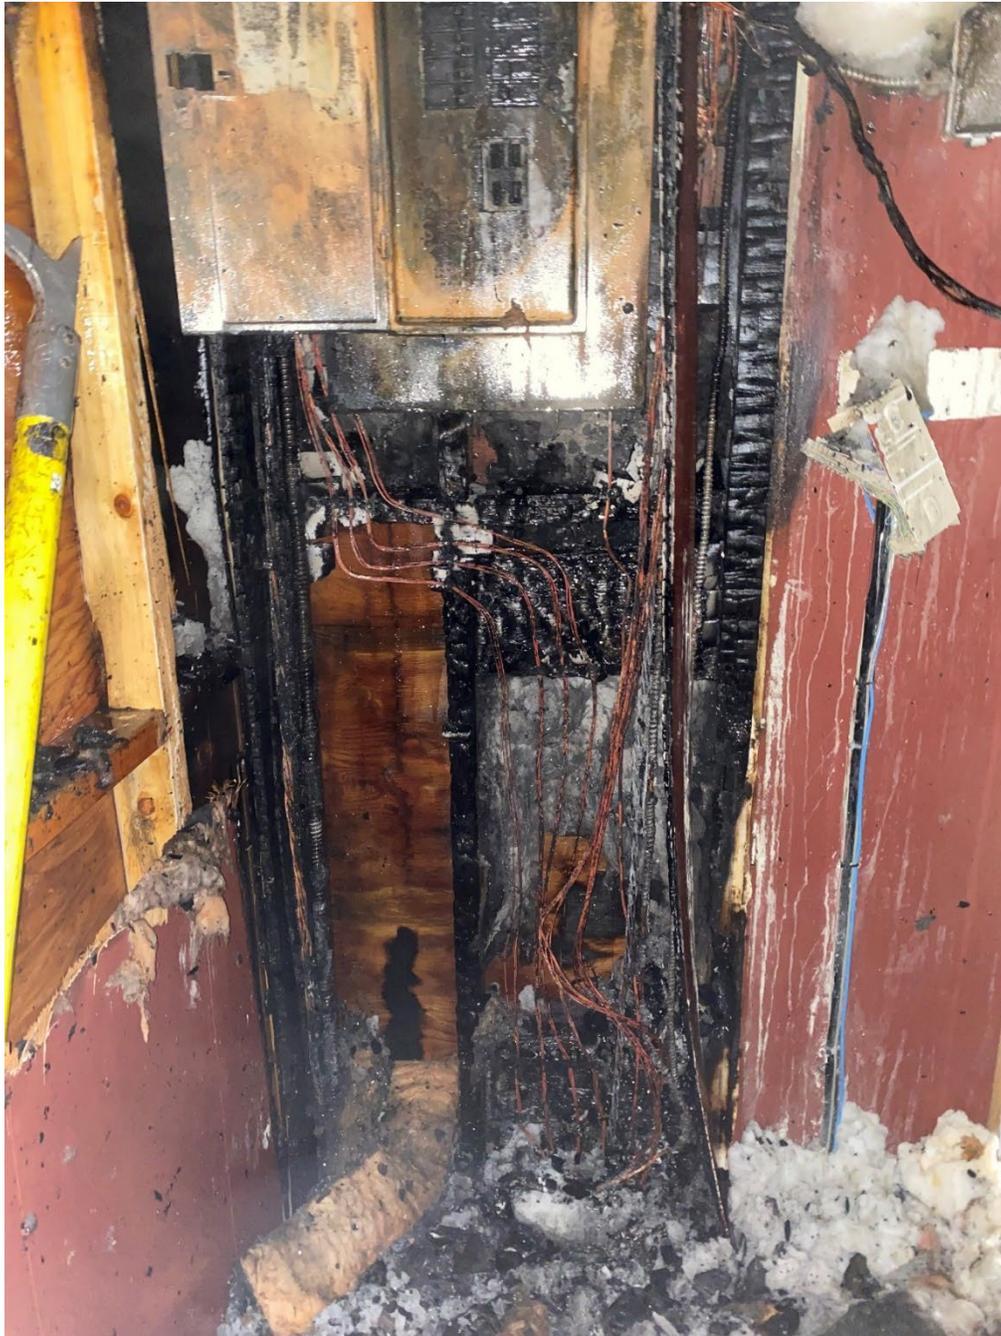
Image 6 - Shows wiring was installed to cross bracing near floor, limiting available wiring space for fished wires. Insulation is in place behind wires in wall, behind cross brace, higher up the wall, below the panel

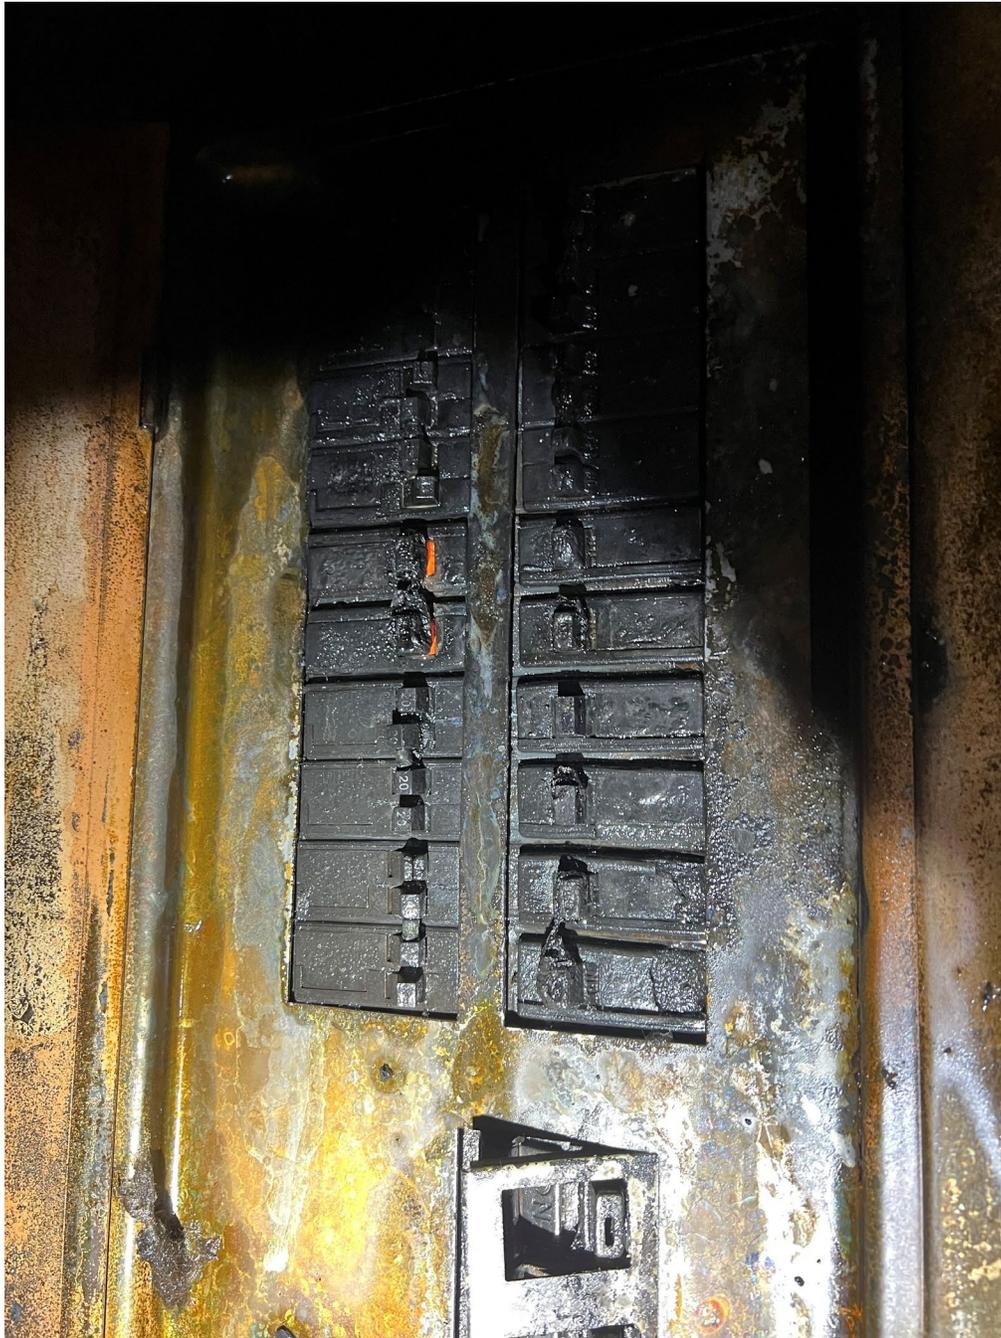
Image 7 - Front view of panel in place. No openings noted, no evidence of fault/flames exiting front of panel.

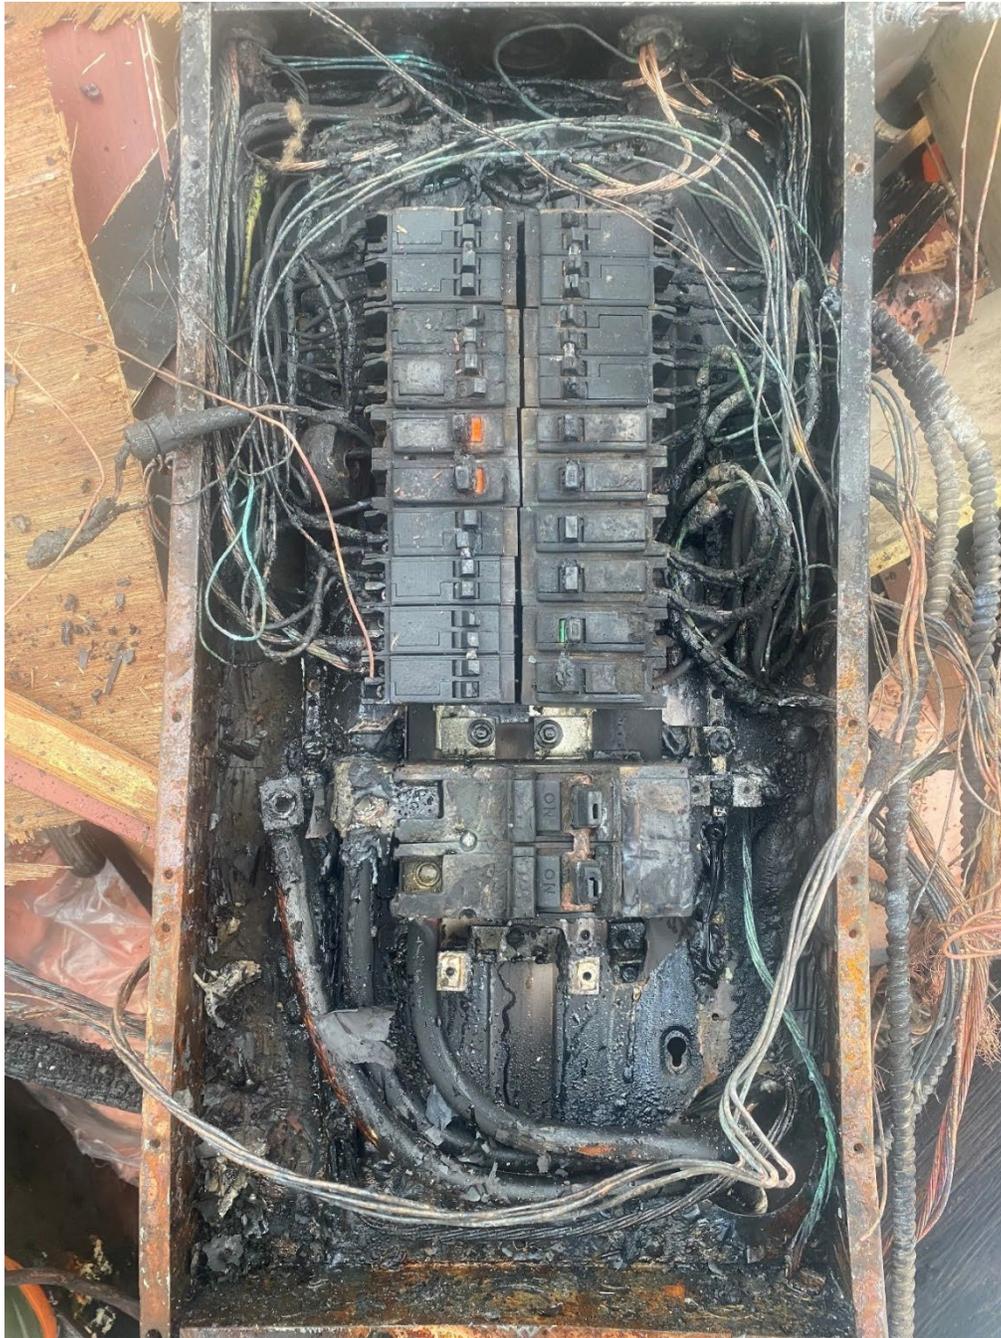
- Contractor removed panel and cover to provide photos of panel interior. There were no evident openings noted for an interior fault that may have occurred. The interior showed no evidence a fire starting in the interior of the panel. Wiring within the panel has extensive heat damage with most conductor insulation removed, however some of the conductors were noted to still have insulation.

Image 8 - Panel removed and laid on ground showing inside of electrical panel. This shows the heat damage that occurred within the electrical panel. Not all insulation of electrical cabling has been melted away.

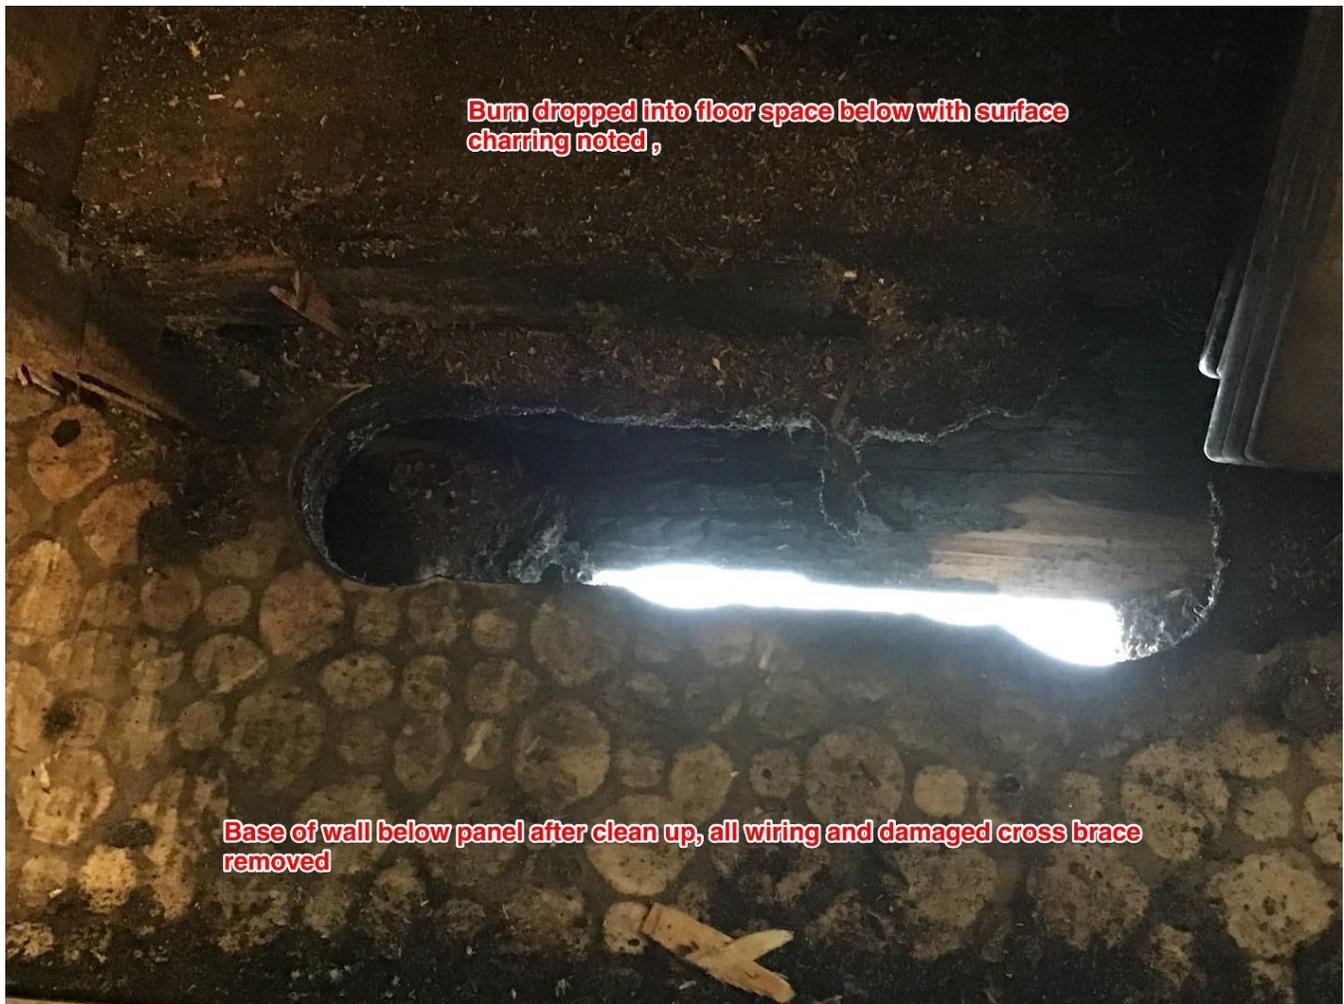
Image 10 - Post clean up view of floor, fire damage noted to enter lower floor space charring wood structure
