## Incident Summary (Posse File#5620261)

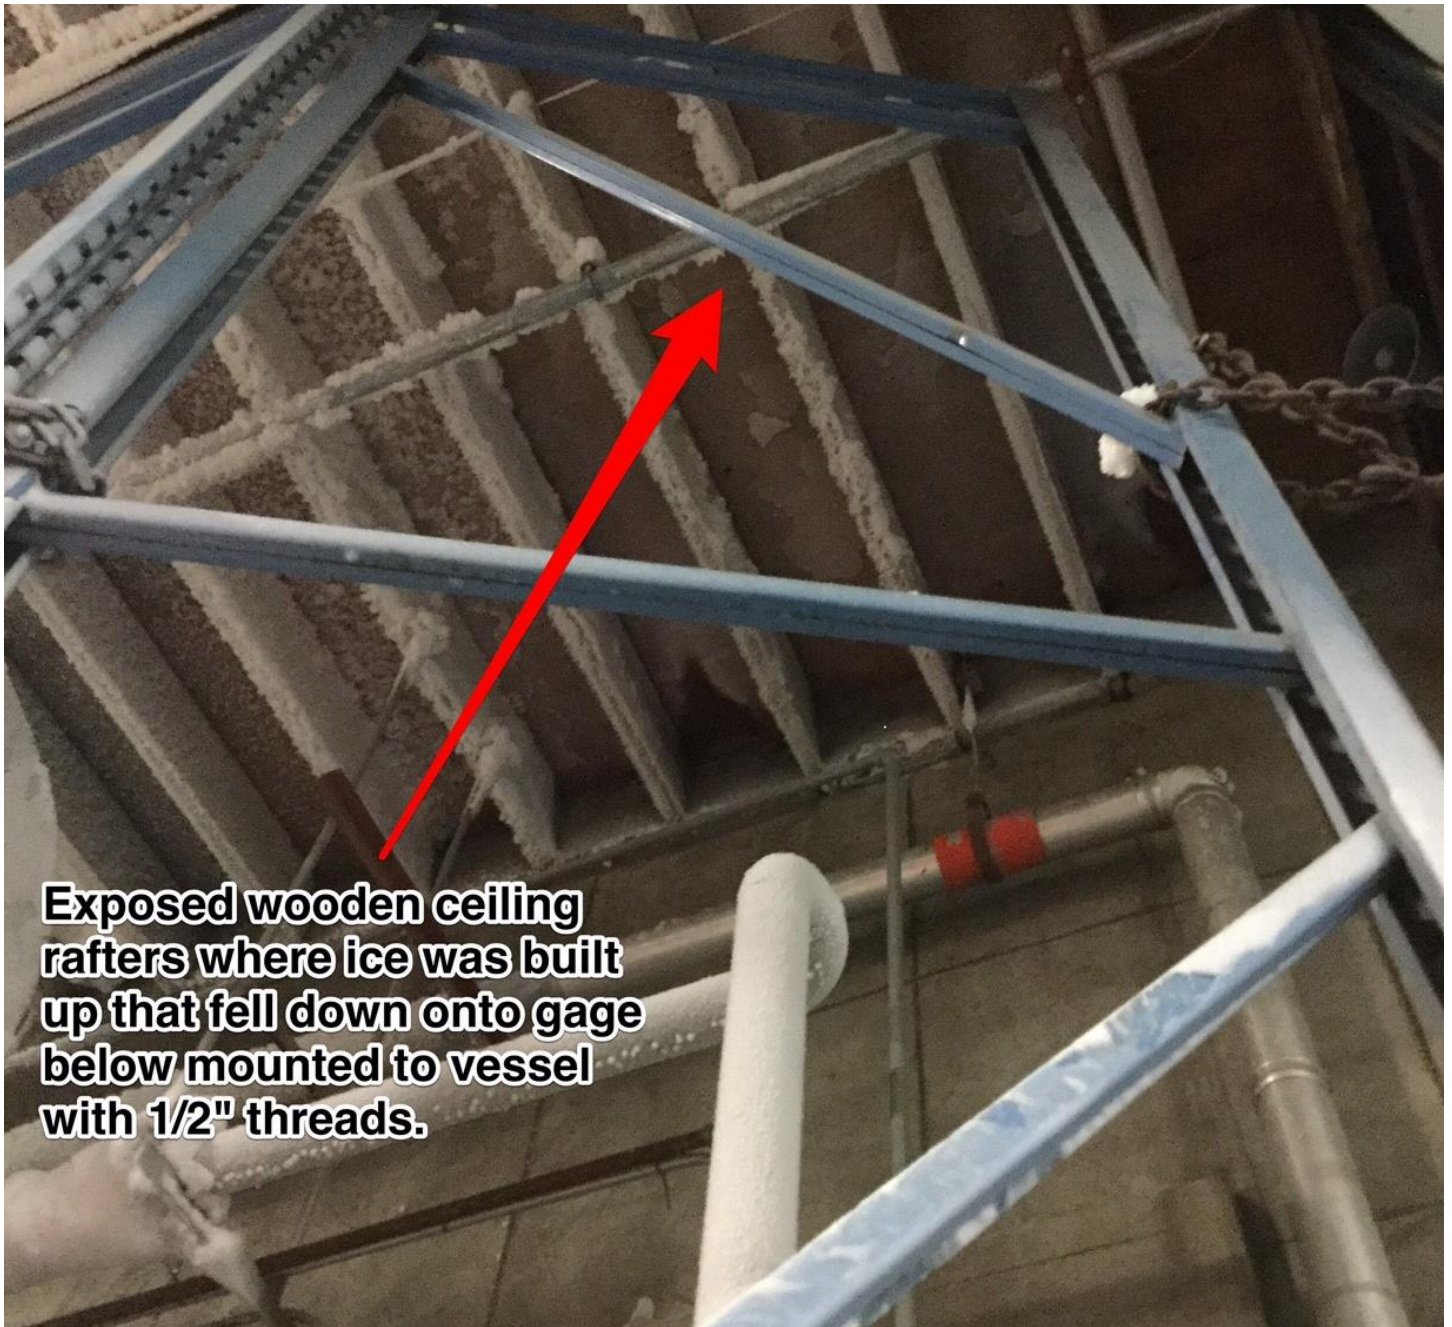
Failure scenario(s)		Exposed wooden ceiling rafters located in the older area of the large scale commercial freezer, developed ice build-up on the surface directly above the pressure gauge that was mounted on the ammonia pressurized vessel. A piece of ice fell from the ceiling and hit the pressure gauge below, breaking its threaded connection causing ammonia to leak out.	
	Facts and evidence		-Ice Build-up on exposed rafters of ceiling in commercial freezer area. -Pressure Gauge directly below the rafters, installed on the pressurized ammonia vessel. -Evidence based on observations during investigation, and witness account from Chief Operating Engineer. -Licensed contractor was onsite at the time and contained the leak immediately, then made the necessary repairs. -Protective barriers were mounted above pressure gage to prevent a future occurrence.	
	Causes and contributing factors		It is Highly probable that the build-up of ice on exposed ceiling rafters was the cause of the ammonia leak from the system. This is based on observations during the investigation, plus witnessed accounts by the Chief Engineer and Licensed Contractor onsite at the time of leakage.

**Exposed wooden ceiling  
rafters where ice was built  
up that fell down onto gage  
below mounted to vessel  
with 1/2" threads.**

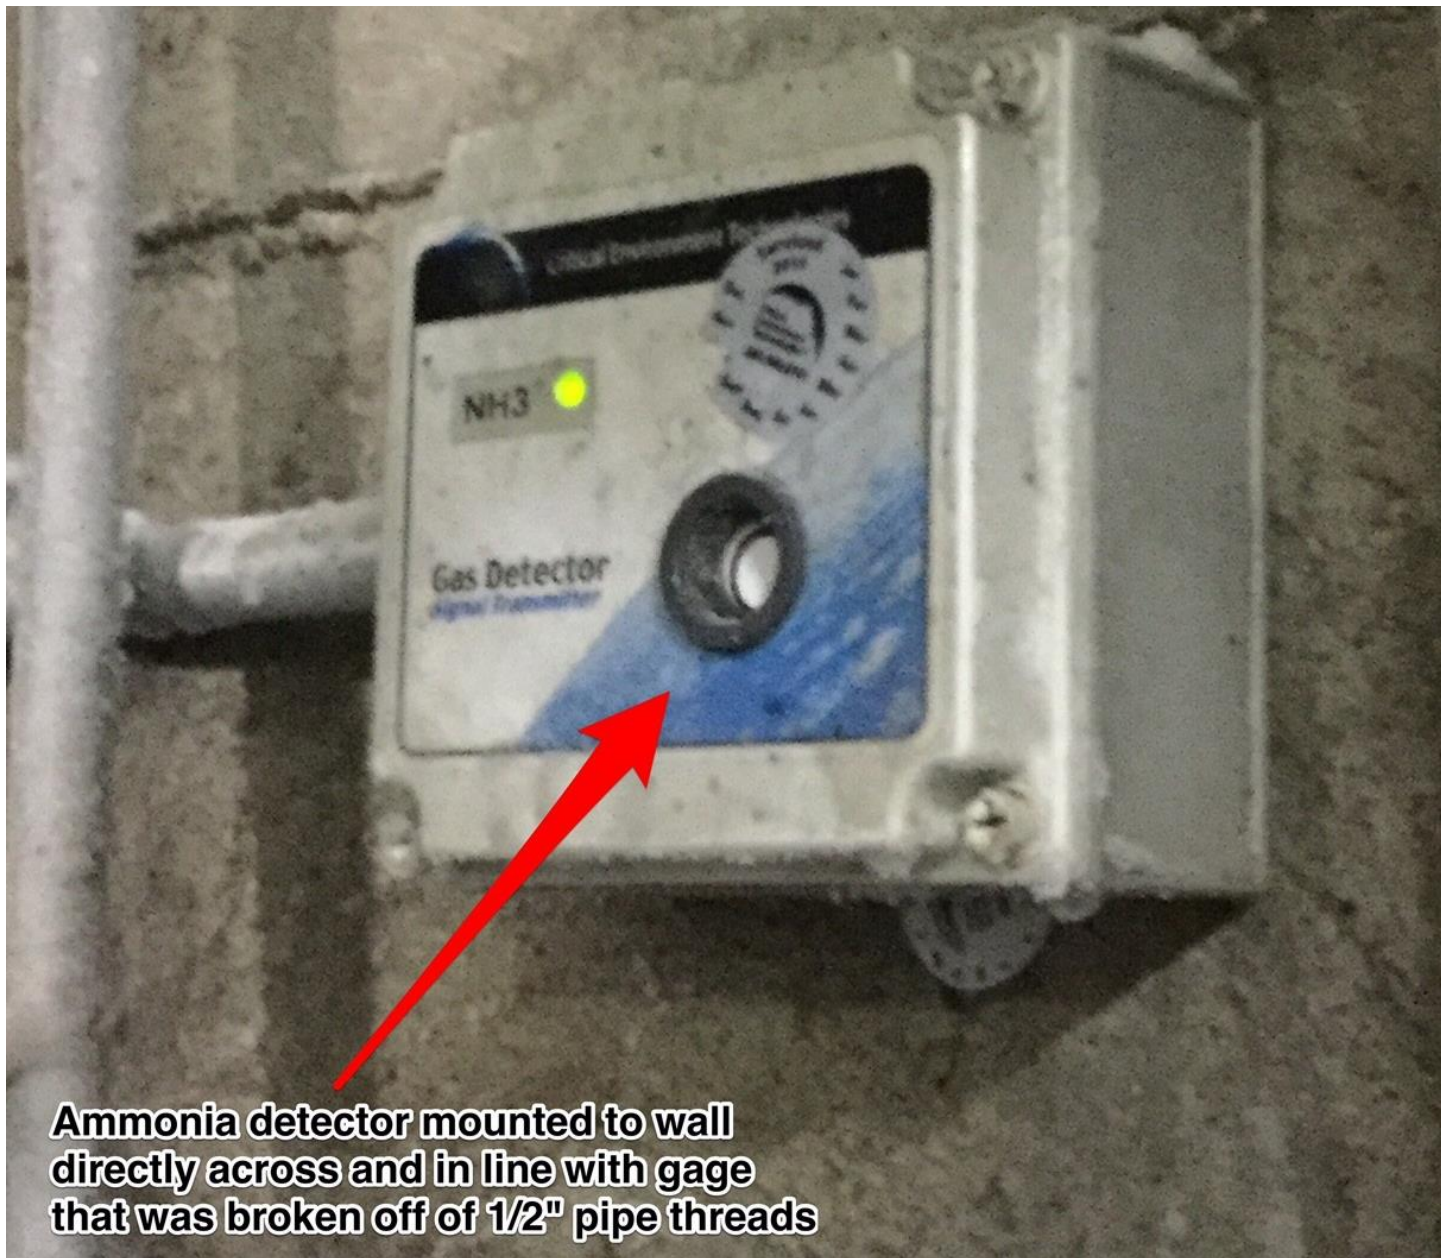
**Ammonia detector mounted to wall directly across and in line with gage that was broken off of 1/2" pipe threads**
