Incident Summary #II-895972-2019 (#14925) (FINAL)

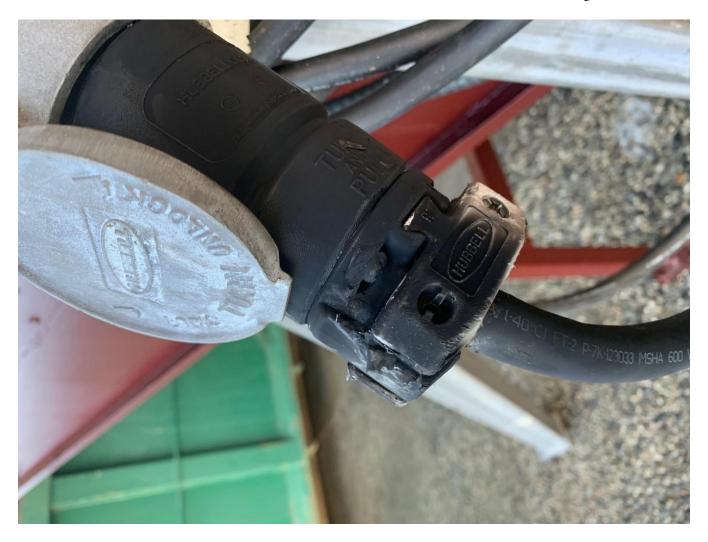
The approved wet location twist lock receptacle was not reviewed for integrity and allowed water in.
	Facts and eviden	There was no procedure to ensure equipment was not impacted by wash down in the area: work procedure was developed after the incident.
		Photos show the damaged receptacle and the integrity of the wiring connections in the junction box.
	Causes and contributing facto	It's likely that the aging wet location twist lock receptacle wasn't sealed correctly and allowed water to enter causing an arc flash when it was energised. The lack of a worker procedure may have been a contributing factor to the incident.

Photo 1: Damaged twist lock receptacle for portable equipment: 30A 480V

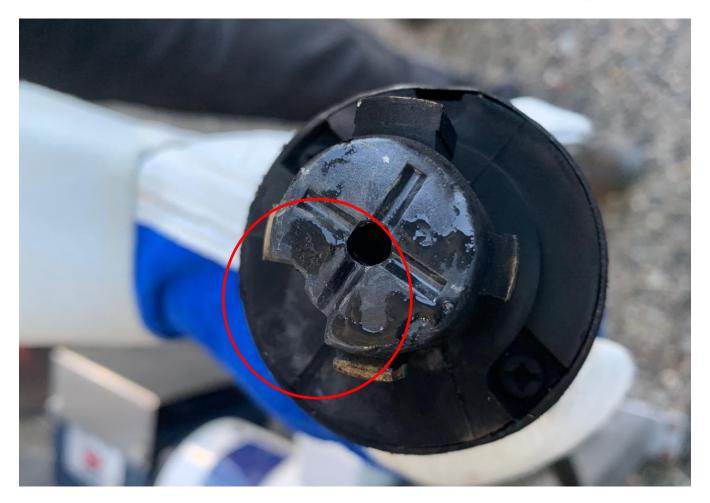
Photo 2: Fail point of receptacle

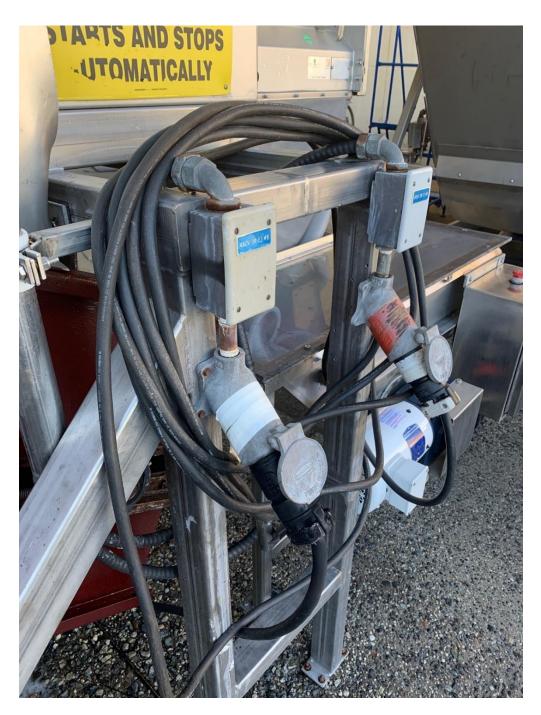
Photo 3: Original installation

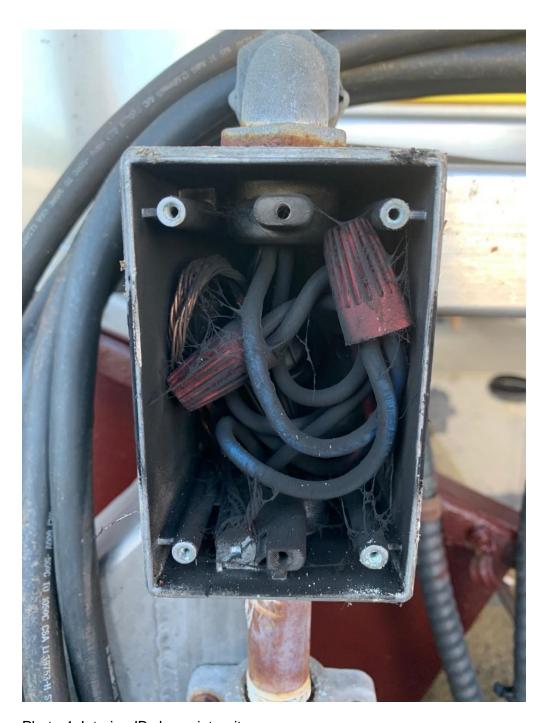
Photo 4: Interior JB shows integrity
