Appendix C: Site Description and Scene Documentation

Ammonia Refrigeration and Brine Cooling System at Fernie Memorial Arena

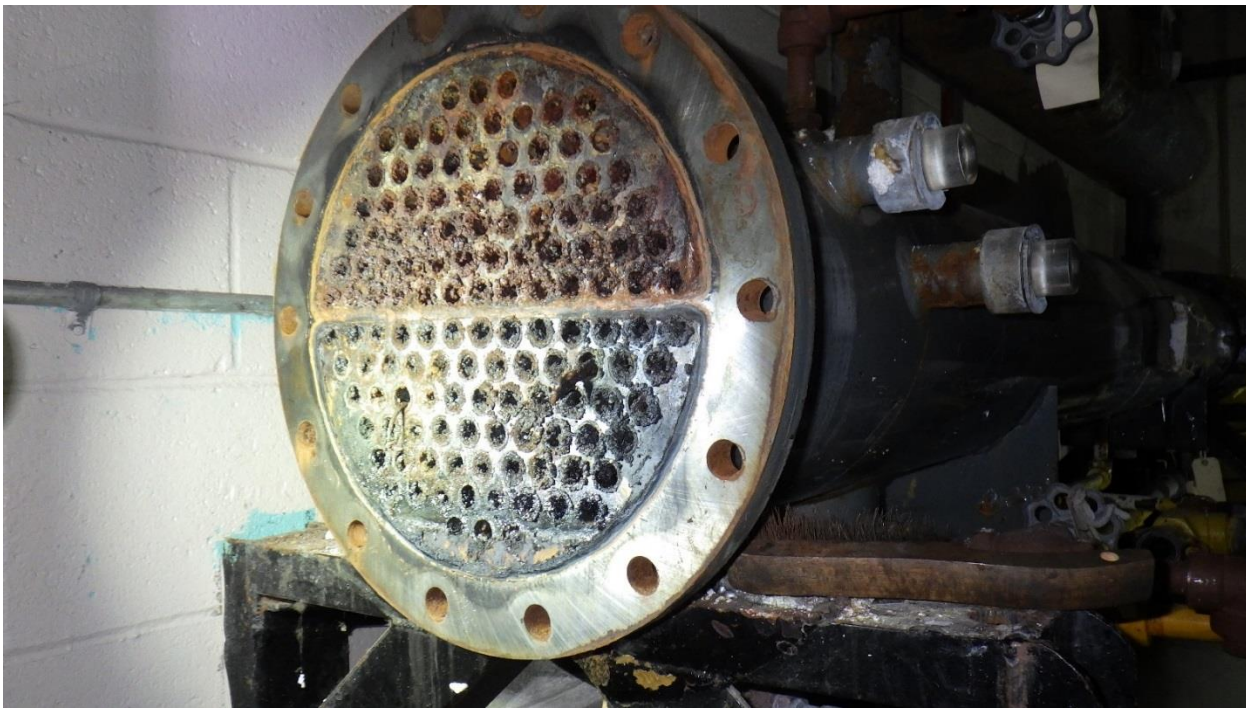
Photo C3-2: Curling chiller, head removed. The brine inlet/outlet tube sheet at the north end of the chiller. Debris and residue is visible on the tubes.

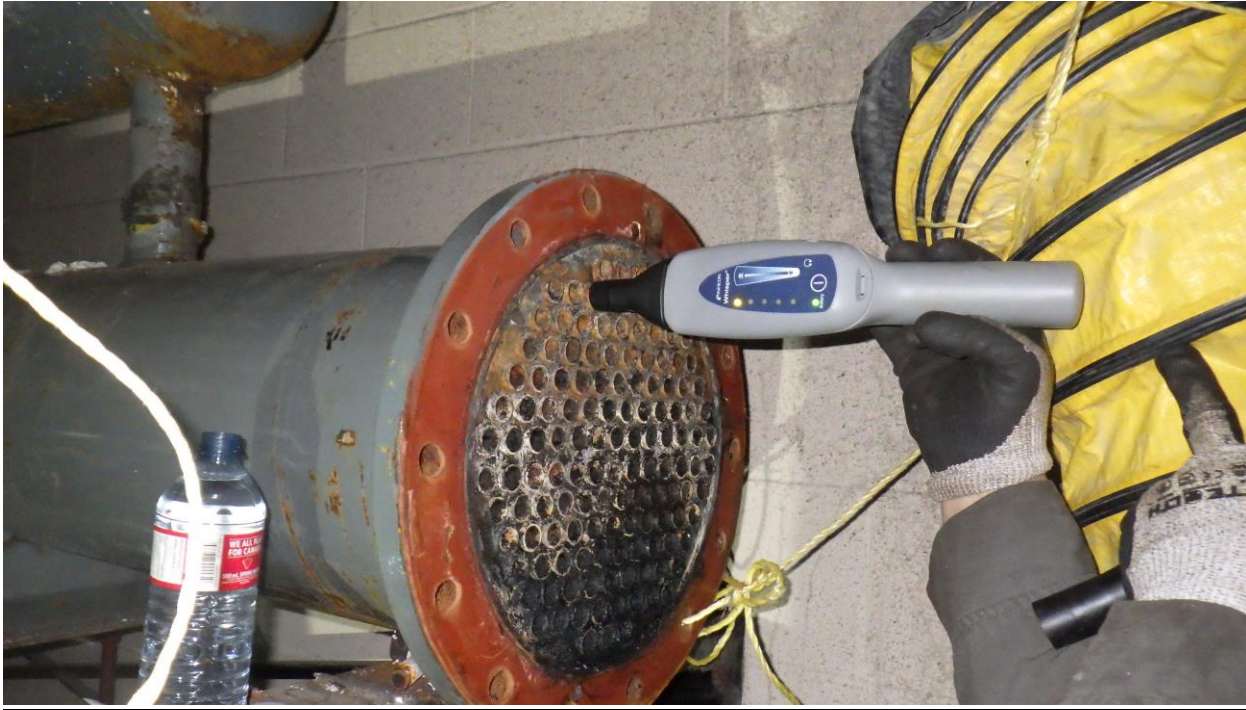
Photo C3-3: Return end tube sheet (south end) of the curling chiller. Debris and residue is also visible on the tubes and sheet.

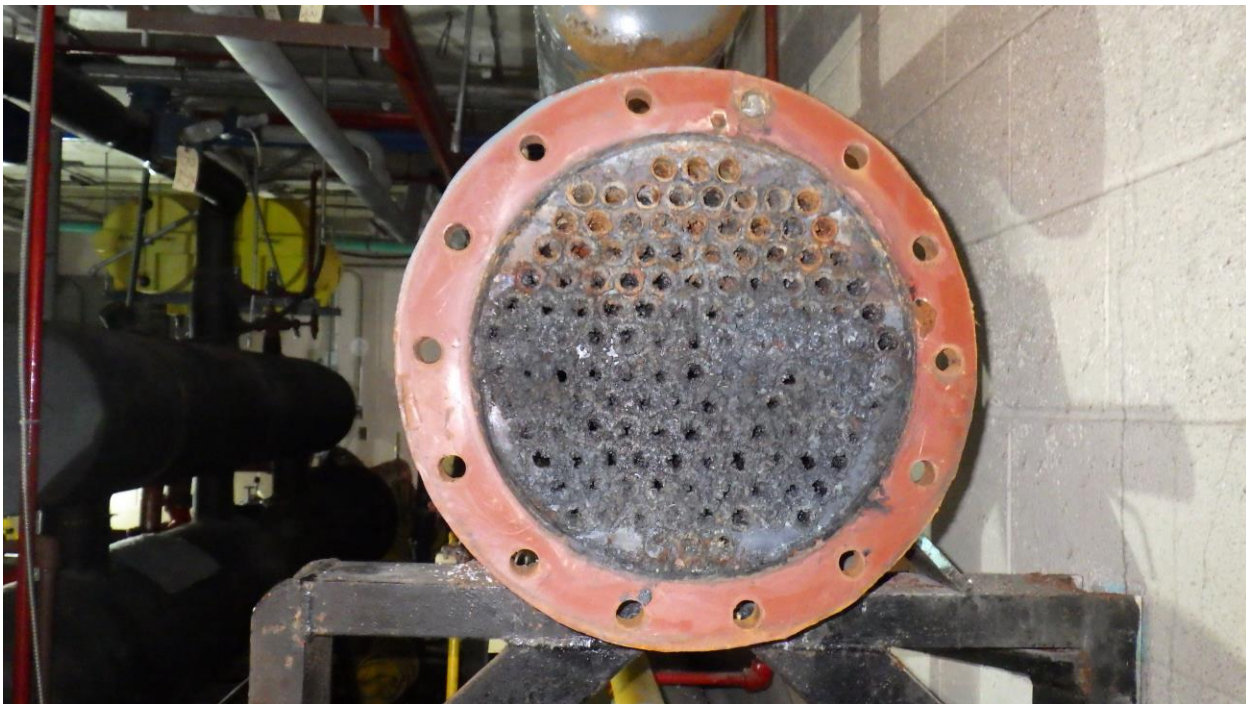
Photo C3-4: Curling chiller, tube sheet upon opening in January 2018 showing residue.

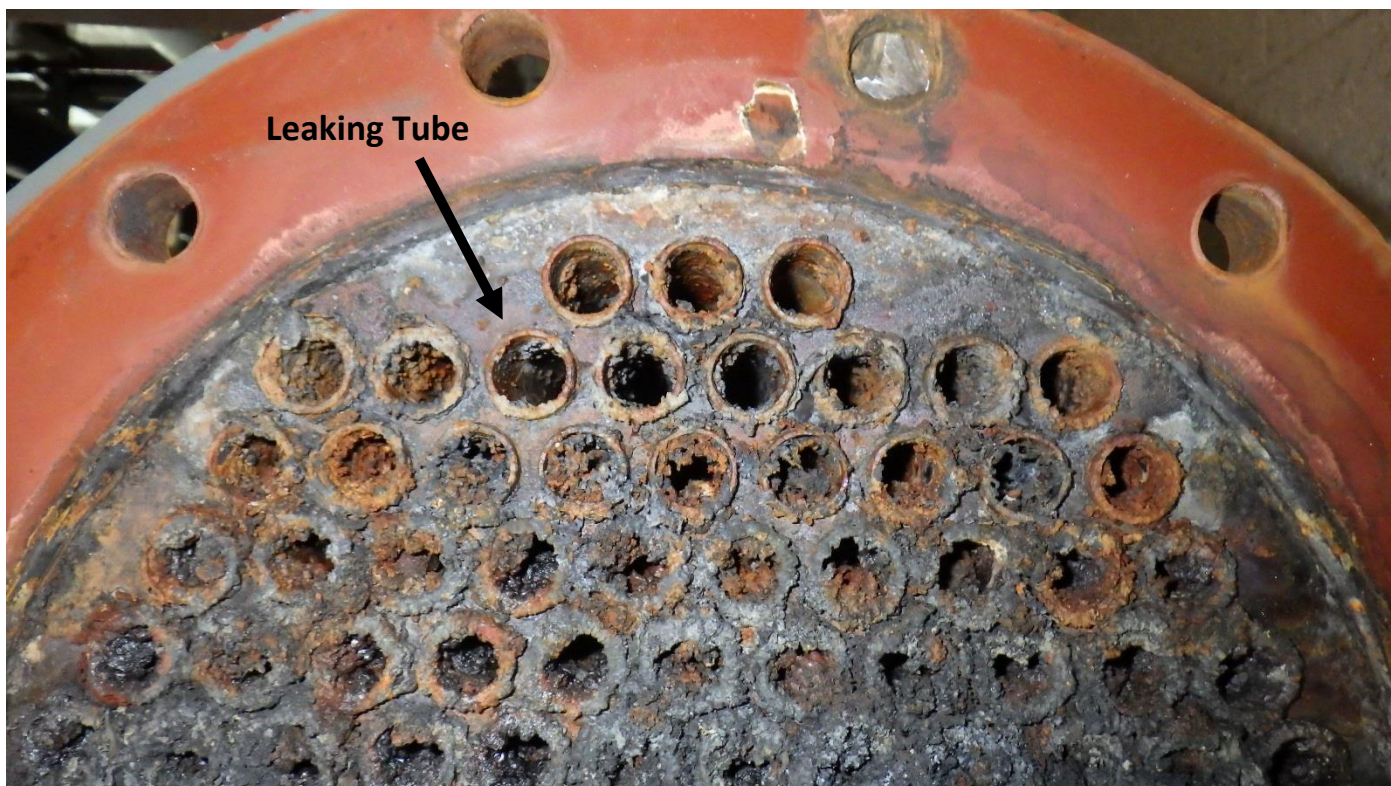
Photo C3-5: Close up of upper tubes from return end of chiller upon opening in January 2018.

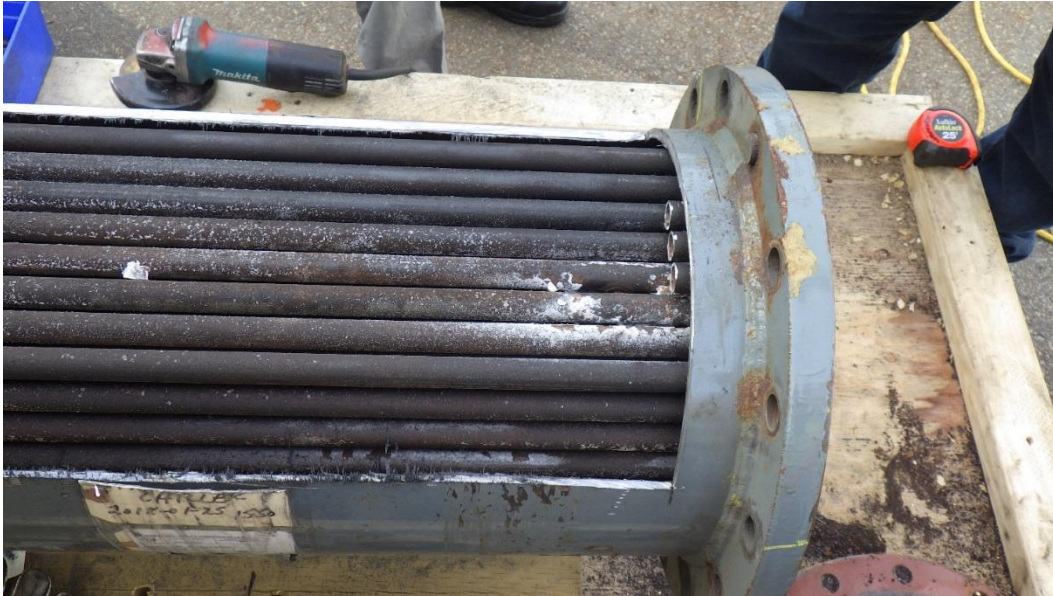
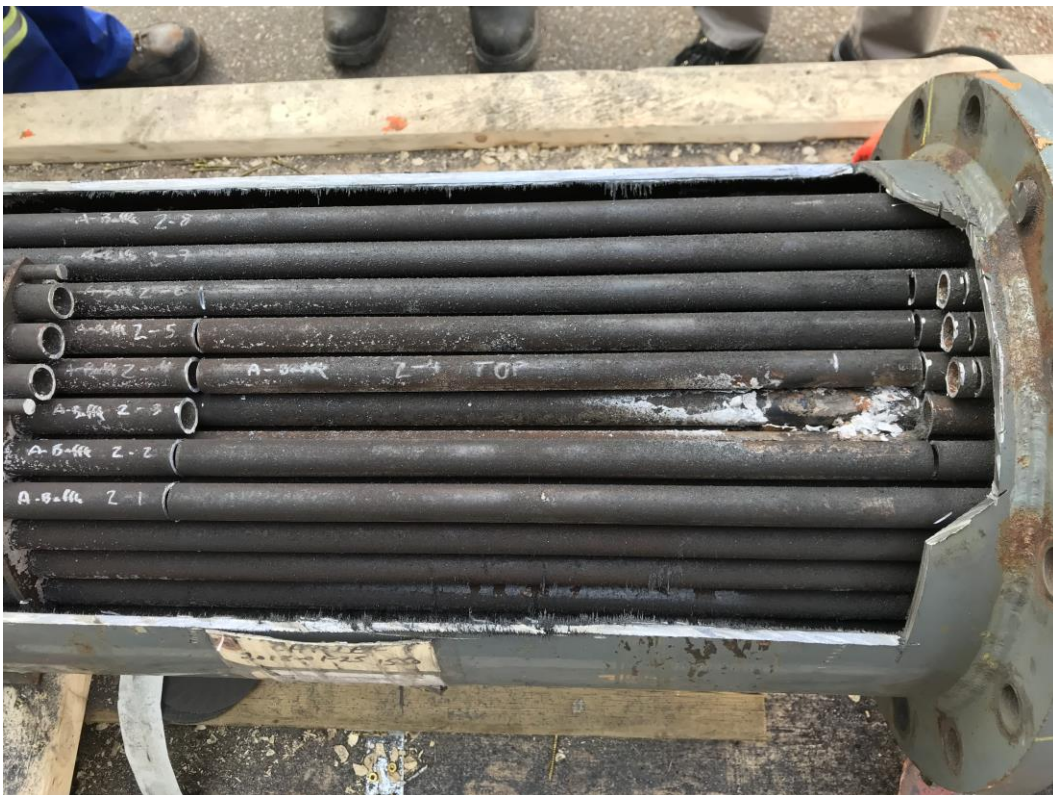
Photo C3-8 and Photo C3-9 (below): Chiller with shell section and top three tubes cut away at return end – white scale indicates brine leak into shell (ammonia) side of heat exchanger. Below shows leaking tube removed with scale deposits and spray patterns on adjacent tubes.

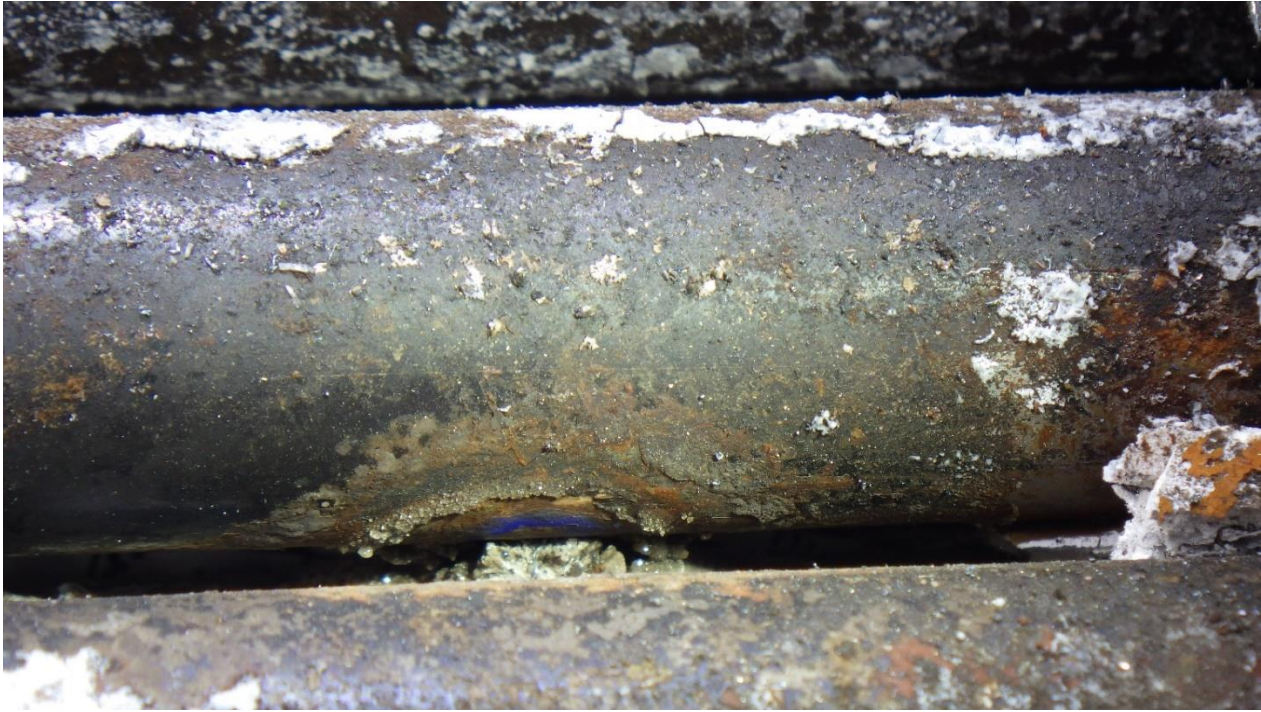
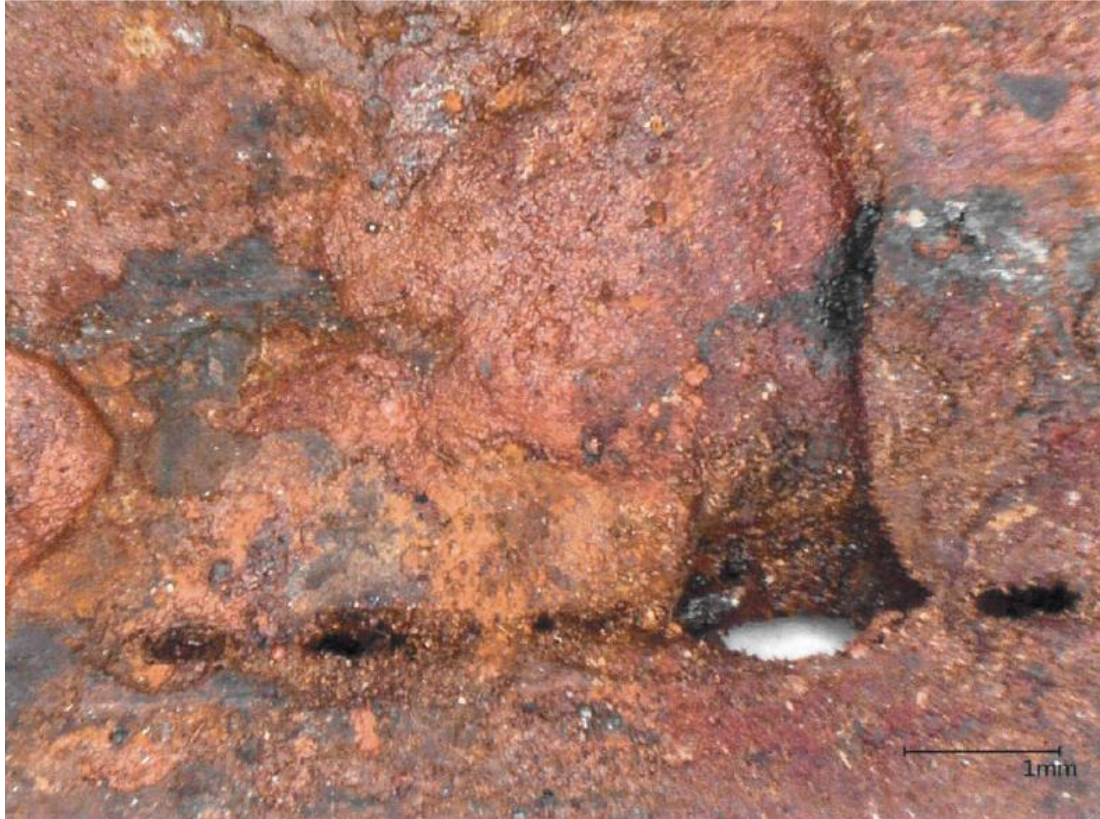
Photo C3-10 (above) and Photo C3-11 (below): Above shows evidence of spray from tube (brine) side into shell (ammonia) side. Photo C3-11 shows close-up of inside surface of the tube and leak location showing erosion of metal from ammonia leak into tube.

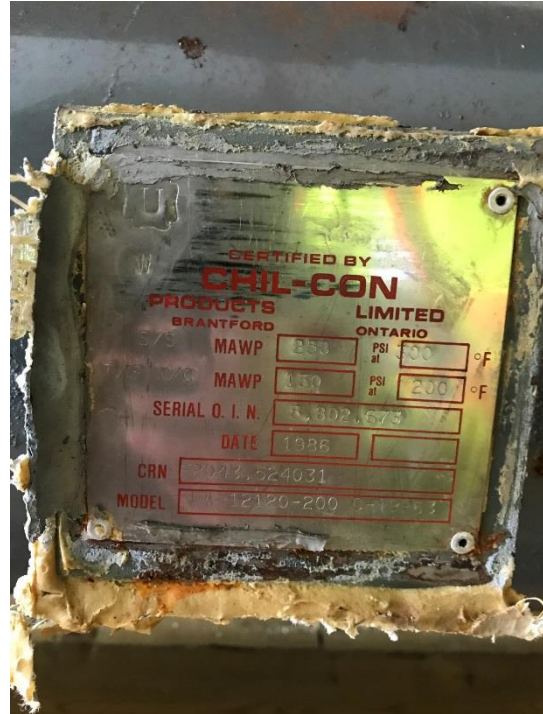
Photo C3-13: Manufacturer's nameplate – Curling System Brine Chiller – Fernie Memorial Arena. Date of manufacture identified as 1986. This chiller was approximately 31 years old at the time of failure

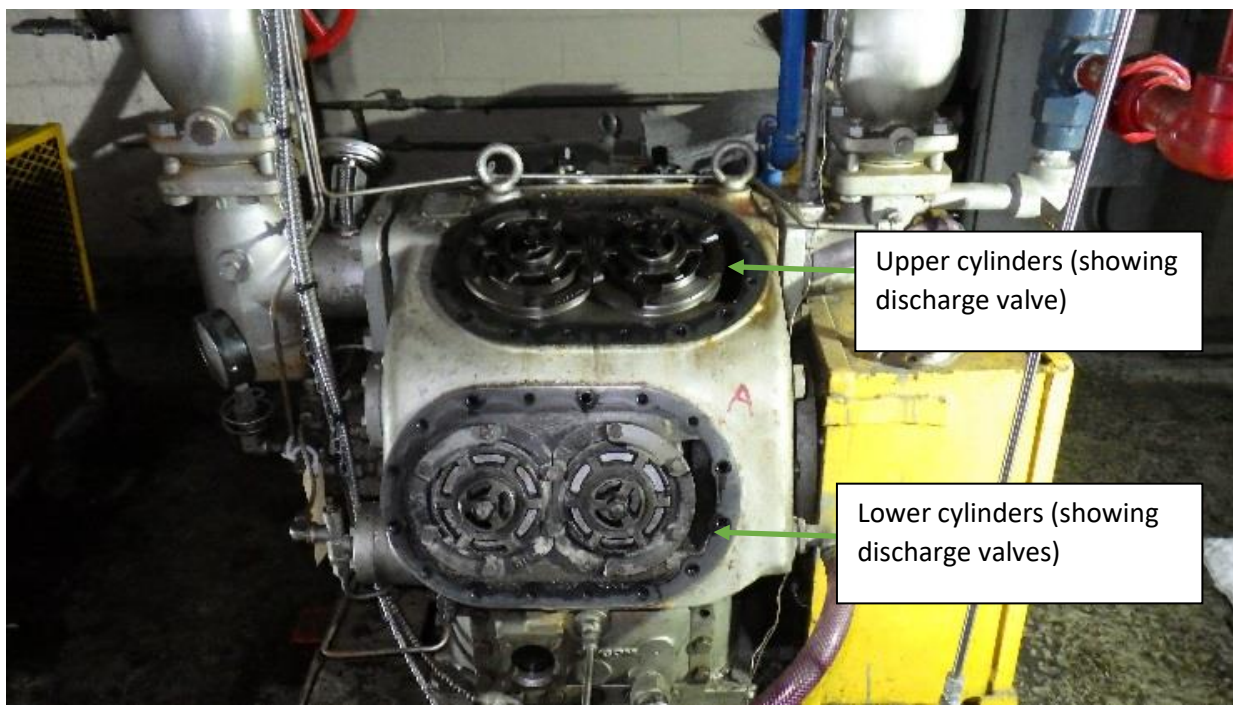
Photo C4-2: Compressor #2 (Compressor #1 similar) with valve covers removed. The lower discharge valves showed salt crystal build up. The upper discharge valves had less salt crystals on the discharge side of the valves and more crystals were present on top of the pistons (see Photo C4-4).

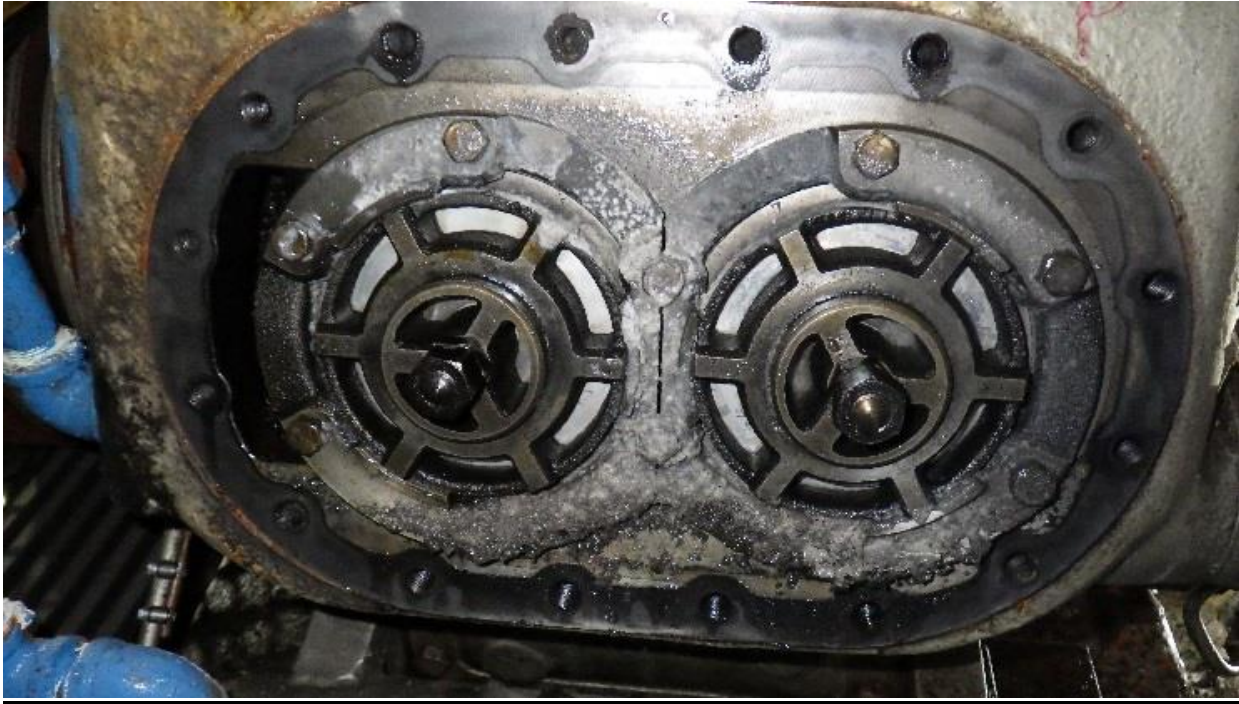
Photo C4-3: Close up of the lower valves in photo C4-2. Build-up of salt crystals from brine around the valves compressors #1 and #2.

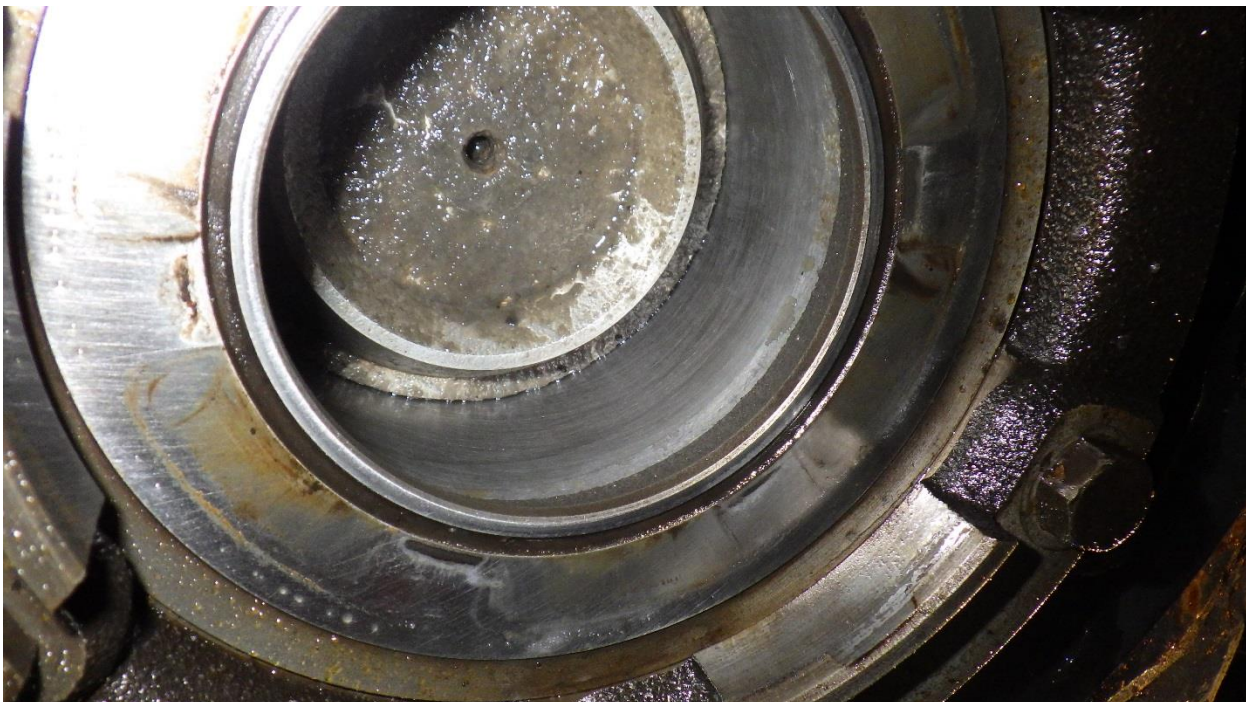
Photo C4-4: Salt deposits/residue from the brine on one of the compressor's upper piston

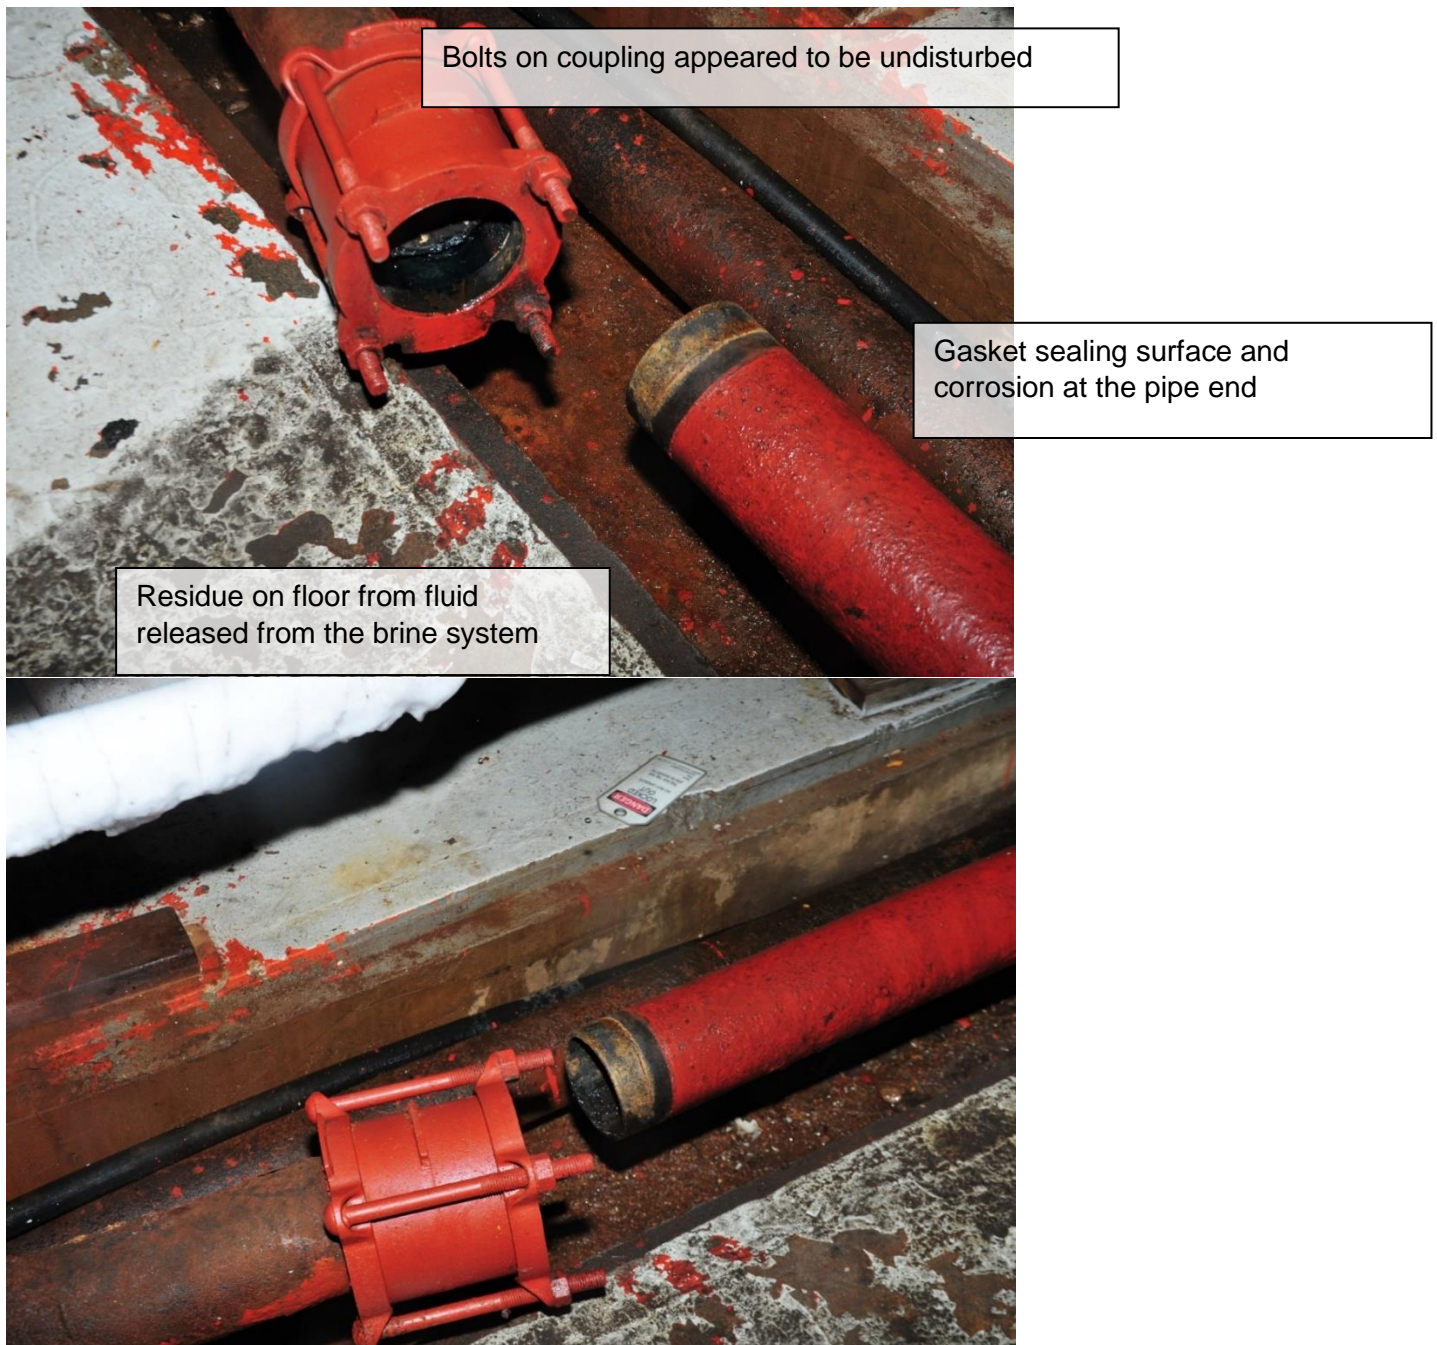
Photo C5-1 and Photo C5-2: Separated brine system coupling.

Photos C5-1 and C5-2 show the coupling dislodged from the piping. The report discusses the configuration of the piping components observed after the incident.

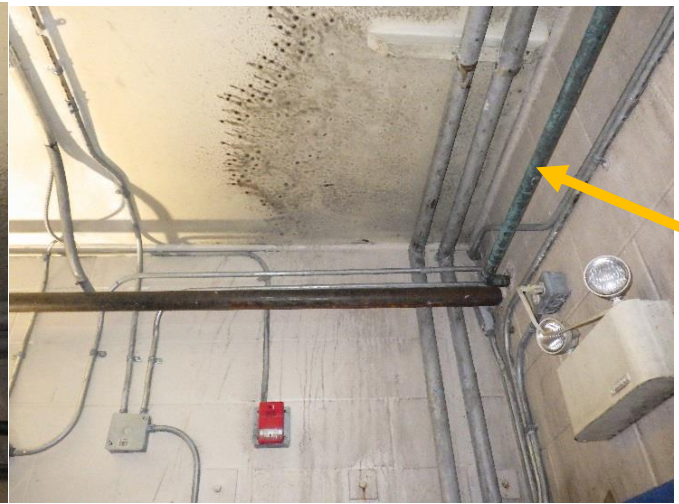
Photo C6-2: SW corner of the mechanical room (above the door to vestibule). Brine spray is seen on the ceiling and walls below. The arrow indicates blue/turquoise discolouration on the copper pipe from exposure to ammonia.

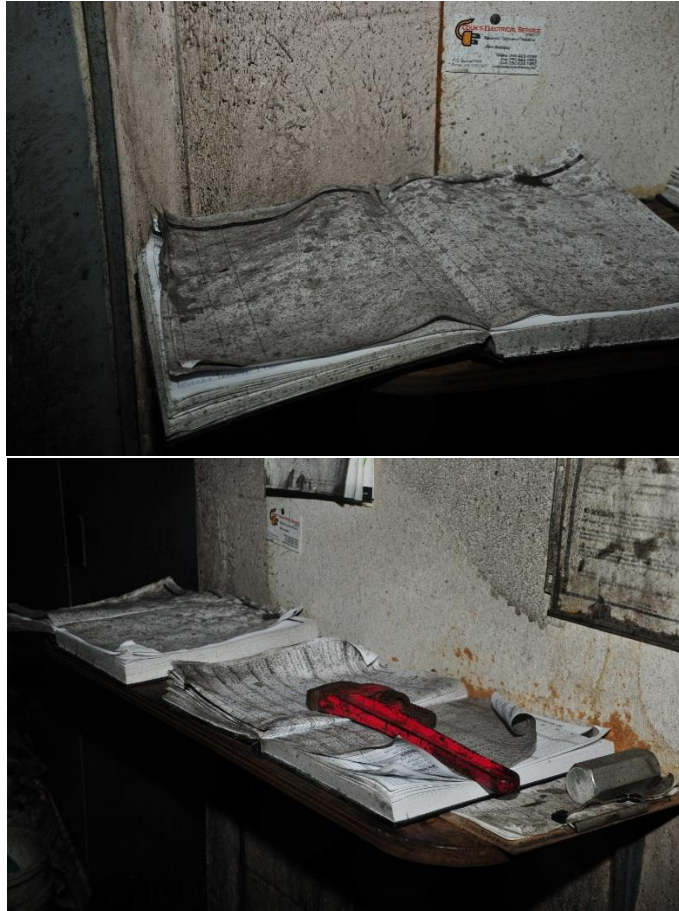
Photos C6-3 and Photo C6-4: View of opened books contaminated with brine spray on a shelf on the mechanical room's south wall. Note the shadowing from spray, suggesting that the spray was directional and projected at and around different components (not evenly misted or distributed throughout the mechanical room).

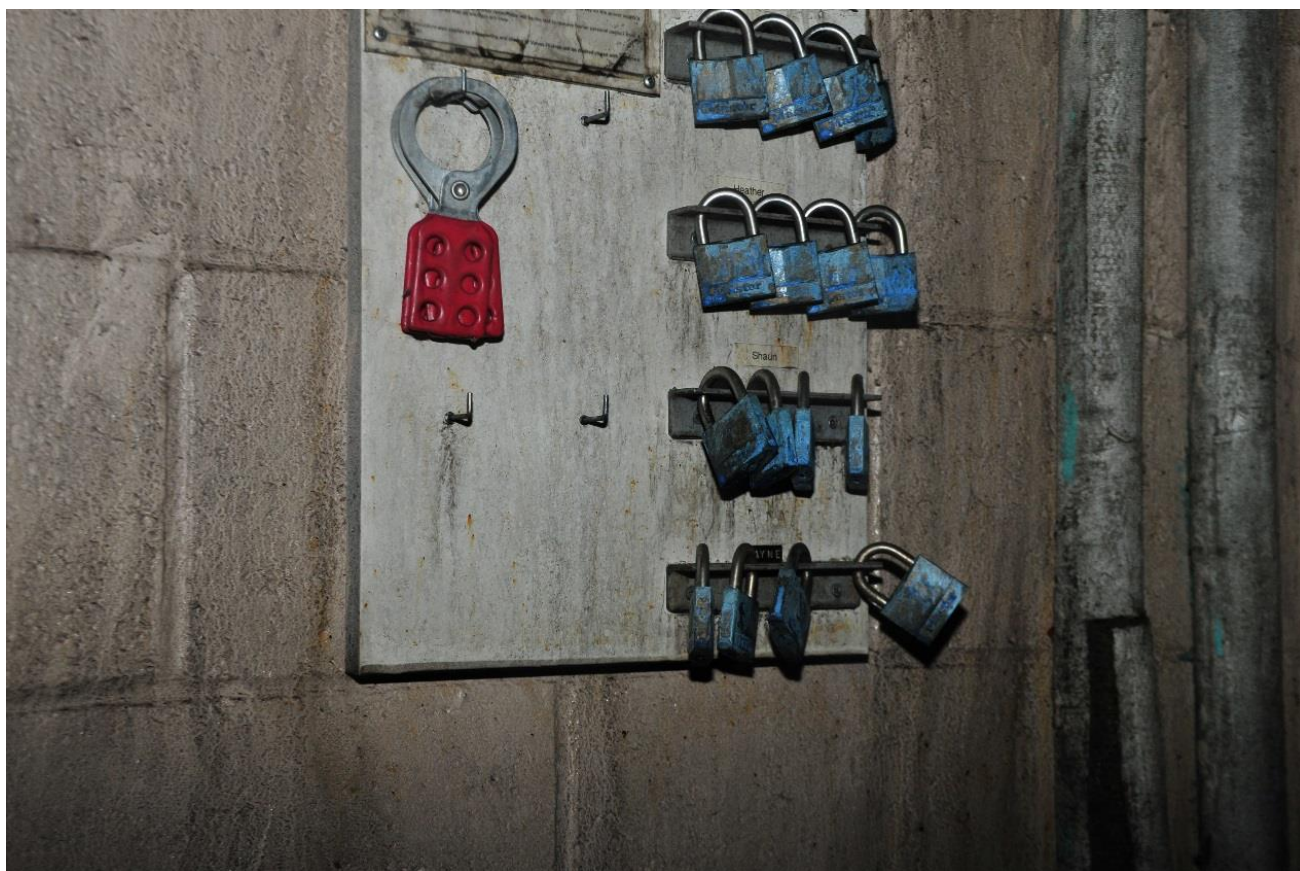
Photo C6-7: Copper locks showing blue corrosion due to ammonia exposure.

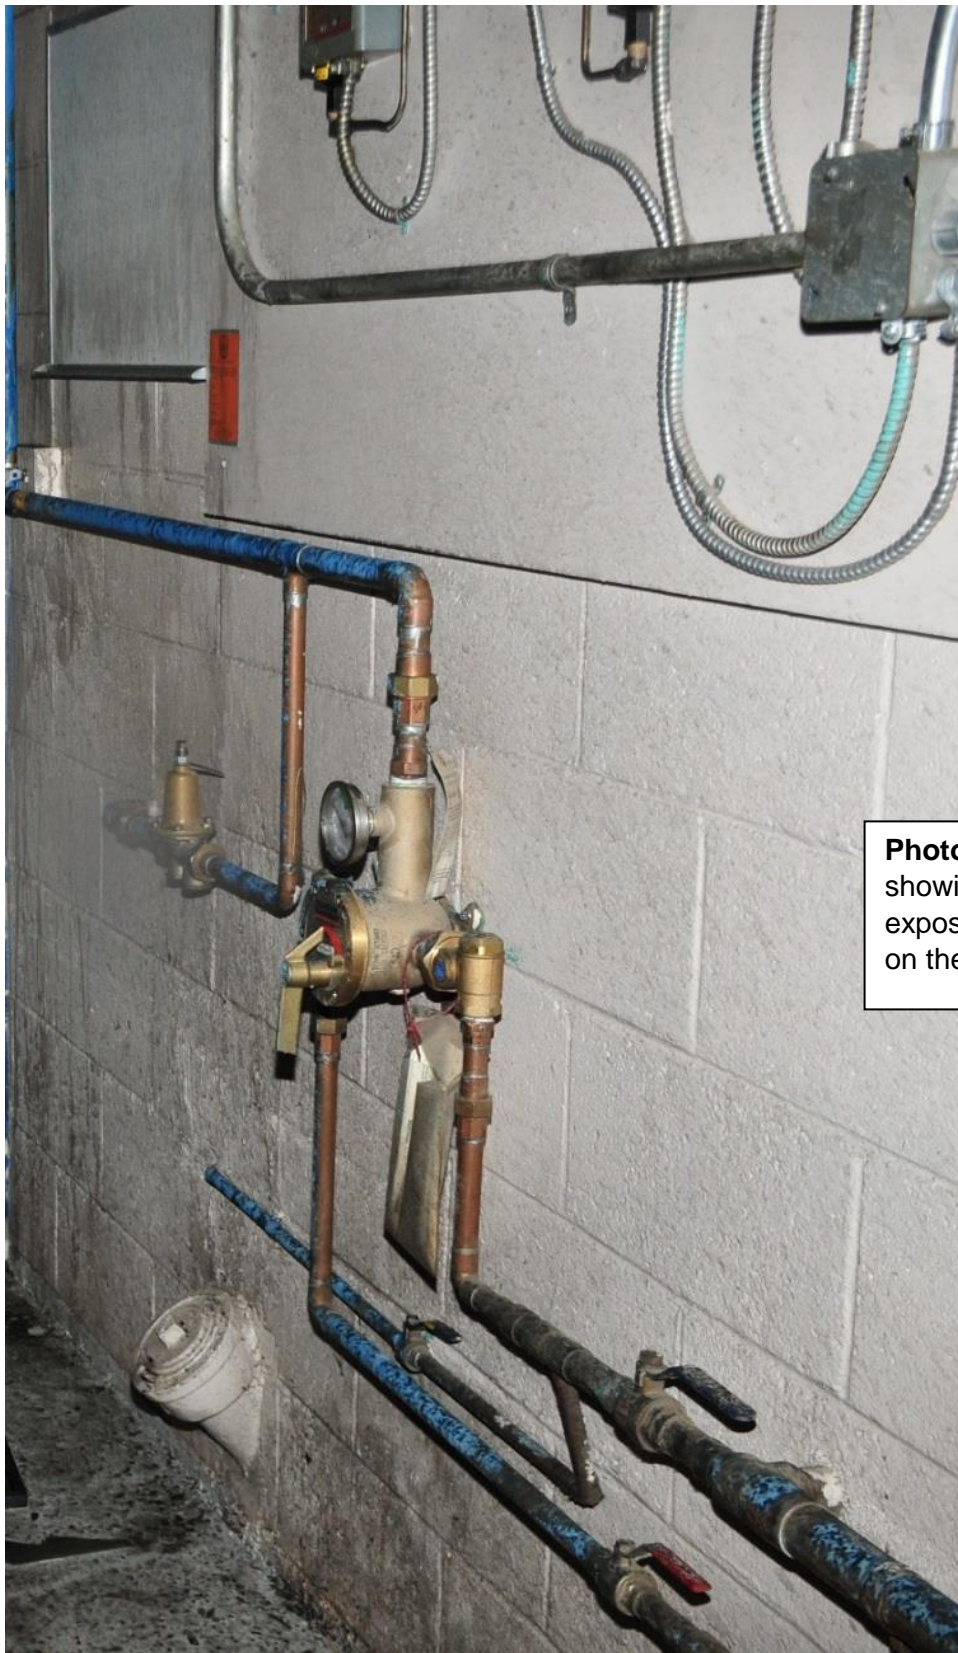
Photo C6-8: Exposed copper piping showing corrosion from ammonia exposure. Brine spray is also visible on the wall and floor surfaces.

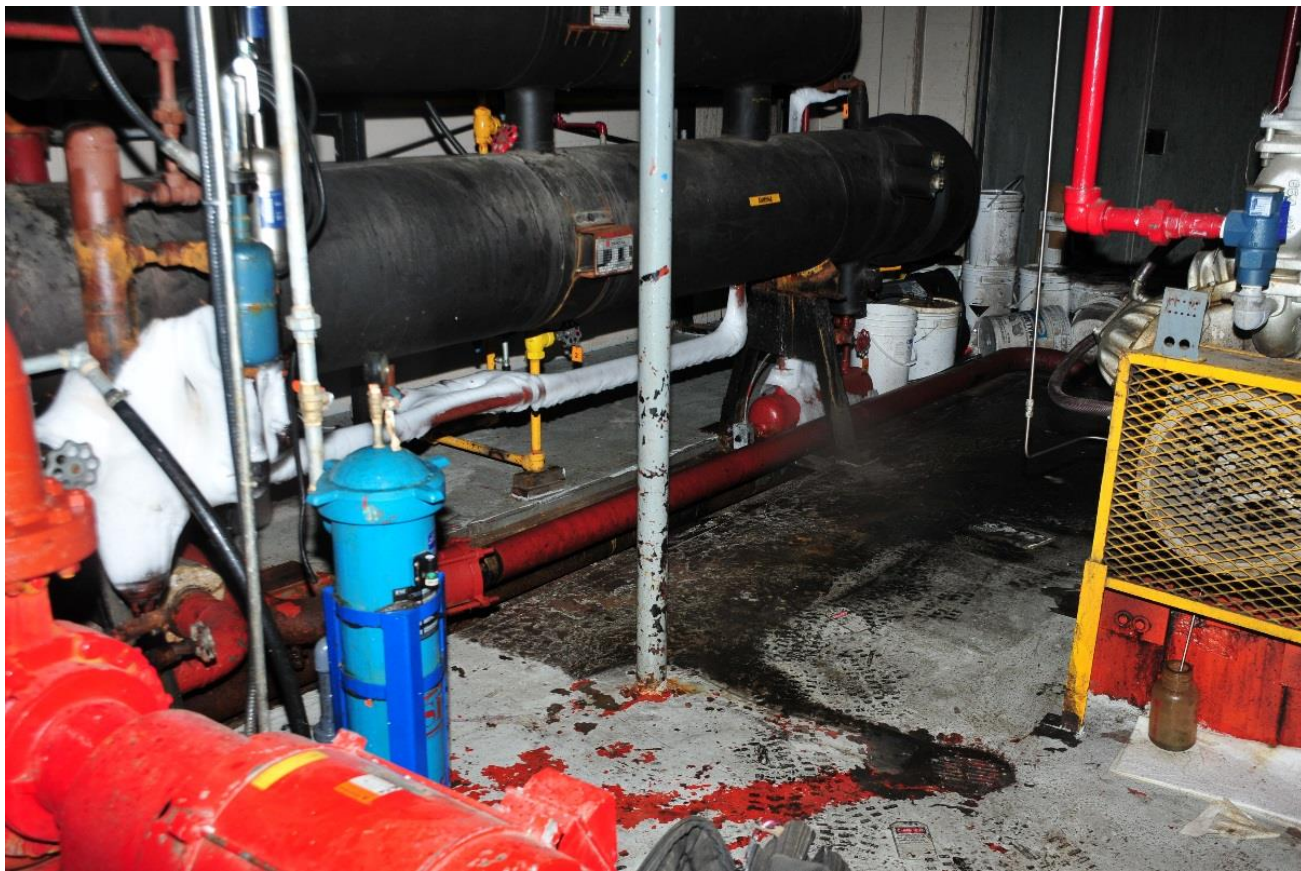
Photo C6-9: Projected contents of the brine piping from the separating coupling.

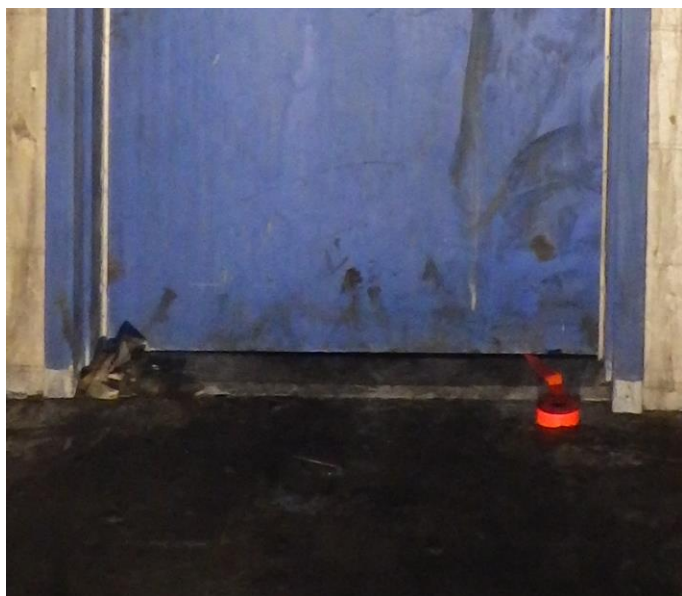
Photo C6-10: Door between mechanical room and vestibule showing gap under door.

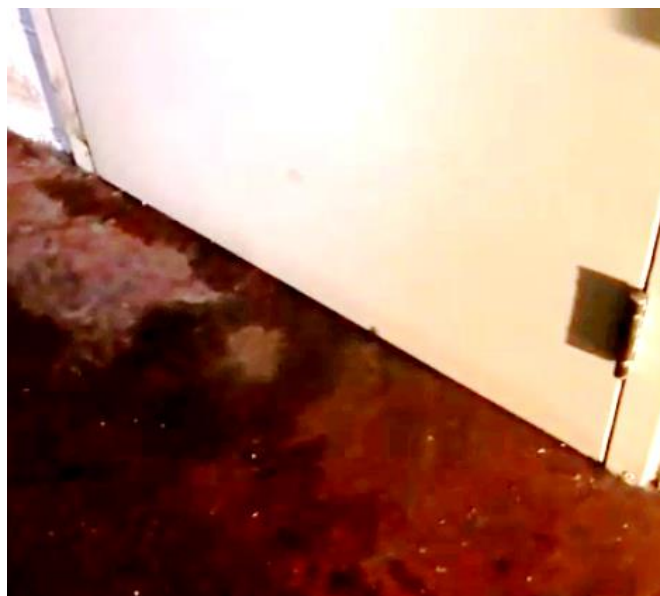
Photo C6-11: Door between vestibule and arena did not incorporate a seal at bottom.

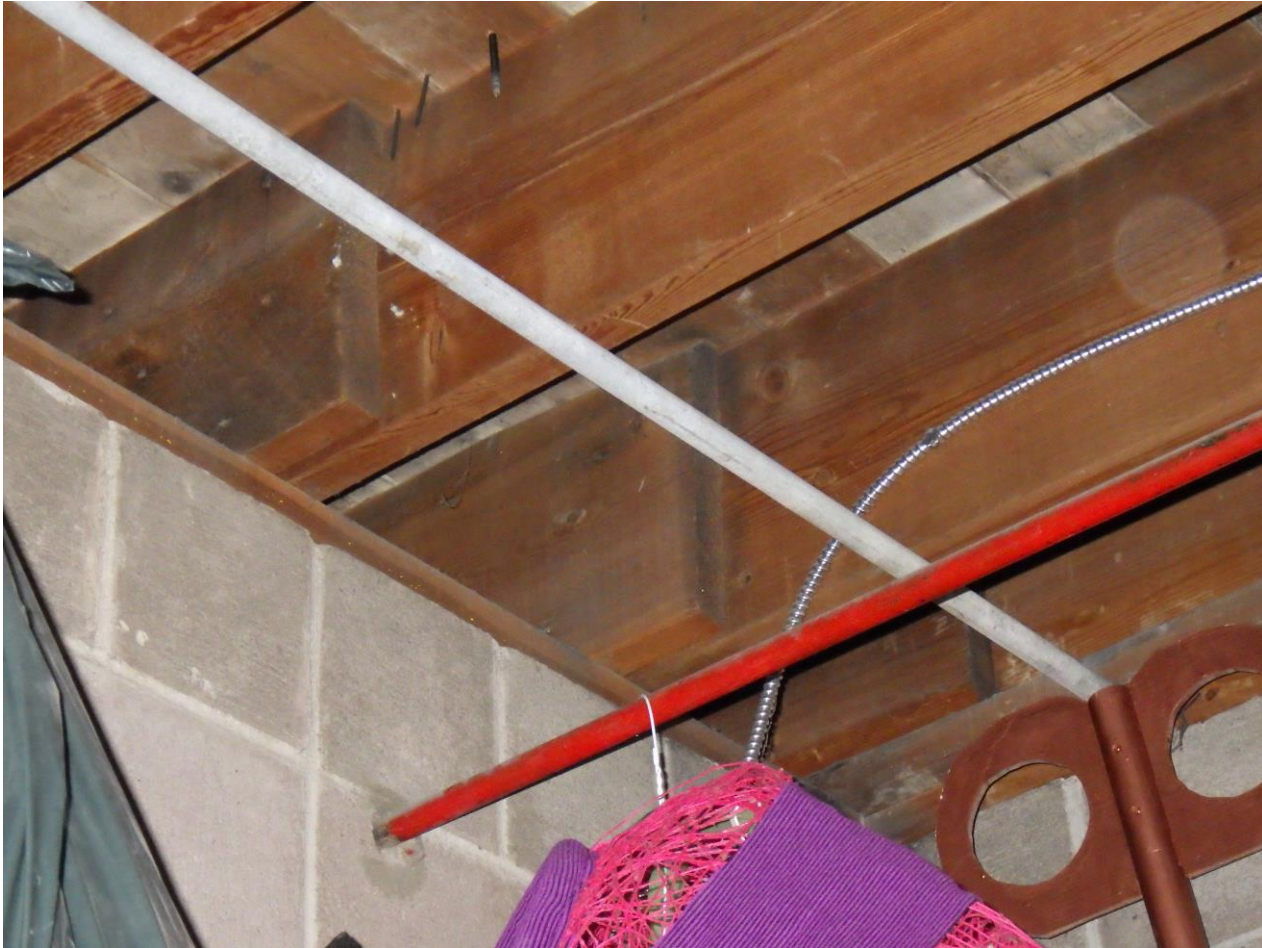
Photo C7-2: Close up of the emergency discharge piping from the mechanical room into the figure skating storage room. The photo shows a costume suspended from the piping.

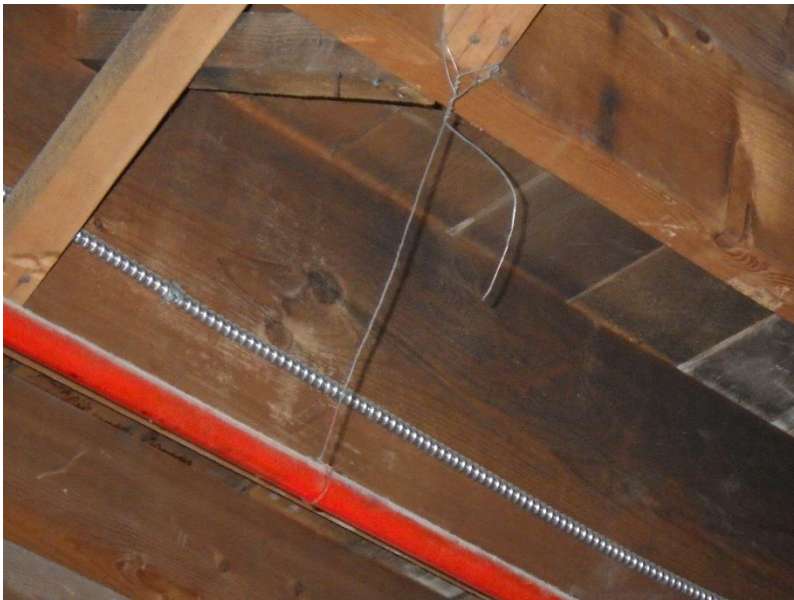
Photo C7-3: Discharge pipe was supported mid-span to ceiling structure by a thin wire.
