Incident Summary #II-1235312-2021 (#23370) (FINAL)

SUPPORTING INFORMATION	Incident Date	August 10, 2021	
	Location	Coldstream, BC	
	Regulated industry sector	Electrical - Low voltage electrical system (30V to 750V)	
	Impact	Qty injuries	0
		Injury description	N/A
	Damage	Injury rating	None
		Damage description	A termination between a fuse and insulated stand off and electrical components in a capacitor bank were destroyed. Burn marks and evidence of an arc flash event occurred inside the capacitor bank enclosure.
		Damage rating	Moderate
Incident rating	Moderate		
Incident overview	A termination to a fuse protecting a single capacitor in a capacitor bank overheated and caused heat stress to a fuse. This heat stress eventually caused the fuse to fail which damage to the electrical components inside the capacitor bank enclosure. This caused the main breaker to the facility to trip.		
INVESTIGATION CONCLUSIONS	Site, system and components	<p>A pellet plant manufacturing facility uses a capacitor bank to correct the plants power factor when large 3 phase motors are started and stopped. This capacitor bank monitors the power factor and automatically brings capacitors on and offline as n

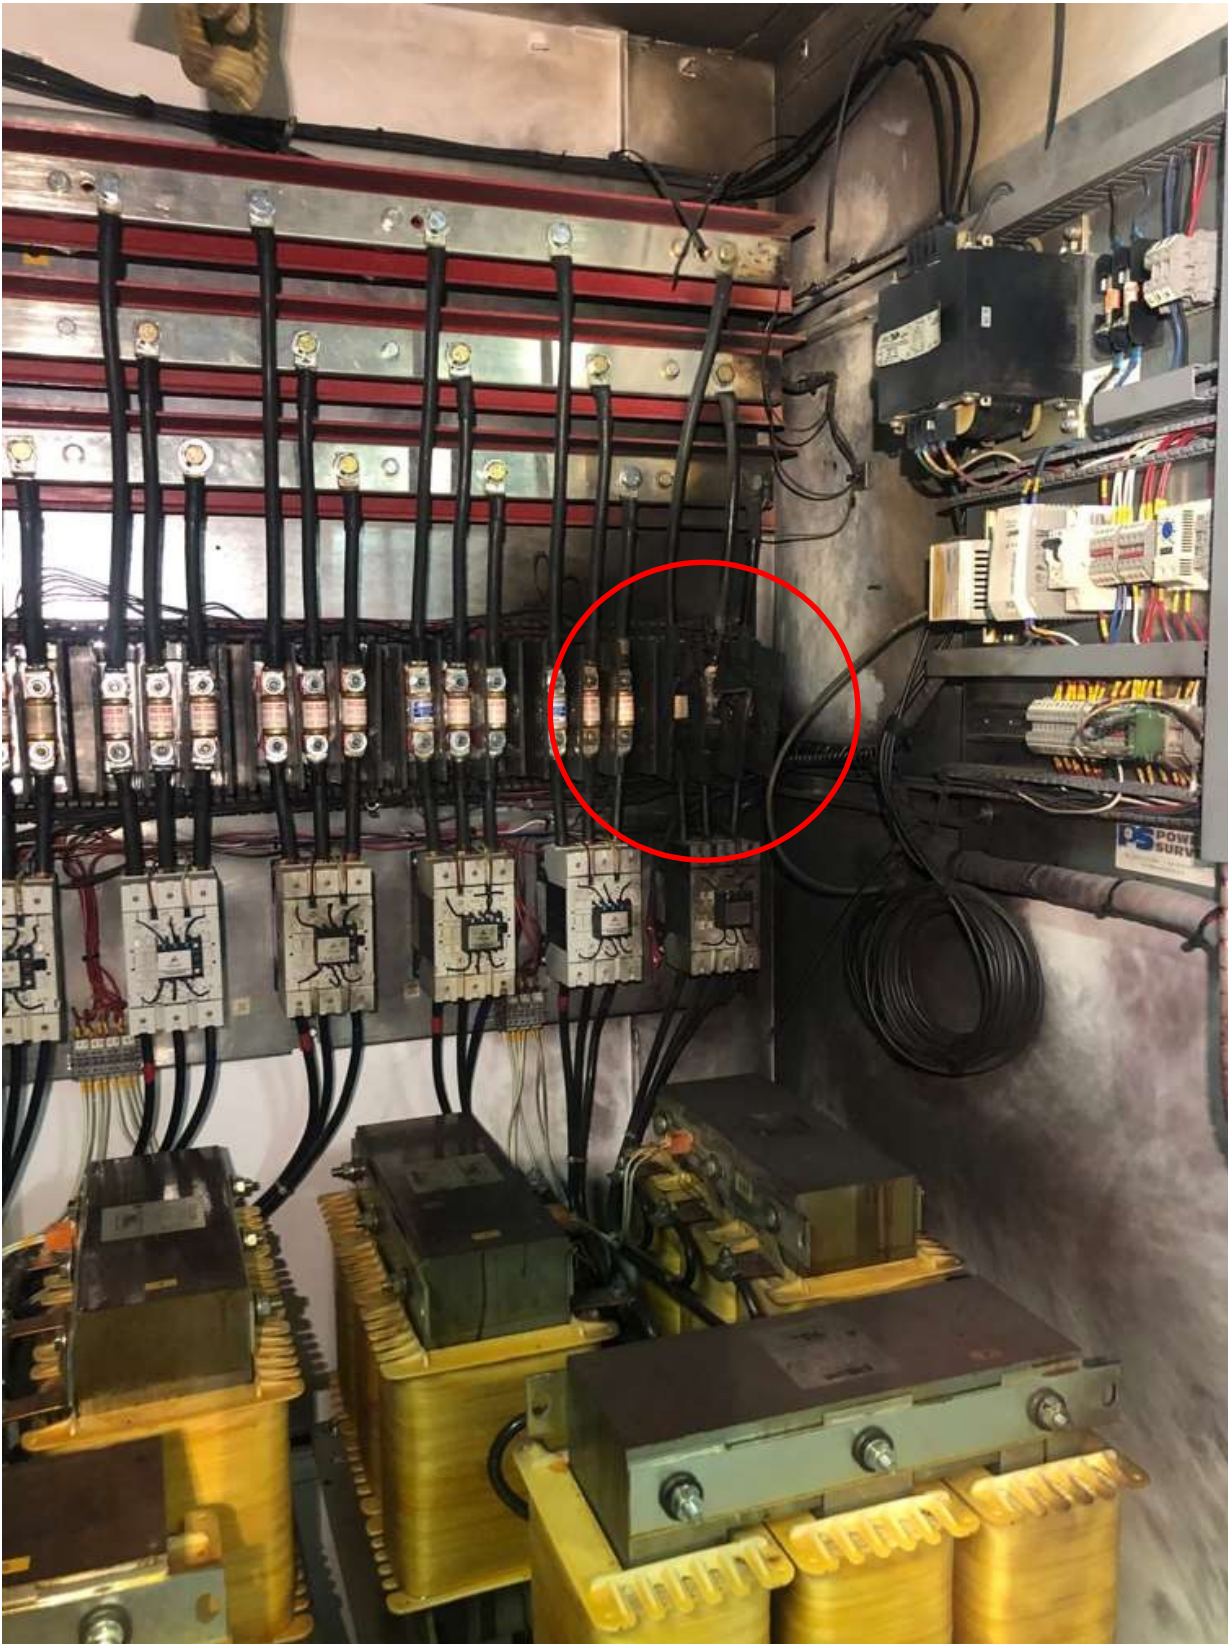
Failure scenario(s)	<p>A single fuse protecting one phase of a capacitor appears to have been subject to heat stress, failed and an arc flash event occurred inside the capacitor enclosure, subsequently damaging electrical components inside and taking the capacitor and facility offline.</p> <p>The device that was used to secure the fuse is an insulated stand off, not a rated fuse holder. This insulated stand off is typically used to separate buss bars in electrical equipment or provide isolation to a ground bar where needed in other installations.</p> <p>The capacitor that this fuse protects is brought on and offline multiple times and is the most frequently used capacitor in the bank aiding to the heat stress put on the termination of the fuse to the insulated stand off.</p> <p>The continual operation of the capacitor and subsequent heating to the termination point on the fuse and insulated stand off, which was unable to dissipate the heat</p>

Interior view of damaged capacitor bank.

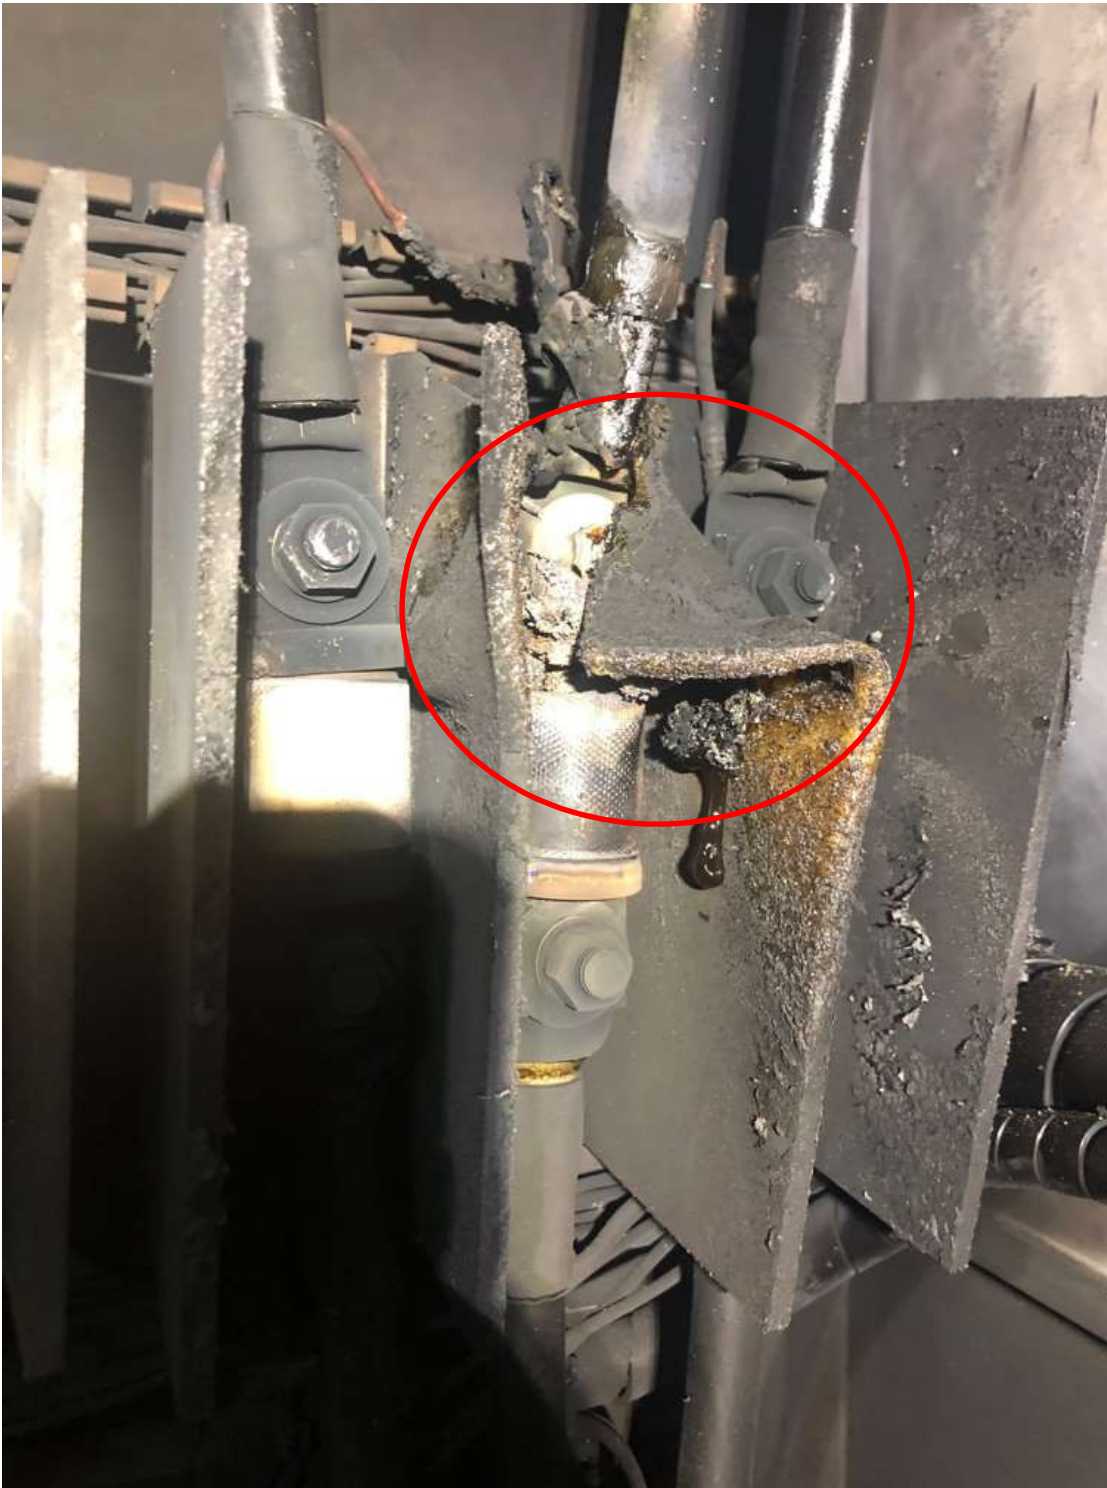
<p>properly, eventually the fuse failed, and an arc flash event occurred inside the capacitor bank enclosure.</p>
<p>Facts and evidence</p>	<p><u>Maintenance Staff Statements:</u></p> <ul style="list-style-type: none"> -Witness reports hearing a very loud bang noise and the main-breaker to the facility tripped to OFF position. -Upon investigation by the maintenance staff, capacitor bank #8's center fuse and connection were destroyed and the blackened area of equipment surrounding the destroyed fuse extends in area approx. 1/2 Meter square. -Maintenance staff then noticed plexiglass fuse divider is melted and folded in towards the destroyed fuse. -Insulated stand off and fuse terminations appear to be affected by intense heating. -Some pitting and arc-flash / plasma event damage is visible on the horizontal buss bars. <p><u>Capacitor Bank Enclosure:</u></p> <ul style="list-style-type: none"> -When a capacitor is brought online it has a large inrush of current which stresses the electrical equipment and aids to the heating of the termination points in the system. -The insulated stand off used to secure the fuse did not have voltage or current ratings for the intended use, like a rated fuse holder. -The fuse was bolted to the insulated stand off using regular steel hardware which does not dissipate the heat like copper material that is used in a rated fuse holder. -The surface area in contact between the insulated stand off and the fuse is limited to a small area which will affect the heating/cooling of this connection when the capacitor is brought on and offline. -The bolt and hardware that was used to secure the fuse to the insulated stand off was melted in place and fused together which was unable to be taken apart. -This capacitor is brought on and offline more frequently than the other capacitors in the enclosure adding to the stress on the termination point, limiting cooling time. -The plexiglass fuse divider installed between the group of fuses to the capacitor showed signs of heat stress, visibly melted when observed.

Melted plexiglass divider and termination.

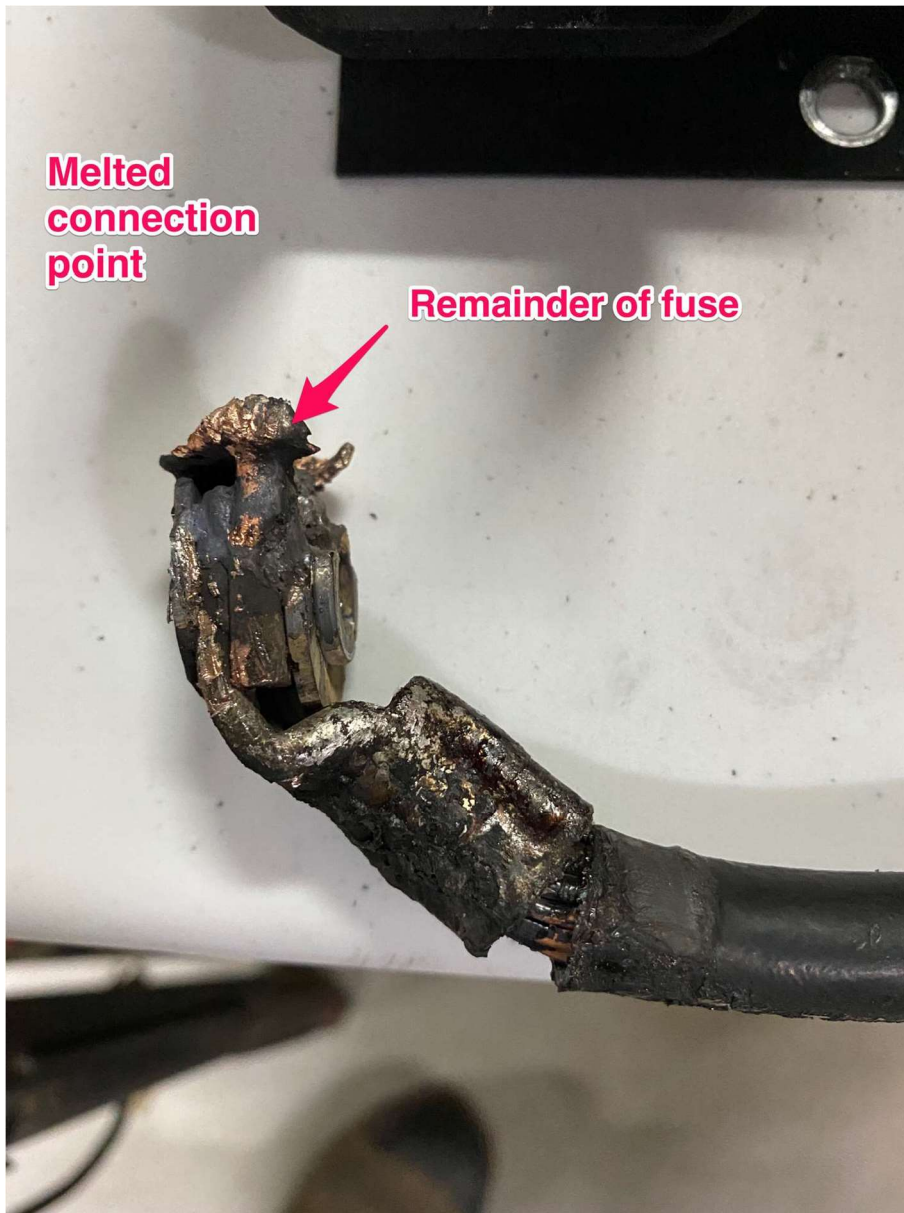
<p>Causes and contributing factors</p>	<p>The failure of the fuse and subsequent arc flash event was likely caused by overheating of the termination point of the fuse to the insulated stand off. This caused heat stress on the fuse which eventually failed.</p> <p>The insulated stand off connections were not rated to be a fuse holder. The surface area where the fuse bolted to the insulated stand off was limited. The steel hardware that was used to attach the components heats quickly and dissipates heat poorly.</p> <p>The failure was limited to the capacitor that was the most frequently used.</p>

Melted connection point.

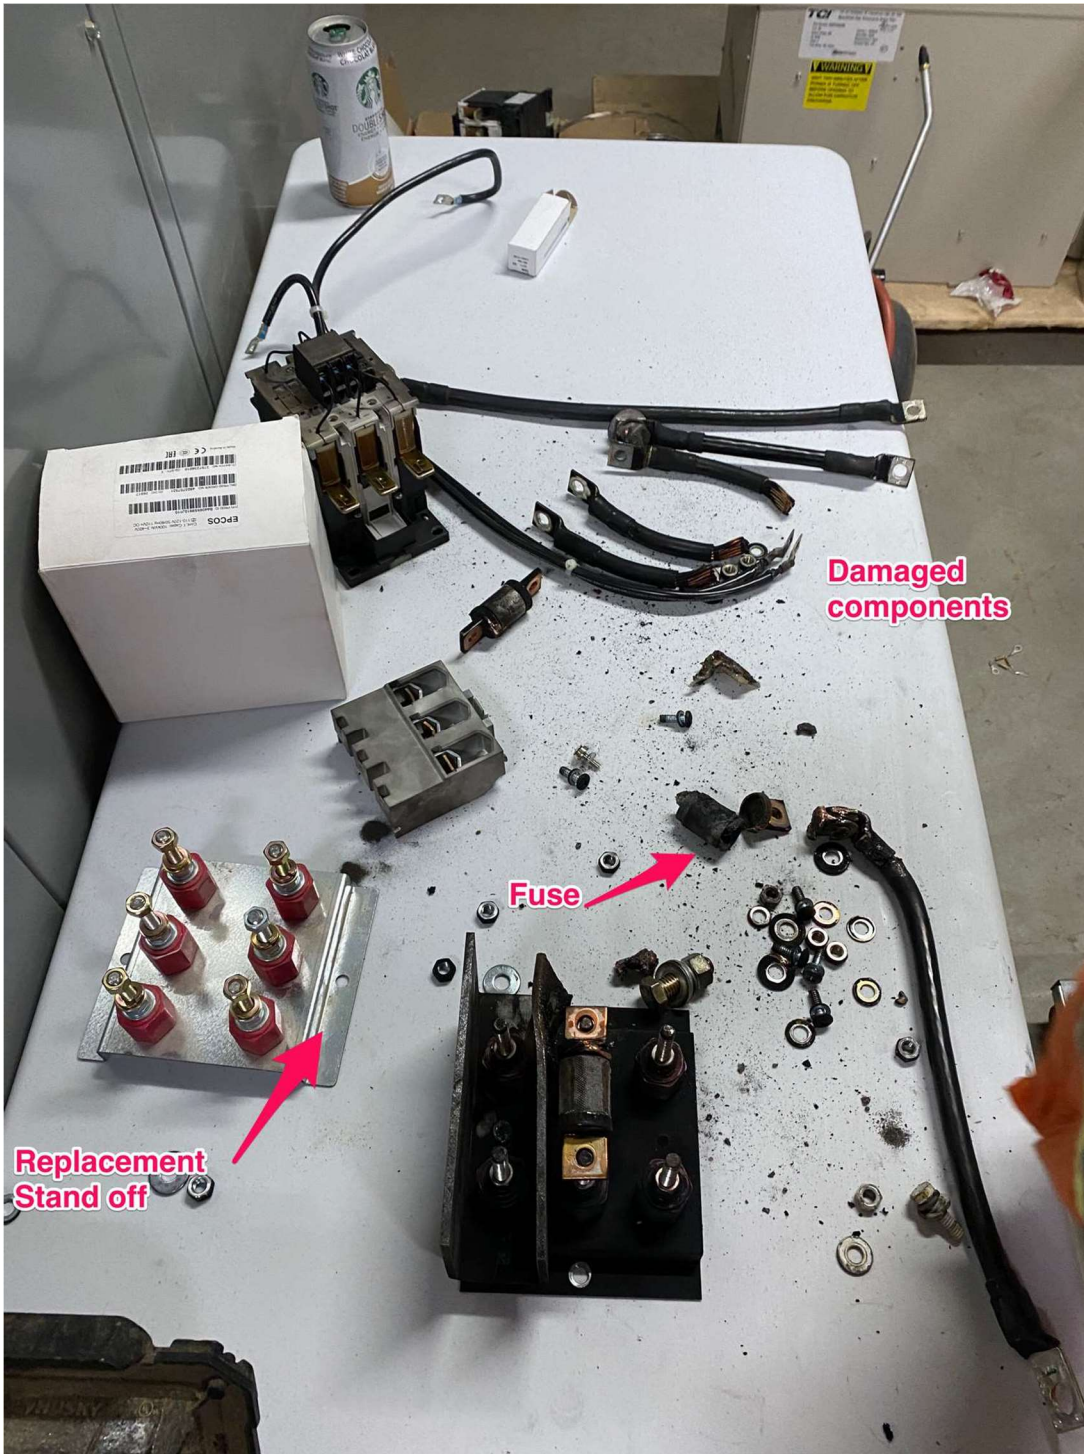
Damaged components.
