Incident Summary #II-1699418-2024 (#45663) (FINAL)

SUPPORTING INFORMATION	Incident Date	April 1, 2024	
	Location	Richmond	
	Regulated industry sector	Electrical - Low voltage electrical system (30V to 1000V)	
	Impact	Qty injuries	0
		Injury description	N/A
		Injury rating	None
	Damage	Damage description	Arcing and heat damage to a 6-50R type plug in electrical receptacle used for electric vehicle (EV) charging which was badly burnt beyond repair.
		Damage rating	Minor
Incident rating	Minor		
Incident overview	While charging the family Tesla at a residential home, the homeowner noticed an odor in the detached garage emitting from the EV 6-50R receptacle. This odor was similar to burning rubber or electronics. The owner found a receptacle failure due to excessive heat.		
INVESTIGATION CONCLUSIONS	Site, system and components	<p>The single-family dwelling has an existing 100AMP Siemens 1phase combination panel board located in hallway of home. The homeowner hired a contractor to install an EV receptacle for a ChargePoint Home Flex EV charger to plug into. The contractor installed #6AWG 3conductor Aluminum conductor wet underground (ACWU) armoured cable, 40AMP 2pole breaker and a 6-50R

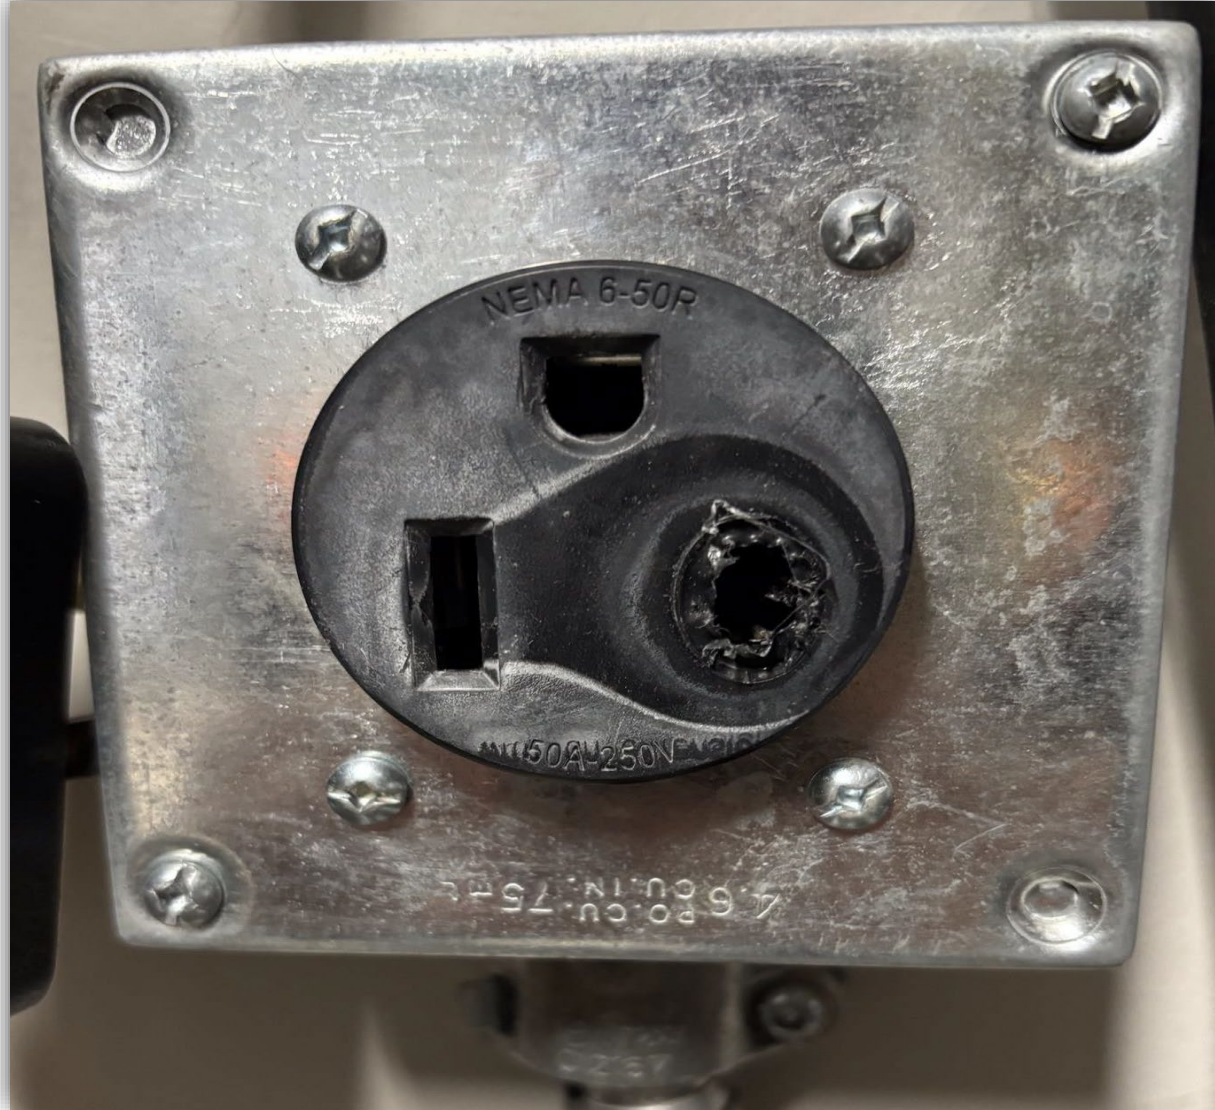
Failure scenario(s)	The homeowner hired a contractor to install a Charge Point Flex EV charger. The contractor hired an unlicensed contractor to install a 40AMP 2pole breaker, 100ft #6AWG 3conductor Aluminum conductor wet underground (ACWU) armoured cable and a 6-50R receptacle. The installation of the receptacle was completed with no anti-oxide compound. The load of the electric vehicle charging caused the connection without the anti-oxide compound to loosen causing a high resistance connection and excessive heat which damaged the receptacle.

Facts and evidence	<ul style="list-style-type: none">• Electrical Safety officer conducted onsite inspection.• No record of installation permit with Technical Safety BC.• Load calculation for addition of EV charging unit not submitted.• Electrical Safety Officer observed receptacle terminations were loose.• Termination of aluminum wiring was completed without anti-oxide compound.• Manufactures specifications for installation of ChargePoint EV charger requires installer to use copper wiring. Contractor installed aluminum.
Causes and contributing factors	<p>The installation of the EV charging receptacle was installed incorrectly by an electrical contractor without the required installation permit. The incident was highly likely caused by the incorrect installation of aluminum wiring without the required anti-oxide compound. This led to a high resistance connection and the generation of high amount of heat which damaged the internal electrical components of the receptacle during the high amperage use of the electrical vehicle charging.</p>

Image 1 – NEMA 6-50 receptacle showing heat damage.

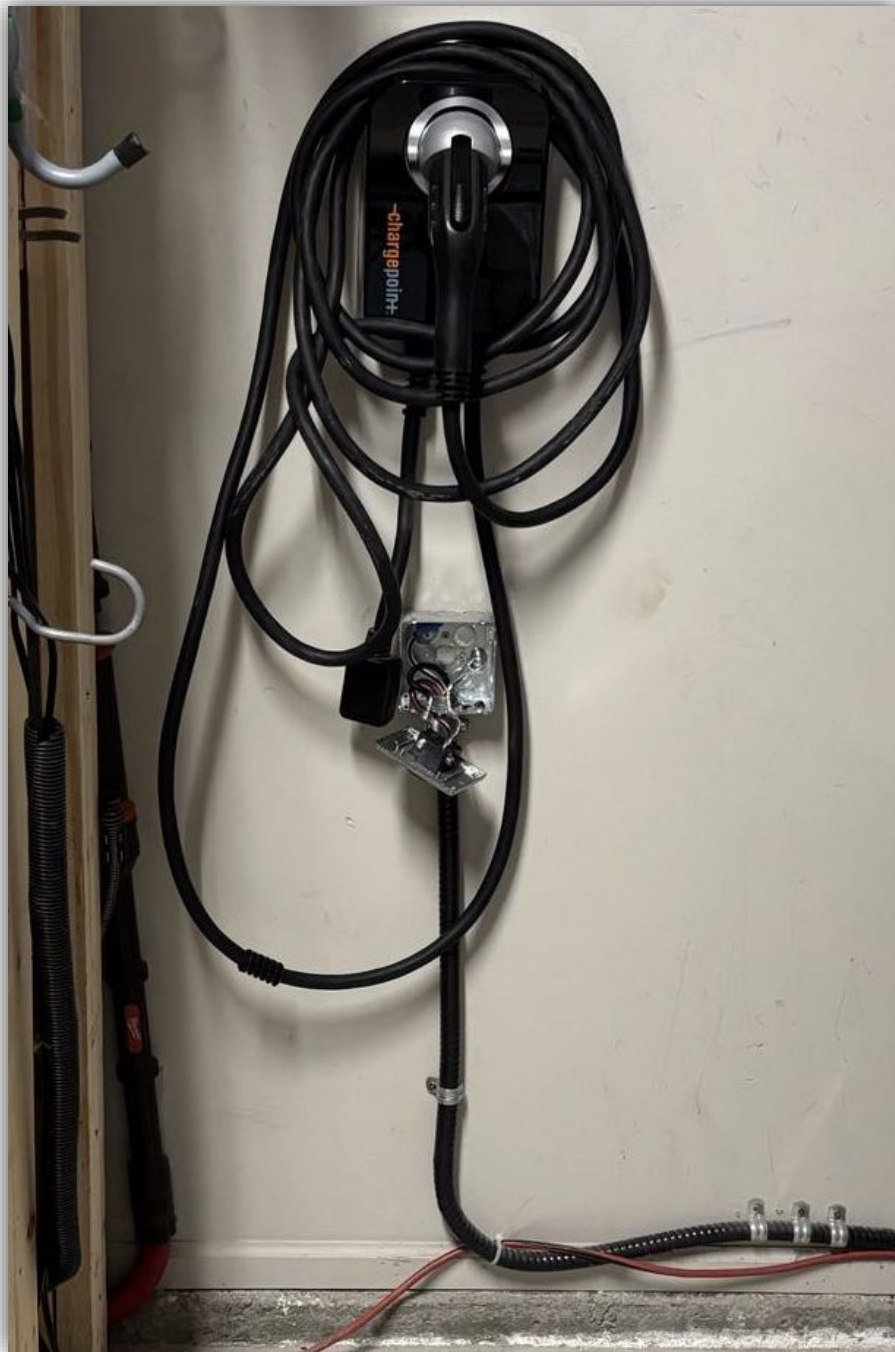
Image 2 – EV ChargePoint charger and plug by receptacle box.

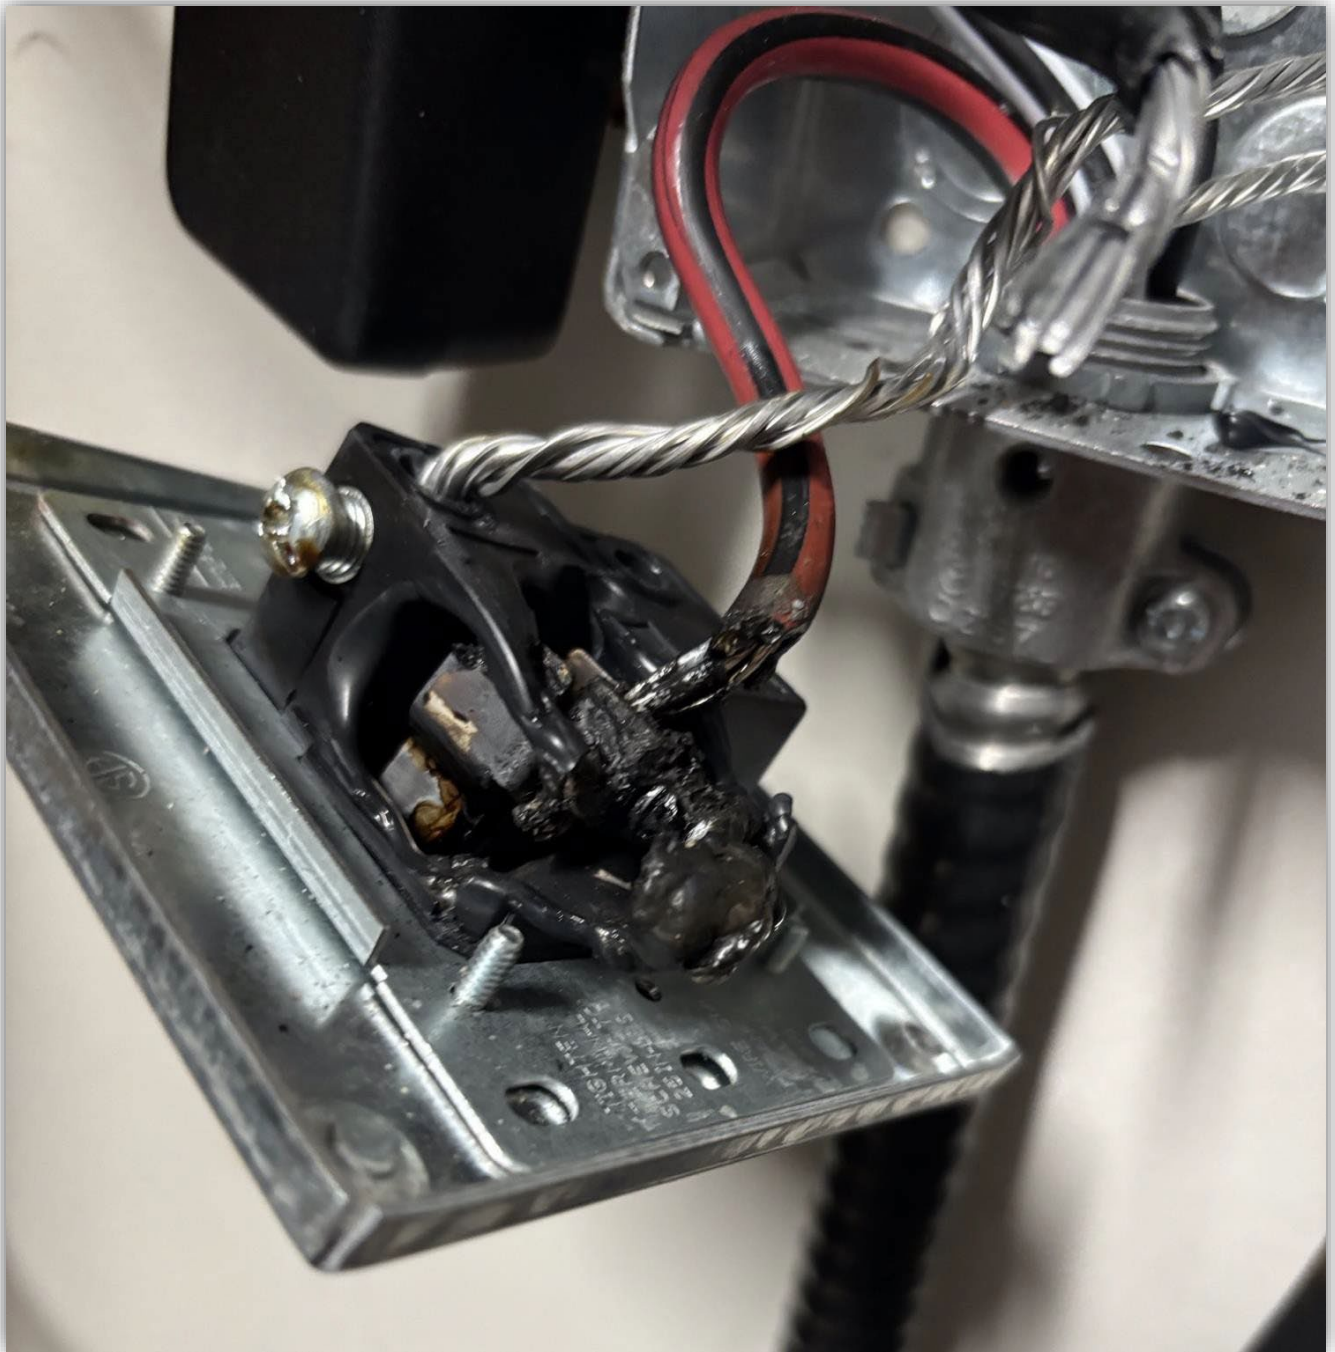
Image 3 – Closeup of overheated connection and aluminum wiring.
