Incident Summary #II-1280282-2021 (#24876) (FINAL)

SUPPORTING INFORMATION	Incident Date	October 12, 2021	
	Location	Richmond	
	Regulated industry sector	Elevating devices - Elevator	
	Impact	Qty injuries	0
		Injury description	N/A
		Injury rating	None
	Damage	Damage description	Plastic devices in control space closet were damaged from heat. Damaged thermostat, drywall, and smoke alarm.
		Damage rating	Minor
	Incident rating	Minor	
Incident overview	A fire ignited in the elevator closet control space, resulting from a premature failure in the variable frequency drives' power components.		
INVESTIGATION CONCLUSIONS	Site, system and components	<p>A mid-rise apartment building that houses two passenger elevators of the electric traction type. The installation is of the Machine-Room-Less type, where the elevator's electric motors are installed in the hoistway, and the controllers are housed in a remote closet located on the premises.</p> <p>The controller cabinet houses the variable frequency drive. The variable frequency drive is a device normally used in motor control applications. They are internally equipped with power electronics that are exclusively designed for smooth speed regu

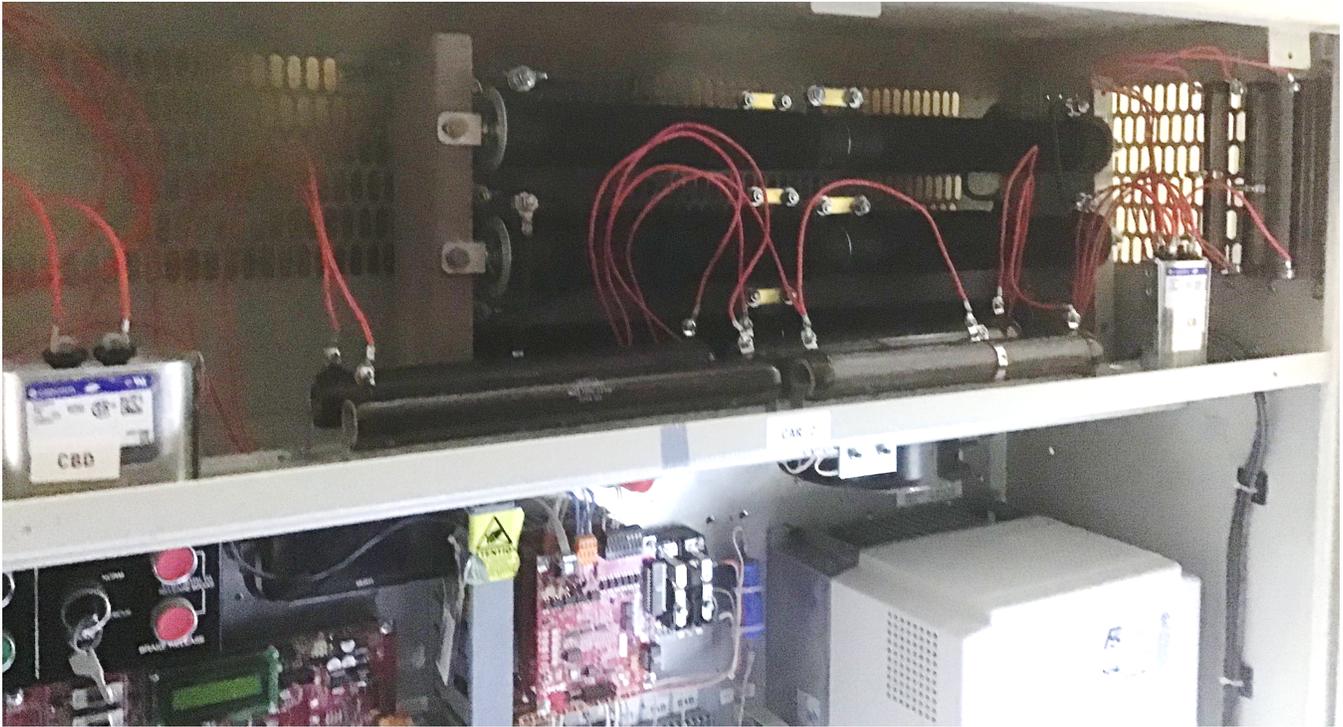
Photo 1: The braking resistors inside it's cabinet that sit on top of the controller.

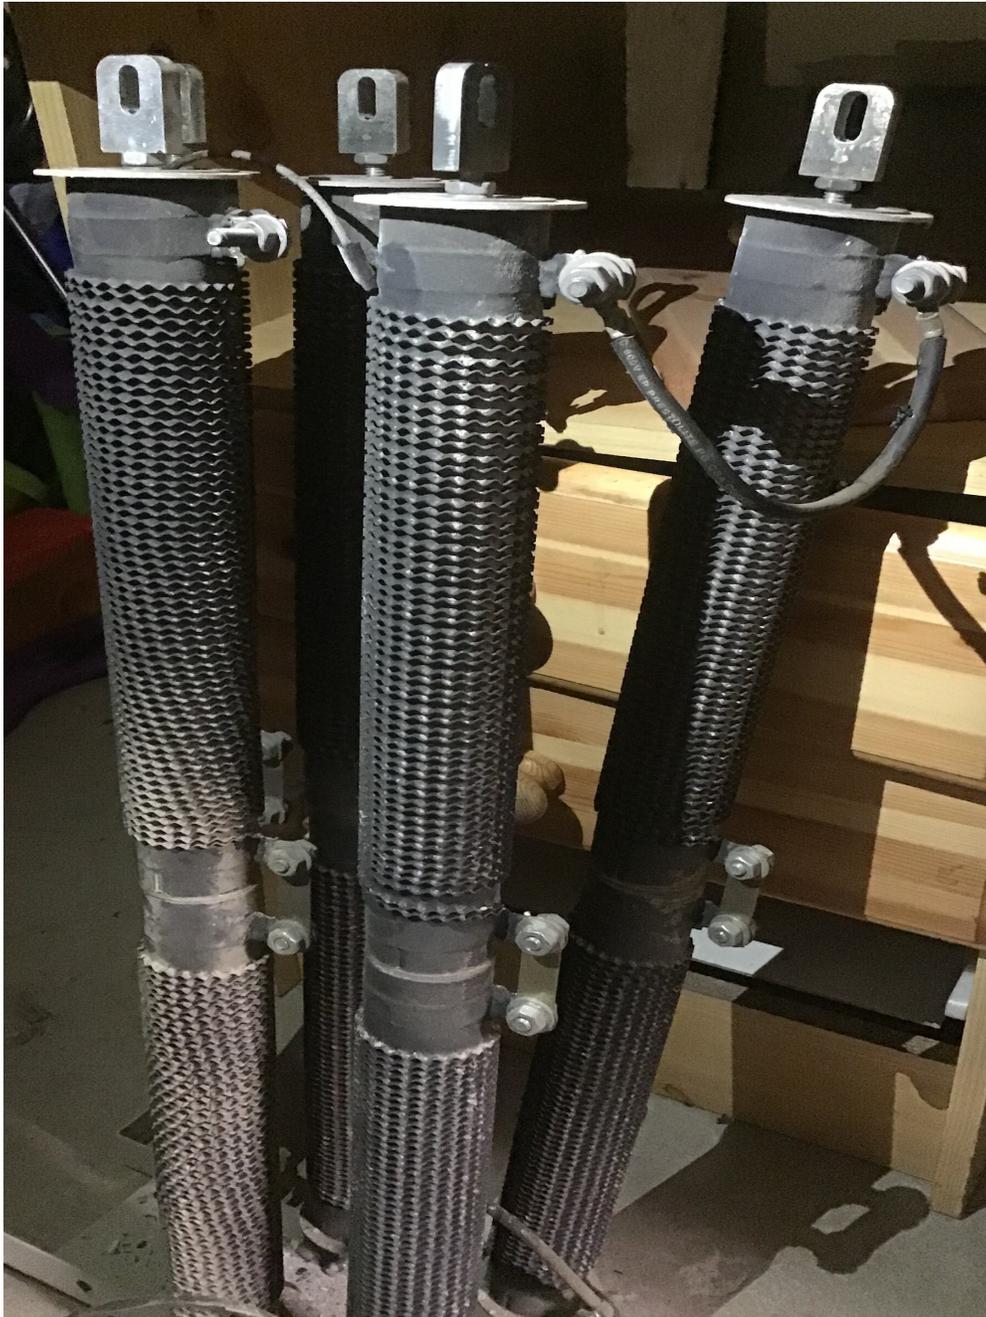
<p>Failure scenario(s)</p>	<p>The braking transistor shorted, therefore allowing excessive voltage to be dumped on the braking resistors continuously. This caused the braking resistors to excessively heat up. A technical bulletin was issued from the manufacturer regarding transistor shorts related to the equipment installed.</p>
<p>Facts and evidence</p>	<p>Site visit November 04, 2021</p> <ul style="list-style-type: none"> • Performed an inspection for new drive replacement (different model than original), new braking resistors and verified fire recall operation after smoke detector was replaced. • Noticed that top layer of drywall behind the resistor cabinet appeared to be damaged by heat as it appeared to be scorched (Photo 3). • Noticed that smoke detector for the controller closet had been removed due to damage caused by fire. • Caretaker stated that the smoke detector melted but activated the fire alarm (Photo 5). • Noticed that the thermostat in the closet was functional and ventilation fan was also operational. • Received a Mechanical Engineering letter confirming that the current ventilation was adequate for the installation and compliant with the B44-07 requirements for keeping temperature within the range specified by the equipment manufacturer. • Noticed that controller had no external thermal switch connected in order to monitor the braking resistor temperature. • Confirmed drive was installed between 2016-2019 • Mechanic stated that the paint of coat around the resistor cabinet had been burned off as a result of the heat. <p>Received a copy of a Technical Bulletin from the controller manufacturer. Bulletin confirmed that drives installed with their controllers between 2016 and 2019 have potential issues with the power modules that could result in premature failure of the drive. The technical bulletin strongly recommends adding a monitoring circuit if replacing a drive with an identical unit.</p>

<p>Causes and contributing factors</p>	<p>It is very likely that a premature failure in the drive's power components resulted in an abnormal and continuous voltage flow to the braking resistors. The continuous voltage flow may have likely resulted in an extreme rise of heat created within the resistor cabinet. It is very probable that any combustible material above or in proximity to the resistor's cabinet would have been affected by its radiant heat. It is plausible that the suggested monitoring circuit, referenced by the drive manufacturer in the technical bulletin, could have prevented the overheating of the resistors.</p>

Photo 2: The original braking resistors that were replaced after being affected by the transistor failure.

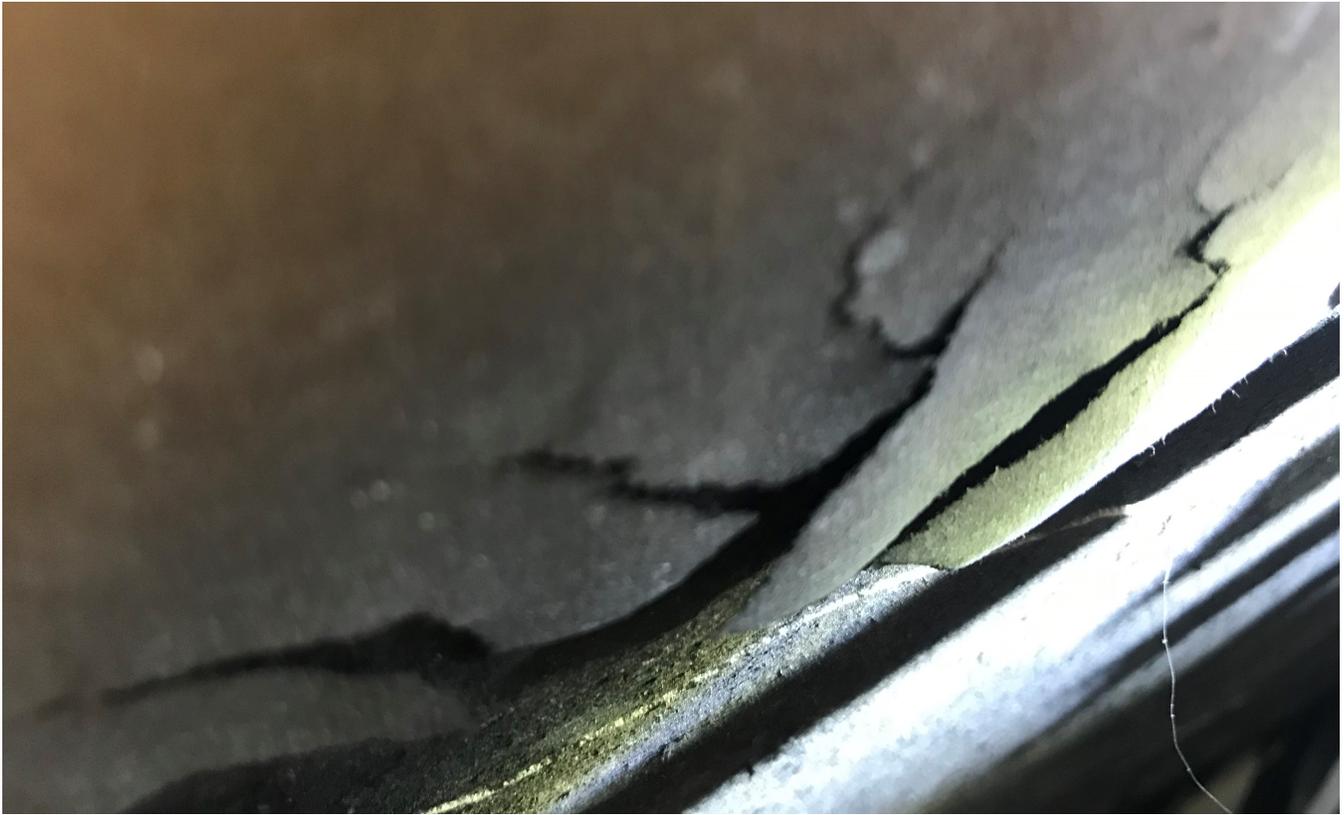
Photo 3: The top layer of drywall located behind the resistor cabinet that appears to have been scorched by radiant heat.

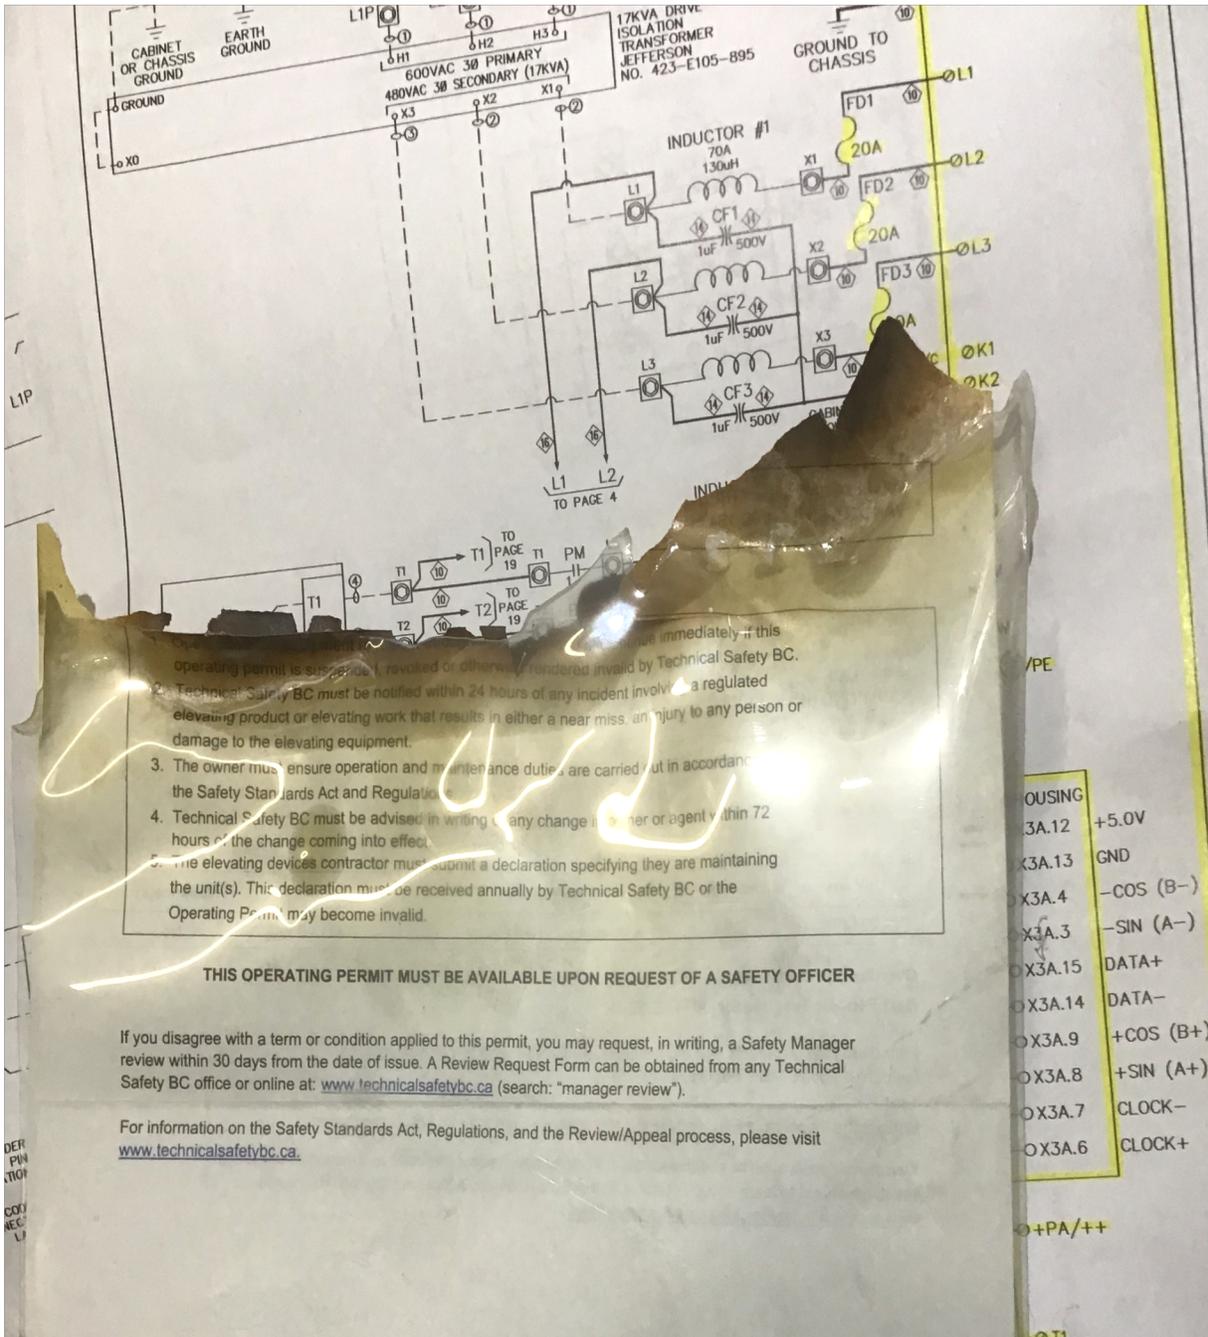
Photo 4: Plastics and other combustible material sitting on top of the resistor cabinet were burned or scorched during incident.

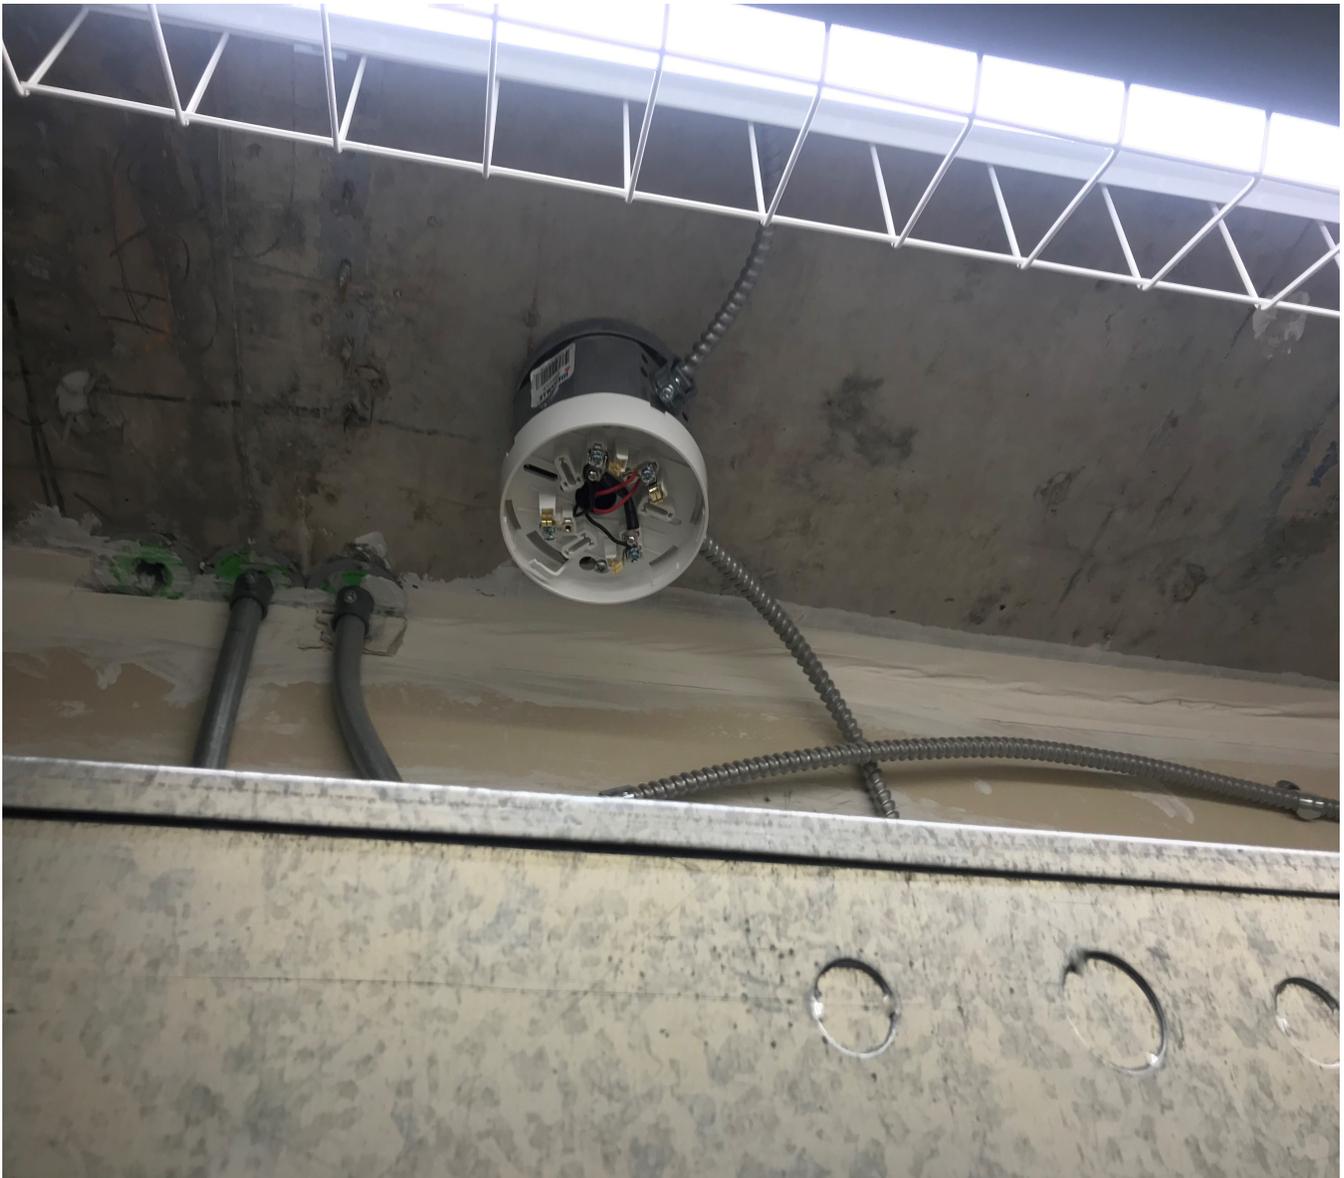
Photo 5: The smoke alarm located in the control space closet and installed directly above the affected resistor cabinet was melted during the incident. The damaged device was removed prior to site visit.
