## Incident Summary #II-777672-2018 (#9805) (FINAL)

SUPPORTING INFORMATION	Incident Date	November 17, 2018	
	Location	Trail, BC	
	Regulated industry sector	Electrical - Low voltage electrical system (30V to 750V)	
	Impact	Qty injuries	0
		Injury description	None
		Injury rating	None
	Damage	Damage description	A 1200A 600V 3PH main fused disconnect, service conductors and adjacent subdistribution equipment sustained damage resulting from an arc blast from a fault to ground inside the main fused disconnect enclosure.
		Damage rating	Moderate
	Incident rating	Moderate	
Incident overview	A short circuit to ground between an ungrounded service conductor and the service equipment enclosure resulted in a sustained arc blast and arcing fault eventually damaging internal components, perforating the metal enclosure, damaging adjacent subdistribution equipment and igniting service conductor insulation. The arcing was sustained because the short circuit fault occurred on the 'line' side of the 1200A main fuses; the arcing continued until the fault current reached a value that opened the current limiting fuses in the primary section of the supply authority owned 1Mva transformer

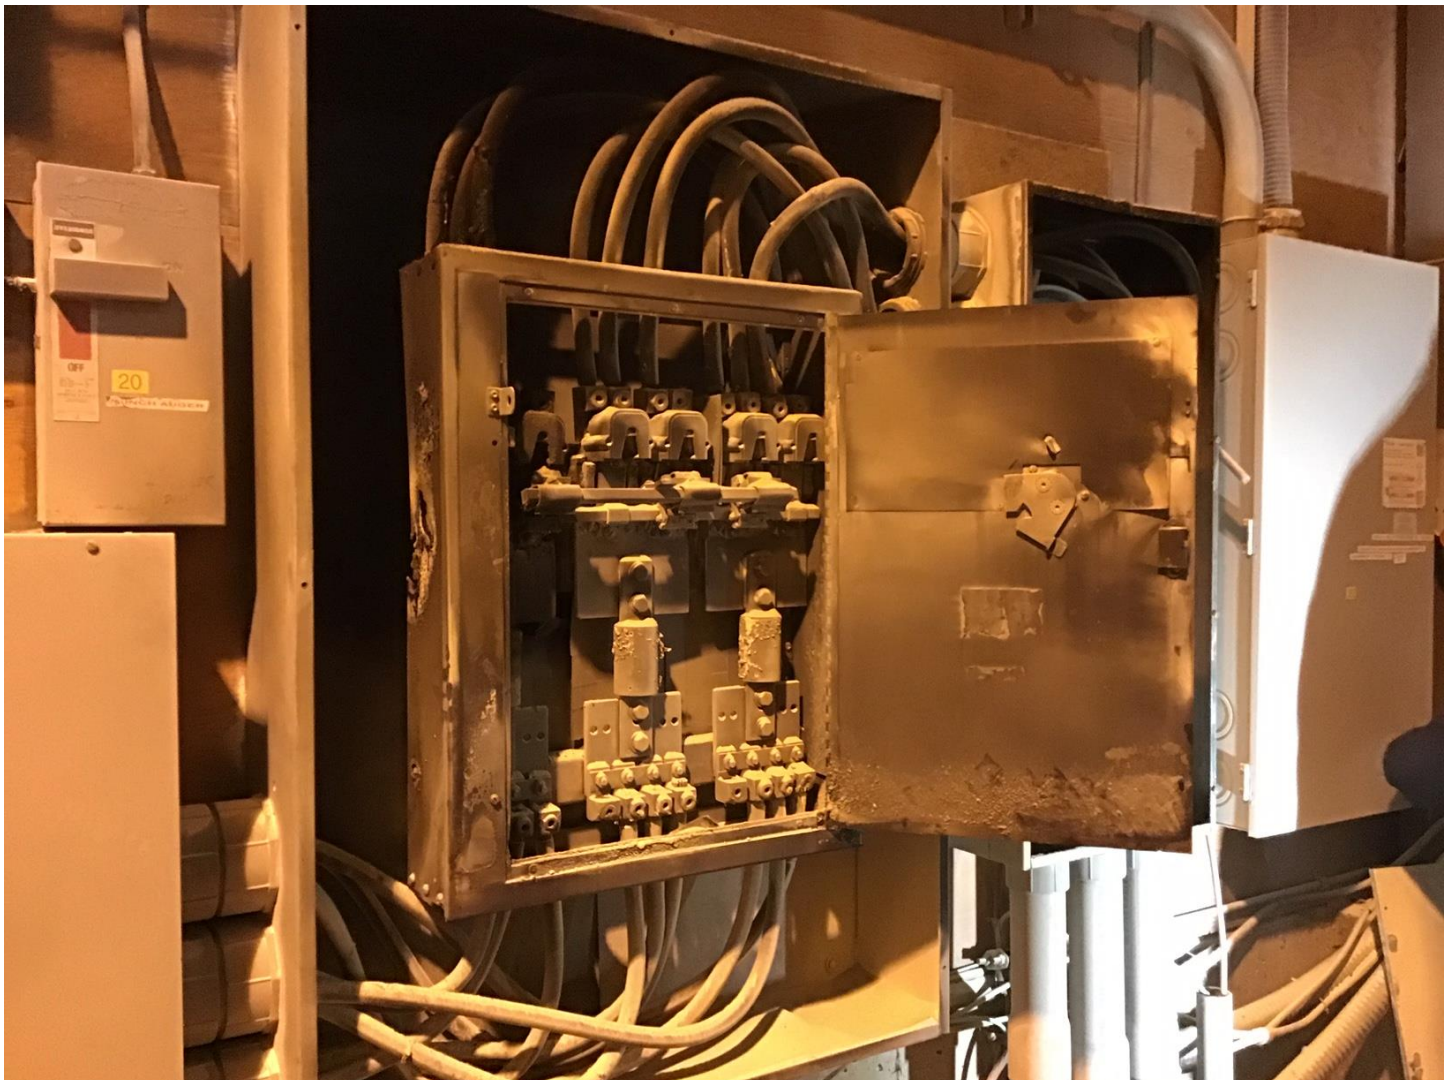
## 1200A 600V main service disconnect

Facts and evidence	<p>Observations by the safety officer confirmed that regulated equipment had failed and contributed to the incident on site: an electrical arc blast between an ungrounded main service conductor termination and the metallic main service enclosure. Photographs of the damaged equipment and statements from the operations staff production managers were obtained by the safety officer.</p> <p>Observations by the safety officer and FSR revealed that the clearance between the main service switch conductor terminations and the service switch enclosure where the incident occurred is approximately 5mm. Additionally, it appears that the main switch conductor termination equipment had been modified: mechanical terminations added to the original equipment resulting in reduced clearance between energized equipment and equipment enclosure. General observations and survey of</p>

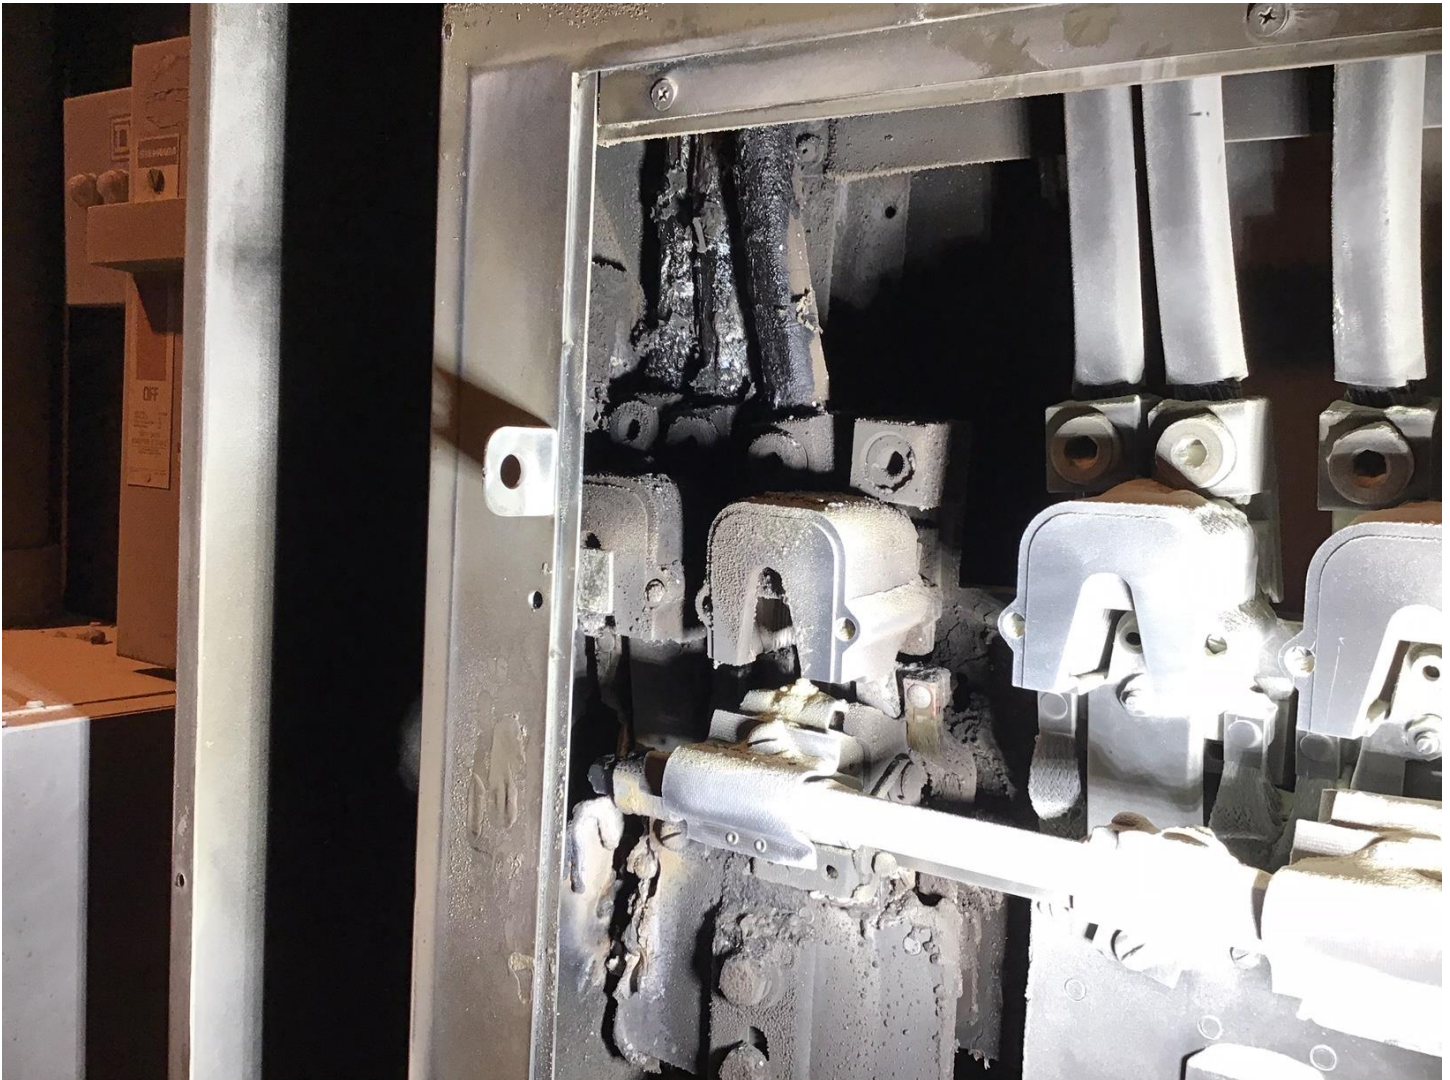
<p>the interior of the recycling facility revealed an elevated level of dust and debris; a result of the battery recycling process and lack of cleaning. Dust accumulations contain plastics and conductive materials (lead, aluminum, copper). The main electric service switch enclosure is rated as Type 1; enclosure rating does not require gaskets or sealing. Over time, process dusts had entered and settled inside the main service switch enclosure. The dust accumulations were not noted and had not been evacuated or cleaned out.</p>
<b>Causes and contributing factors</b>	<p>All evidence and observations conclude that the conductive metallic dusts created an unintended circuit between the main switch conductor termination and the bonded-to-ground enclosure.</p>

'A' phase service conductor termination on left in photo: area of short circuit to ground; clearance between 'A' phase termination and equipment enclosure is less than 5mm; conductive debris accumulated between the termination and enclosure creating an unintended circuit to ground.

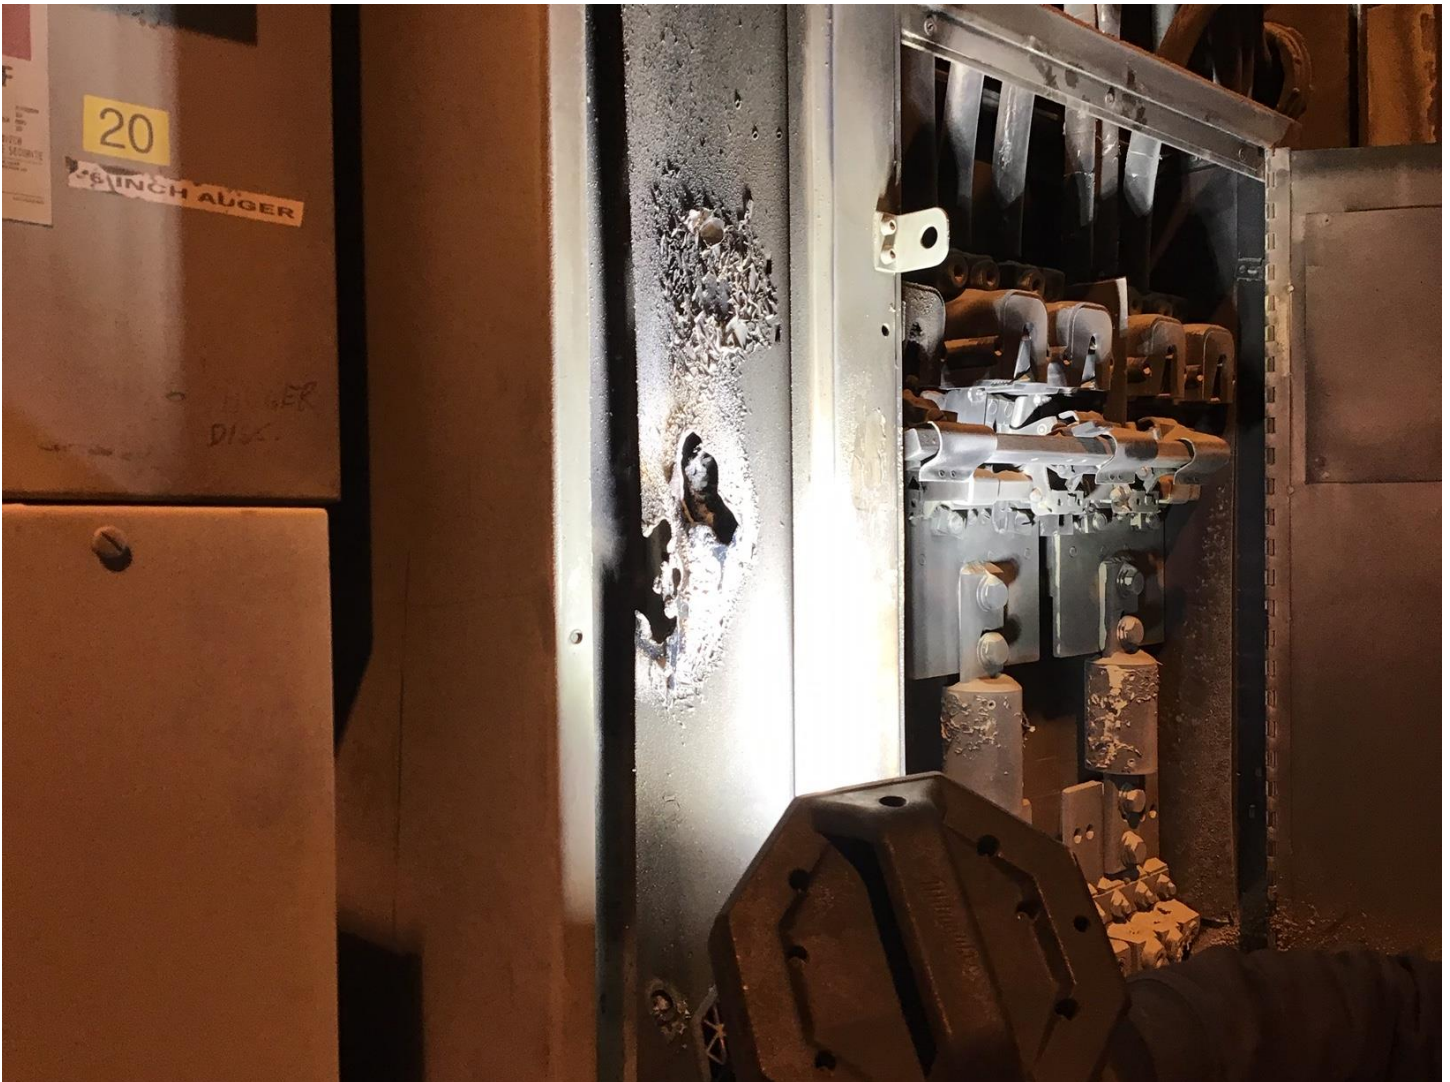
External damage, enclosure perforation
