Incident Summary (5623115)

SUPPORTING INFORMATION	Incident Date		July 23, 2017	
	Location		Armstrong, BC	
	Regulated industry sector		Low Voltage Electrical System (30-750-volts)	
	Impact	Injury	Qty injuries	1 individual and 2 pets
			Injury description	The one individual sustained electrical burns to legs and knees due to shock from being submersed in the body of water (2 pets were electrocuted)
			Injury rating	Major
	Damage		Damage description	Initial damage to pump created a large release of electrical energy
			Damage rating	Major
	Incident rating		Major	
	Incident overview		<ul style="list-style-type: none"> - Individual took the family pets to creek for a swim and to check submersible irrigation pump - When the pets entered the water they immediately passed away - The Individual, upon entering the water quickly afterwards to rescue the deceased pets received what is believed to be an electrical shock but was able to grab a branch, and crawl out and back up hillside to residence. - The residence, approx. 150' uphill is where he collapsed and another individual found him

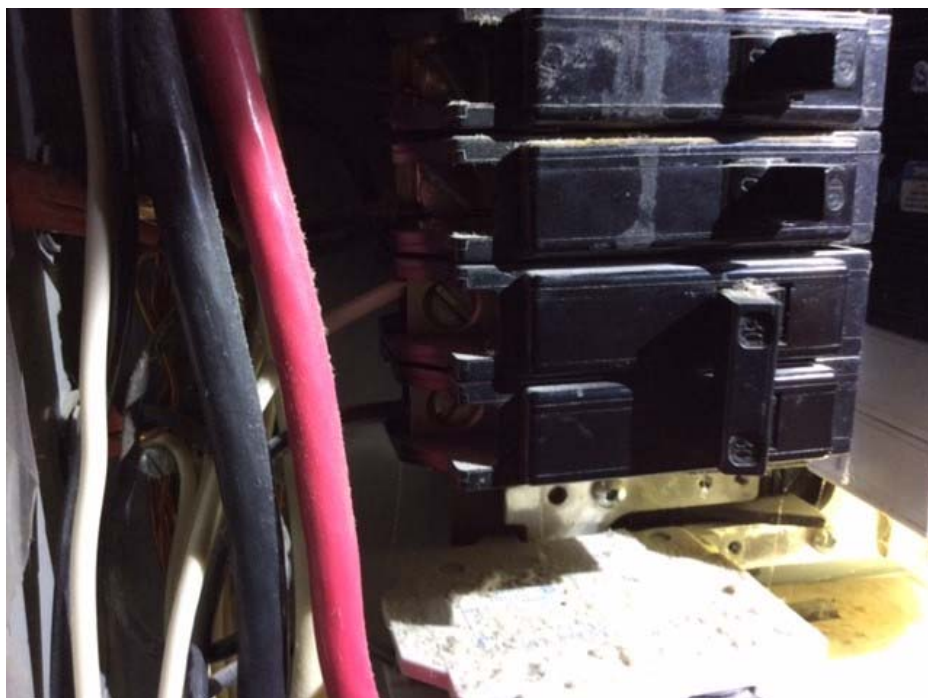
Pump 2P 30 amp residence Overcurrent Device

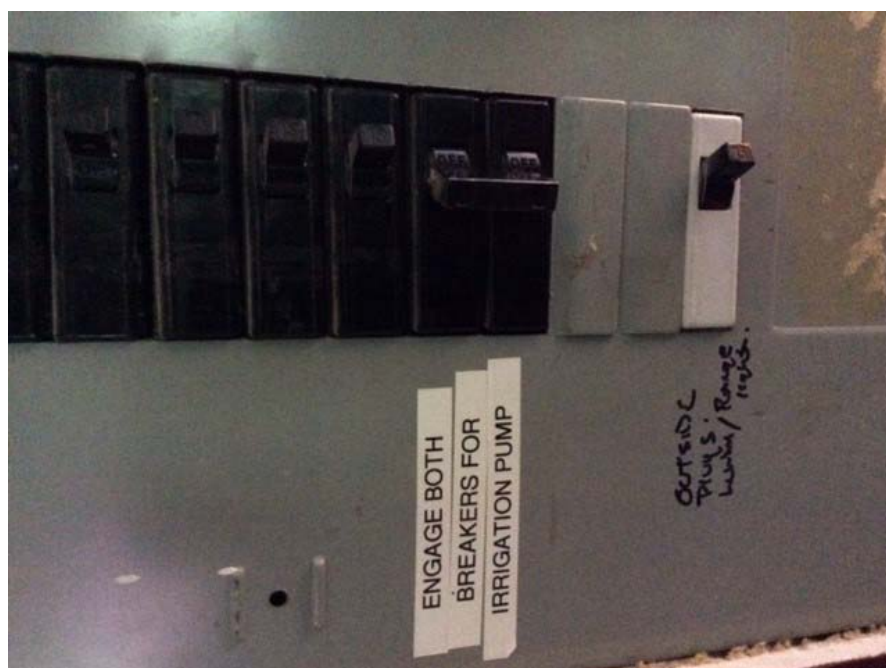
Pump O/C device label

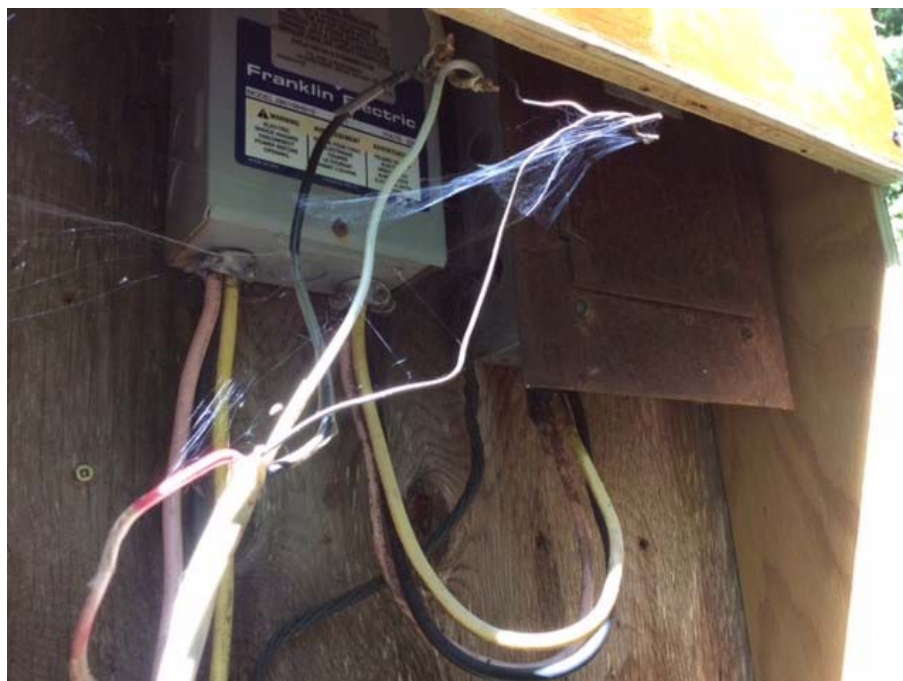
<p>Causes and contributing factors</p>	<p><i>Evidence suggests that a mechanical failure of the pump assembly led to the electrical failure of the pump motor. With no short between phases and a resistance still in the circuit, the overcurrent device failed to see any fault.</i></p> <p><i>It is highly probable the pump was energized at time of entry and that with multiple wiring issues of the installation it was very likely the combination of the ground- faulted submersible pump failure with no direct grounding connection to the electrical system and no approved ground fault protection created an energized body of water using the installed grounding rods as a path. A grounding system installed at the creek plus multiple unapproved splicing methods created a cable installation with a higher impedance path that did not allow the overcurrent device at the residence to operate properly</i></p>

As found existing power feeder exposed with no protection

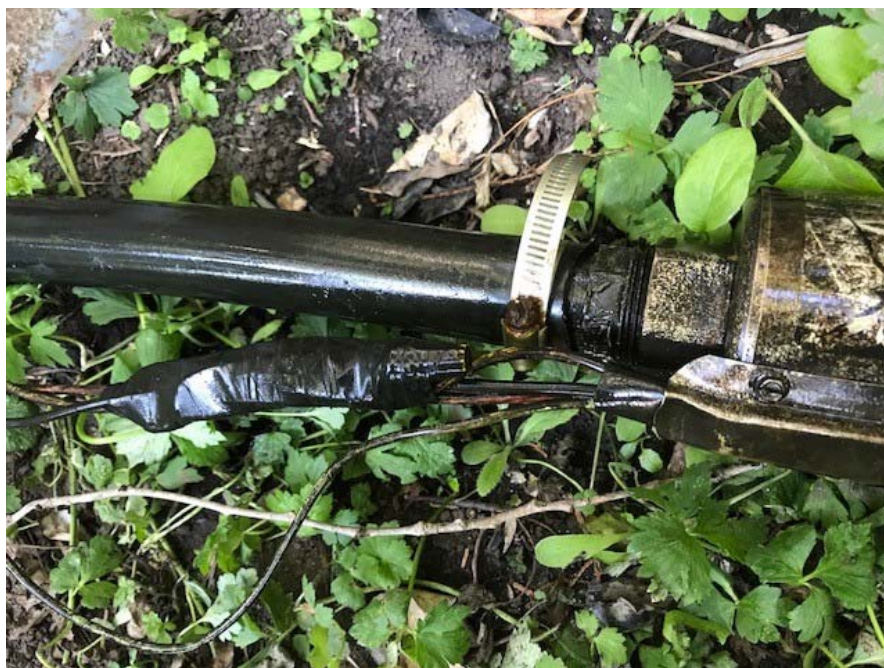
As found splice to motor

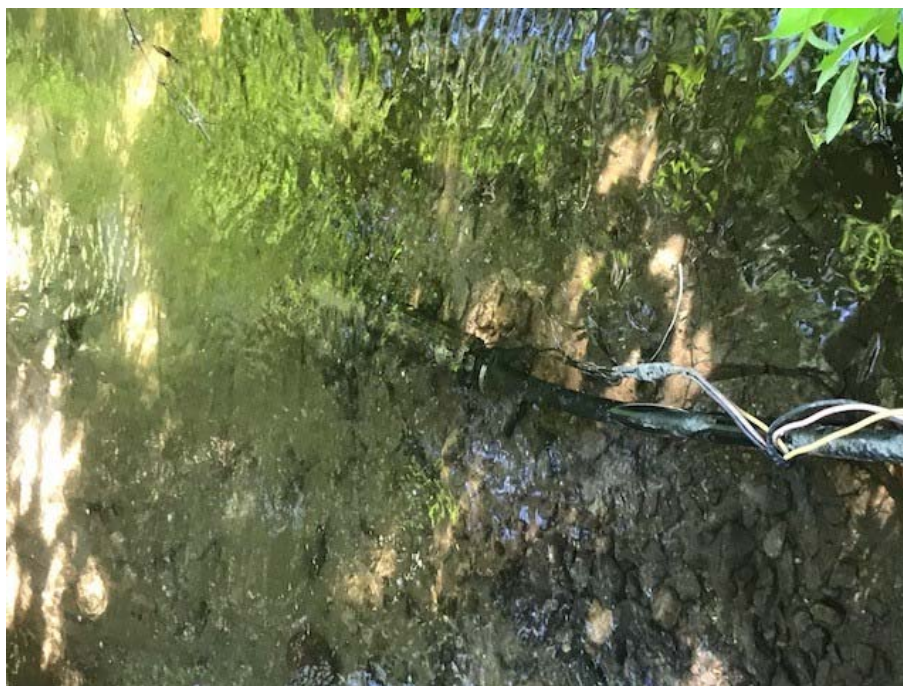
Pump re-inserted by ESO's for metering/ meggar testing following day

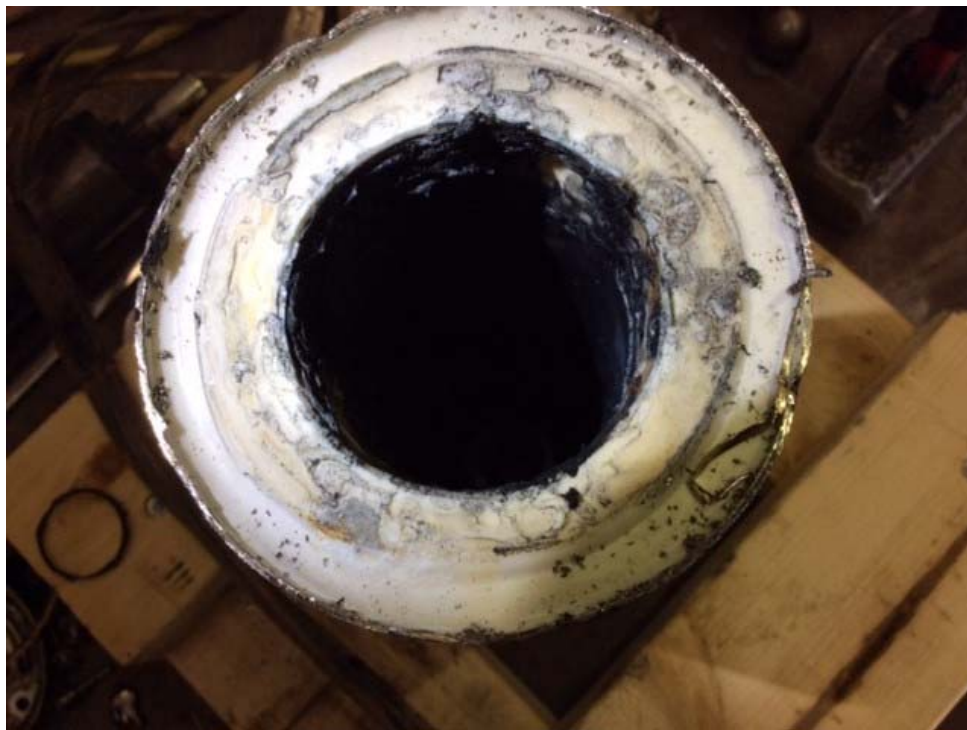
Cut end of stator- damaged noted from rotor jammed at upper right. Windings visible

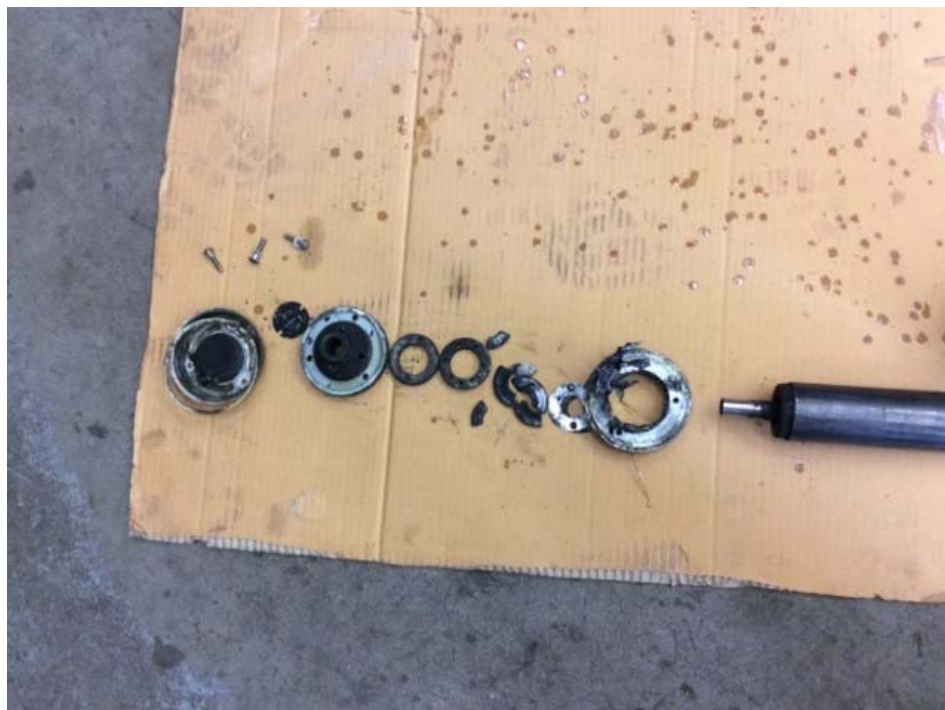
<p>Facts and evidence</p>	<ul style="list-style-type: none"> - A witness stated they attempted to run the water pump a few days prior however it failed to operate. The pump was left alone and they would wait until the homeowner returned from out of town, 'they believed they had the power de-energized' - A second witness stated the wiring was existing when they purchased the site approx. 27 years ago. This witness stated he replaced the pump approx. 4-5 years ago <p><i>Investigation of site found;</i></p> <ul style="list-style-type: none"> - No GFCI protection for irrigation pump circuit installed at main supply source at residence or at stream location - Multiple open splices and damaged cable were noted along the route from the residence to the stream. - Non-compliant wiring and control methods for irrigation pump that included NMD cabling used in exposed / wet locations/ - Pump and pump control had no access to disconnecting means of equipment, with fuses not accessible without removing screws and enclosure cover - Additional ground rods and ground cable installed with splices at creek - A Myers submersible pump was installed in an open body of water- laying on the bottom of the creek bed - Pump ground/bond conductor was not terminated or connected to electrical system - Unapproved submersible splices were noted with no mechanical protection where required - The manufacturer's instructions state that this type of pump is not to be installed in any pond, river or other open body of water that could be used for swimming or recreation due to risk of electrical shock - Reviewed the electrical utility lines nearby to confirmed no trees or branches were in contact - Testing at site showed a short to ground was found on all conductors. - The pump was removed from site and taken to pump servicing center for further testing. <p><i>Investigation of pump at pump servicing facility;</i></p> <ul style="list-style-type: none"> - Confirmed that leads had shorted to ground - Upon opening of the pump, the rotor was visibly jammed into stator at thrust bearing end, carbon thrust bearing was also destroyed, - The thrust bearing was not in the right seated location

Thrust bearing pump end layout

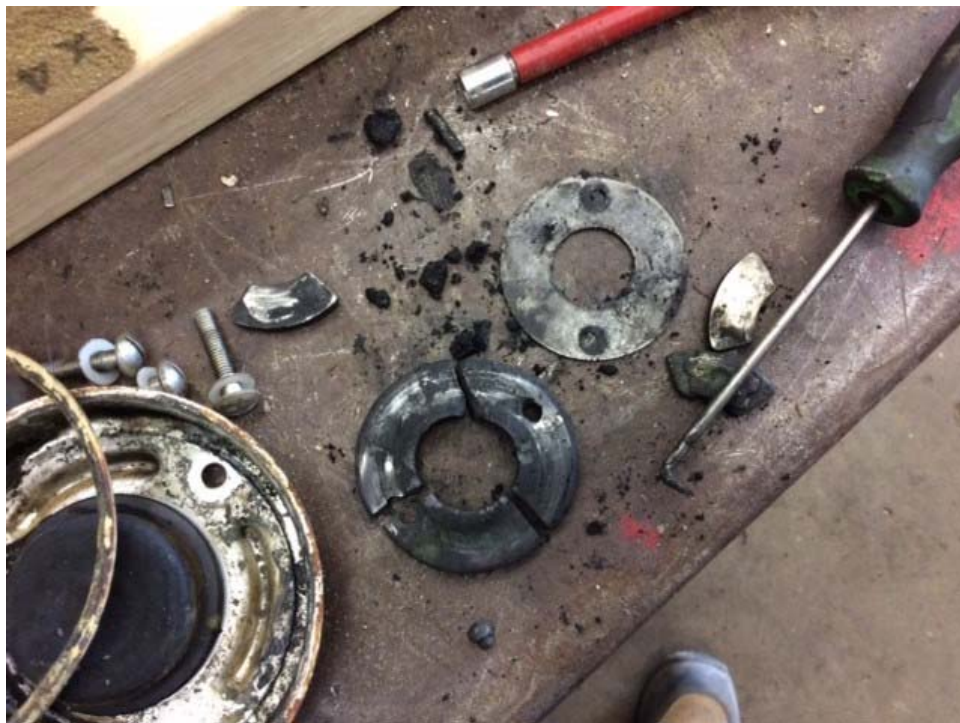
Broken Carbon Thrust Bearing
