Incident Summary #II-1440356-2022 (#29912) (FINAL)

SUPPORTING INFORMATION	Incident Date	September 22, 2022	
	Location	Interior	
	Regulated industry sector	Passenger ropeways - Above surface ropeway	
	Impact	Qty injuries	0
		Injury description	N/A
	Damage	Injury rating	None
		Damage description	A work carrier was reversed into the bottom station of a ski lift resulting in minor scuffing over 16" of the haul rope with no broken wires and a bent handrail on the upper deck of the carrier.
		Damage rating	Minor
Incident rating	Minor		
Incident overview	During the operation of the above ground passenger ropeway for inspection and maintenance, the work carrier attached to the ropeway was driven into the lower station terminal, with a passenger on board and without the collapsible upper rail lowered causing contact between the carrier and station damaging the work carrier.		
INVESTIGATION CONCLUSIONS	Site, system and components	<p>The ski lift at the facility is a detachable chair, above surface ropeway that transports passengers to the top of the ski hill on carriers attached to a ropeway suspended by towers. For maintenance, repairs, and inspections, a specialized work carrier, designed

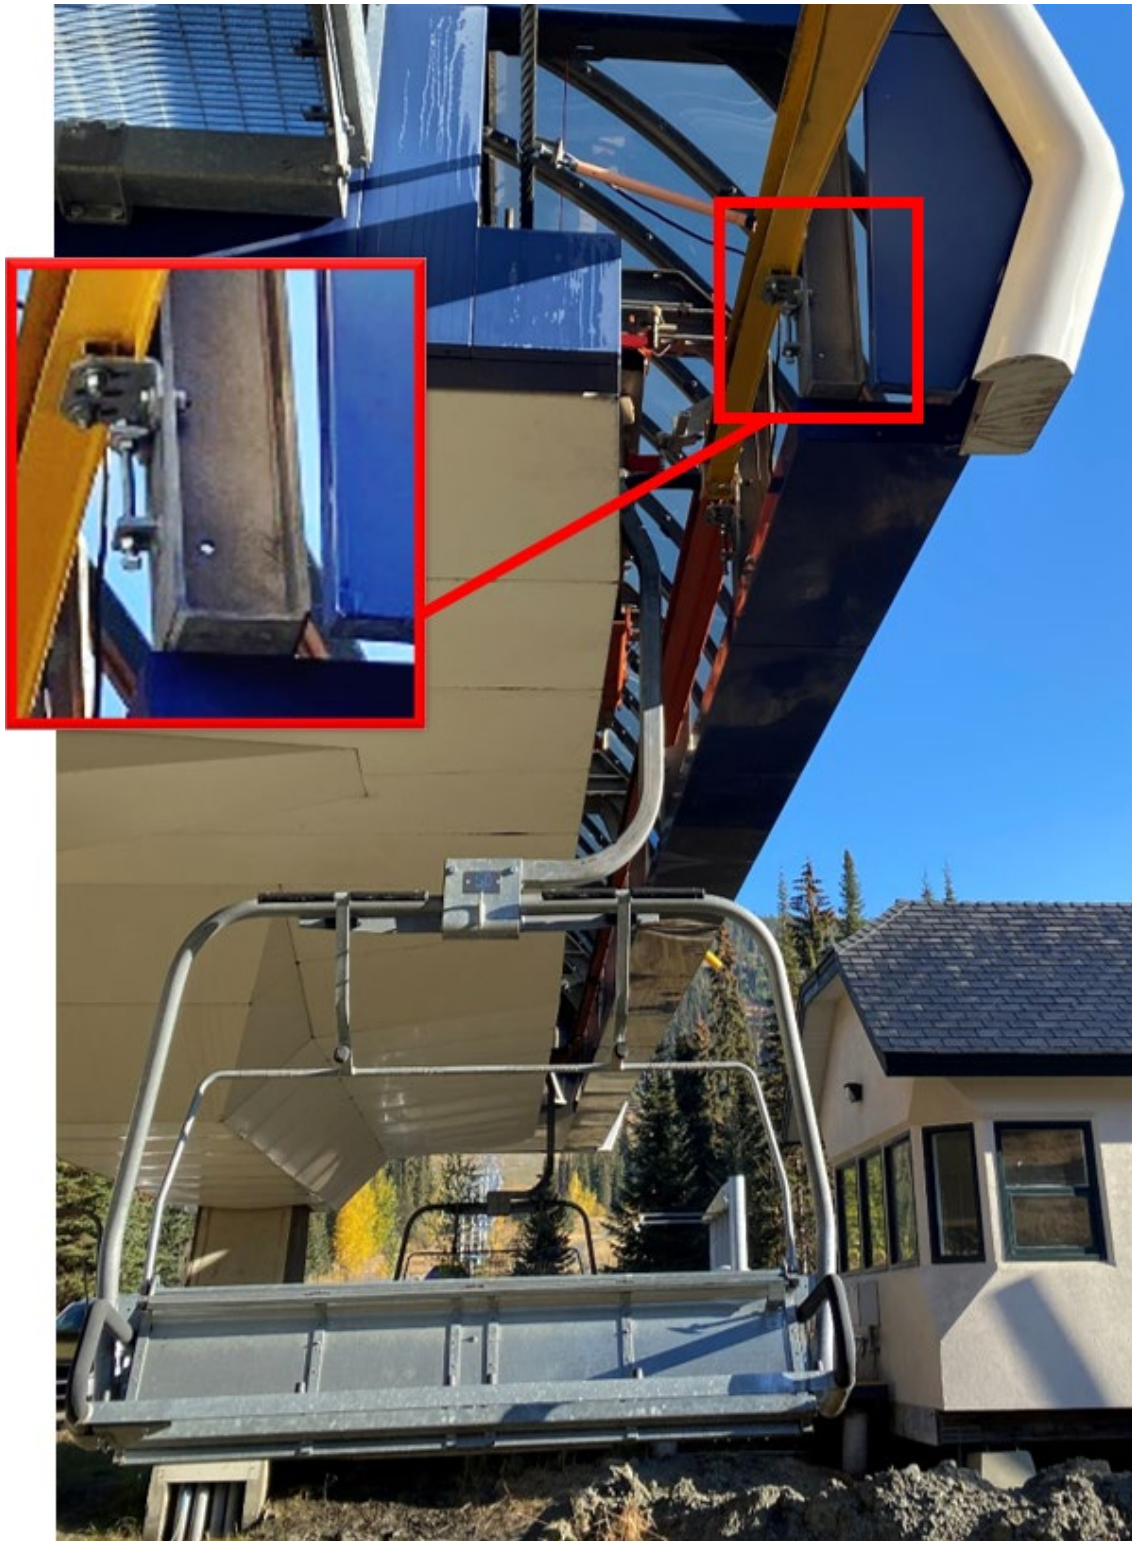
Photo 1 – A typical passenger carrier in the lower station of the lift. [RED] Area the work carrier handrail contacted the station structure when it was reversed into the station.

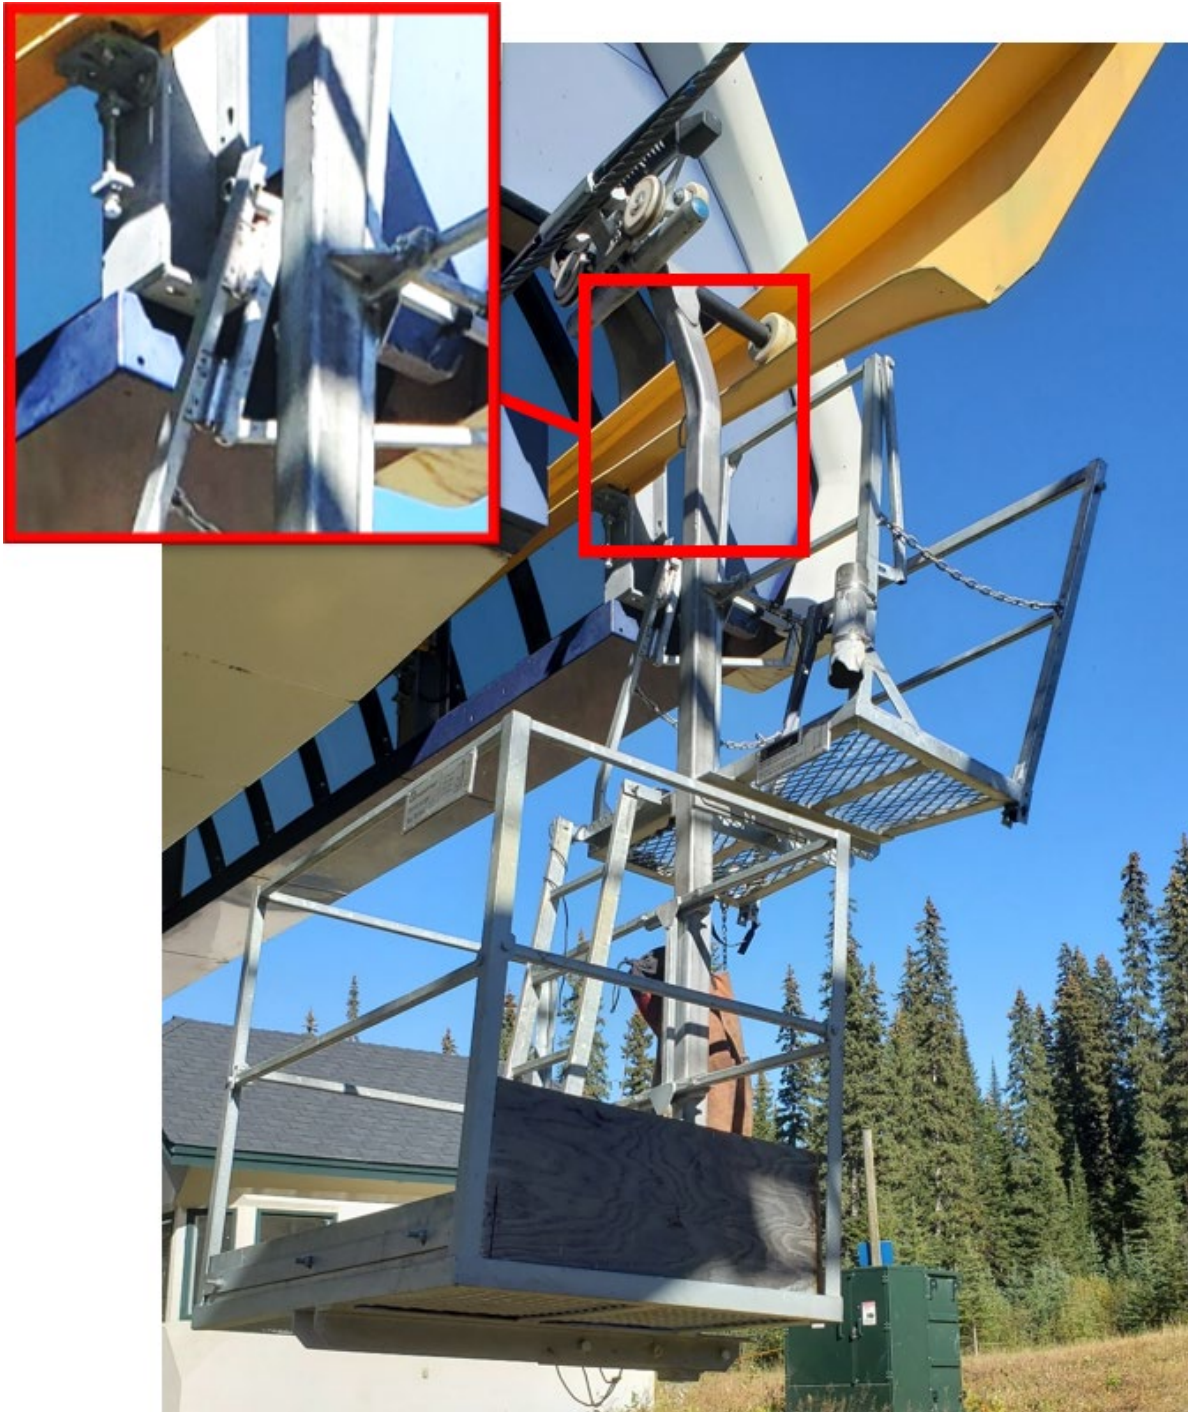
- The handrail of the damaged work carrier is 42” height from the upper platform.
- The clearance interference between the top of the rail and the station structure is approximately 3”.
- There is a warning tag affixed to the upper platform instructing to always enter the station at slow speed with the upper basket in the lowered position.
- Tower #2 is within visible and audible range from the lower station platform.
- Two other lifts at the facility were observed not requiring the work carriers to lower the upper platform handrails to allow the carrier to pass through the stations.

- The system design of the work carrier from the manufacturer allows interference between the upper handrail and the station structure and relies on administrative controls and work procedures to avoid contact with the station structure.

Photo 2 – The work carrier at the lower station. **[RED]** The area of contact between the upper handrail and the station.

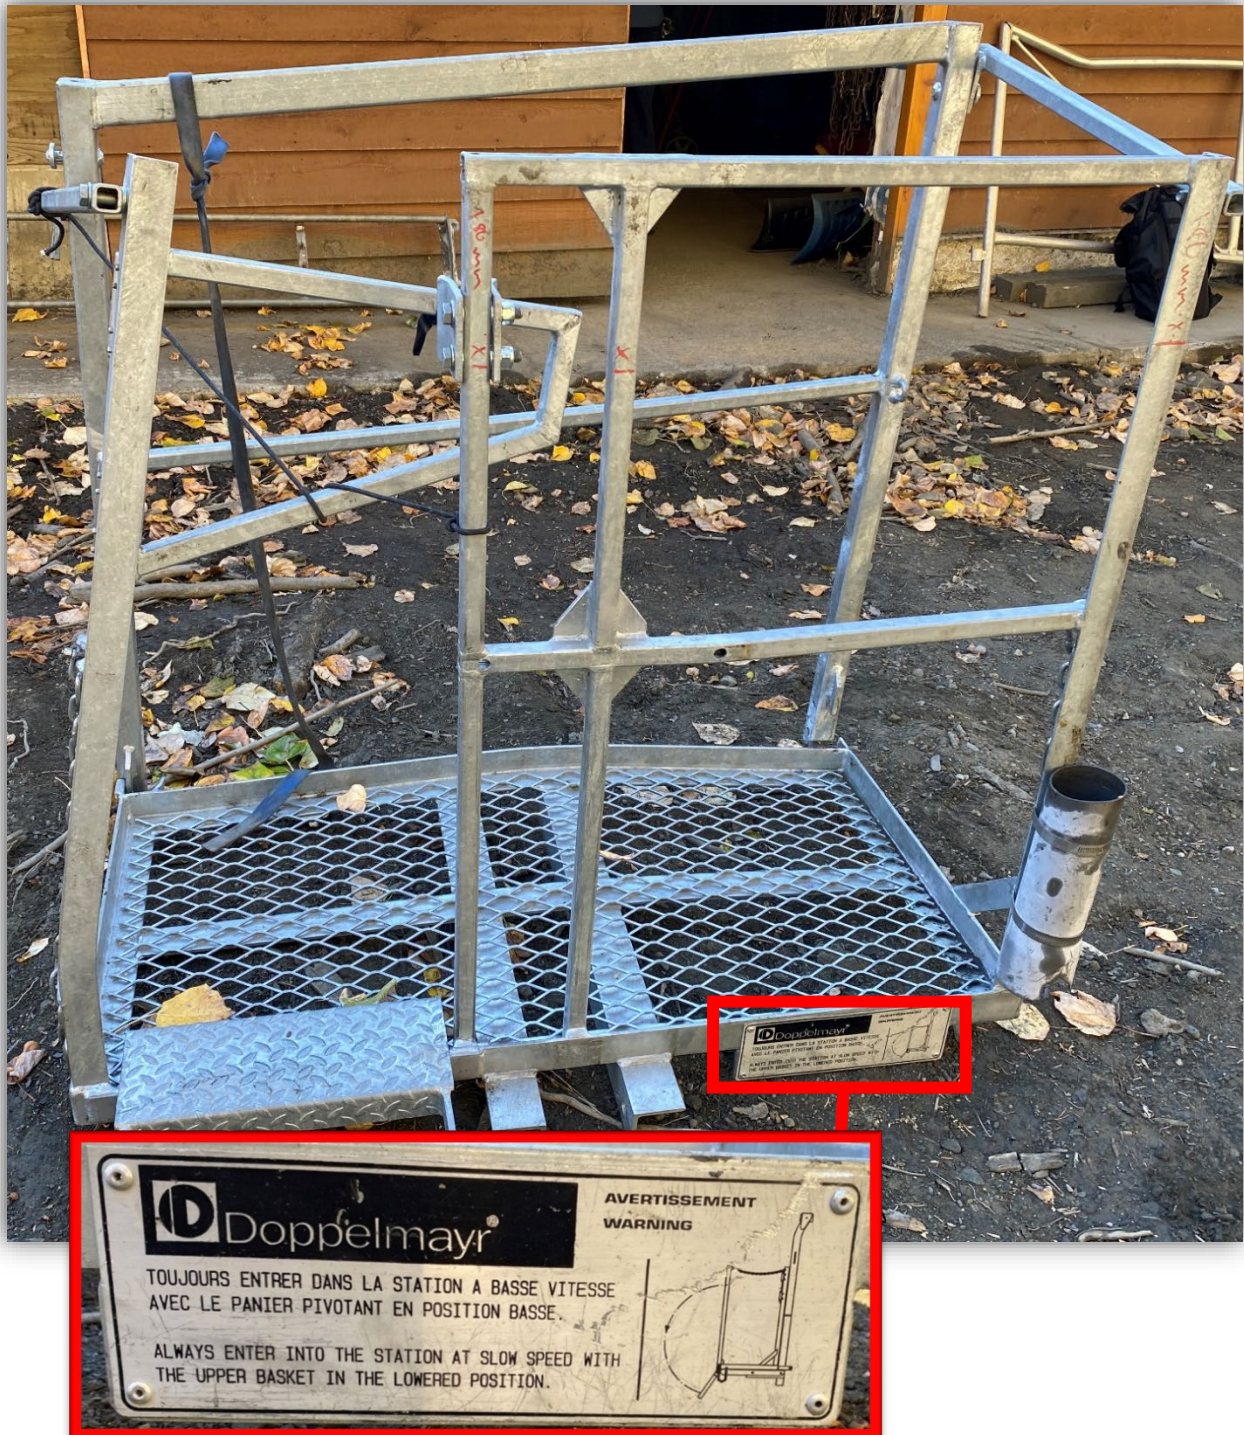
- The carrier has a warning plaque attached to the carrier that warns to lower the basket handrail before entering a station.

Photo 3 – Upper platform of work carrier removed after the incident showing the damaged handrail. [RED]
Warning tag affixed to the work carrier platform.

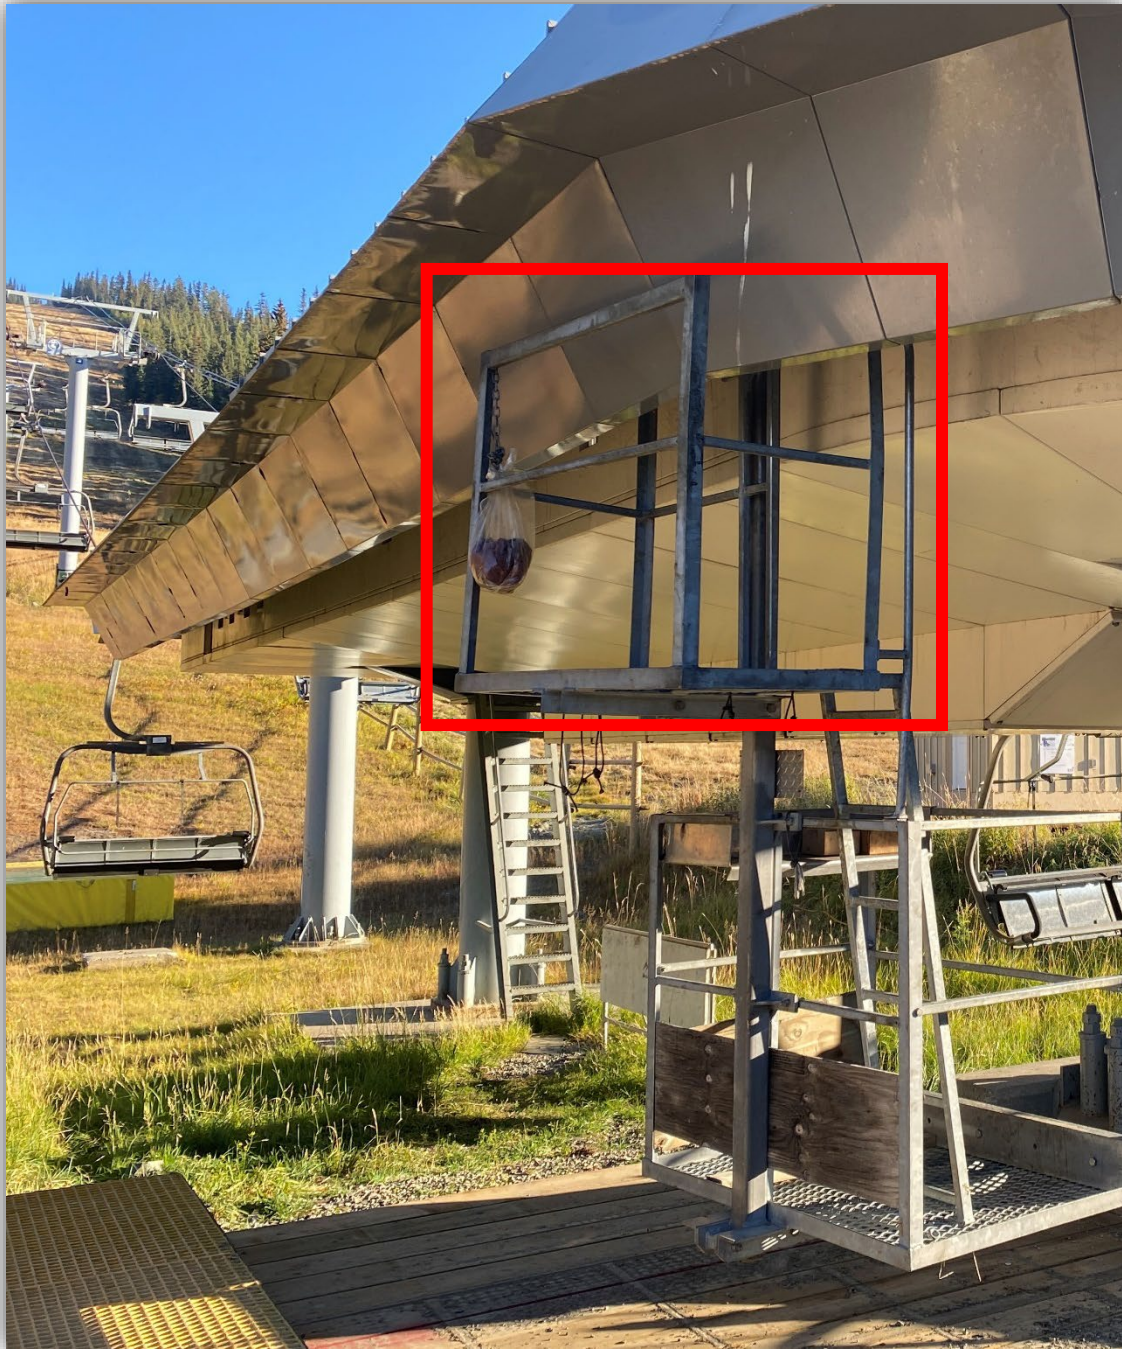
- There weren’t any issues that day with the radio communications and they had worked well.
- Not all lifts have work carriers that require the railings to be raised and lowered to clear the stations. Some of the older lifts are designed with clearance and the carrier railing won’t contact the stations.

Photo 4 – A different work carrier at another lift at the same facility. **[RED]** Fixed upper platform handrail that clears the station without the need to be lowered.
