Incident Summary #II-1450906-2022 (#30115) (Final)

SUPPORTING INFORMATION	Incident Date	January 2, 2022	
	Location	Cobble Hill, BC	
	Regulated industry sector	Electrical - Low voltage electrical system (30V to 750V)	
	Impact	Qty injuries	0
		Injury description	N/A
		Injury rating	None
	Damage	Damage description	Internal electrical components of the dust collector and the branch circuit feeding it were heat damaged.
		Damage rating	Moderate
Incident rating	Moderate		
Incident overview	At a new wood manufacturing plant, the internal electrical wiring and components of a dust collector and the branch circuit conductors feeding the dust collector overheated causing them to melt. The failure resulted in loss of use of the equipment and required repairs to bring the equipment back into service.		
INVESTIGATION CONCLUSIONS	Site, system and components	<p>The site is a new commercial wood manufacturing plant with associated electrical equipment used in the milling, shaping, and assembly of wood products.</p> <p>Wood dust collection machines and associated dust collection ducting equipment are installed in the production areas and are intended to manage dust produced by the equipment used i

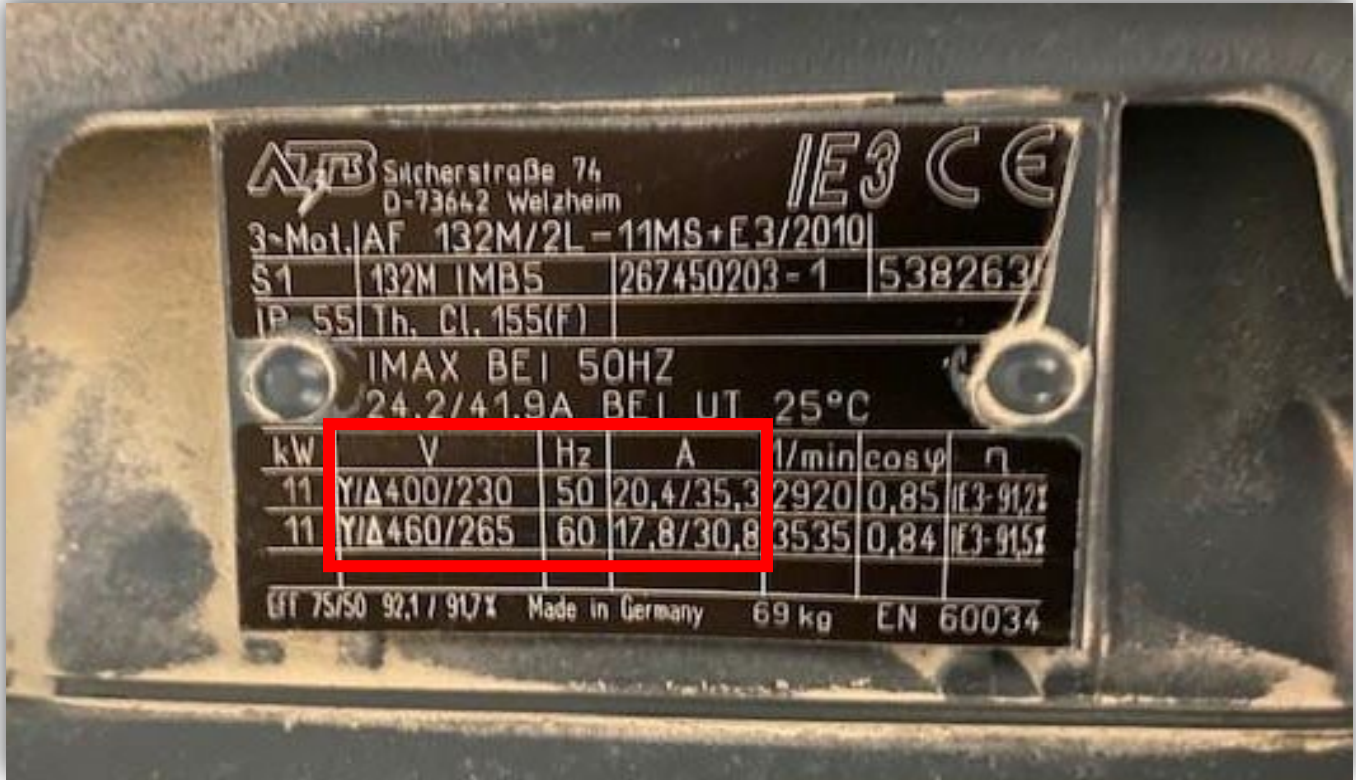
The dust collector was marked with a “CE” certification mark that is not recognized in British Columbia for certification as an approved electrical product ([Image 1](#)).

The dust collectors in this case had been evaluated and labeled with a “QAI” label that is a recognized approval mark in BC. The certification mark is required to be on the equipment for a qualified individual to connect the electrical equipment and the manufacturer’s name plate ratings are to be followed when connecting the equipment to ensure the proper rated branch circuit and overcurrent protection are installed ([Image 1](#)).

- The name plate rating on the dust collector is 230 Volt, 32A, 60 HZ, 3PH, 11KW ([Image 1](#)). With a name plate rating of 32A normal practice would be to install a 40A branch circuit.

Image 1 - Dust collector electrical name plate and approval label.

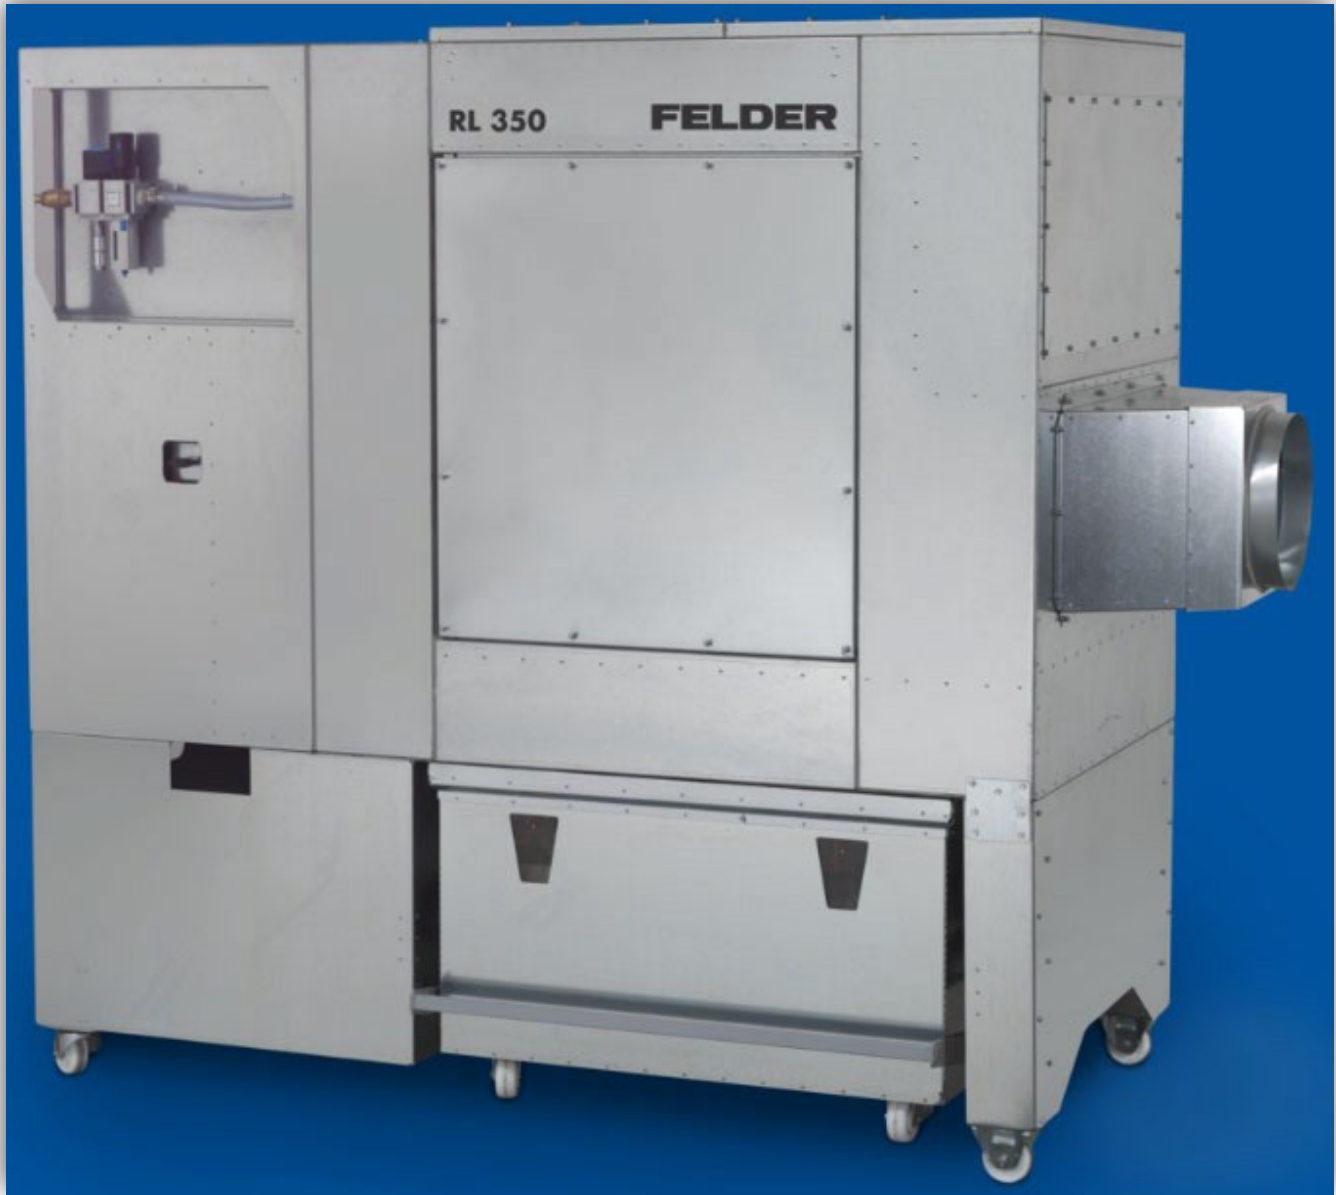
During operation, the dust collector was tripping the 40A circuit breaker. The equipment operators observed heat damaged internal electrical wiring, and a contactor within the dust collector equipment, as well as heat damaged branch circuit conductors and connections in the external junction box used to connect the equipment.

Image 9 – The 40A circuit breaker installed for the dust collector branch circuit.
