Incident Summary #II-1740368-2024 (#49609) (FINAL)

SUPPORTING INFORMATION	Incident Date	July 28, 2024	
	Location	Kelowna, BC	
	Regulated industry sector	Electrical - Low voltage electrical system (30 to 1000V)	
	Impact	Qty injuries	0
		Injury description	N/A
		Injury rating	None
	Damage	Damage description	Transit bus shelter low voltage electrical wire (flex cable) insulation and conduit melted due to electrical fire.
		Damage rating	Minor
	Incident rating	Minor	
	Incident overview	<p>Flames and smoke were coming out from behind a metal flashing which is present to prevent public access to the underground cabling and connection points for a bus shelter's transit sign.</p> <p>When fire crews removed the flashing at the base of a vertical support post for the roof structure during suppression efforts, they observed there was melted conduit plastic and bare wires due to the insulation melting. The wires sparked a couple of times while fire suppression efforts were done then stopped which indicated it was energized at that time.</p>

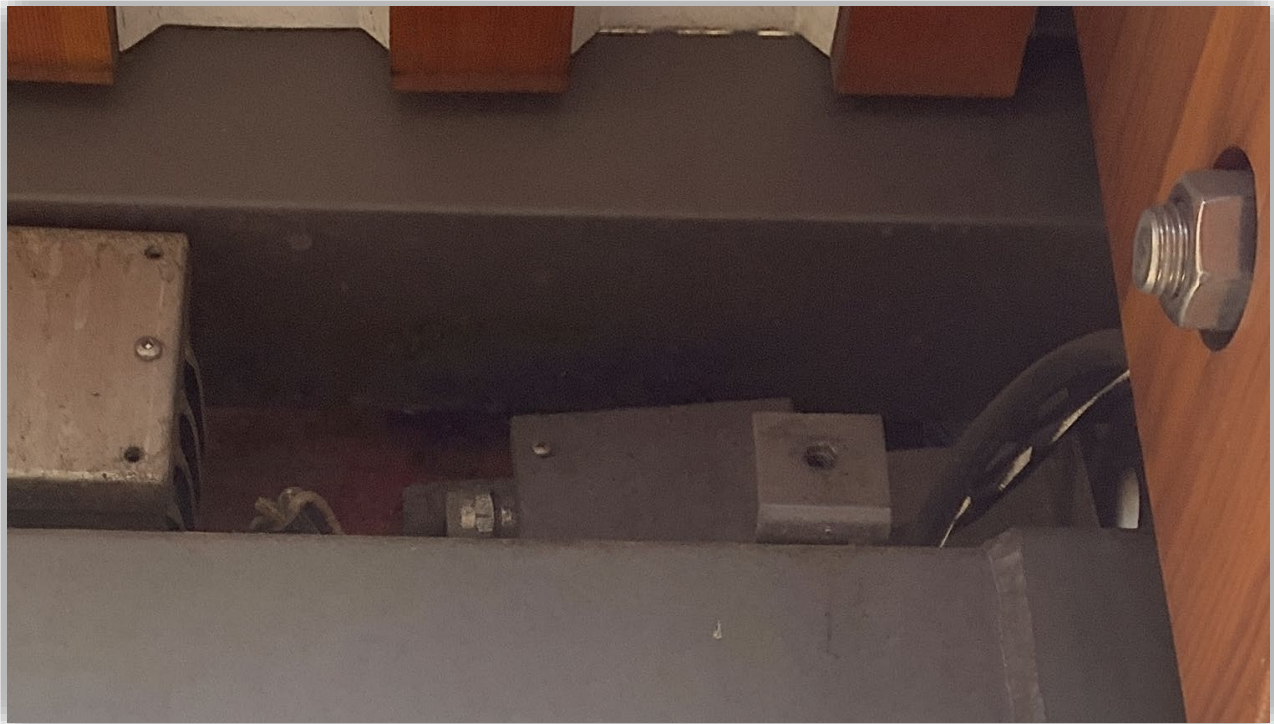
<p>Facts and evidence</p>	<p>Field Observations:</p> <ul style="list-style-type: none"> No evidence of certification approval was observed on the shelter or components although rear/underneath could not be viewed. It would be typically located in plain sight from the top or sides (Image 1). Damage was isolated to an area with two electrical circuits known to have been energized at the time, a lighting circuit, and a circuit feeding a decommissioned transit sign. The transit light supply conductors were Teck 90 armoured cable and appeared to be part of the original installation. The transit sign conductors were cab tire (flexible cable). The cab tire cable that was the likely source of the fire although the exact failure point could not be identified after the fire (Image 2). <p>Correspondence with City Staff:</p> <p>City staff indicated a similar cable type and method of decommissioning was present at the bus station across the street, and likely others.</p> <p>Electric Field Service Representative (FSR):</p> <p>The FSR observed the cab-tire feed that had been installed for transit signage (now removed) appeared to have failed. They stated it may have occurred when stretched and ran underground in conduit that shares power supply for bus shelter lighting fan in Teck 90 cable. It rained that day and as cable was not under load, water may have migrated into contact with the conductors causing the incident. Cab-tire for all shelters was to be disconnected as it was not in use.</p> <p>Fire Department:</p> <p>The fire department observed there was melted conduit plastic and bare wires due to the insulation melting. The wires sparked a couple of times while fire suppression efforts were done then stopped indicating a likely energized cable.</p>

Image 1 - Bus shelter lighting; connection point part of shelter approval. No evidence of certification mark can be seen.

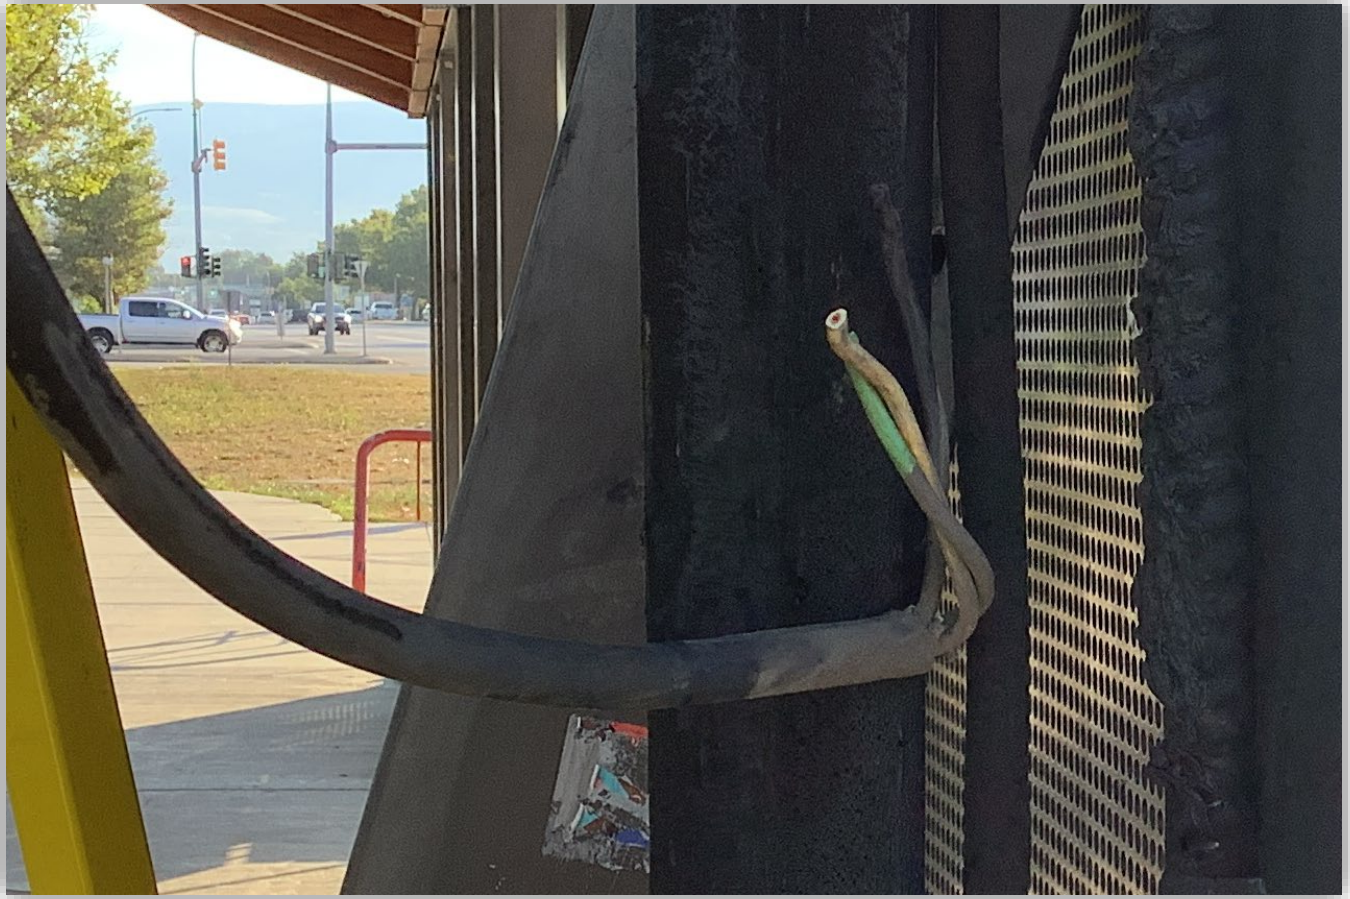
It is likely when the transit shelter sign was decommissioned from electrical service, the cable supplying the transit shelter sign was not disconnected from the source voltage.

Image 2 - Cable taped off; sign disconnected-Energized from vault (see [image 3](#) -source).

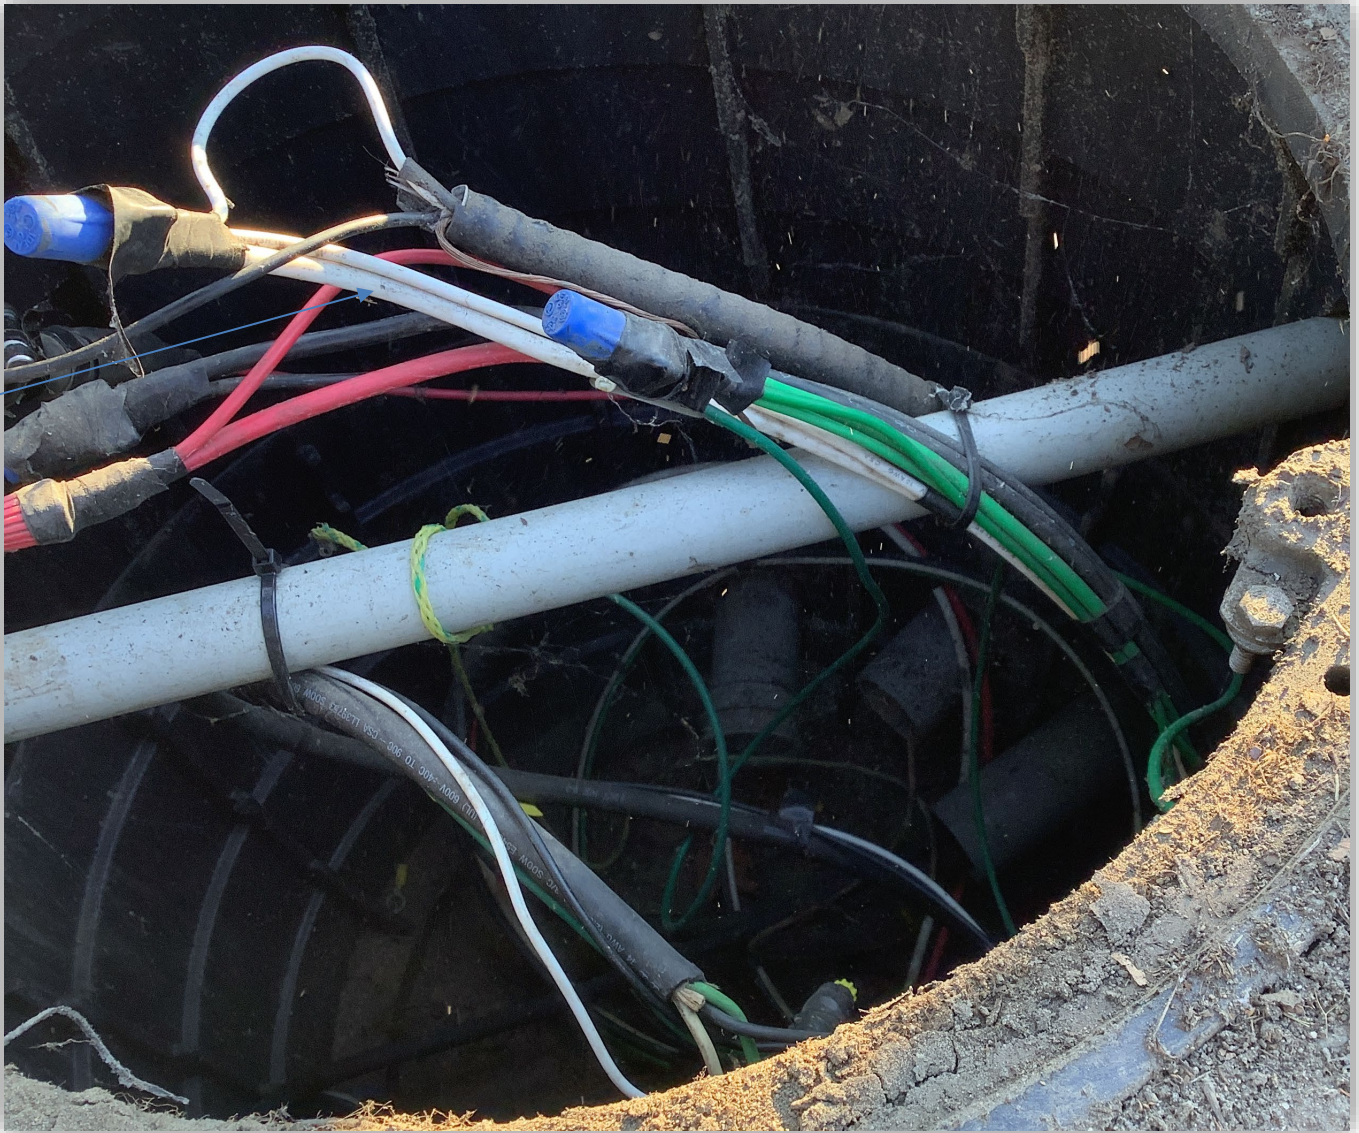
<p>from exposure to weather elements by having them inside a box, but they were left out as there is currently no requirement for this therefore it is up to the individual.</p> <p>The incident subject cable was added after for the sign (Image 3).</p>
<p>Failure scenario(s)</p>	<p>Cab tire cable (flexible cable) was used for the power supply to the transit sign when it was installed in an underground conduit. Cab tire cable is not approved for this type of installation and mechanical damage during installation could not be ruled out. Original Teck 90 cable was previously installed for lighting. The incident subject cable was added after for the sign.</p> <p>When the transit sign was decommissioned, the cable was left energized. It is possible that a combination of mechanical damage to the cable, as well as moisture intrusion resulted in a short circuit in the energized cable, creating heat and/or sparks which ignited nearby combustibles.</p>

Image 3 - City lighting vault; source voltage connected to flex cable.

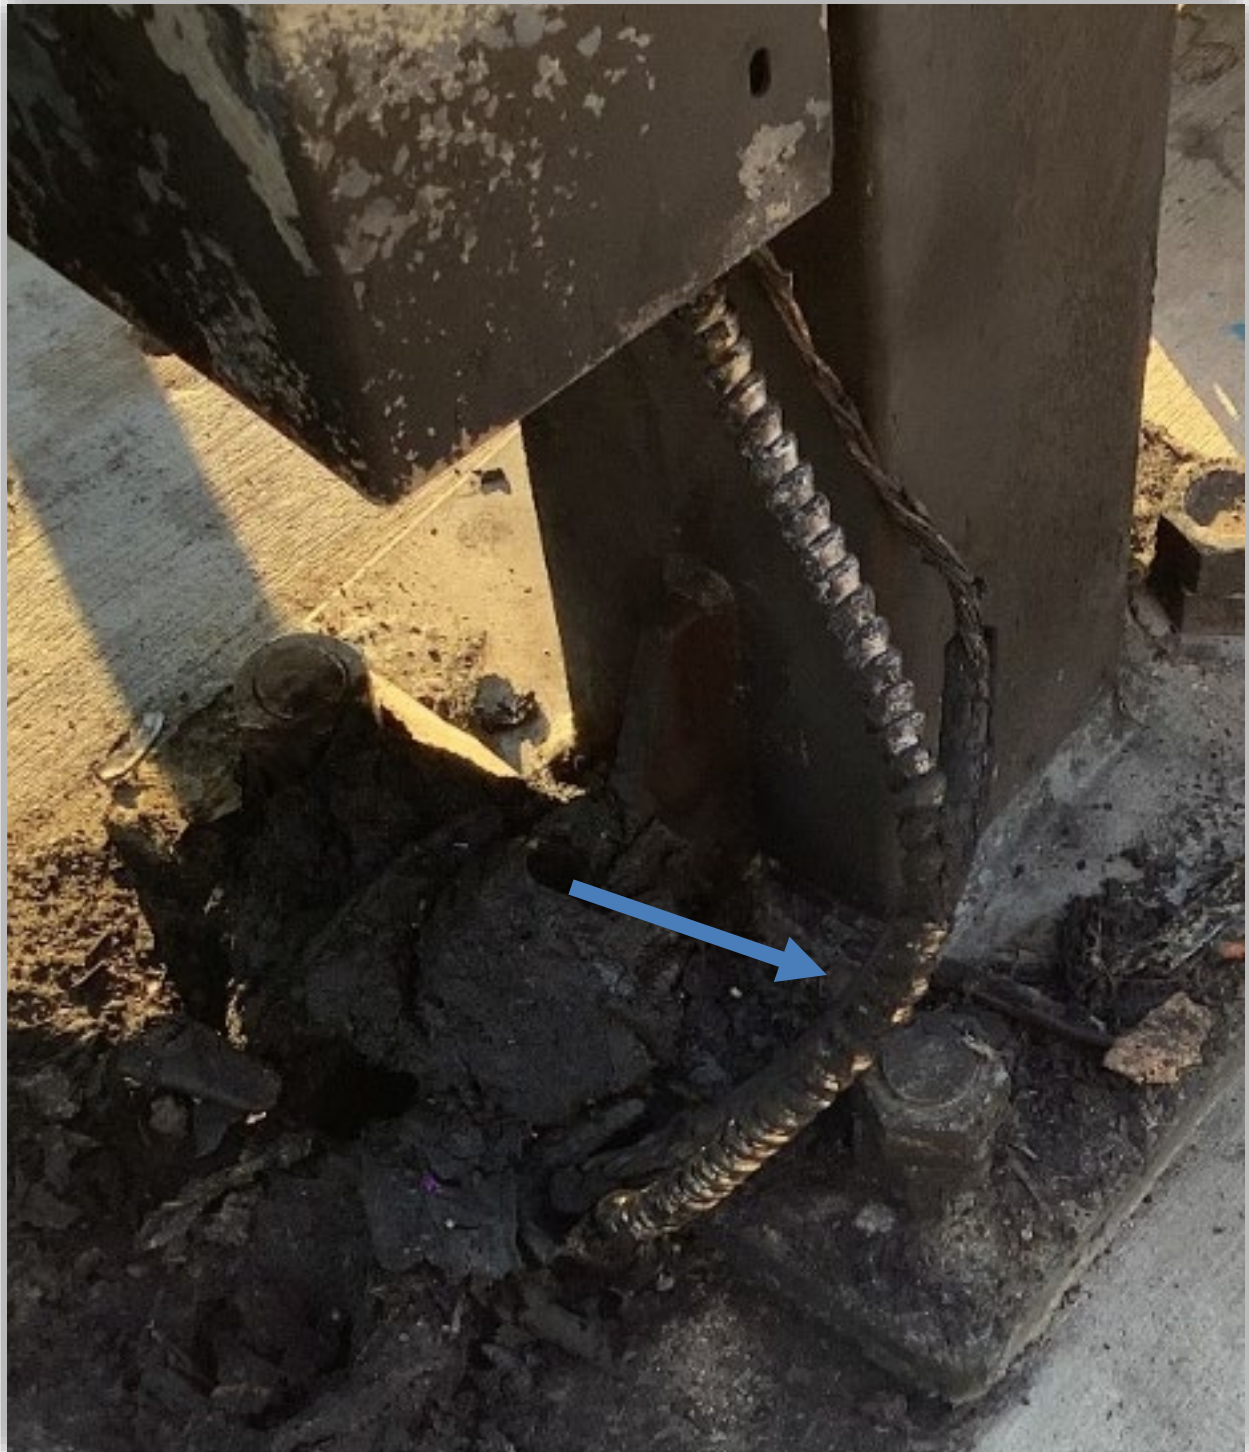
It is likely that a combination of moisture intrusion and mechanical damage led to a short circuit which created sufficient heat to ignite nearby combustibles. As a specific failure point could not be identified, it is possible a partial short circuit occurred resulting in heating, which did not immediately trip the overcurrent protection allowed a hazard to be present and combined with an eventual fail-point that combined may have caused the incident fire. As a specific failure point could not be identified, it is possible a partial short circuit occurred resulting in heating, which did not immediately trip the overcurrent protection.

As cab tire is not meant for this type of installation, it is possible that it was more susceptible to mechanical damage such as strain and/or abrasion during installation.

Image 4 - Cable fail point inside bus shelter.

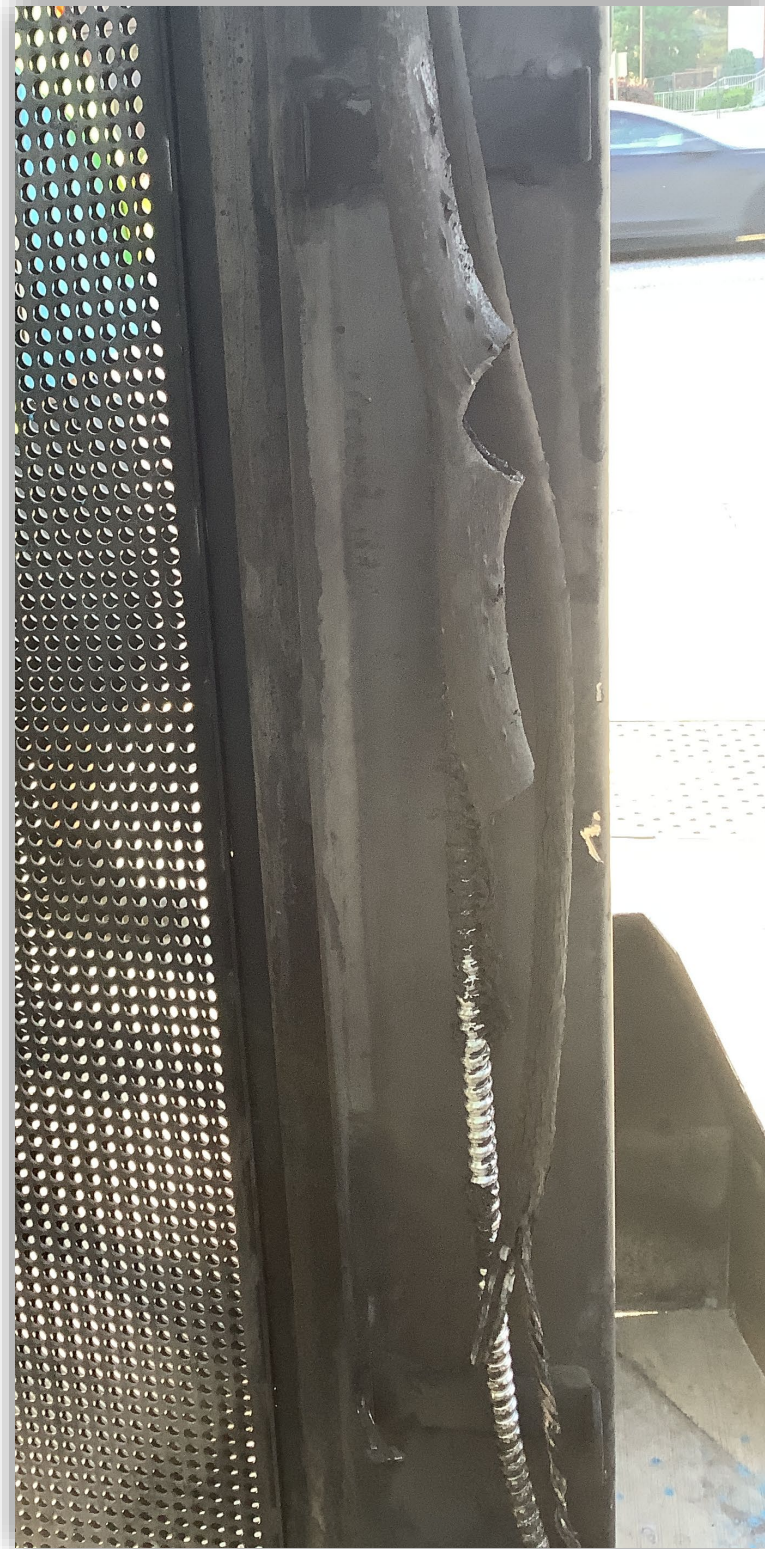
Image 5 - Overview bus shelter; damaged to armoured cable and sheath.
