Incident Summary #II-1525788-2023 (#33751) (FINAL)

SUPPORTING INFORMATION	Incident Date	March 24, 2023	
	Location	Quesnel	
	Regulated industry sector	Gas - Natural gas system	
	Impact	Qty injuries	0
		Injury description	N/A
		Injury rating	None
	Damage	Damage description	Corrosion damage beyond repair to two boilers and their venting systems. Damage from corrosion to the existing brick chimney of the building.
		Damage rating	Moderate
Incident rating	Moderate		
Incident overview	Two boilers with low inlet water temperature and corrosive condensate overflowing from their combustion chambers had heavy corrosion to their natural draft venting systems. Both boilers and venting systems were scheduled for replacement due to the damage.		
INVESTIGATION CONCLUSIONS	Site, system and components	<ul style="list-style-type: none"> Two natural draft boilers classed as Category 1 appliances were utilized to heat the publicly occupied space via radiators throughout the building. Category 1 venting, single walled and double walled which must be run to the end/ top of the existing chimney. Hydronic piping with bypass valve installed in the primary loop which is used to control the temperature of t

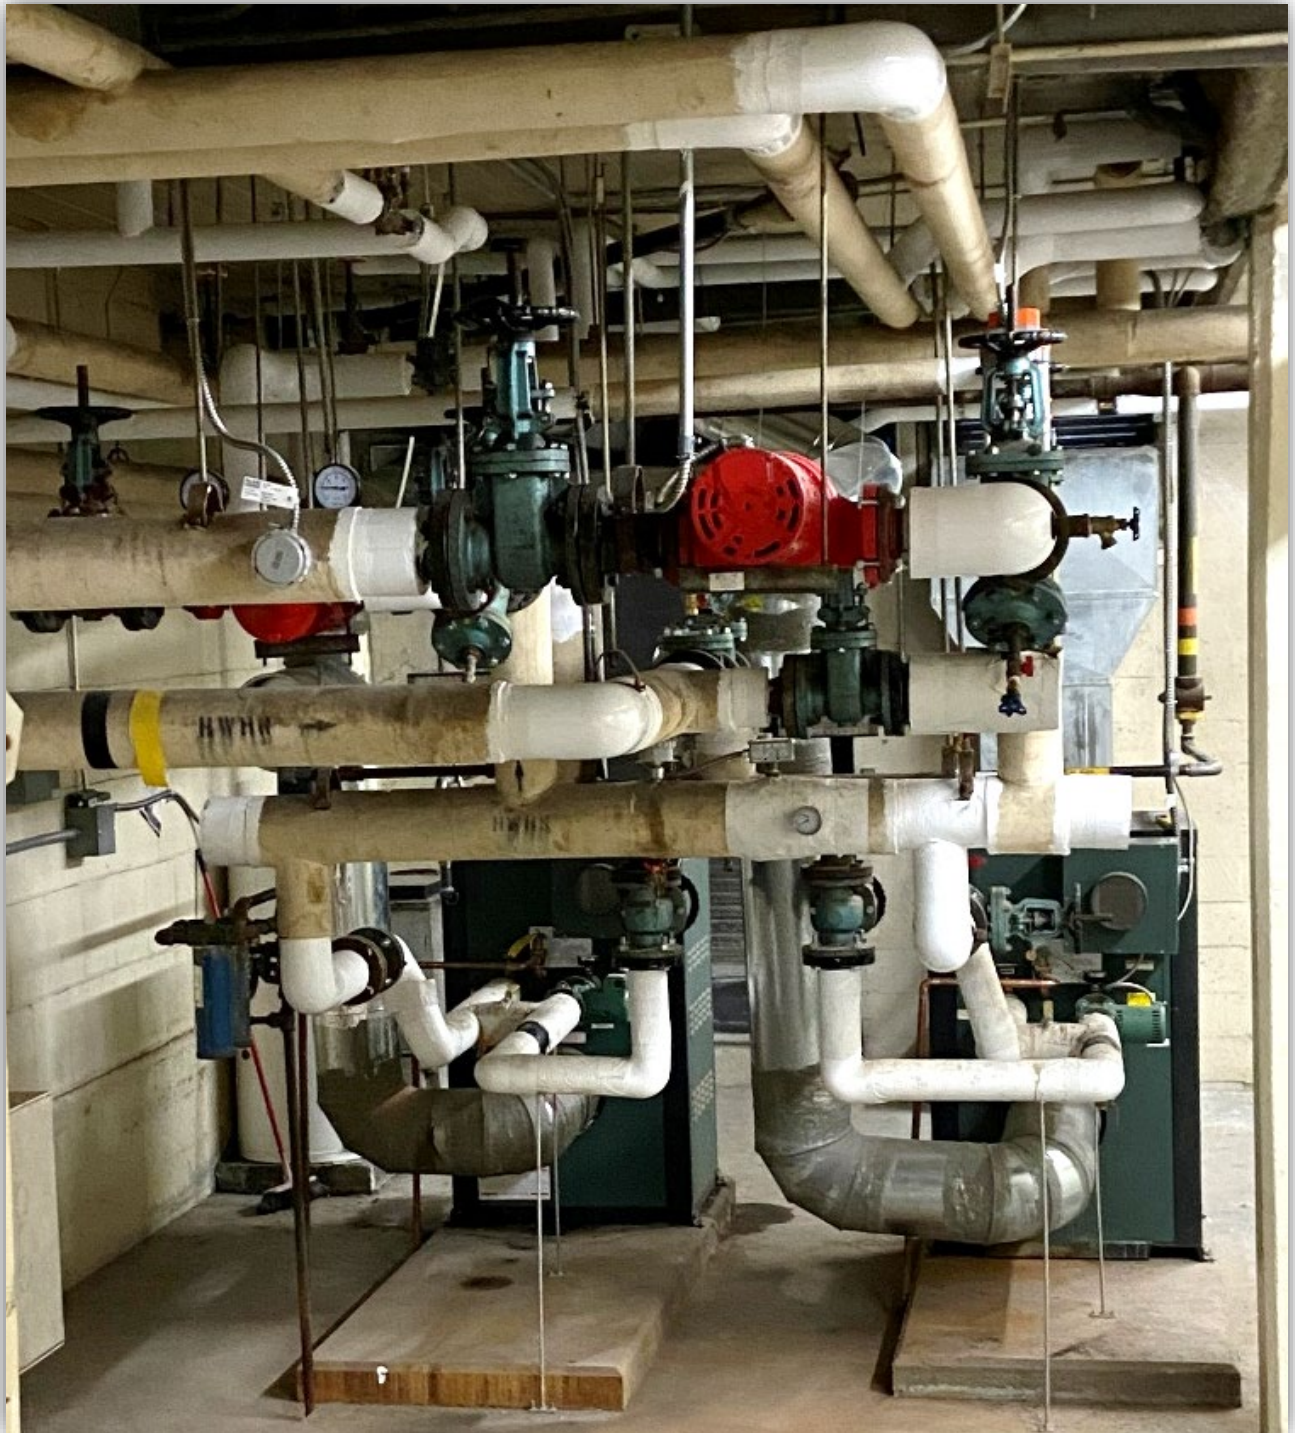
Photo 1 – Both boilers rear-side view.

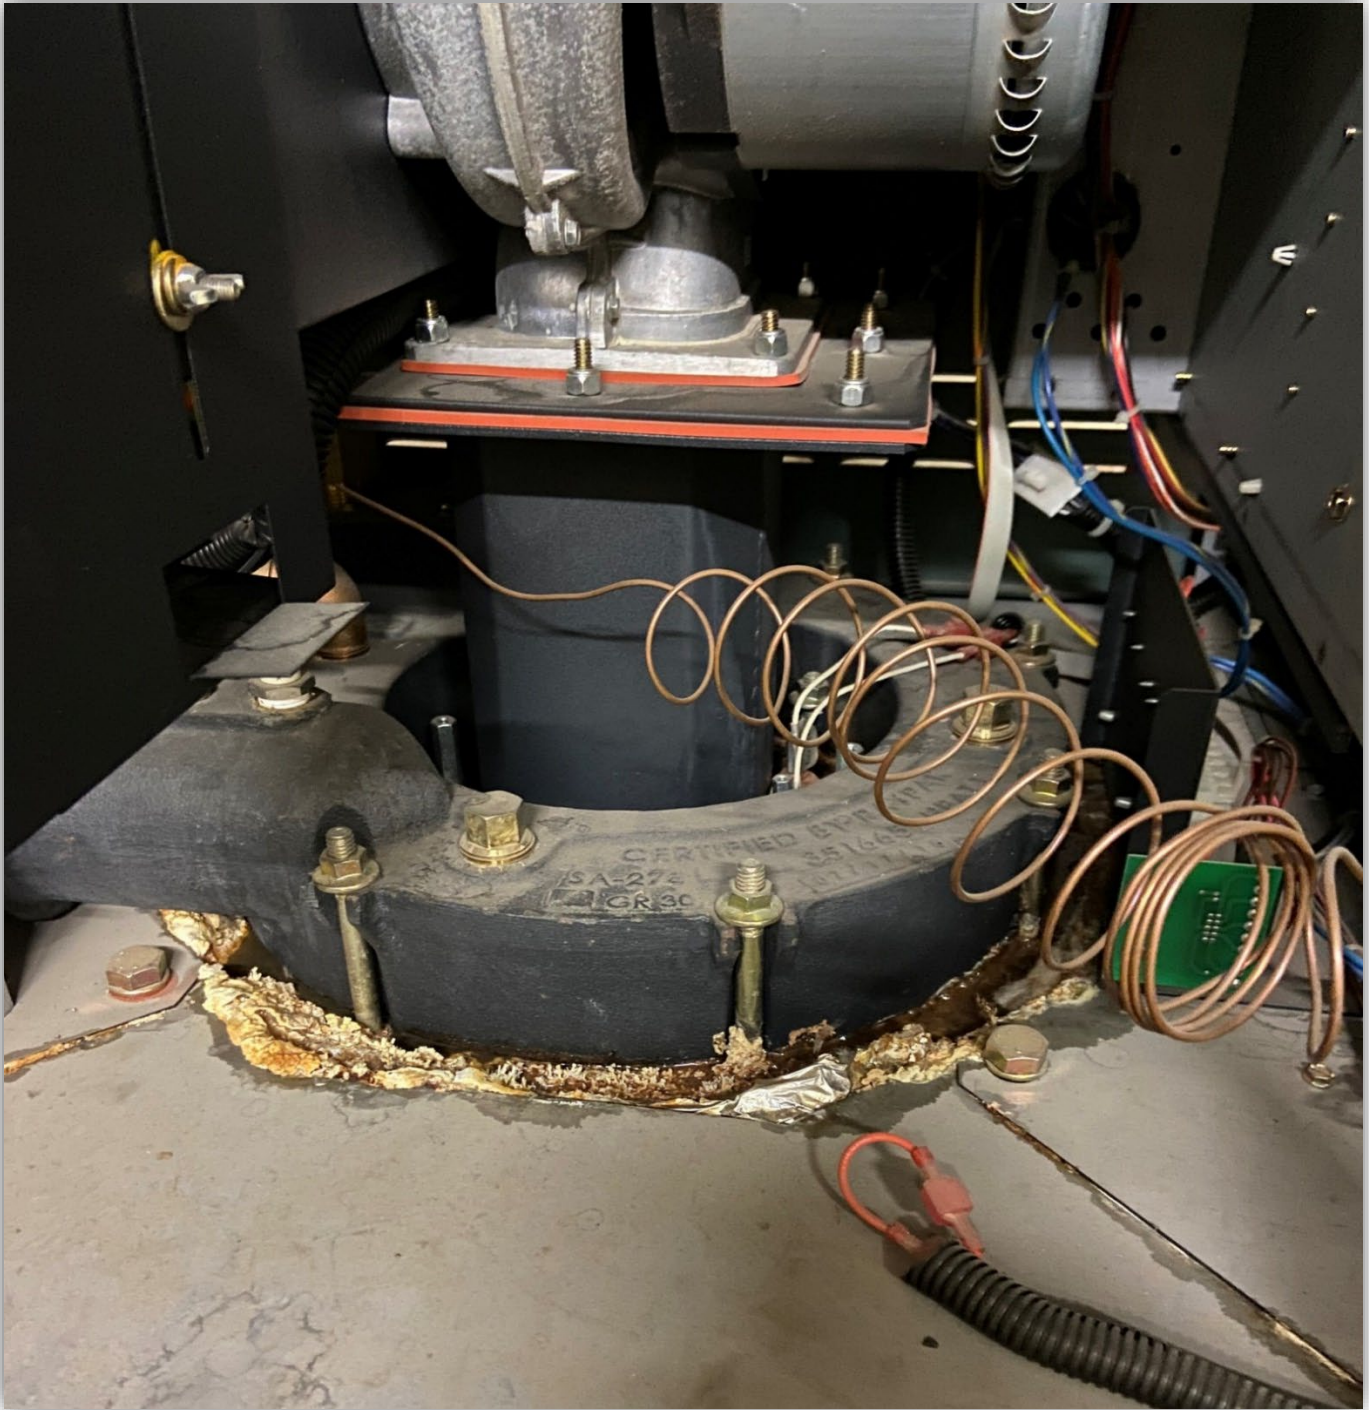
Photo 2 – Top of boiler 2 showing the leak from the gasket.

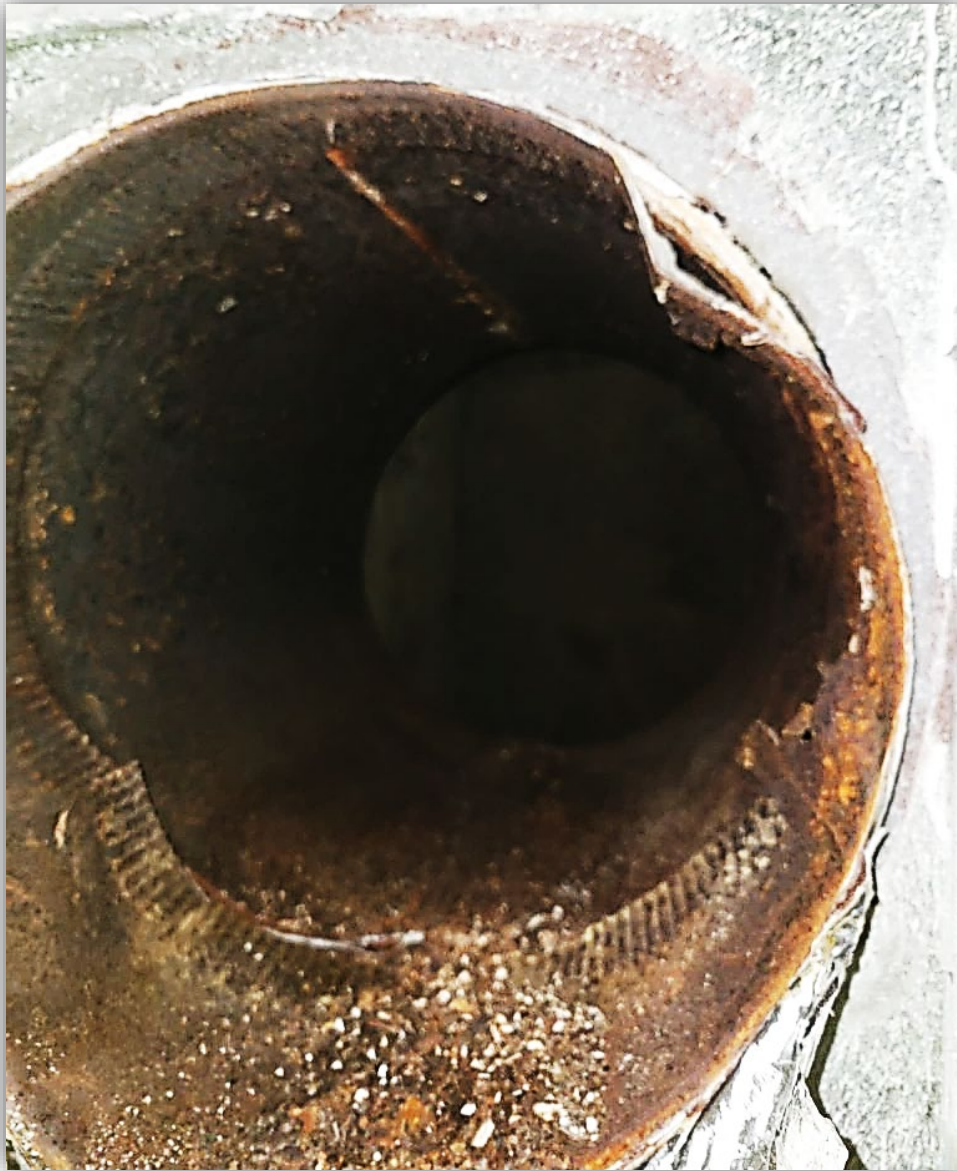
Facts and evidence	<ul style="list-style-type: none"> • Single wall venting from boilers was installed up to the wall of the existing brick chimney. The venting system was not installed within the existing chimney where it should have been run to the termination/end of chimney with approved material which would have been the double-walled venting. • Both boiler pumps had been replaced within the last few years. The bypass mixing valve was found to be in the completely closed position and not adjusted to the manufacturer’s requirements of ½ open to ensure proper delta T of 16 to 39 F. The boiler operating manual advised this valve should be of the automatic type.
Causes and contributing factors	<p>The cause of the incident was that the inlet water temperature was too low as the bypass mixing valve was left in the off position causing excessive condensate in the boiler combustion chamber and venting.</p> <p>Contributing factors:</p> <ul style="list-style-type: none"> • The exhaust venting not running to the top end of the brick chimney creating a situation where condensation leaked back into the venting system. • The venting being thinner (26 gauge vs. 24 gauge) than required by code may have led to quicker corrosion.

Photo 3 - Vent common header interior going into chimney with no pipe going upwards, concrete cinder blocks are visible.

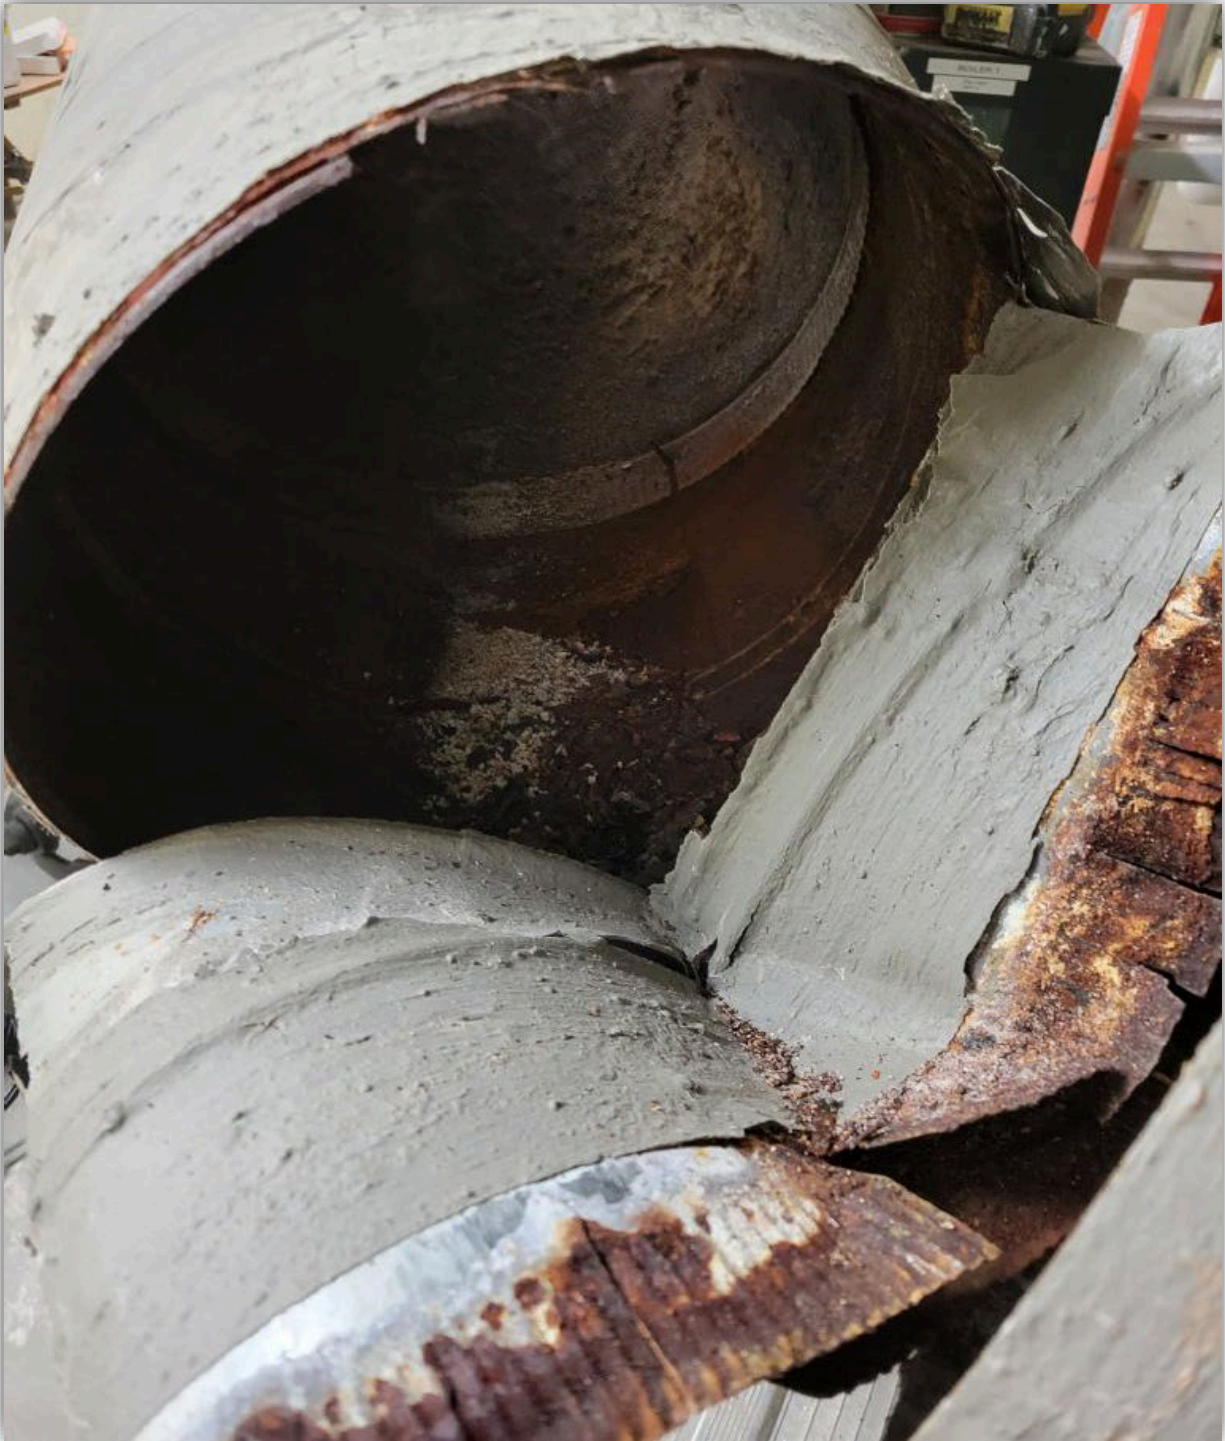
Photo 4 – Venting common header with corrosion damage, photo taken after removal.

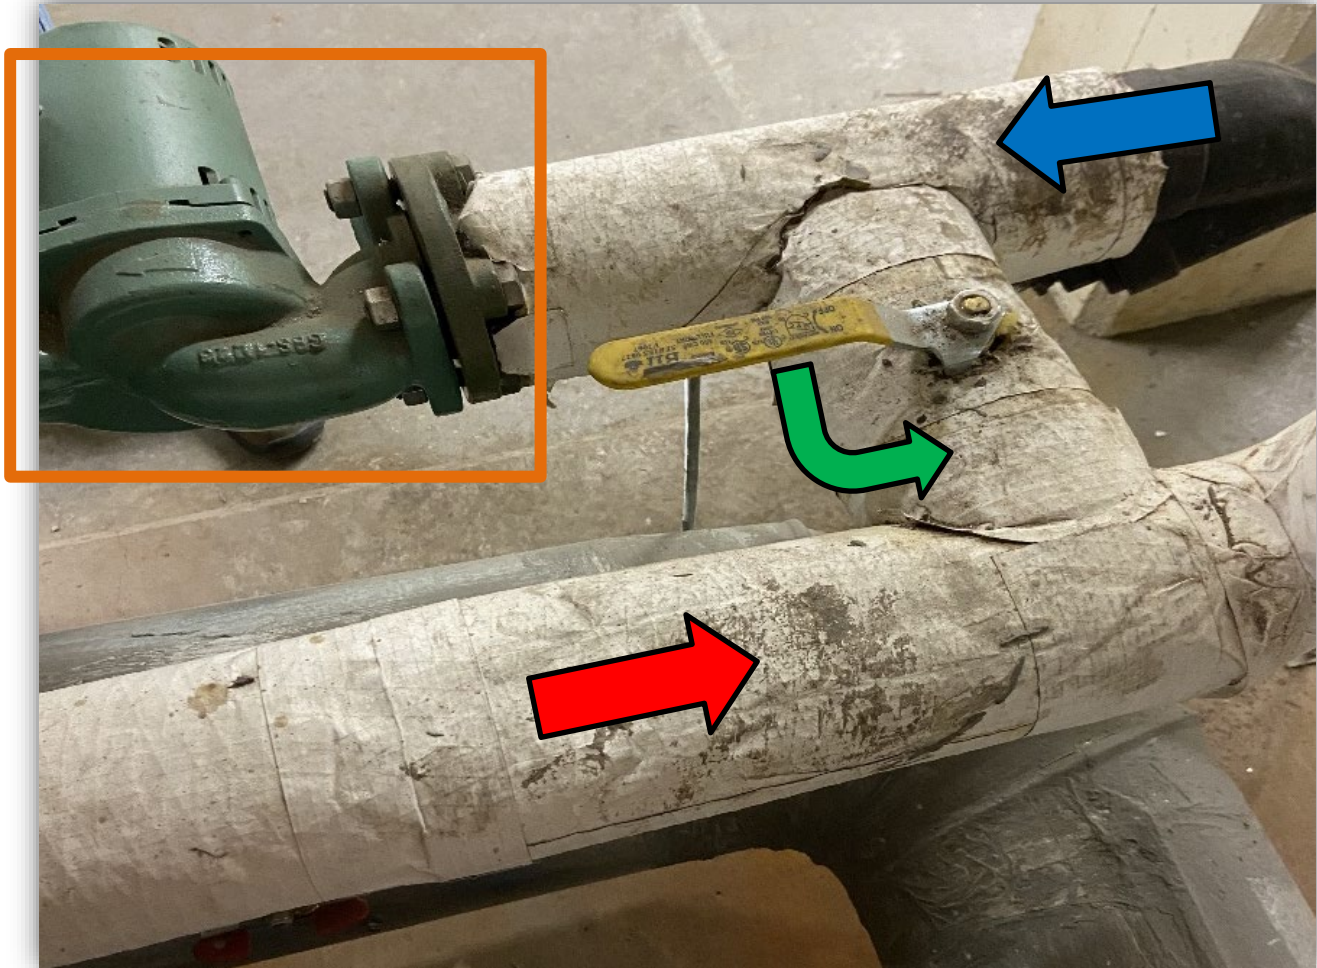
<p>By-pass valve: A device by which the flow of a fluid can be started, stopped, or regulated by a movable part that opens or obstructs passage. In a hydronic loop the valve is used to regulate the temperature of the return water to the boiler to maintain the manufacturer’s recommended temperature.</p> <p>Boiler “short-cycling”: occurs when an oversized boiler quickly satisfies process or space heating demand and shuts down until heat is again required. Return water temperatures which are too cold can cause this issue.</p> <p>Delta T - difference between the inlet and outlet water temperatures.</p> <p>The boiler manual states for the Delta T - Adjustment of the manual bypass valve is critical to proper operation of the heater. The manual bypass valve should be adjusted to achieve a minimum inlet water temperature of 120°F (49°C) for Hydronic Heating.</p>
Failure scenario(s)	<p>Category 1 single wall venting failed due to condensation occurring inside the indoor venting. The indoor venting was found to be run up to the existing chimney wall only, and not within the chimney. The chimney is approximately 30 feet tall outdoors. The vapor running up in this space was condensing and running to the bottom of the chimney where the indoors venting was attached and was not able to escape the venting via a drip-leg/dirt-leg. The boiler insulating jacket was found to be dripping condensate. The gaskets at the top of the combustion chamber showed signs of failure. There was condensation found within the combustion chamber where only gases should be. The boilers, as stated by the on-site personnel, were running on the high limit for two minutes and then shutting off for another two minutes and were not found to be running on low limit at all. The bypass valve was found to be in the completely closed position causing the natural draft boilers to operate outside of the manufacturer’s recommendations. The boilers had been noted to be short cycling as a result of return inlet water being too cold.</p>

Photo 5 – Inlet temperature bypass valve. The valves for both boilers were left in the closed position as shown in the Photo. To mix the municipal water (**BLUE ARROW**) with the warmer boiler loop water (**RED ARROW**), the valve would be moved in the direction of the (**GREEN ARROW**),. This would allow for adjustment to the inlet temperature setting for the pump (**ORANGE**) to supply to the boiler.
