Incident Summary #II-1100021-2020 (#19840) (FINAL)

SUPPORTING INFORMATION	Incident Date	November 13, 2020	
	Location	Delta, BC	
	Regulated industry sector	Electrical - High voltage electrical system (greater than 750V)	
	Impact	Qty injuries	0
		Injury description	None
		Injury rating	None
	Damage	Damage description	Private overhead high voltage transformer bank platform collapsed.
		Damage rating	Major
	Incident rating	Major	
	Incident overview	A 12KV high voltage private overhead pole line H frame transformer bank structure collapsed during a wind storm. The transformer bank fell over hitting the side of a warehouse building. The building and staff in the building lost power for 24hrs.	
INVESTIGATION CONCLUSIONS	Site, system and components	<p>The high voltage 12,000Volt overhead private pole H Frame transformer bank consists of 3 high voltage conductors and 3 single phase 12KV 167KVA transformers installed on a platform in a H configuration.</p> <p>The H frame is constructed of 2- 40 foot treated class 2 wooden poles supported by steel u channel beams and wooden planks horizontally for the transformer platform.</p> <p>The high voltage conductors are attached at the cross arms at

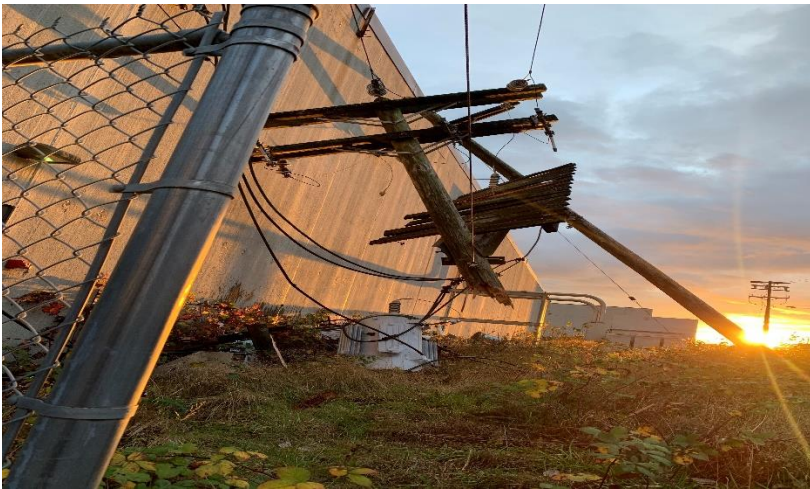
<p>A gust of wind caused side loading on an old class 2 wooden pole causing it to break.</p> <p>The structure would then twist and collapse. (See photo #1)</p>
Causes and contributing factors	<p>The class 2 pole was dry rotten due to age. The pole was subjected to a moist environment for more than 40 years.</p> <p>The life expectancy of a treated pole is around 50 years.</p> <p>It is highly likely the lack of ongoing preventative maintenance on aging infrastructure was the cause of the incident.</p>

(Photo #1) High voltage transformer platform collapsed

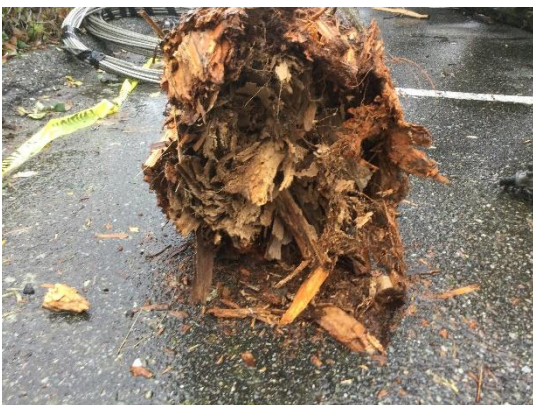
(Photo #2) West pole dry rotted out at base where subject to years of wet soil.

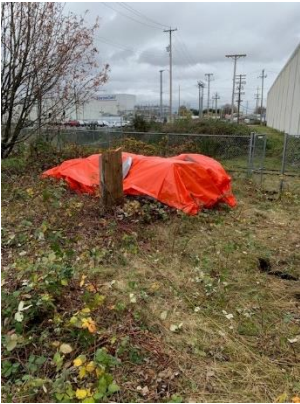
Failure scenario(s)	<p>During a wind storm, the overhead H frame structure was subjected to heavy side wind loading.</p> <p>The west wooden pole broke off at the base level, the H frame structure twisted and the other east pole broke (see photo #3), the structure then collapsed onto the side of the building.</p> <p>The twisting of the structure caused the high voltage conductors to contact each other and short out.</p> <p>The primary conductor high voltage fused cut outs were blown open from the line to line short before the structure landed on the side of the building.</p>	
	Facts and evidence	<p>-The H frame structure was aging infrastructure from the 1970's.</p> <p>-The class 2 wooden pole was dry rotted at the base (see photo #2 and #4) and it supported three 1600lbs transformers.</p> <p>-There was no annual electrical maintenance program for the aging pole line.</p>

(Photo #3) east pole

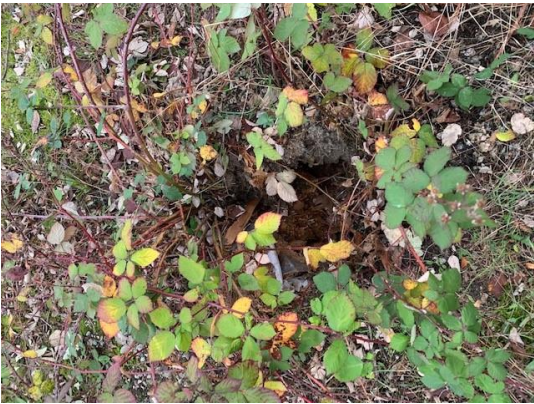
(Photo #4) west pole base in soil
